Facility Infrastructure Safety & Repairs

Lakeview Junior
High School

Prairieview
Elementary School

Health Life Safety Survey

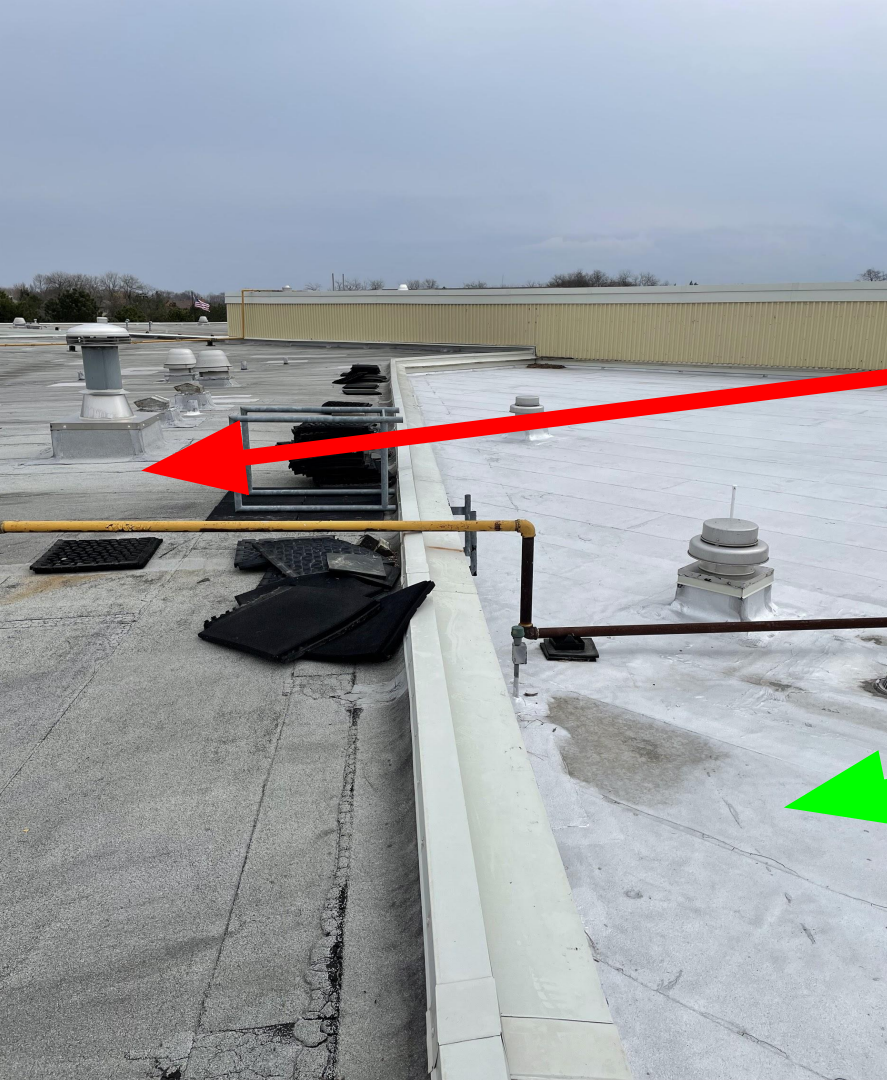
Lakeview- Roofing

- Roof on the left side of the photo-approximately 22 years old. Roof Sections 1-3
- Roof on the right side of the photo-newly replaced in the summer 2021. Roof Sections 4 & 5
- Has been on Master facility plan reports since 2014 (LEGAT architects)
- Undergoes semi annual maintenance.

***Beyond useful life & warranty and has repeatedly been repaired. In significant danger of insulation saturation and leaks, leading to structural integrity compromise and mold*-HLS**

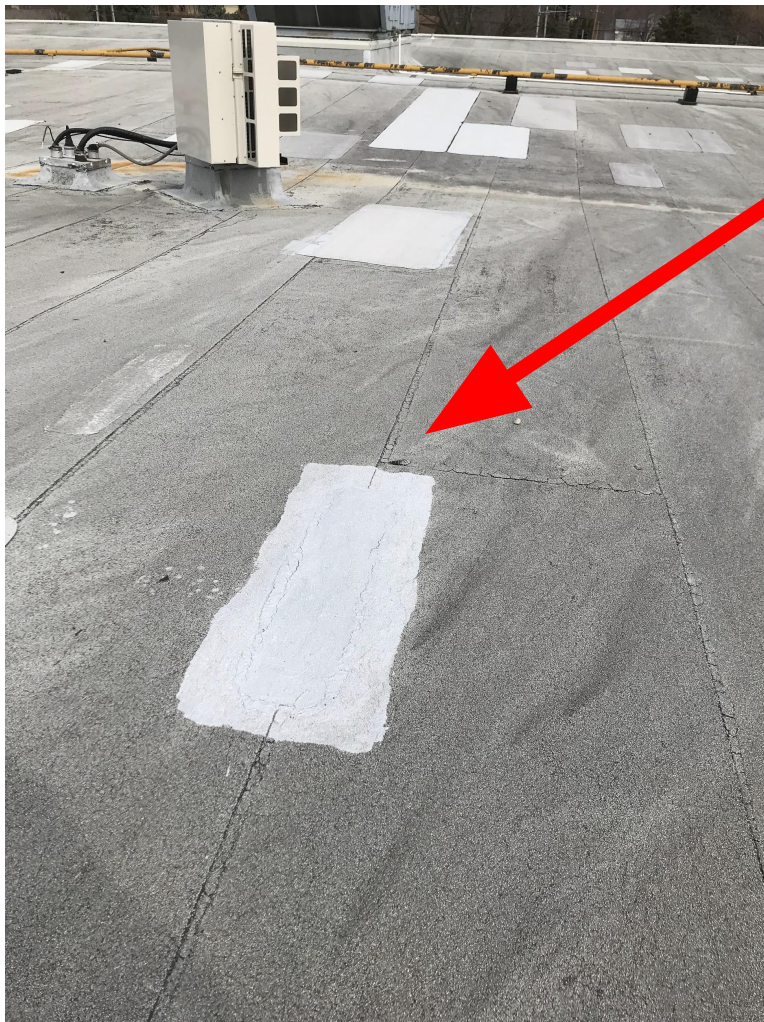
On the Left-
see patches that
have been made-
varying shades of
silver/gray.

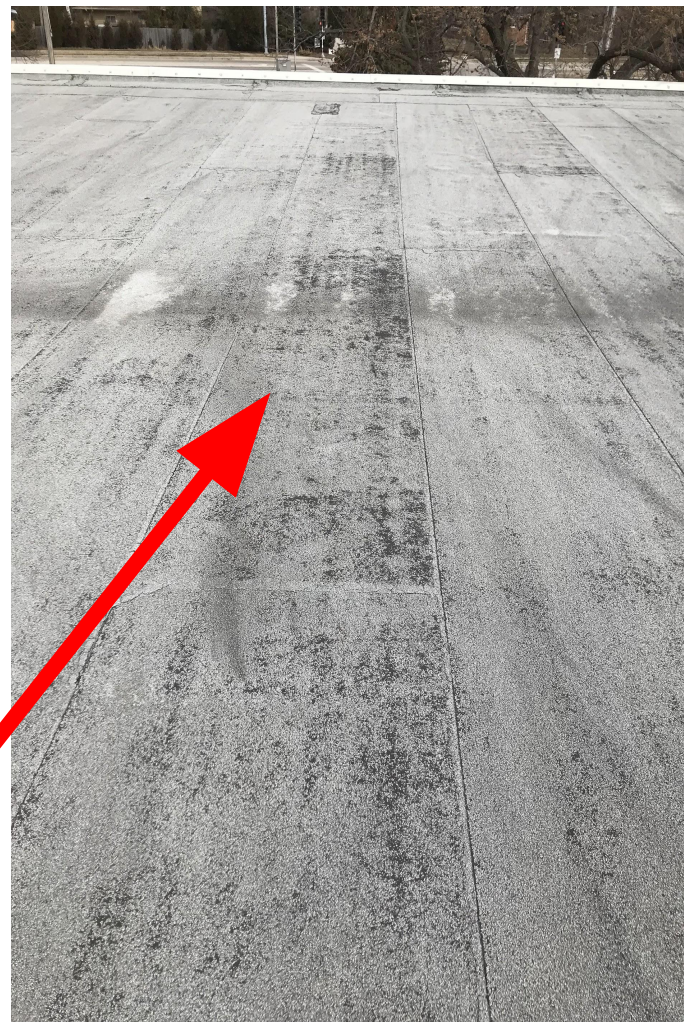
On the Right-
see the darker
sections where the
silver/gray color is
wearing thin- this
shows the bare
rubber of the roof
membrane.

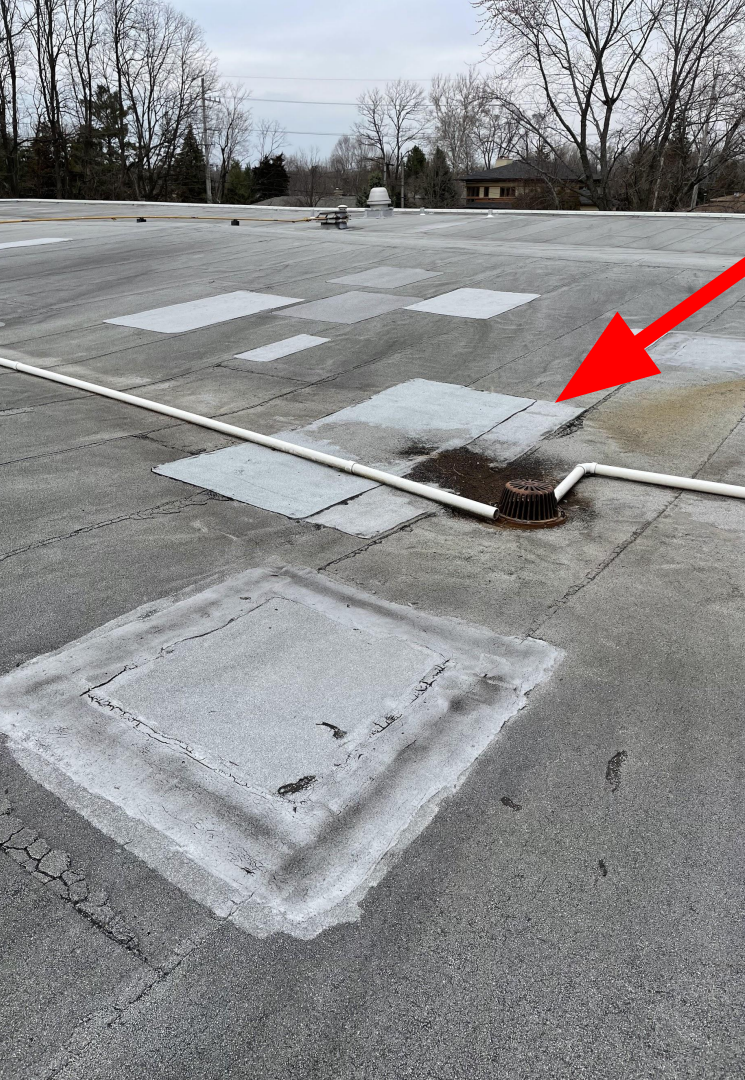
On the Left-
some larger
patch areas and
a roof drain.

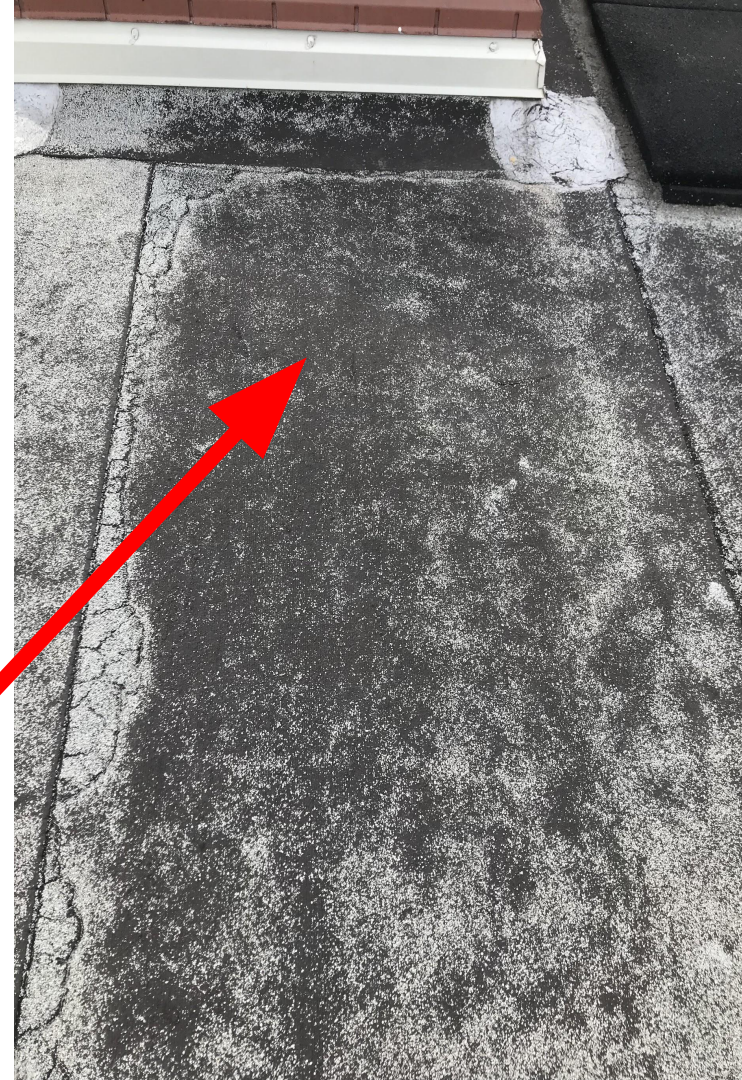
On the Right-
heavily degraded
section of surface
coating.

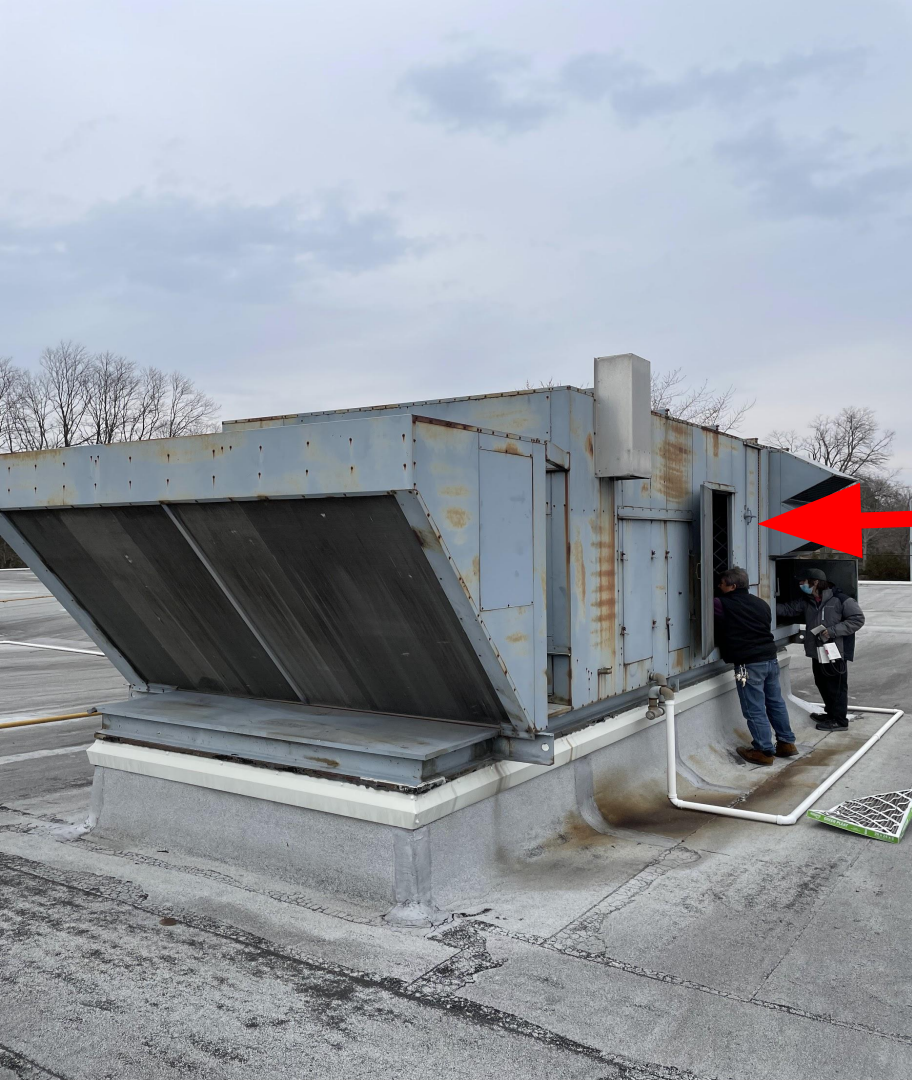
HVAC

- 7 total RTU's (Roof Top Units)
- Multi Zoned air handler
- Units heat & cool (not simultaneously)
- All 7 units have been on Master facility plan reports since 2014 (LEGAT architects)
- Units undergo quarterly filter changes and semi annual coil cleaning.

***Units have outlived their useful life according to ASHRAE standards.*-HLS**

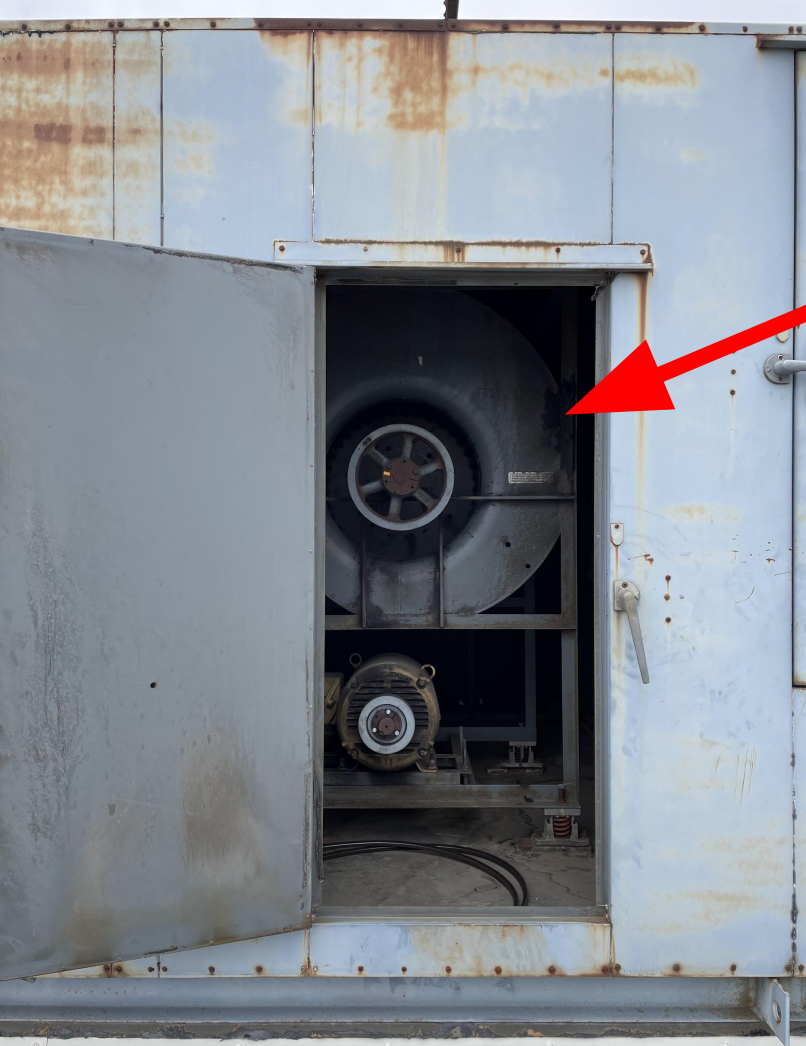
Fan Cage Assembly

- Rusting structures of blower fan cages.
- All repairs of any structural part is no longer available- requiring welding/fabrication.
- Quarterly belt changes

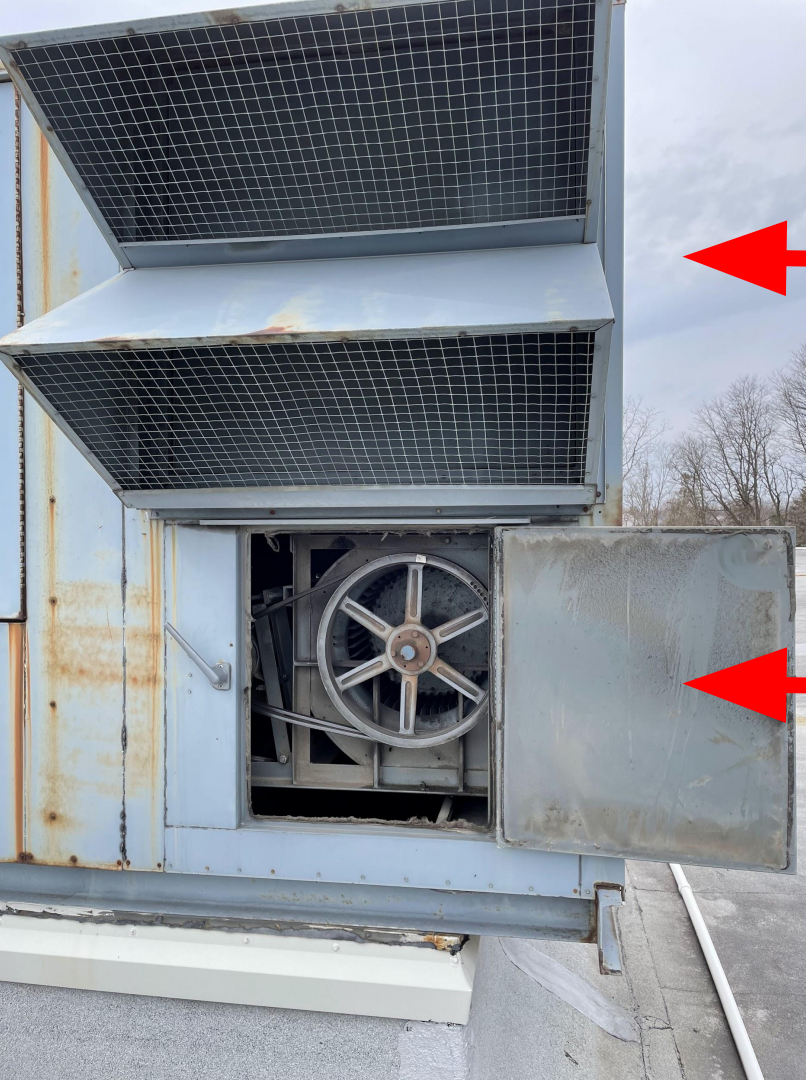
- Heating air intake and damper control section
- Inability to control dampers via BAS system. (manual set by season)

- Fan cage assembly parts require fabrication if failure
- Doors/hatches operation affects efficiency of units
- Quarterly belt changes

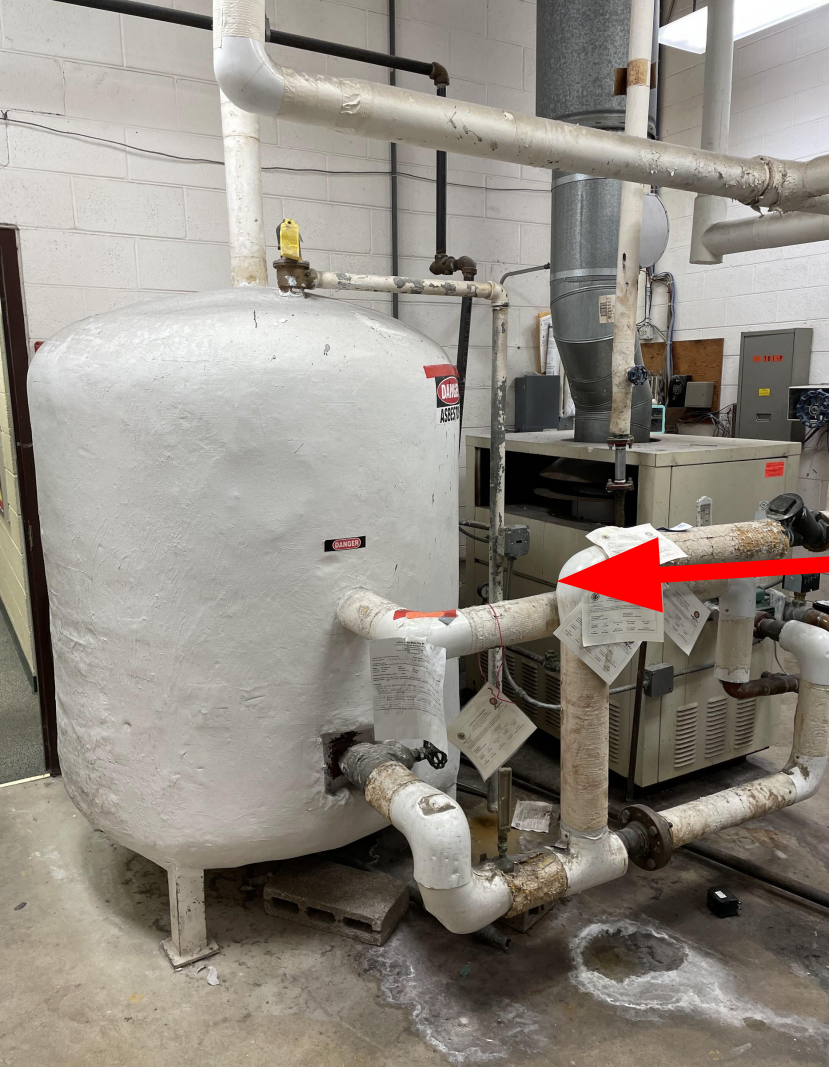
Lakeview- Hot Water Boiler

- Estimated last replaced in 1995
- Tank & pipe insulation contains the last known asbestos in the building. (current asbestos plan is up to date and monitored by PSI-Intertek.)
- \$50,000 maintenance grant has been awarded for replacement during 2022.

***Water heater & storage tank are showing signs of failure* -HLS**

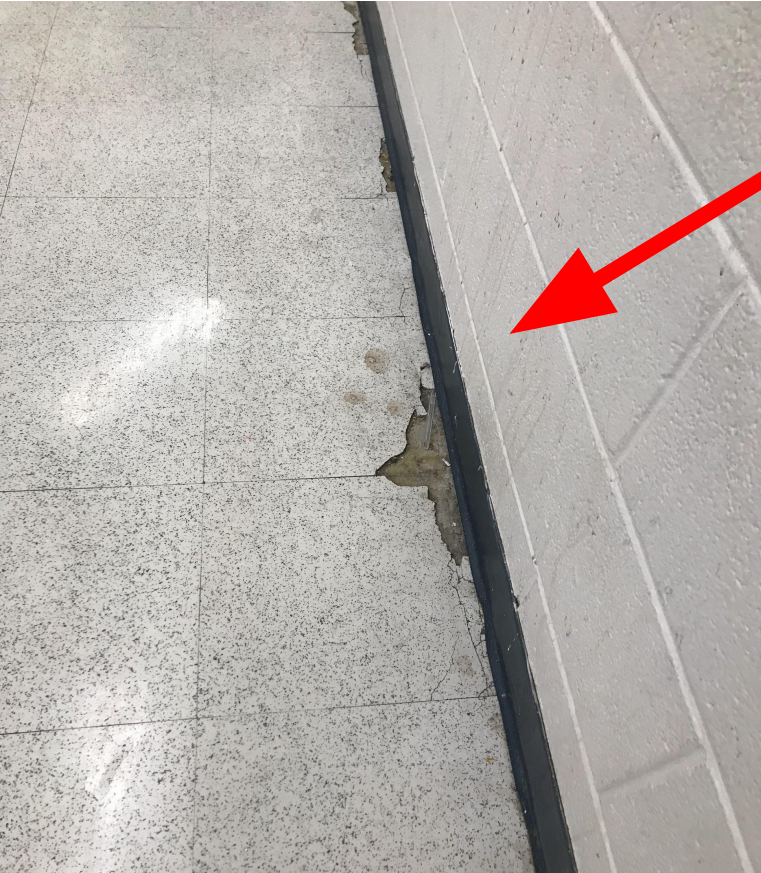
Prairieview
cracked floor tiles.

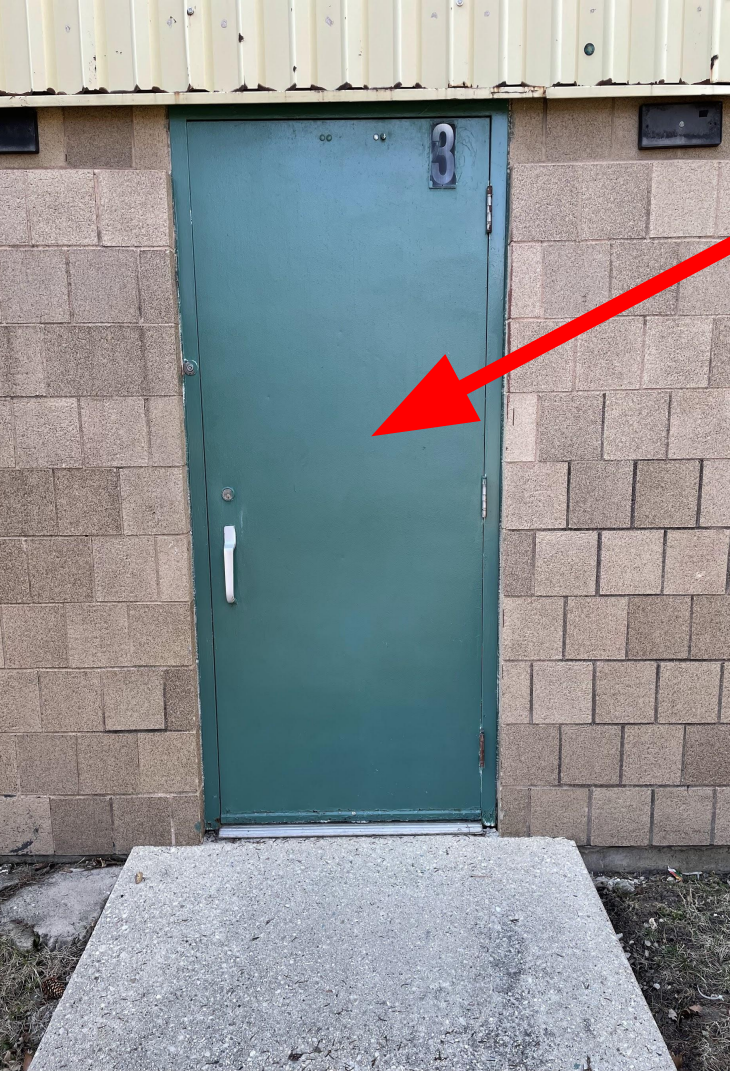
- Many of the exterior doors are suffering from rusting sections, rotting & broken sills & unlevel/unsealed sections based on exterior concrete settling or cracking
- Door hardware and functionality is inconsistent throughout the building.

On the Left-
an original exterior
door.

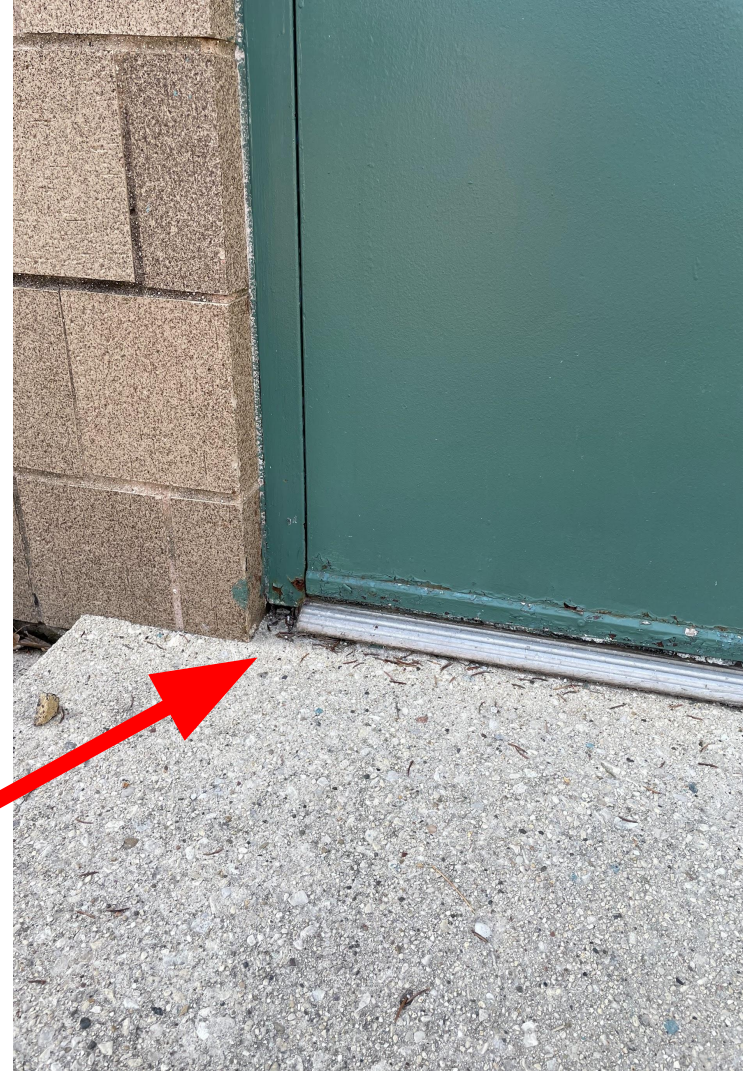
On the Right-
signs of rotting of the
door frame.

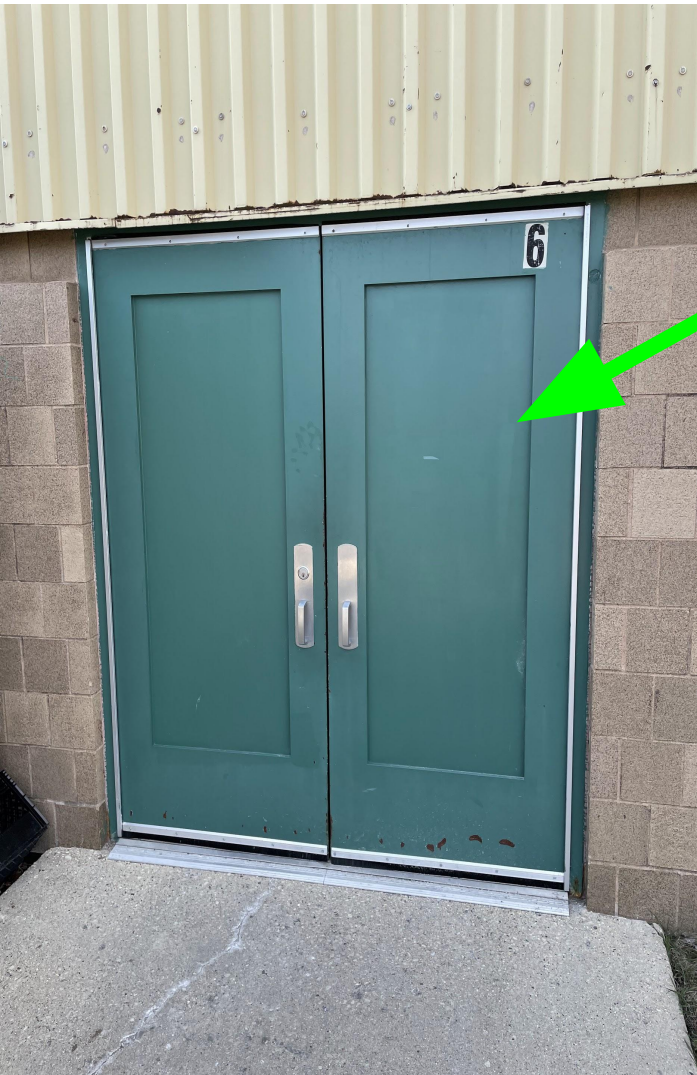
On the Left-
example of
repurposed older
doors. Removed
glass, welded
steel plate to use
as Gym exit
doors.(Done in
house)

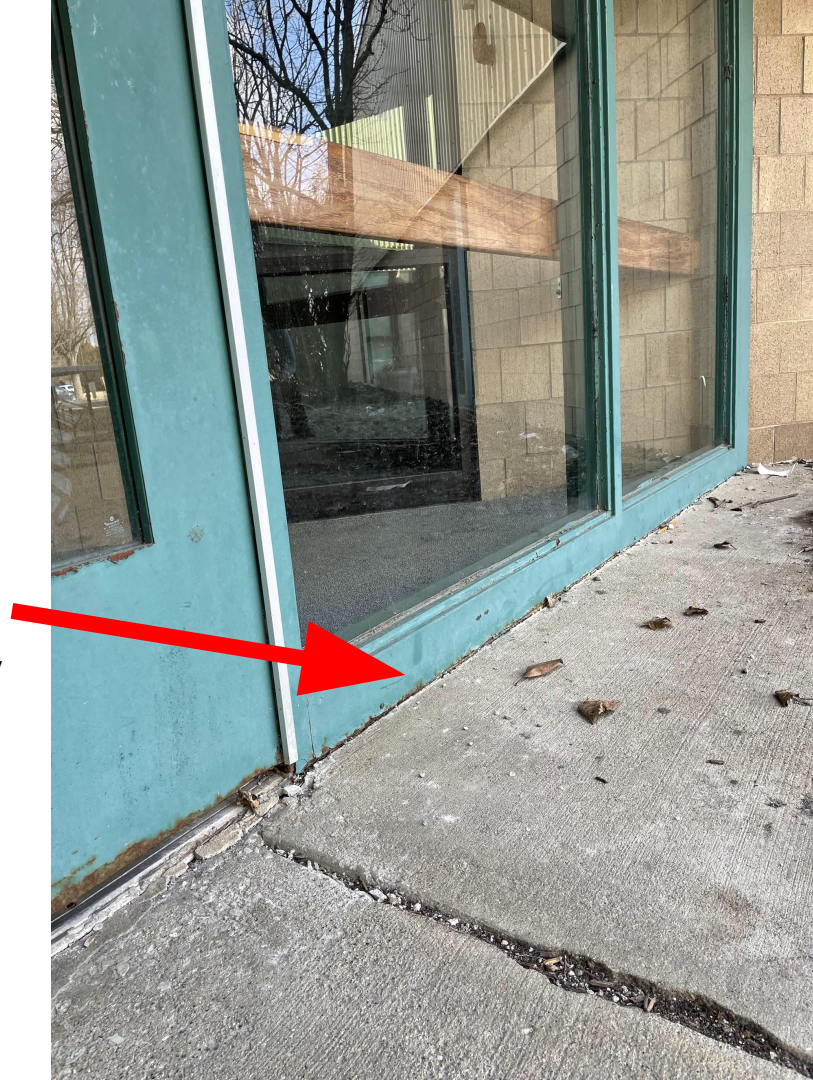
On the Right- many
original windows &
frames are also in
need of attention.

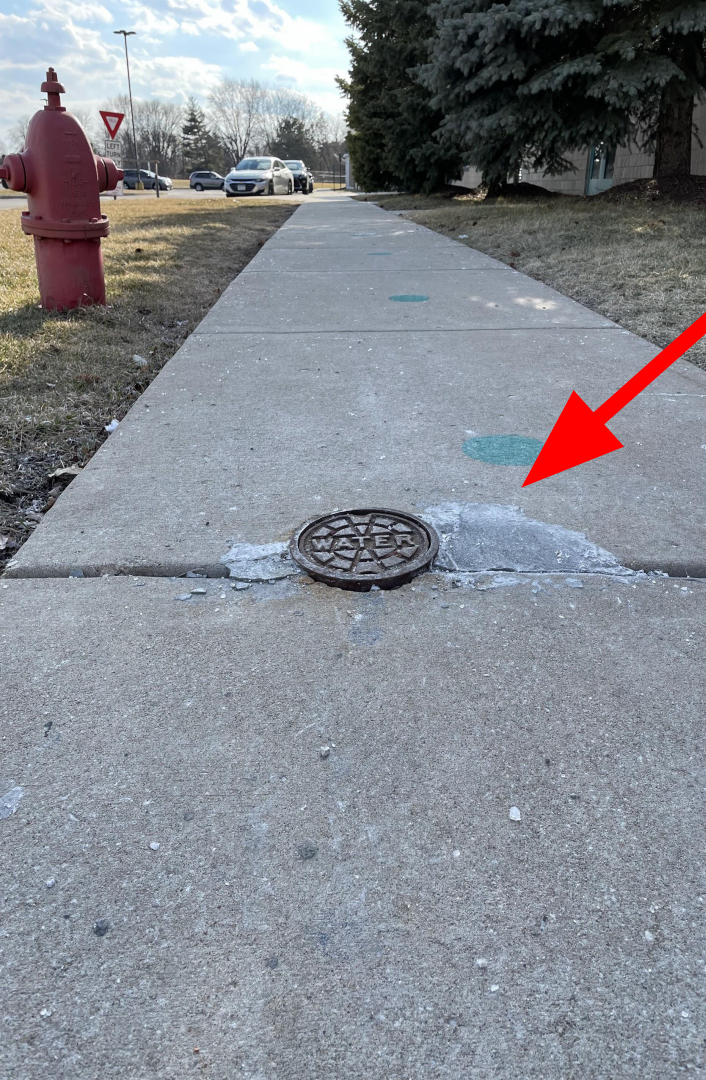
On the Left-
example of a self
patched hazard and
raised water service
access trip hazard.

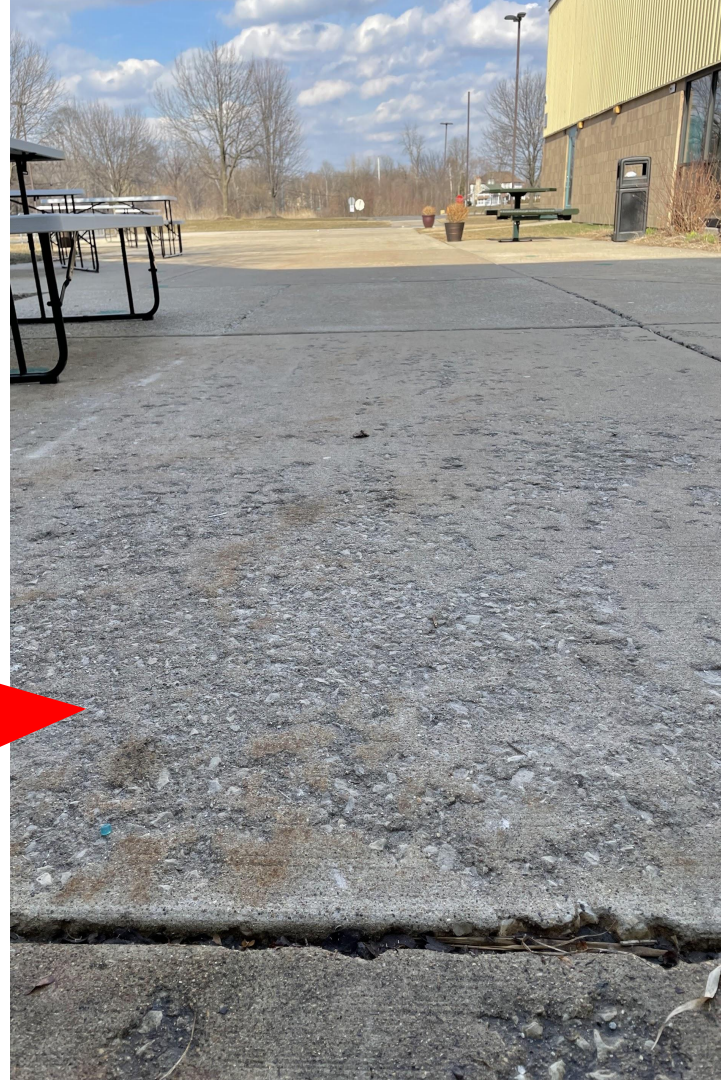
On the Right-
example of the pitting
& popping that
occurs over time and
degrades concrete.

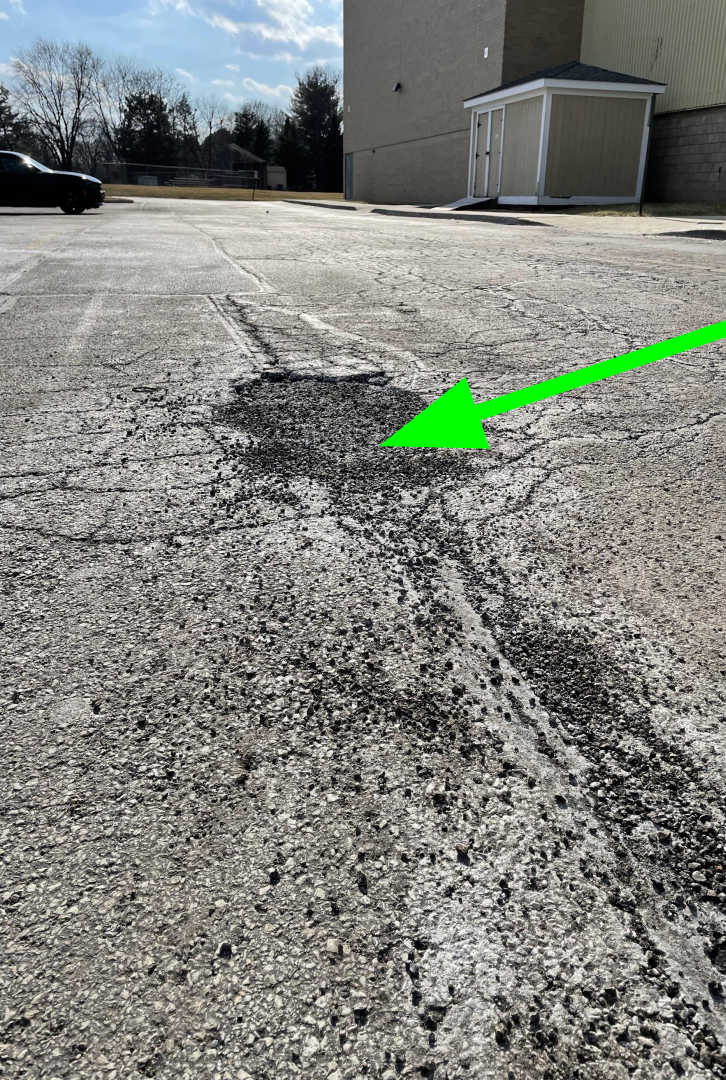
On the Left-
example of potholes
patched. (patched in
house as needed)

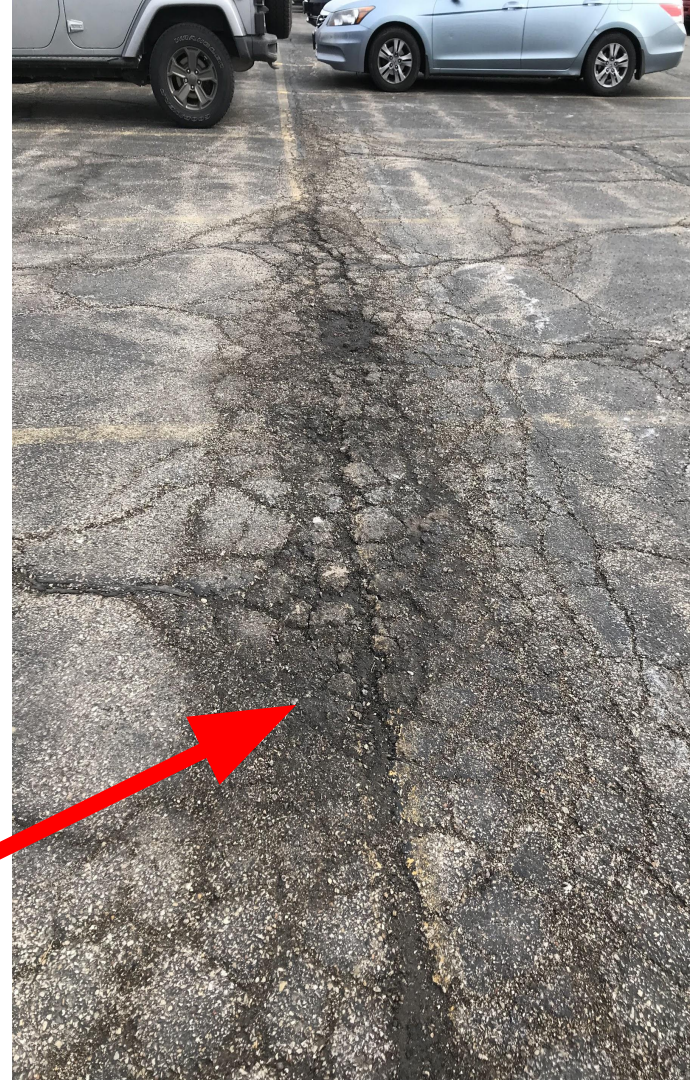
On the Right-
example of fatigue
cracking of the
asphalt.

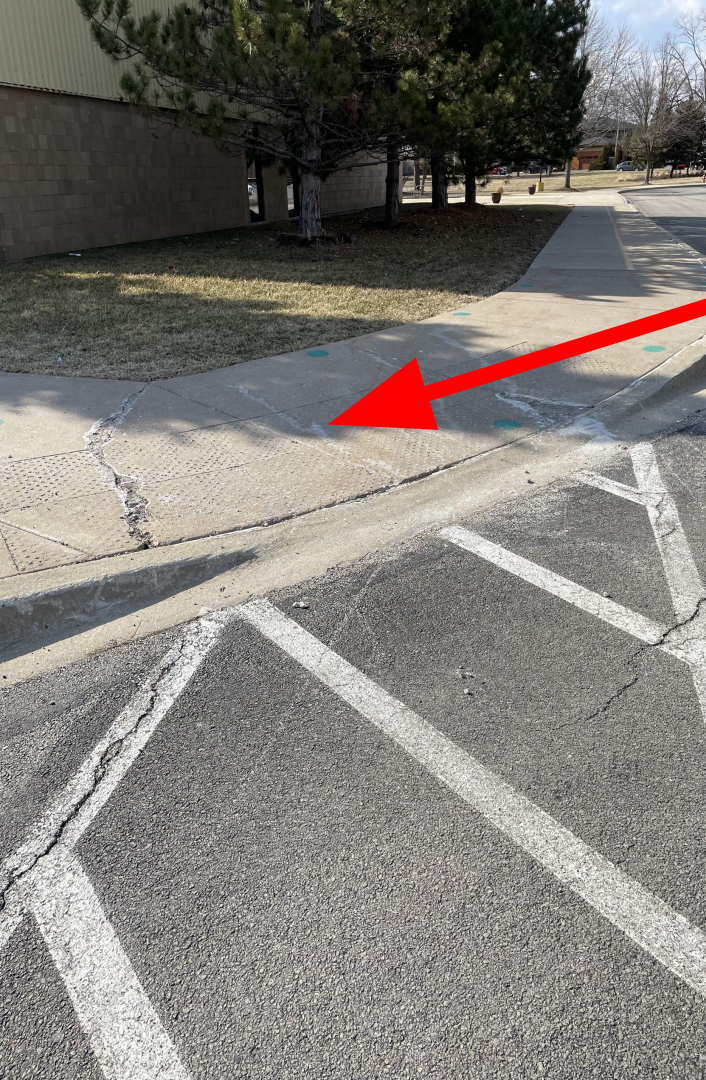
On the Left-
cracking sidewalk
ramp. Also missing
current ADA pad &
current specs.

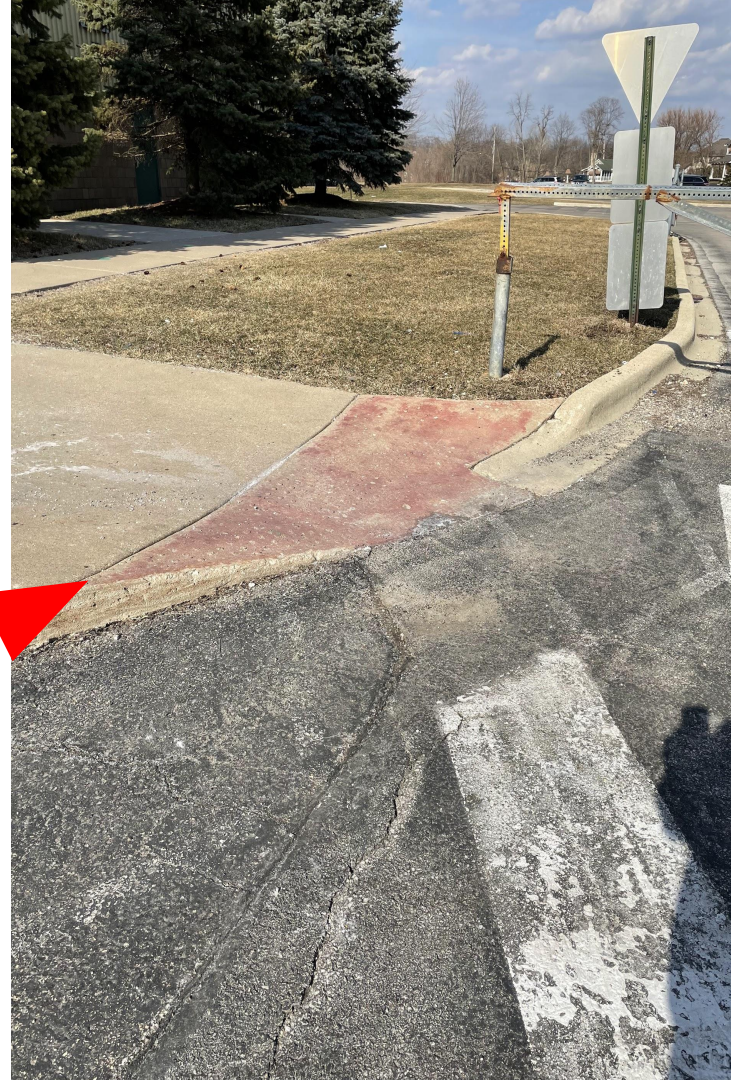
On the Right-
example of an
insufficient sized
access ramp W/out
current ADA pad.

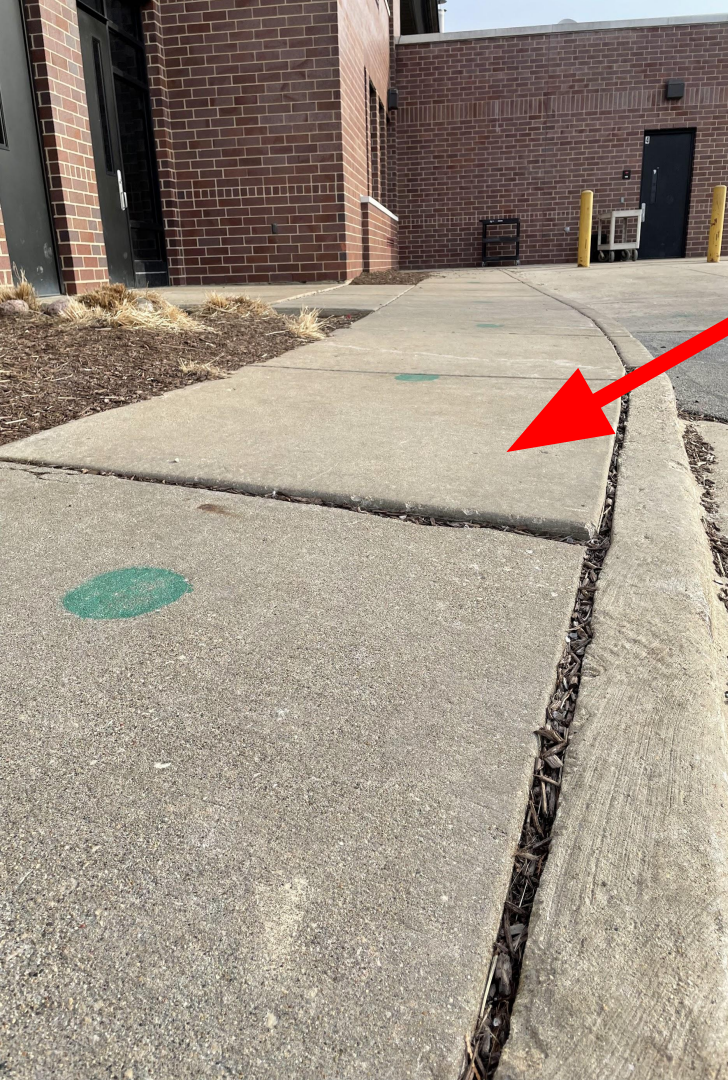
On the Left-
example of height
differences at
Prairieview.

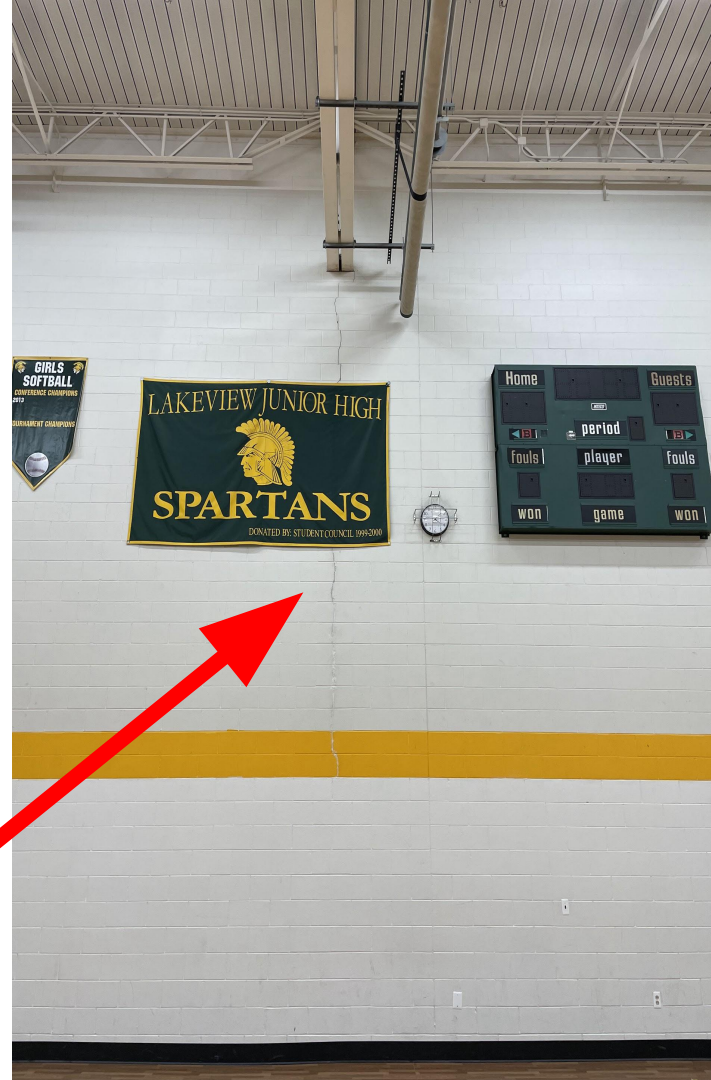
On the Right-
vertical crack in wall
block-Gym 2 at Lakeview.

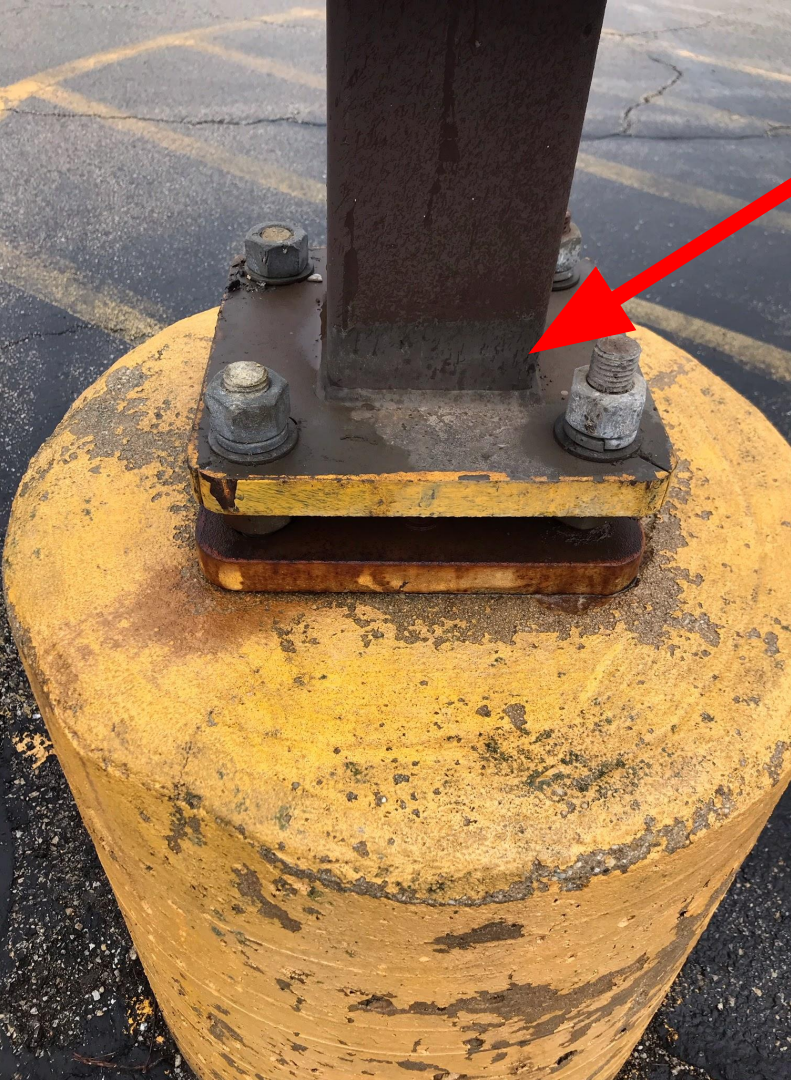
Rusting base

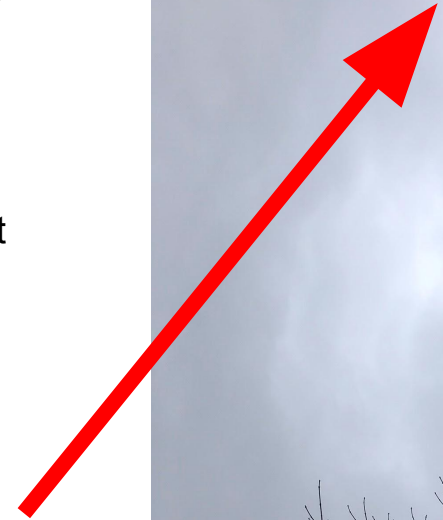
Missing head
