## Halifax Area School District

Elementary School Facilities Assessment  
January 24, 2017

Halifax Area School District  
Existing Facilities Report – Enders-Fisherville Elementary School  
791 Enders Road, Halifax, PA 17032

## Halifax Area School District Existing Facilities Report – Halifax Elementary School 3940 Peters Mountain Road, Halifax, PA 17032

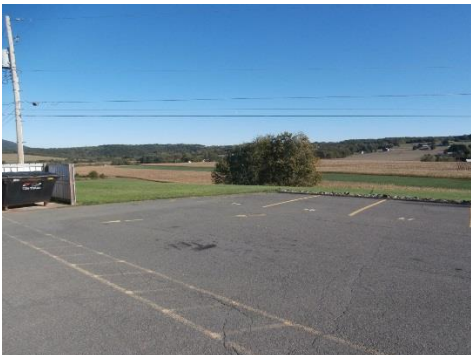
*Looking east at paving (note rock lined stormwater facility behind curb at right)*

Sidewalks and Paving: The sidewalk along the front of the school appears to be in good condition and provides a flush section to allow for handicap access (though the ramping in this area may not be ADA compliant with respect to areas of flat walkway beyond the limits of the ramp). The concrete curbing along the described sidewalk appears to be in satisfactory condition. There is a bituminous curb along the southern most parking spaces that has cracks in numerous locations allowing vegetation to grow between the curb and the paving itself (which may or may not have been intentional in order to allow drainage to pass through the curb into the stone-lined area behind). Sidewalks along the rear of the building are nominal and solely provide access from the edges of paving to the modular building entrances located on this side. There is no curbing on the back (or east) side of the school. Paving across the site generally appears to be in satisfactory condition with some areas of cracking.

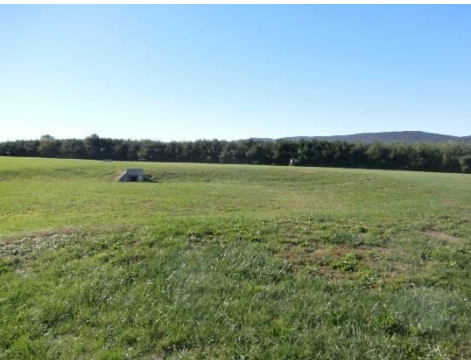
*Stormwater management basin*

Storm Water Management: There is a single detention basin at the northeast corner of the building which was likely constructed in conjunction with the modular units. No pipes were observed discharging into the basin but it appears that some of the roof drains on this side of the building may discharge at grade and sheet flow into this basin. There did not appear to be any storm sewer inlets along the front or back side of the building. This basin discharges to a level spreader that overflows to the adjacent grade and runs towards the northern portion of the site. There is also stone bed/trench just behind the bituminous curb located along the southern most parking spaces which may be utilized to collect surface stormwater runoff from the adjacent parking area/driveway (no discharge of any kind was observed from this facility).

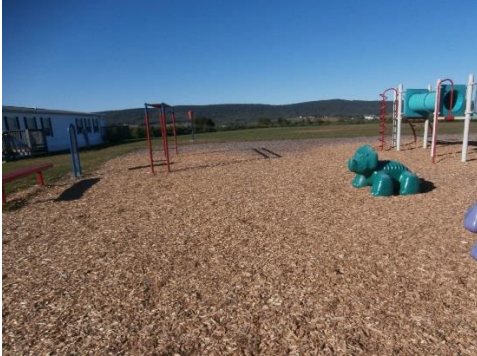
*Soft surface play area*

Play Areas: A large “soft surface” play area with multiple pieces of play equipment is located on the east side of the school. The equipment and the overall state of the play area appears to be in good condition (note that there is no fence surrounding this play area). A “hard surface” play area is located between the soft surface play area and the school (note that this area is also used for daily parent drop-off/pick-up and appears to accommodate overflow parking for large events). This paved area is in satisfactory condition with two basketball hoops and backboards on either end. There is a utility pole and guy wire located just off the edge of the south side of this play area that can present safety concerns for students at play.

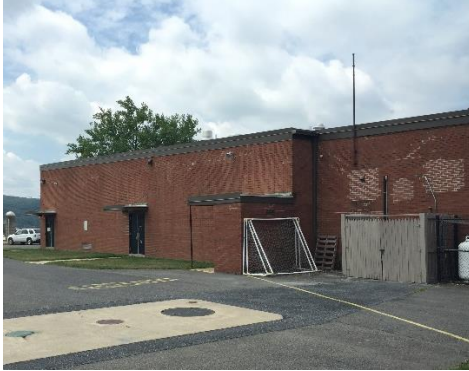
Detail of existing brick

Facade: The exterior facades are primarily brick veneer with CMU backup. Areas of glazing have been infilled with EIFS on most of the perimeter. There are many areas where surface deterioration is evident. Many of the window heads have deteriorating flashing. Caulking around windows and at control joints are showing signs of aging in a majority of areas. Exterior lighting is outdated. In general the exterior is in fair condition with areas of poor condition noted.

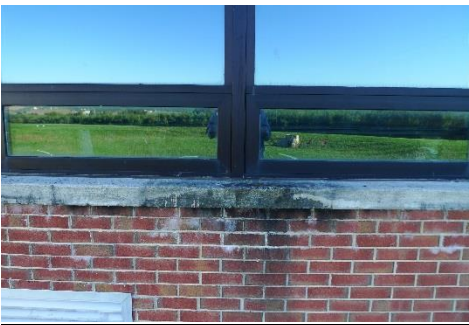
Detail of existing sill deterioration

EES.EX.02 Repair deteriorating sills.

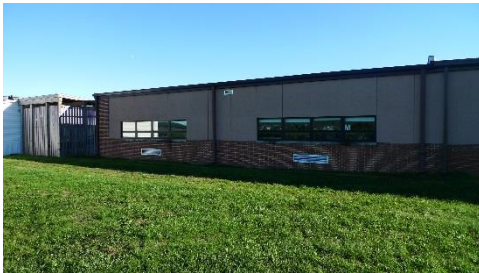
Brick/EIFS/Fenestration

Fenestration: Windows are in poor condition showing signs of age and are in need of replacement. Several of the frames and glazing had been modified to accept window A/C units. Exterior window sills show signs of water infiltration and damage. The window frames and seals have exceeded their life cycle. Some exterior doors were not well protected and show signs of damage.

EES.EX.04 Replace windows as required.

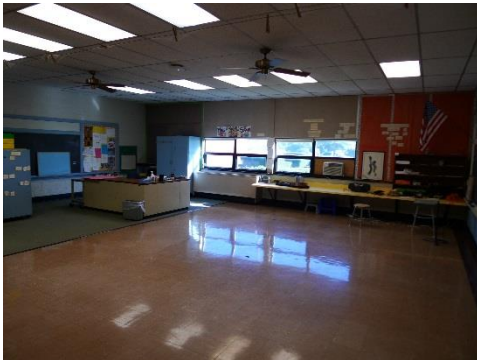
Flooring: Most of the corridors in EES have VCT flooring. Classrooms are a mixture of full carpet, full VCT, or a combination of both. These are in fair condition. The library is primarily carpet with an adjacent room of VCT. The nurse room is carpet. The main entry is VCT and the front office is carpet. In most locations the floors are in fair condition showing signs of aging.

Classroom flooring

**EES.BI.01 Repair damaged flooring and base.**

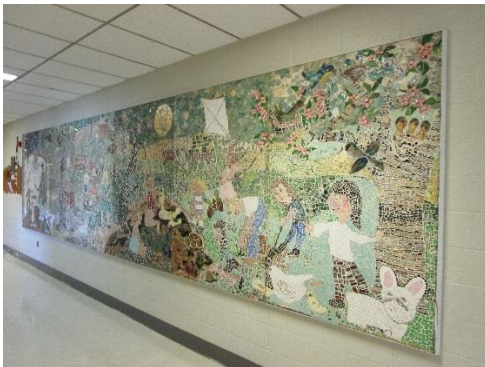
Mosaic to be preserved

**EES.BI.03 Consider providing protection to wall mosaic.**

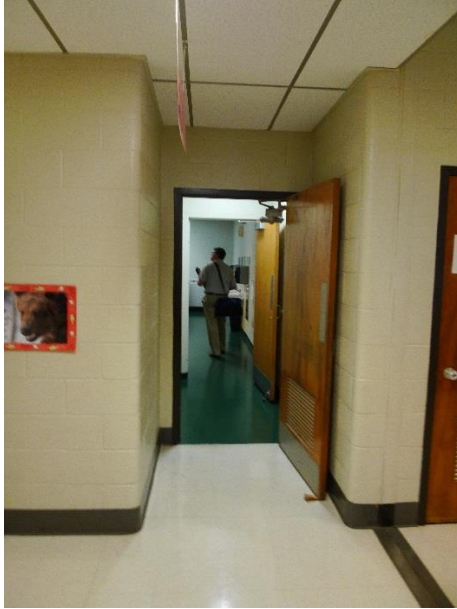
Approach to restroom

EES.BI.07 All hardware and fixtures should be replaced with equipment compliant with current ADA requirements.

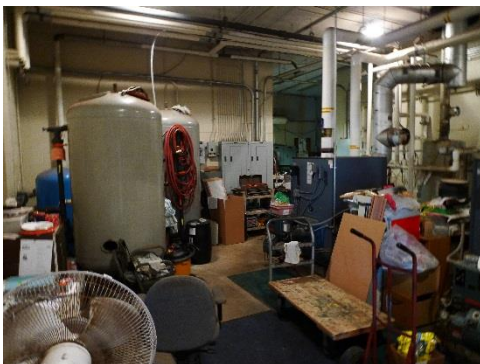
*Existing mechanical room*

The boiler room contains two Weil McLain 588 oil-fired cast iron hot water boilers that were installed in the late 1990's. Base mounted pumps distribute the heating hot water through the building in insulated copper piping. The pumps are in need of replacement (one has had a motor replaced). Vertical piping

contained in concealed locations or drops within existing block walls are most likely original to the building. An underground fuel oil tank is located outside of the boiler room. A leak detection system is present. Each boiler's breeching has a barometric draft control damper. An automatic glycol feed system is present in the heating water system. The Webster burners are functioning adequately. The outside air intake for the boiler room does not have an interlocked control damper on it and it is currently blocked. The ASHRAE Median Service Life for the boilers and burners are 35 and 21 years respectively. The boilers themselves appear to be in fair condition but other components of the system are overdue for replacement.

EES.HVAC.01 The boilers are in fair condition but the auxiliary systems associated with the central heating plant are in poor condition and should be replaced.

EES.HVAC.06 The burners and fuel oil duplex pumps show signs of oil leakage and should be replaced. They are near the end of their projected life cycles. Additionally, blending pumps should be provided to prevent thermal shock and extend the lives of the boilers.

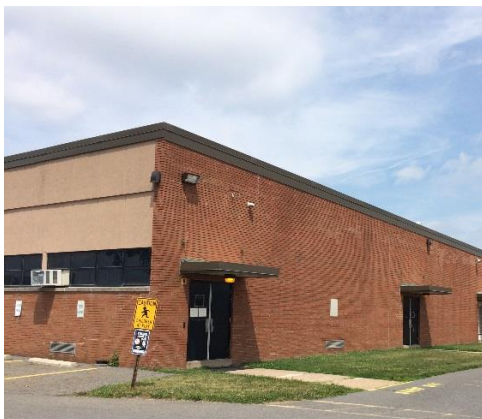
Auxiliary air conditioner at multi-purpose room

Several spaces, including some of the administration suite spaces, the server room, the cafeteria and select classrooms have through wall packaged terminal air conditioning units (PTAC's). Outside of the administration suite these units are technically through-window units. The district noted that certain students have medical conditions that are exacerbated at higher temperatures so the PTAC units move around the building annually with the students. The PTAC's provided to condition

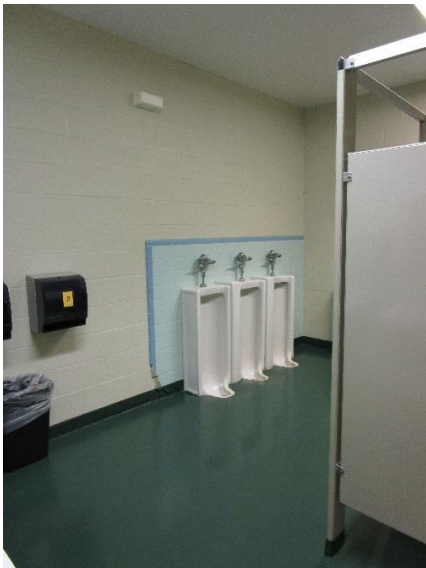
*Original plumbing fixtures*

**Plumbing Fixtures:** Most of the plumbing fixtures appear to be original with some replacements during the renovations and in most cases are in poor condition. There are no ADA/Accessible fixtures based on the current regulations. Most faucets are not provided with low flow as required by the current plumbing code. Also, tempering valves required by current IPC plumbing codes at public handwashing lavatories have not been installed. Most flush valves are old and it is likely that the flushing volume is more than 1.6 gpm.

EES. PLUM.05 Overall most plumbing fixtures are in poor condition and should be replaced with new low flow fixtures and low lead compliant faucets. Renovations to the toilet rooms should address any ADA/Accessibility issues as well as current water conservation requirements and the "Reduction of Lead in Drinking Water Act". Remaining fixtures should be updated to ANSI A117.1/ADA compliant accessible fixtures as part of any future renovation. Consideration should also be given to providing ASSE certified tempering valves at handwashing fixtures for scald protection as required by current plumbing codes.

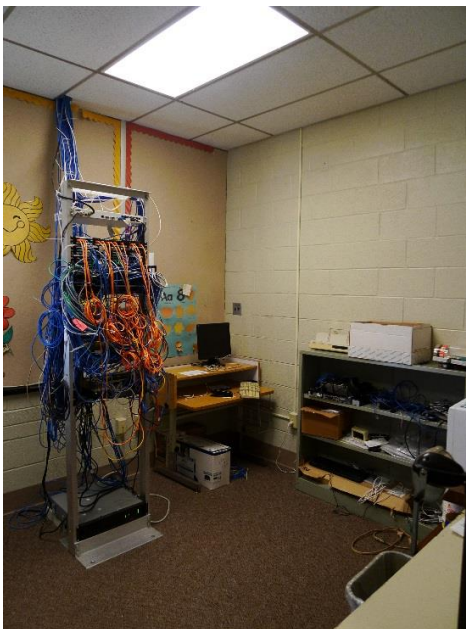
The Main Distribution Frame (MDF) for the building is located in a room adjacent to the teacher's lounge central to the building. The data rack is a full height two post rack without wire management. The building wiring solution is Cat 5E. The MDF is of sufficient size for the rack however wire management should be added for the many cables on the rack. No additional network equipment was observed in the building.

Existing server room

EES.HVAC.09 The PTAC in the server room should be replaced with a ductless split system.

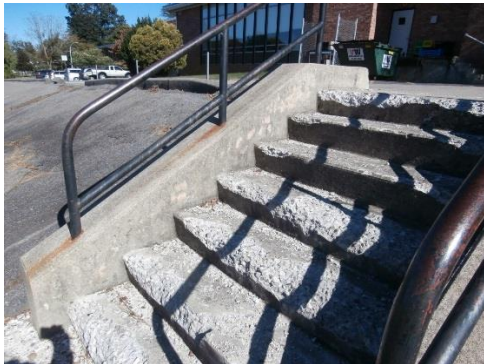
*Deteriorated stairs at rear of building*

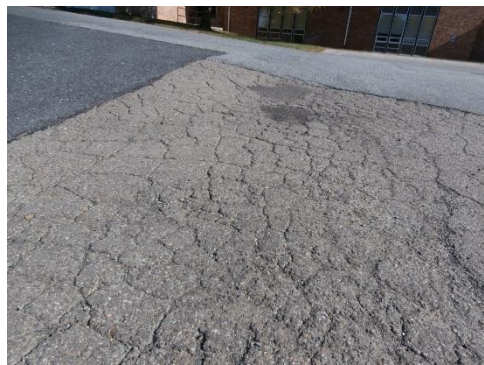
*'Alligatoring' and cracked pavement near staff parking (rear of building)*

Sidewalks along the rear of the building are only short “stub” pieces that provide access from the edges of paving to the building entrances located on this side. There is a set of concrete stairs between the various levels of paving that is crumbling and dangerous for any kind of use. Curb on the back side of the building is limited to small sections of bituminous curb that that are in poor condition.

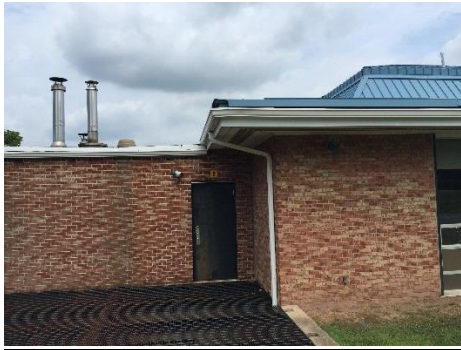
Surface deterioration at roof transitions

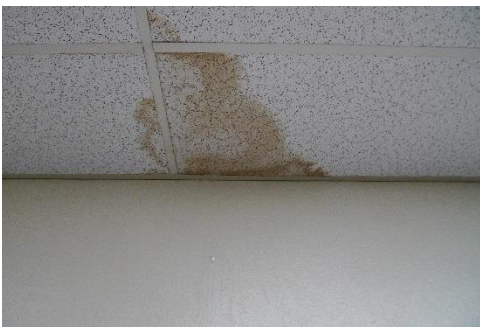
Water damage at upper level ceiling

**HES.BI.03 Replace damaged ceiling tiles.**

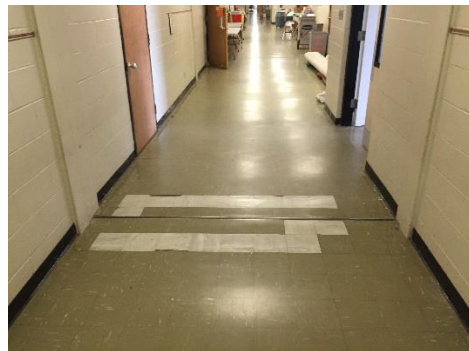
Corridor floor repair and damaged tiles

**HES.BI.01 Repair damaged flooring and base.**

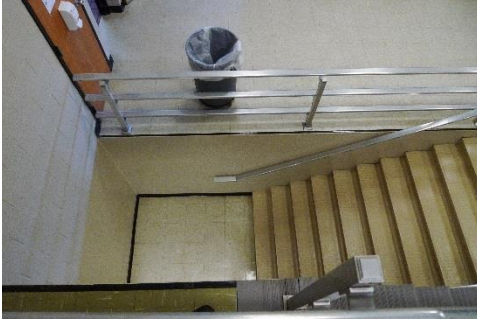
High fall risk at main stair

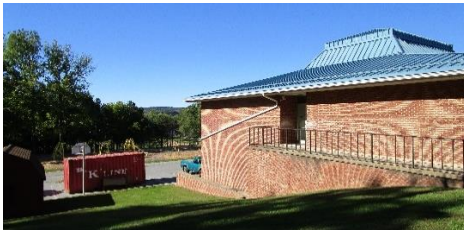
High fall risk at egress path/exterior storage

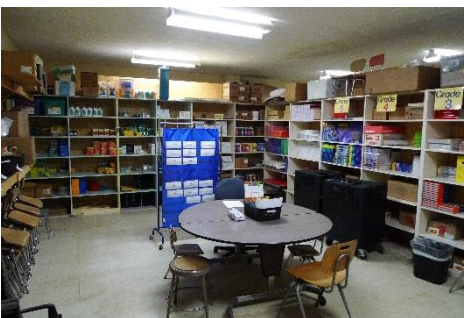
Group Instruction: There are a few small group instruction areas in the school. A reading support SGI is currently located in a windowless storage room on the lower level. The school does not have a large group instruction space.

Reading SGI in windowless storage room

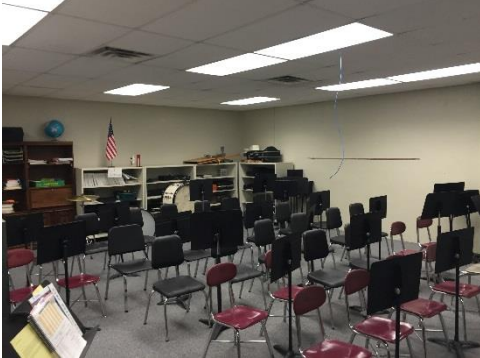
Windowless band and music rooms

HES.ED.08 Consider creating classrooms with access to natural light.

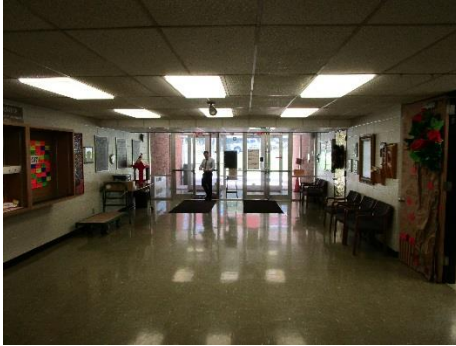
*Existing entrance is not secure*
