# Southeast Local School District

## District Facility Study

## **Southeast Local School District – Facility Study**

# Southeast Schools - High School Assessment

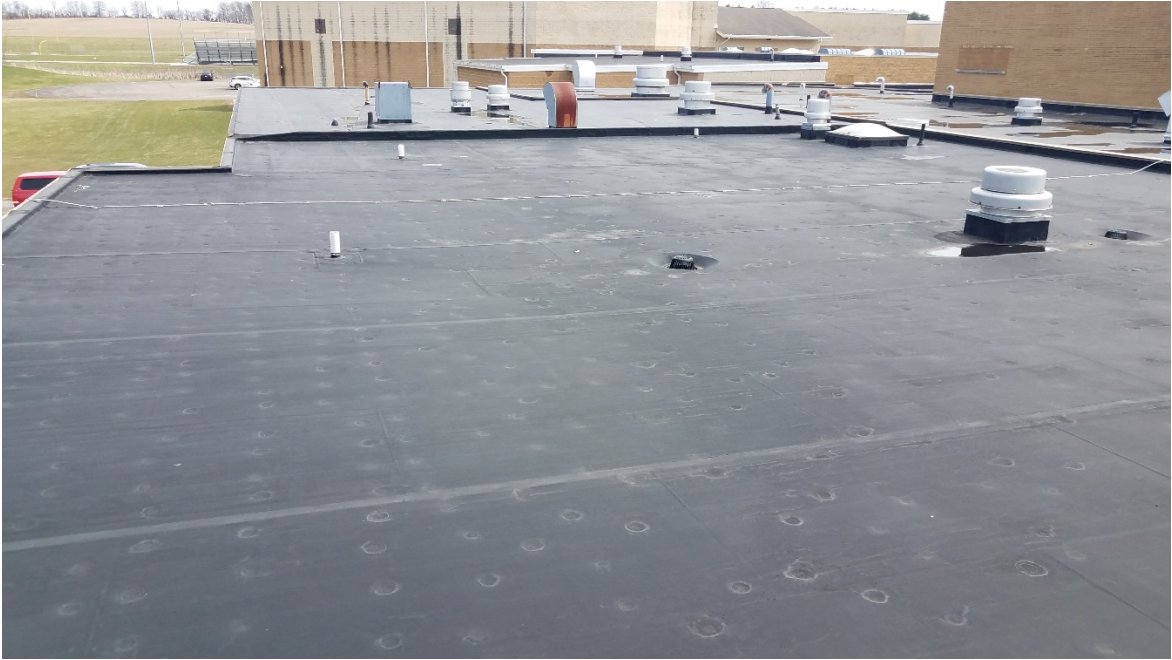
**Description:** The original building has an EPDM system installed approximately 17 years ago and recent leaks have been reported. There are various roof sectors that have small areas of ponding water due to lack of positive roof slope/ drainage. Roof drainage is provided via internal roof drains. While no emergency roof drains have been provided, the low roof edge does provide for emergency overflow. In several areas, roof repairs and patches were apparent. It is our understanding that the district will be undertaking a project in the summer of 2022 to provide new flashing and building edge repair.

**Rating:** 3 Needs Replacement

Roofing at High School

**Recommendations:** With the typical EPDM roof system life expectancy being 20 years, the District should anticipate a roof replacement project in the next 2 to 4 years. While the replacement and repair of roof edge and flashing should extend the life of the roof, the roof membrane and attachment to the substrate may occur. The roof replacement project should utilize a tapered insulation to create positive roof slope/ drainage. The roof replacement should also include the installation of additional roof drains and emergency roof drain overflows in areas without access to a low roof edge

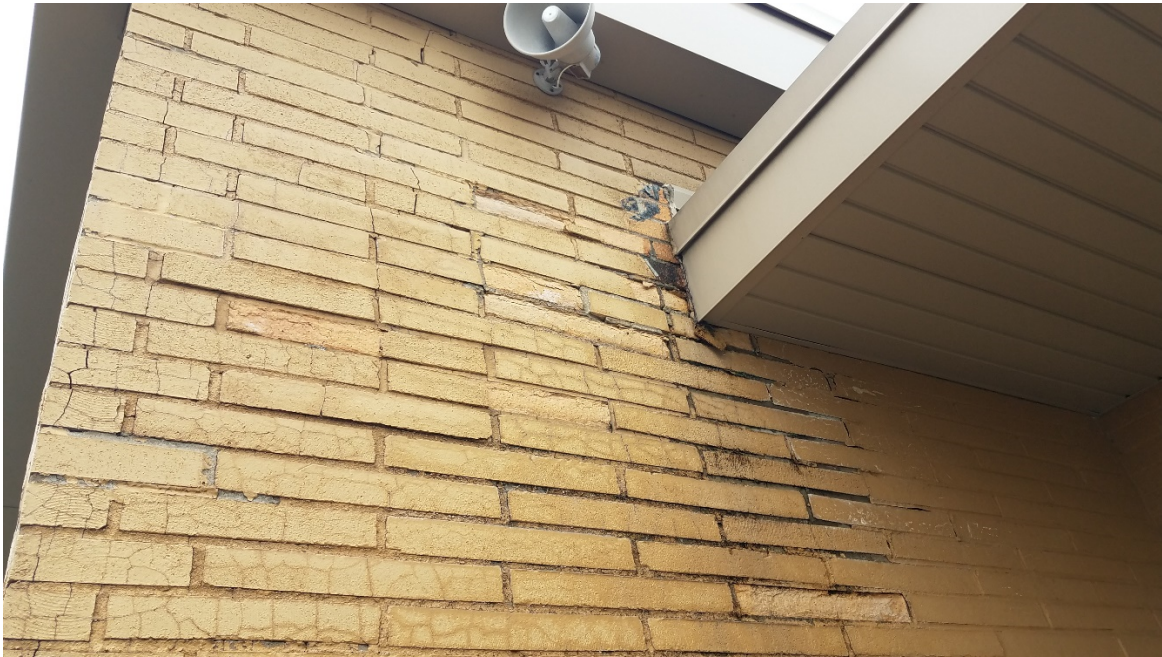
Description: The building exterior utilizes a brick veneer on a masonry bearing wall system that is in overall good condition with the exception of various broken or chipped brick at selected locations (the majority of the broken/chipped brick are located at the west end of the building at the industrial arts wing). The spalling of the brick may be caused by the paint coating that was applied to the brick during the 2005 renovation. While we do not know the specific product used, the use of a non-breathable coating that traps moisture and moisture vapor in the face of the brick could account for the spalling of the brick. Exterior masonry control joints are visible and show signs of deterioration. The brick on the upper portion of the student dining is showing cracking at the corners and appears to be shifting in the lintels above the larger mechanical grills and windows. This area does not have adequate control joints which may account for the cracking. In several locations adjacent to concrete walks, the mortar has deteriorated from the use of salt in these locations. The majority of the building's door and window caulking joints are showing signs of deterioration. The building's brick and veneer show signs of dirt accumulation and staining from the gutters. The interior walls are of painted concrete masonry units and are in overall good condition. There are several locations where cracking is apparent but do not appear to be structural in nature.

Rating: 2 - Needs Repair

Spalling and Cracking Brick at High School

Recommendations: Selected replacement of broken brick veneer, recaulking of building joints, wash entire brick veneer, provide control joints in the Upper student dining area, and repair mortar joints at sidewalks are recommended. It is also recommended that after washing, it would be necessary to either reapply the paint coating on the brick areas, or remove all paint and apply a breathable coating.

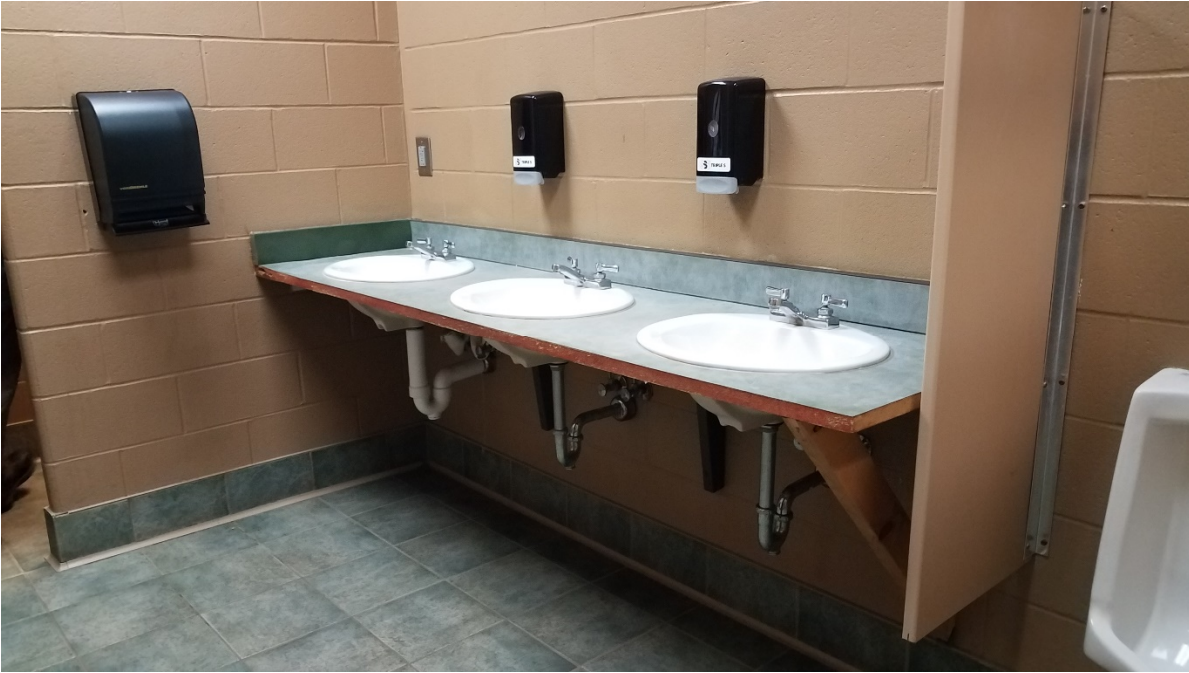
Lavatory Counters in Toilet Rooms

**Recommendations:** Replacement of all carpet. Refinish and repaint gymnasium floor and cafeteria floor. Casework in Both Family and Consumer Sciences and the Chemistry lab should be replaced with updated cabinetry. Fume hood in the Chemistry lab should be replaced depending on curriculum and use. Sink counters in the toilet rooms should be replaced.

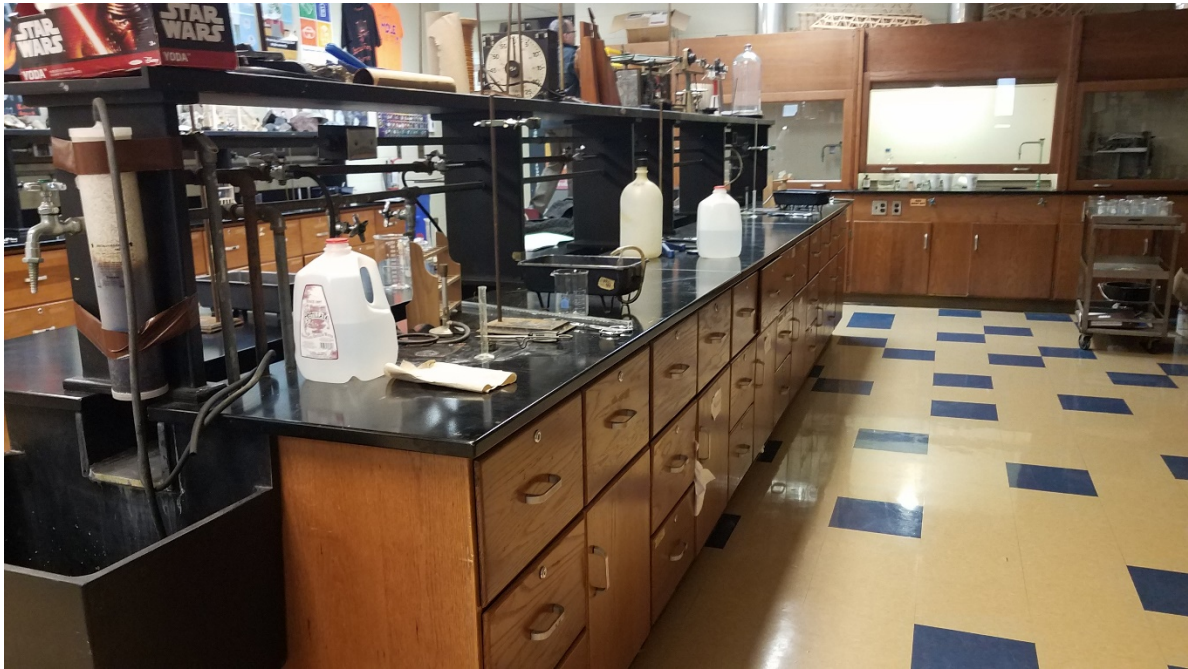
Existing Science Casework in Chemistry Lab

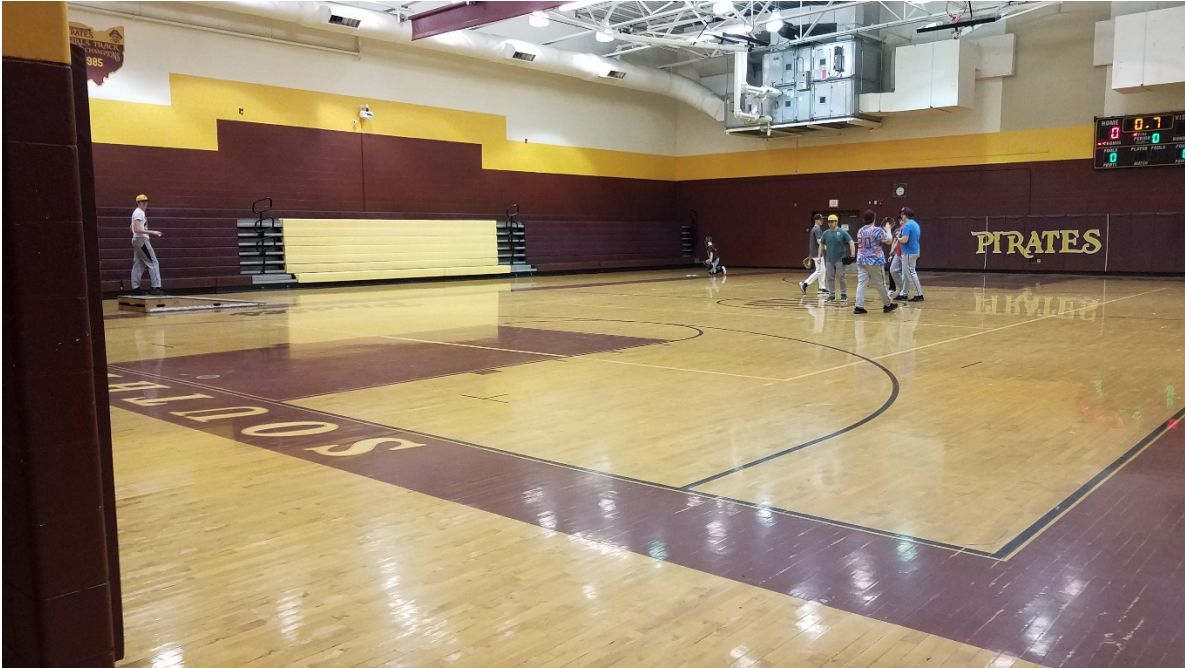
Gymnasium Floor

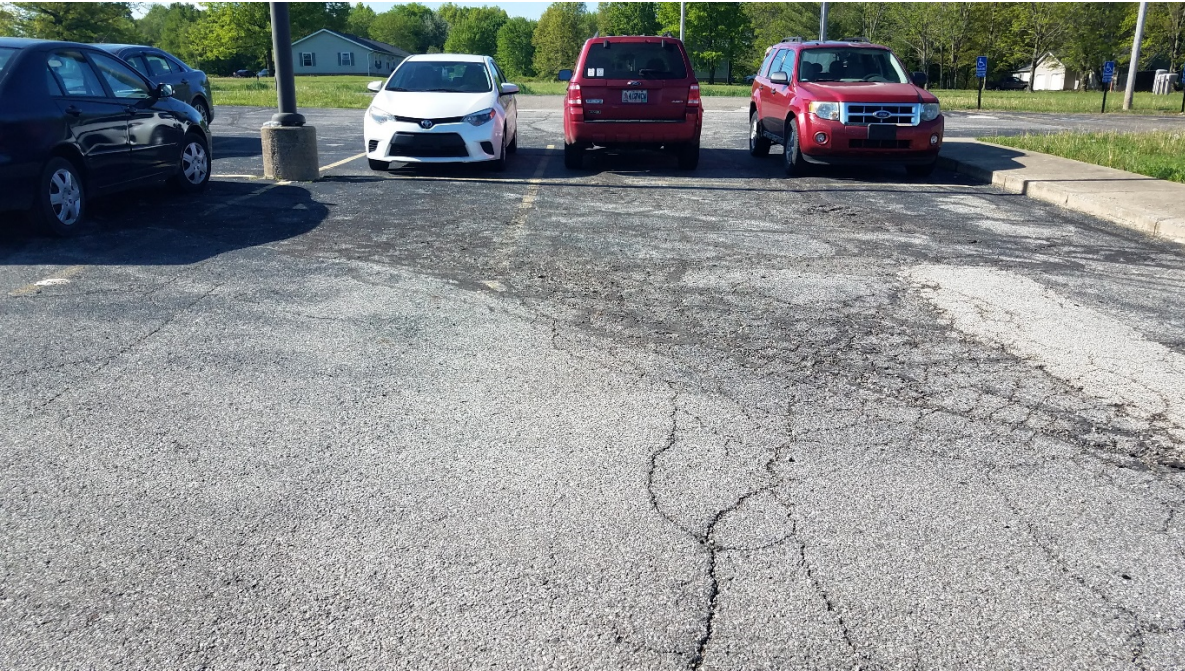
**Description:** The building sits on an approximately 40 acre site which is contiguous with the Elementary School. The site appears to drain adequately using slope and area drains, both in paved and grassy areas. Concrete walks and curbs appear to be in reasonable condition, with some small areas of chipped curbs which we believe is attributed to snow plows. Paved access road in front of the building and front parking area near the stadium are severely deteriorated. There are signs of cracking throughout this section and numerous potholes and some patched areas. The paved area to the west and south of the building appear to have been replaced recently, but could benefit from being sealed to extend the life of the paving.

**Rating:** 2 – Needs Repair

Parking Adjacent to Stadium

**Recommendations:** In areas where pavement has recently been replaced, provide a seal coat and restripe. In areas where the pavement is cracking and has been repaired previously, Mill off Top wear course, repair all soft / damaged areas, and provide new top / wear coat.

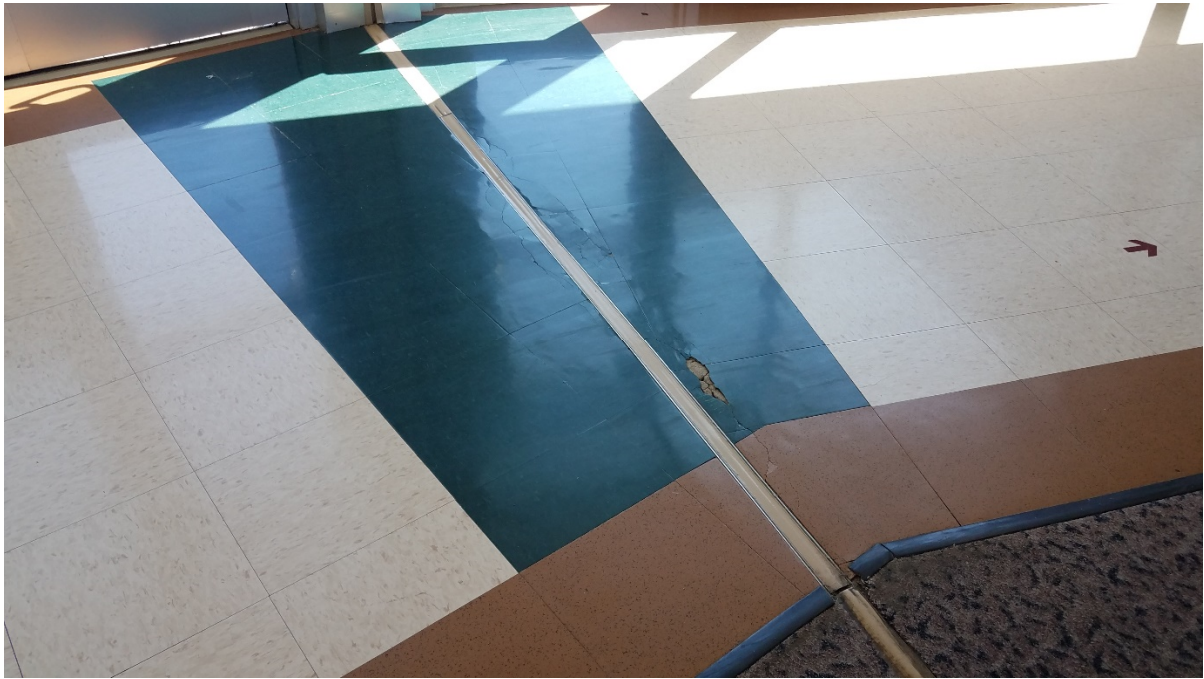
Cracking at Expansion Joint

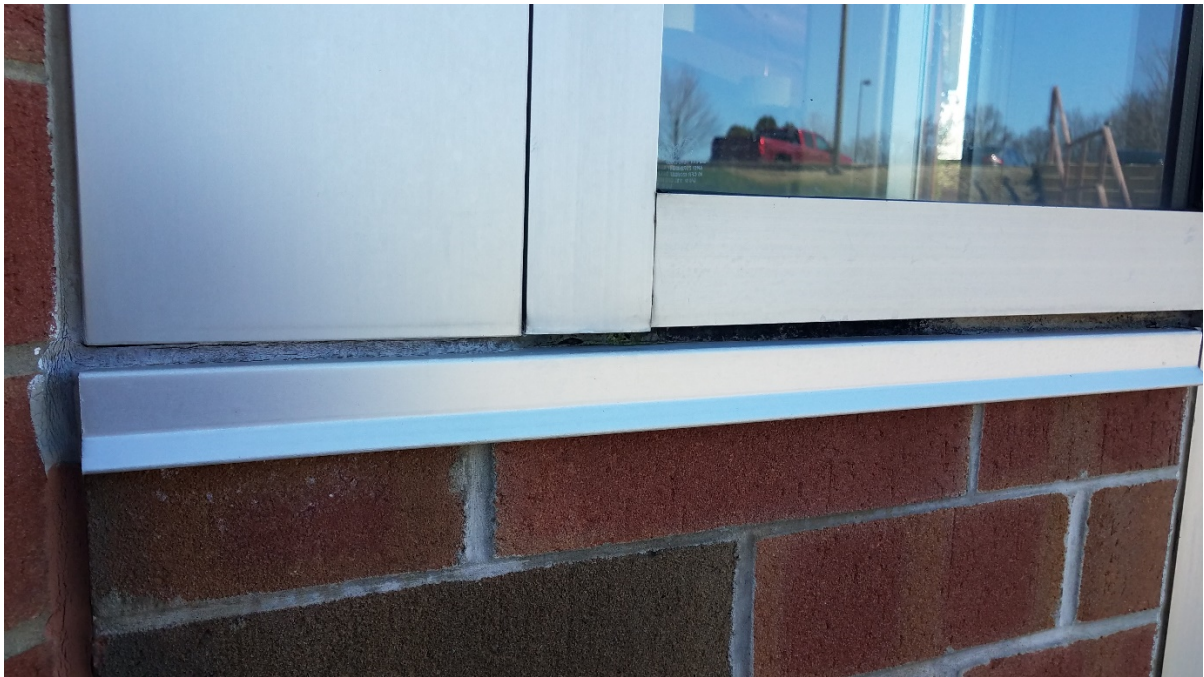
Sealant at Windows

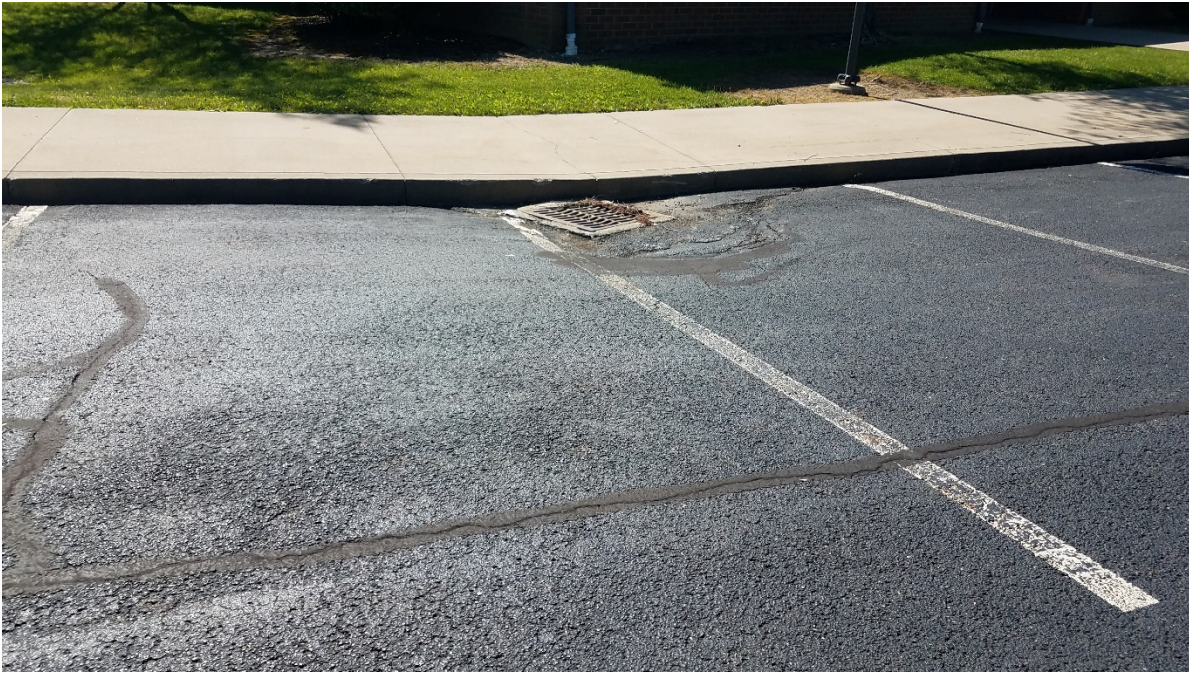
Paving at Parking Lot

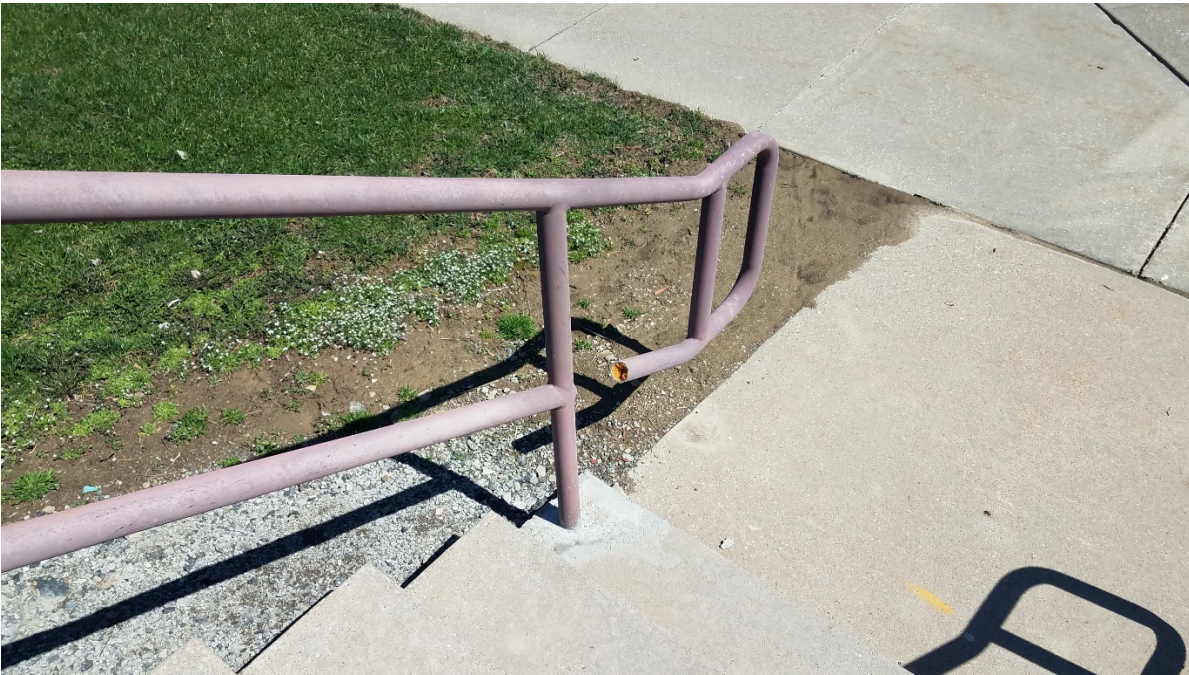
Handrail at Front Parking Lot

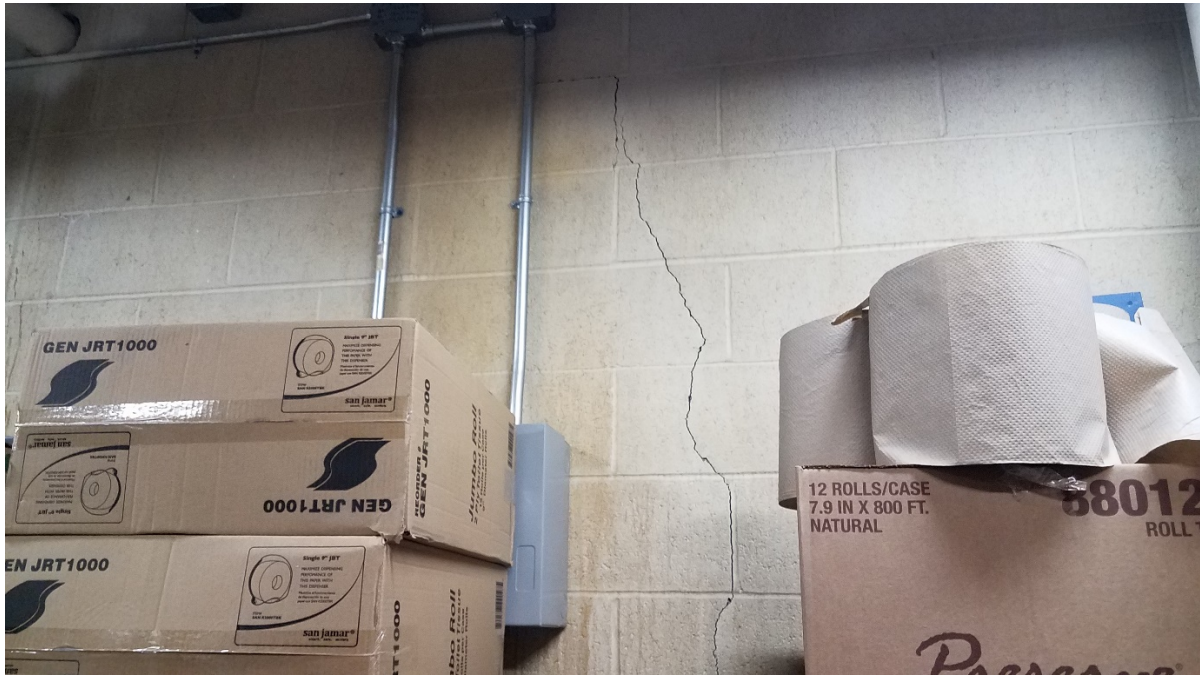
Vertical Crack in Main Electrical Room

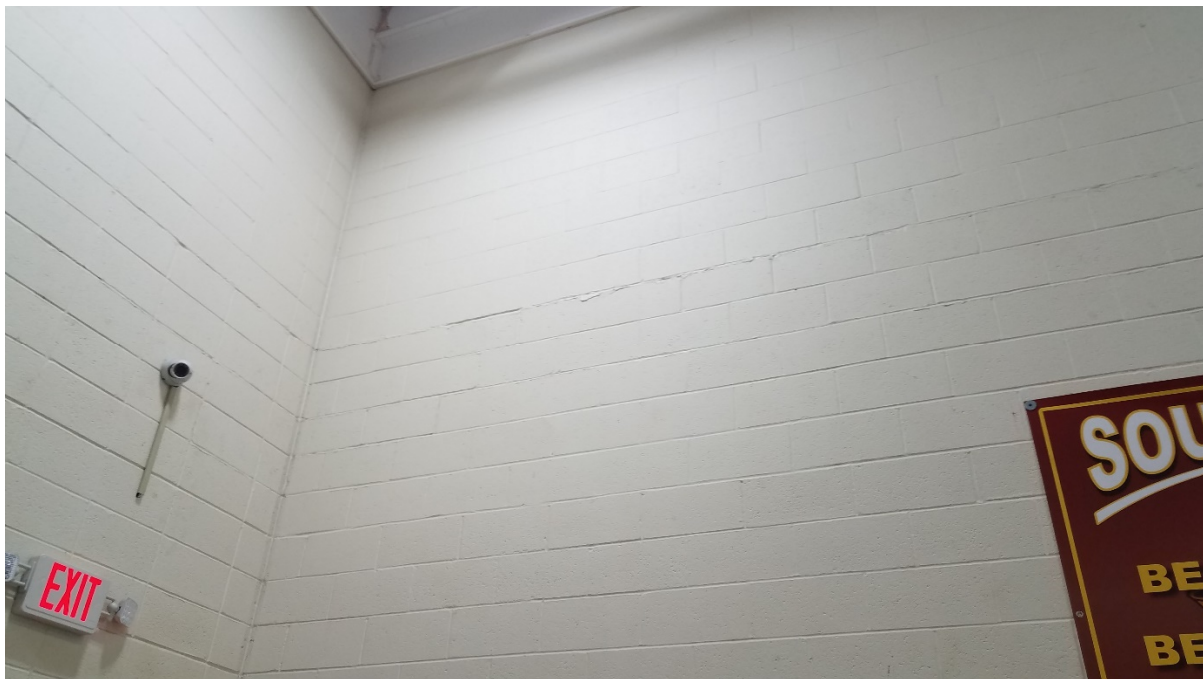
Horizontal Crack at Gymnasium

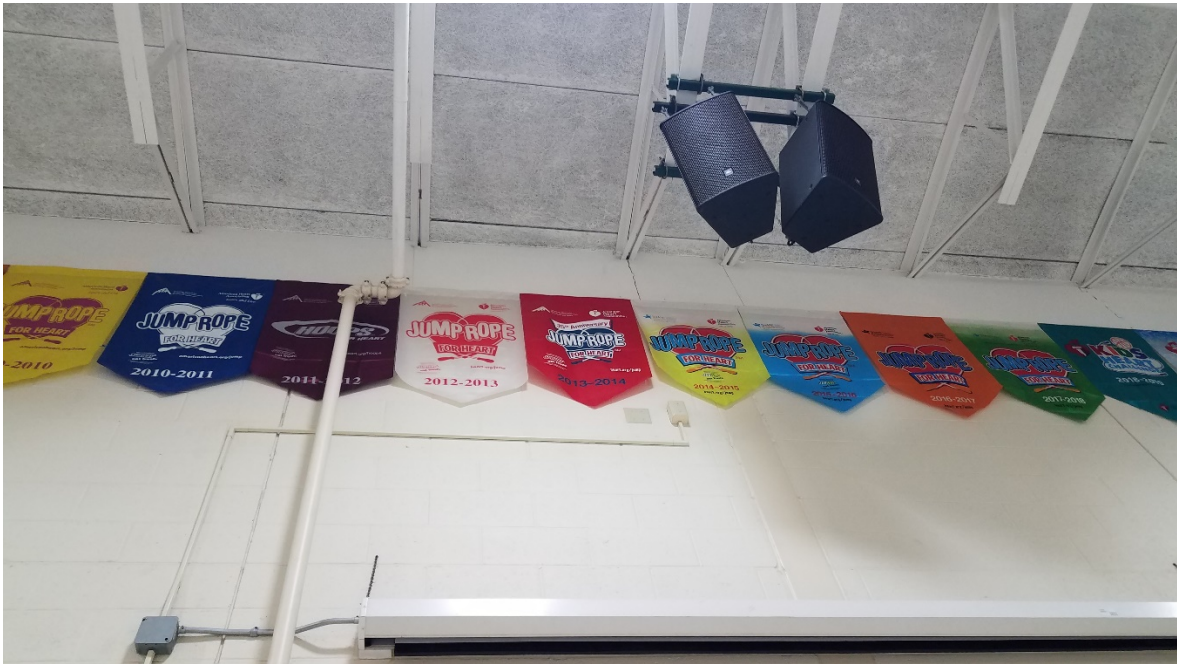
Vertical Cracks at Gymnasium

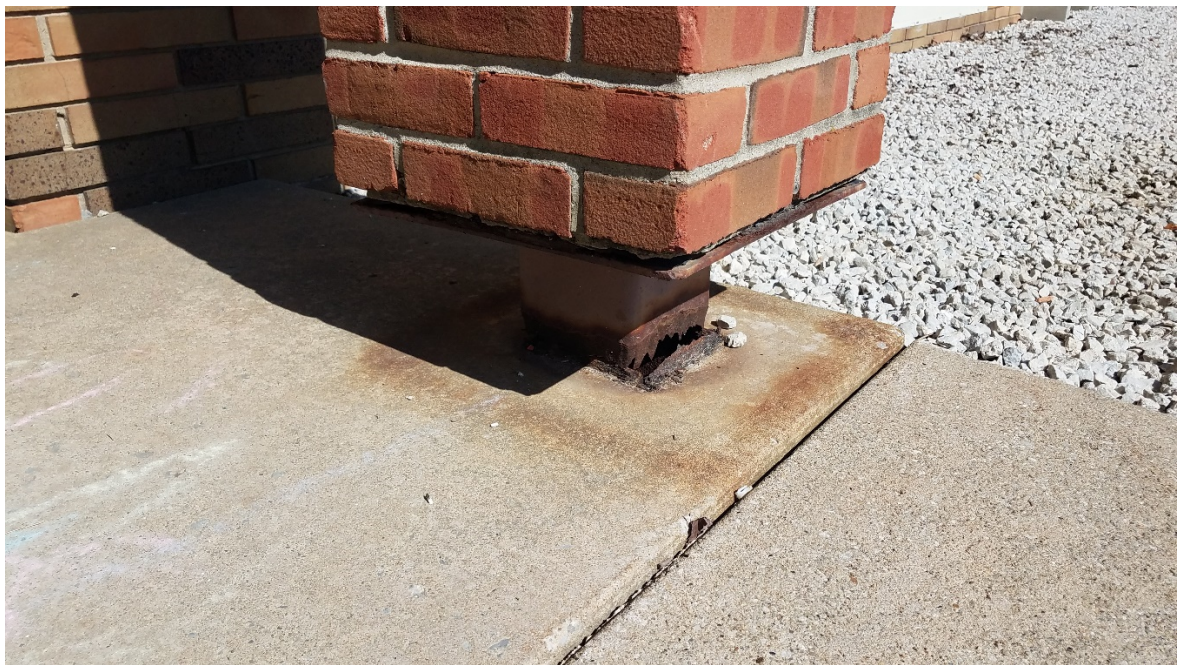
Column Base at Entry Overhang

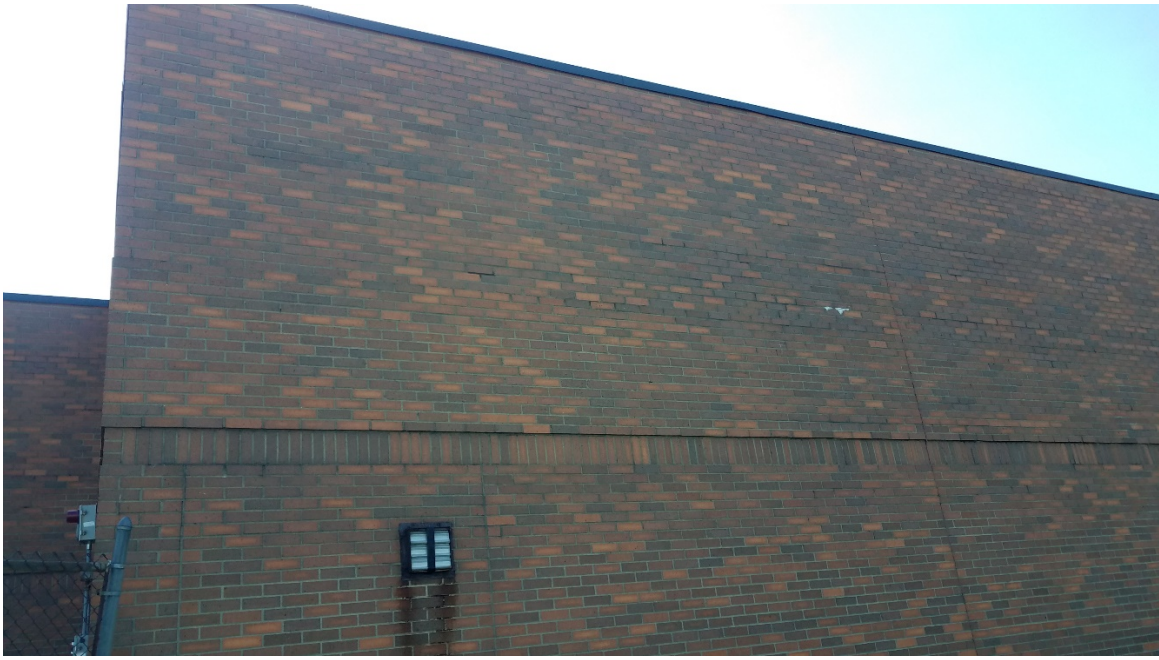
Partial Height Control Joint at Corner – Full Height Control Joint approx. 20ft from Corner

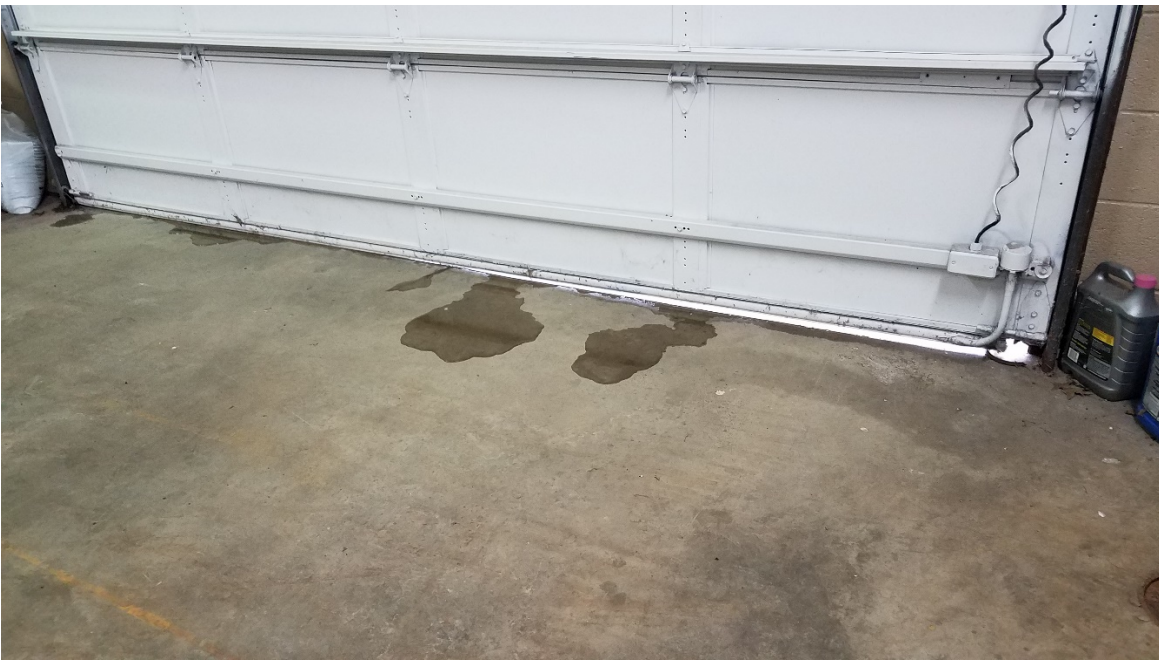
Garage Door Leak During Rain Storm

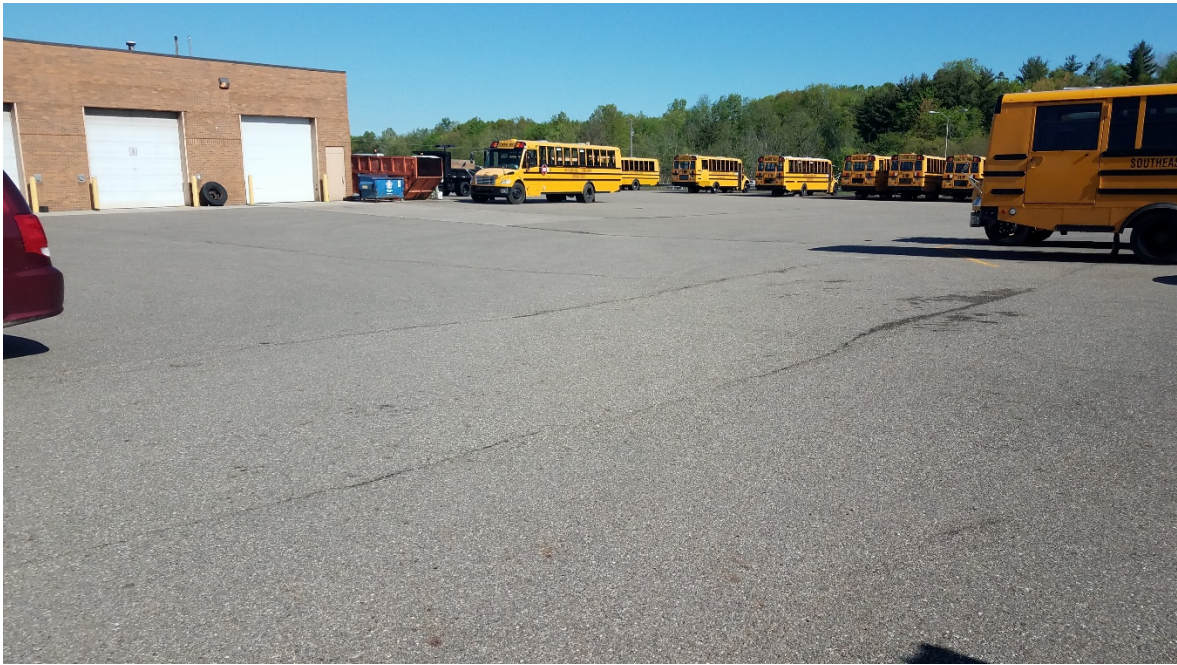
Paving Condition on Site

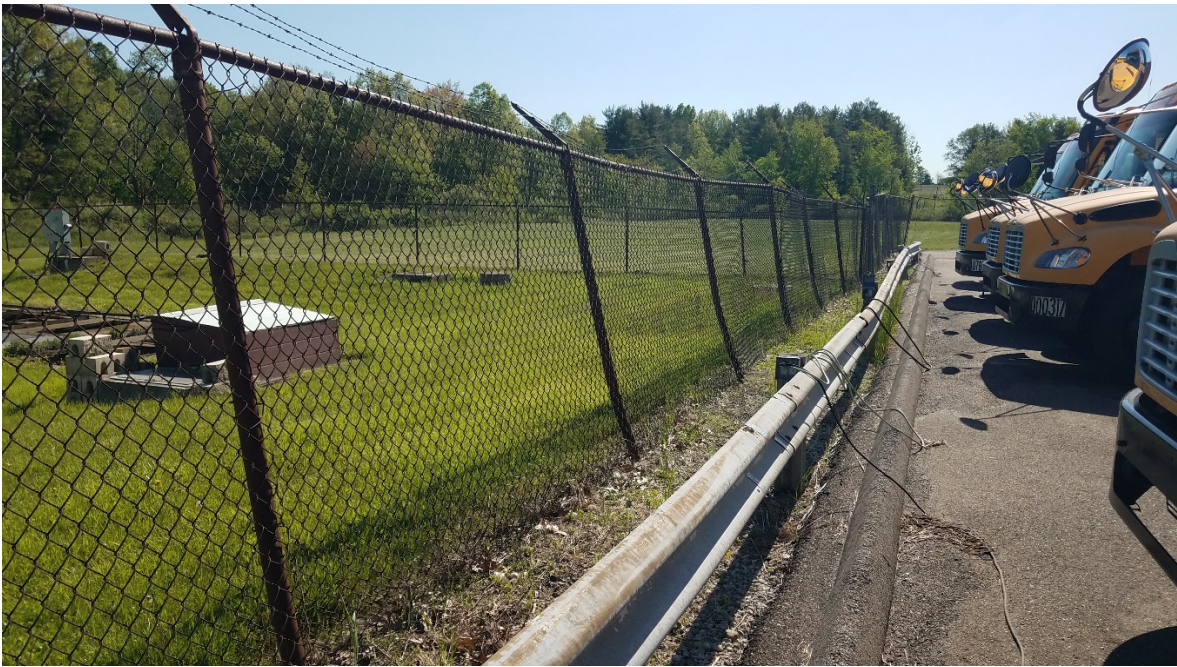
Chain Link Fence at North Side of Site
