GAINES ELEMENTARY

GAINES ELEMENTARY SCHOOL

300 Lansing Street, Gaines

GAINES ELEMENTARY
ROOF CONDITION REPORT

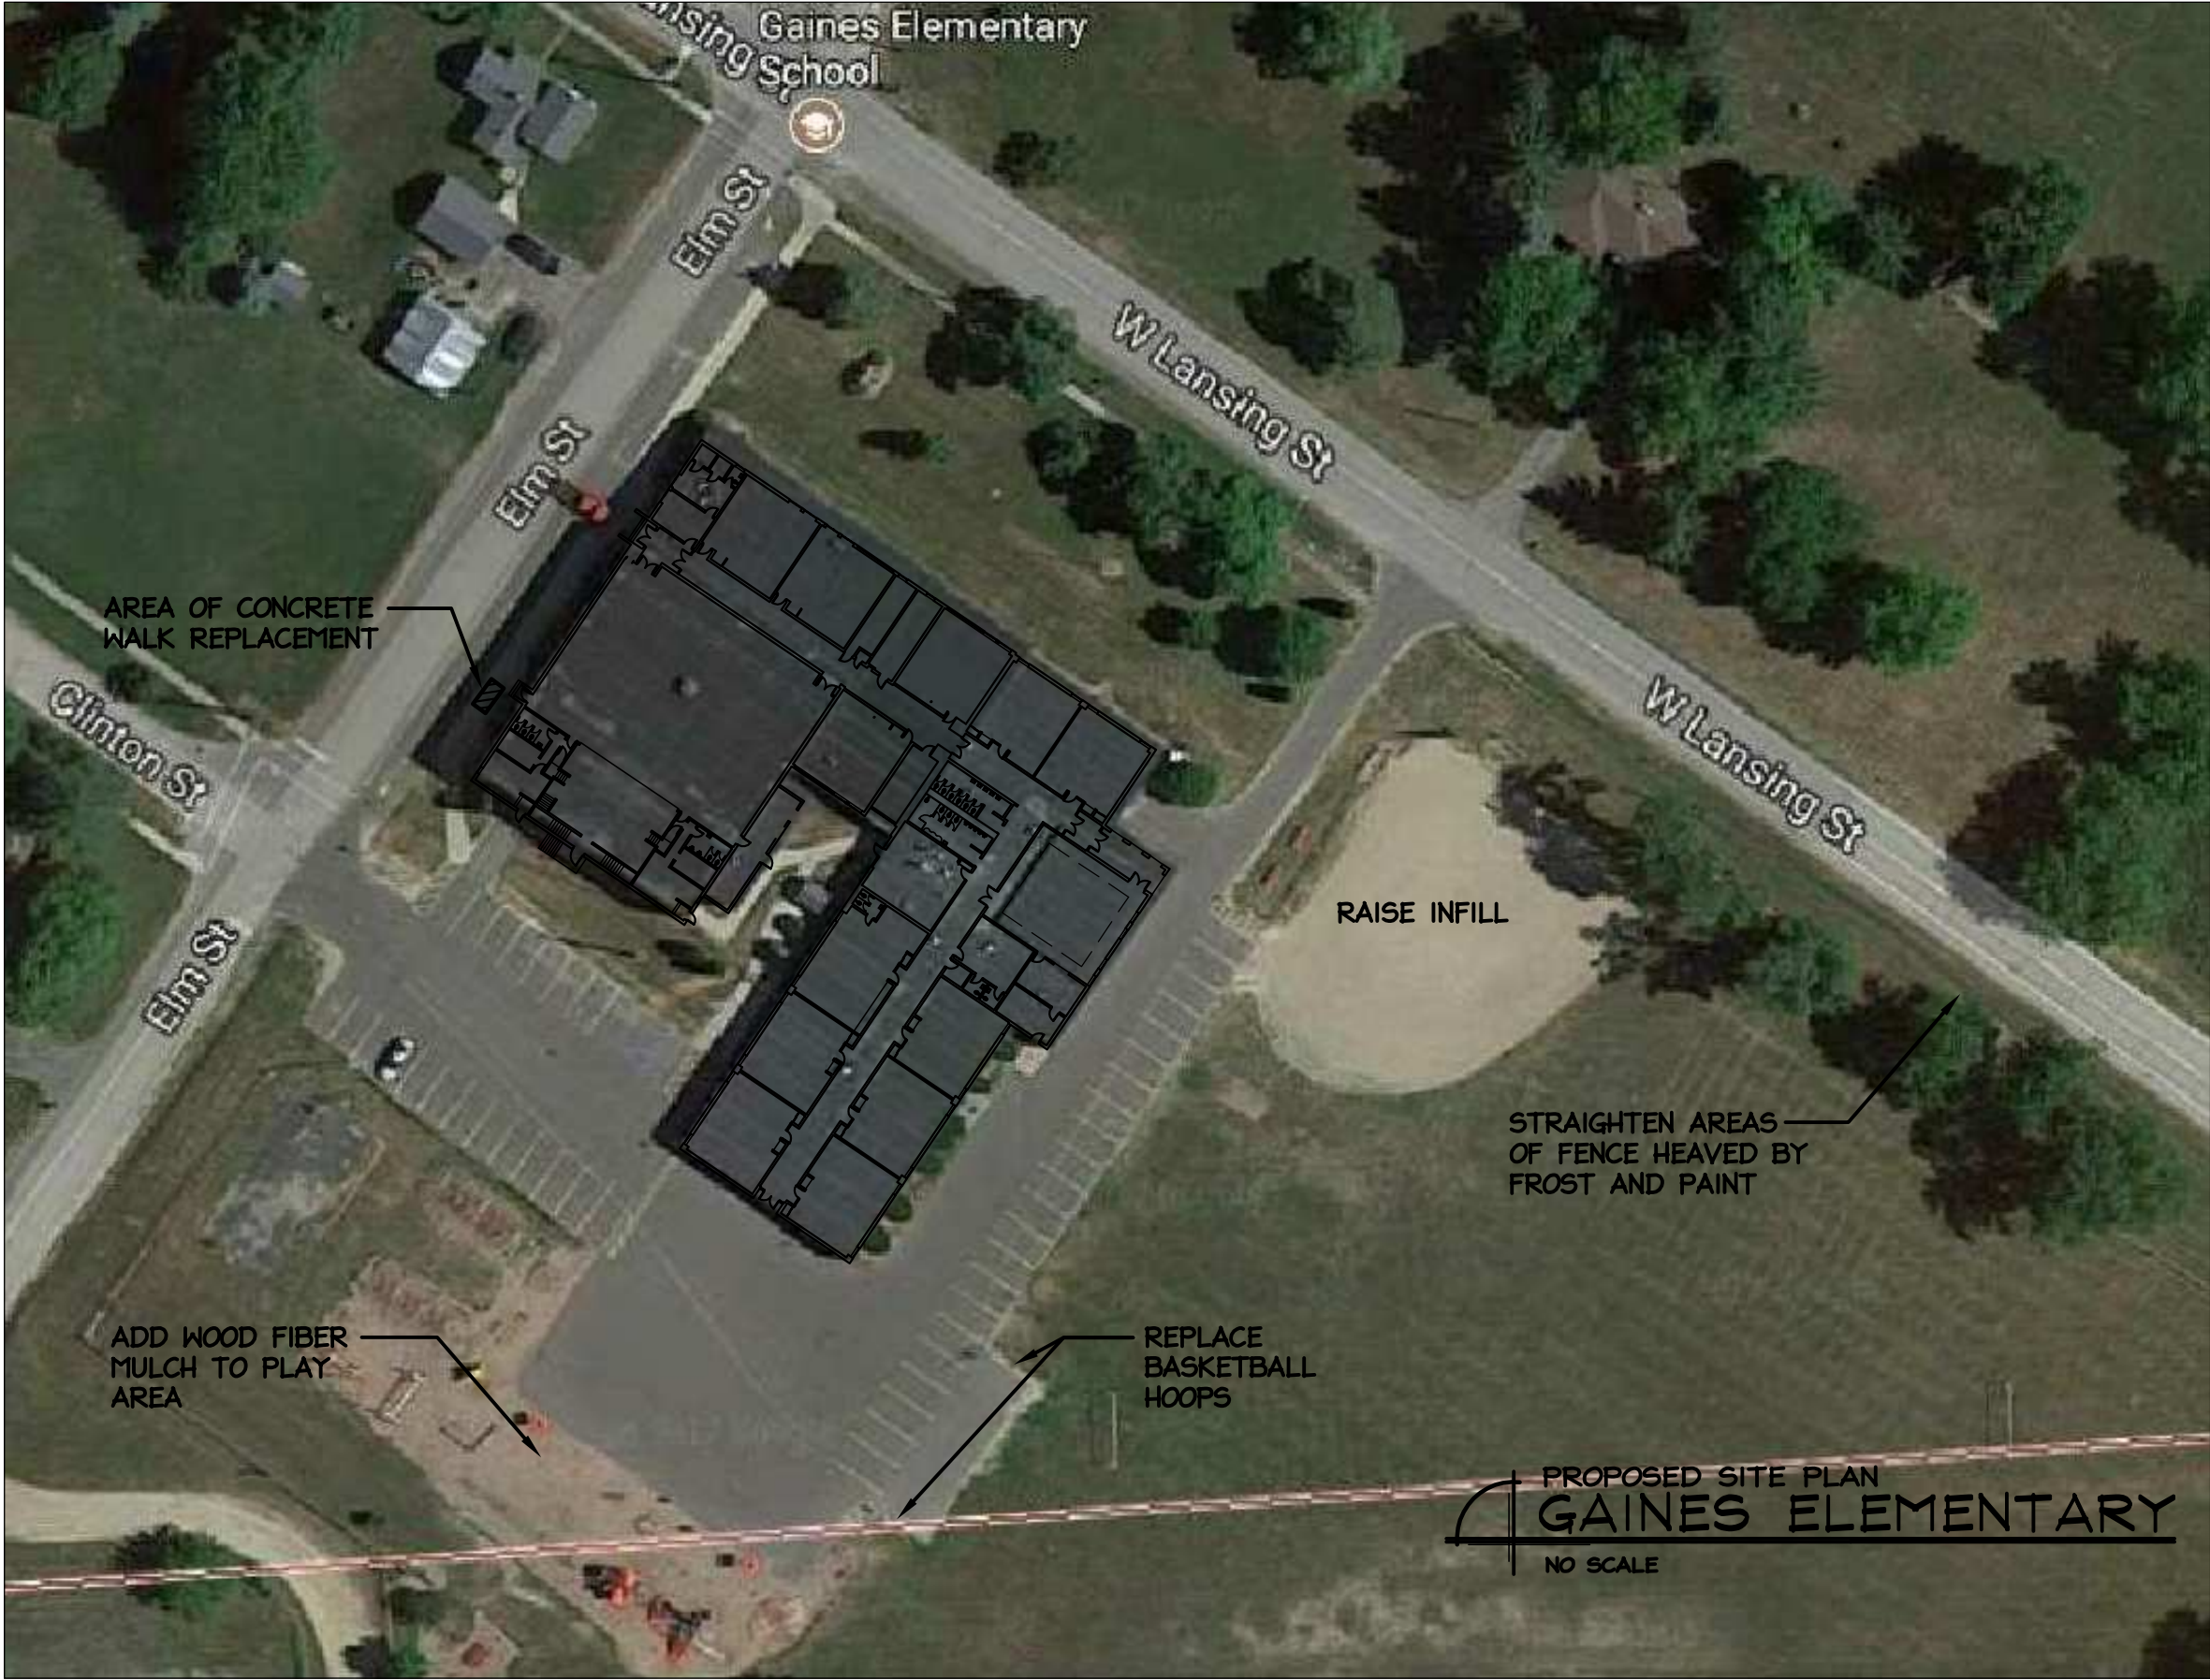
PROPOSED SITE PLAN
GAINES ELEMENTARY
NO SCALE

AREA OF CONCRETE
WALK REPLACEMENT

RAISE INFILL

STRAIGHTEN AREAS
OF FENCE HEAVED BY
FROST AND PAINT

ADD WOOD FIBER
MULCH TO PLAY
AREA

REPLACE
BASKETBALL
HOOPS
