## 2024 LANSING PUBLIC SCHOOL CONDITION MAP

## Lansing KS Financial Summary Overview

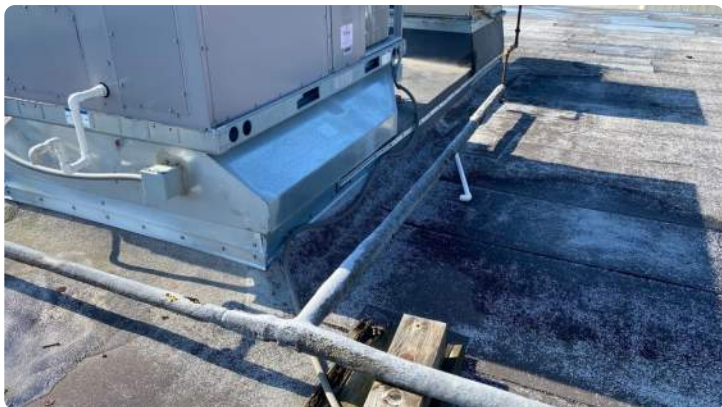
Photo showing condition of the projection flashings.

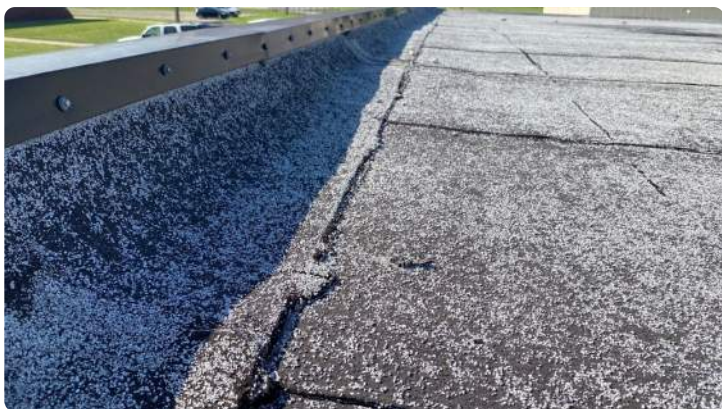
Photo showing condition of the perimeter flashings.

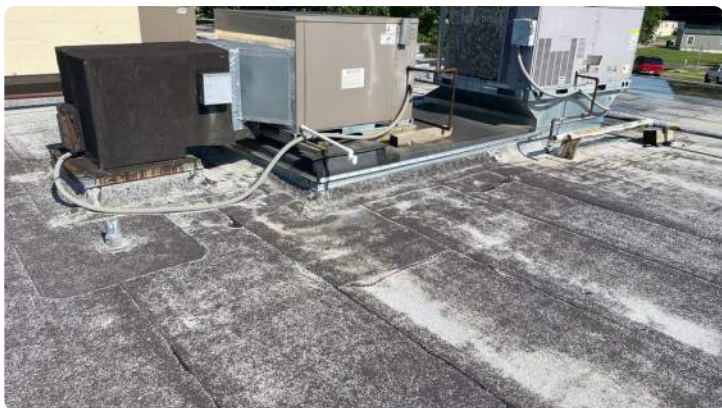
Photo showing deterioration of the field around the units.

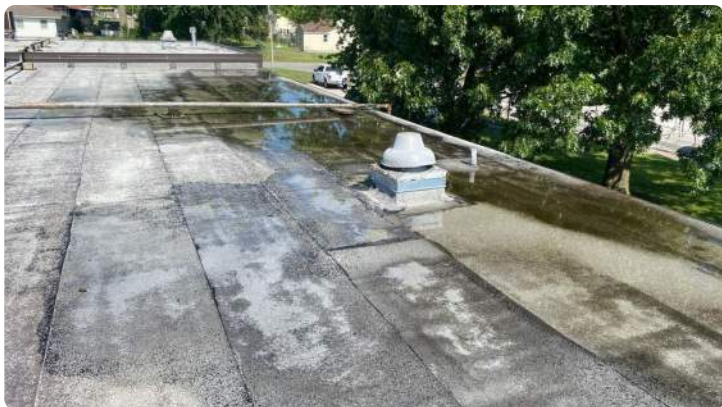
Photo showing additional ponding water.

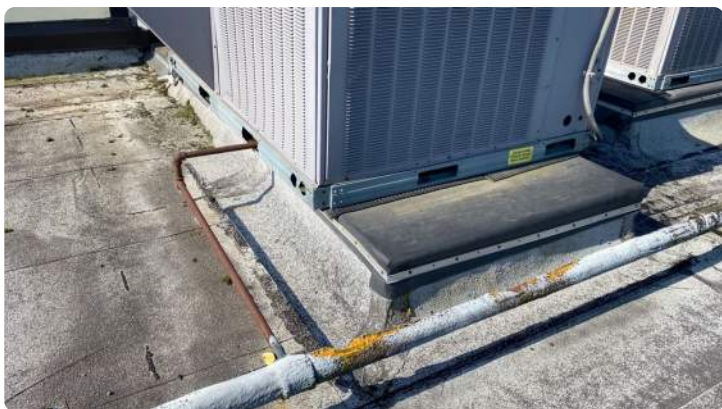
Photo showing condition of the projection flashings.

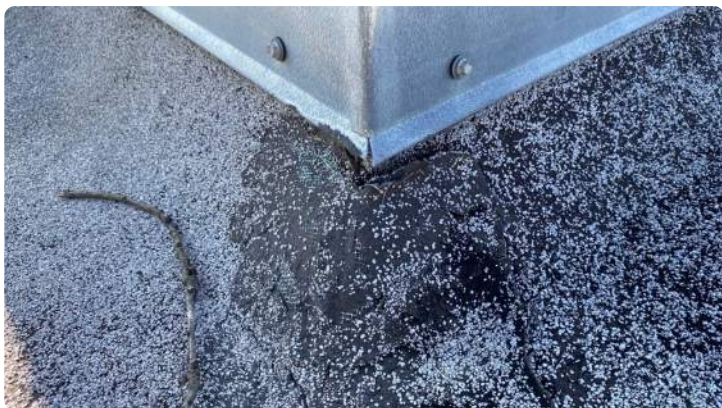
Photo showing deteriorating projection flashings.

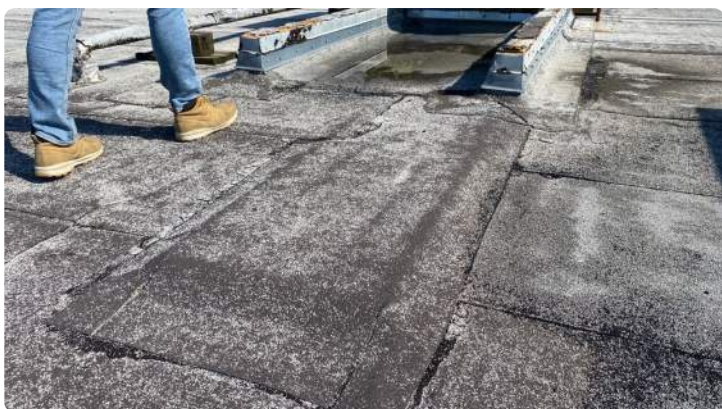
Photo showing deteriorating field.

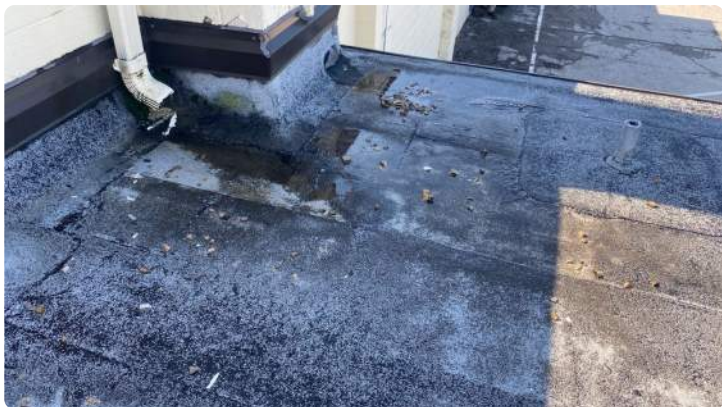
Photo showing deteriorating field.

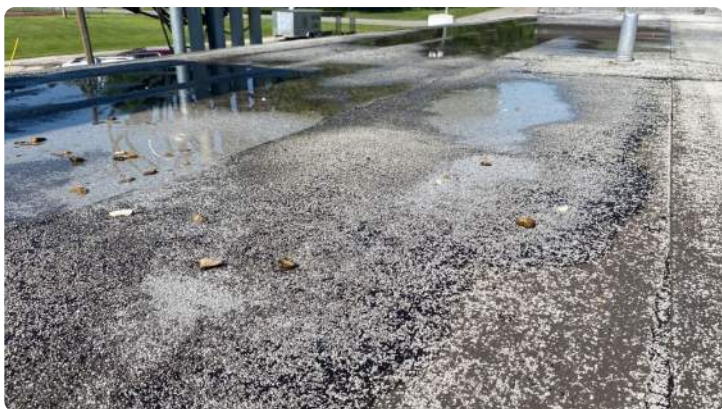
Photo showing ponding water.

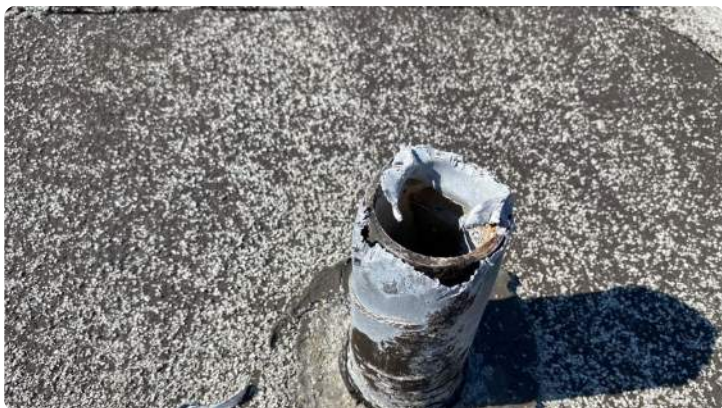
Photo showing cracks in lead covered vent stack. Repaired as part of the maintenance agreement.

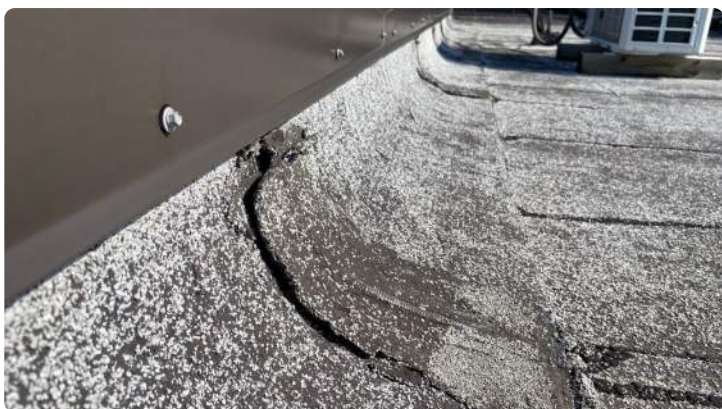
Photo showing crack in the perimeter flashings.

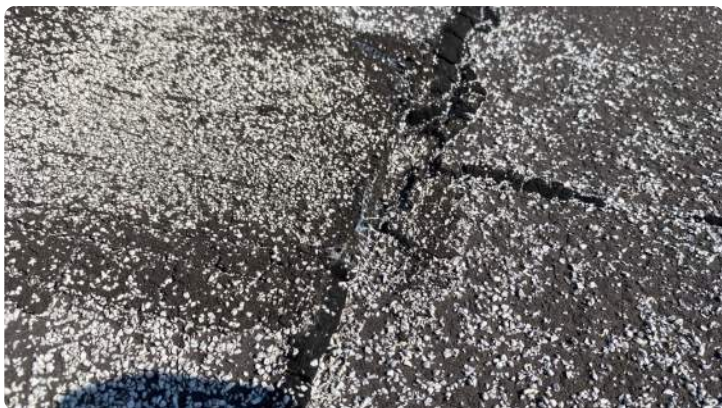
Photo showing skim exposed in deteriorating field.

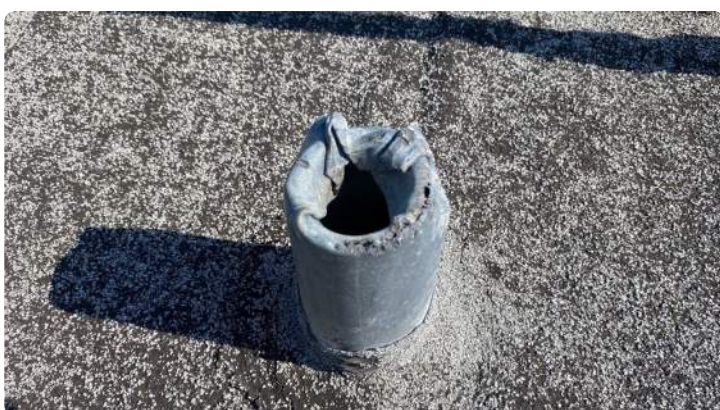
Photo showing cracks in lead covered vent stack. Re-paired as part of the maintenance agreement.

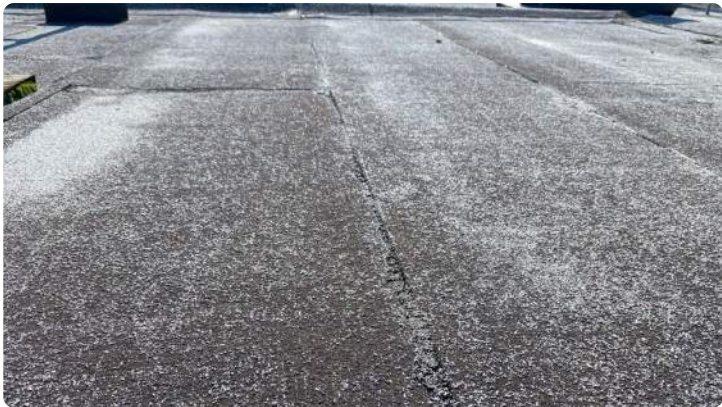
Photo showing deterioration of the field.

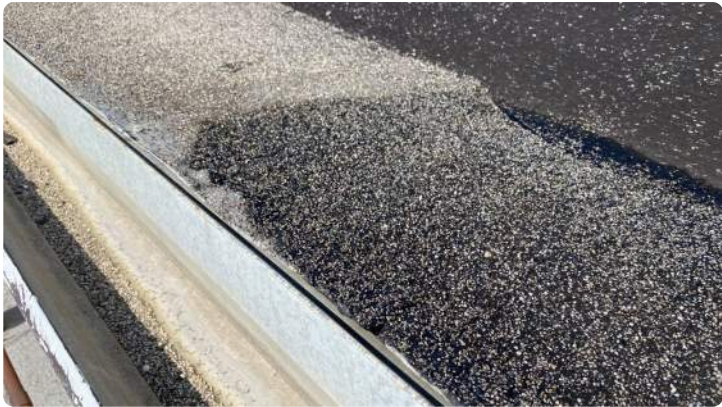
Photo showing deterioration of the coating.

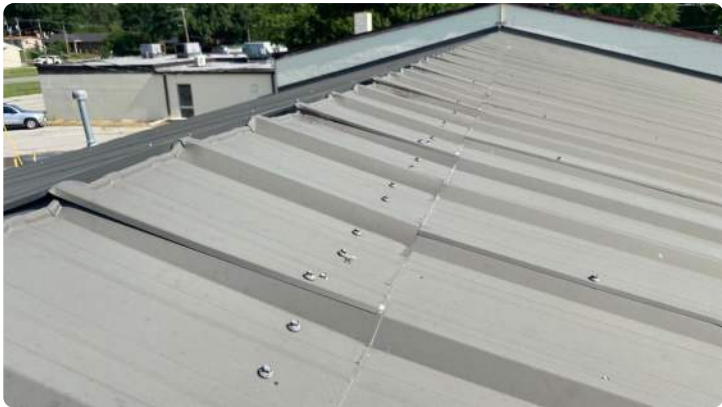
Photo showing fasteners beginning to back out.

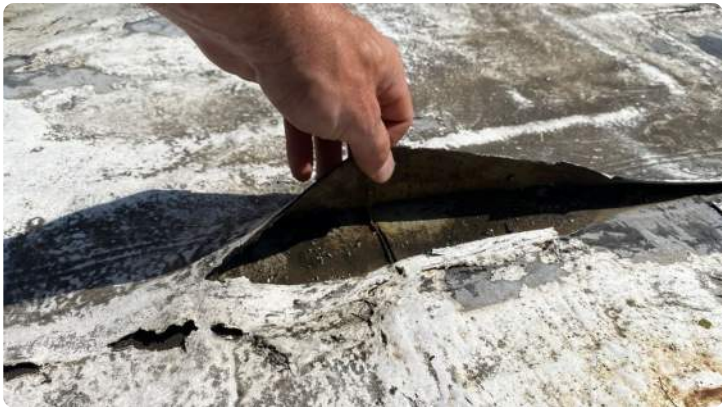
Photo showing a seam pulling loose.

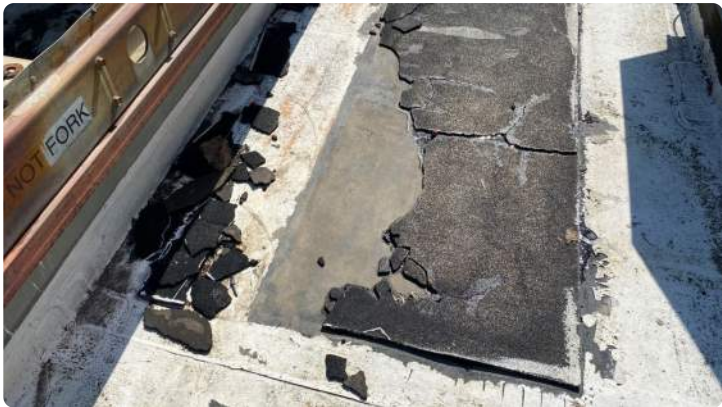
Photo showing walk pads deteriorating.

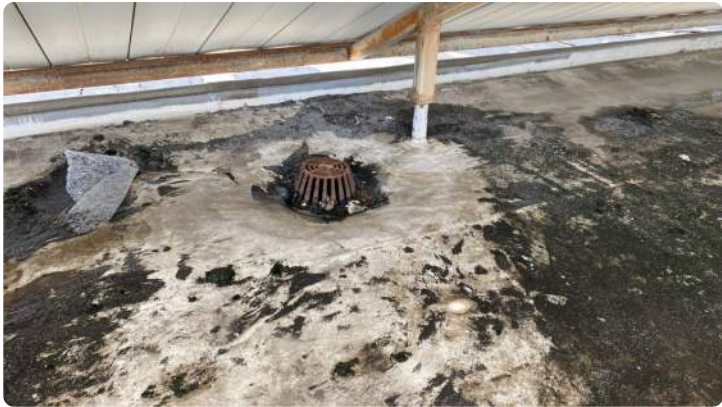
Photo showing coating deteriorating around drain.

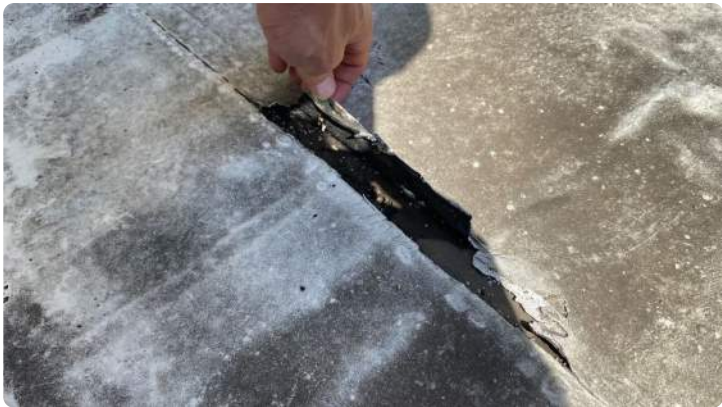
Photo showing coating pulling up at seams.

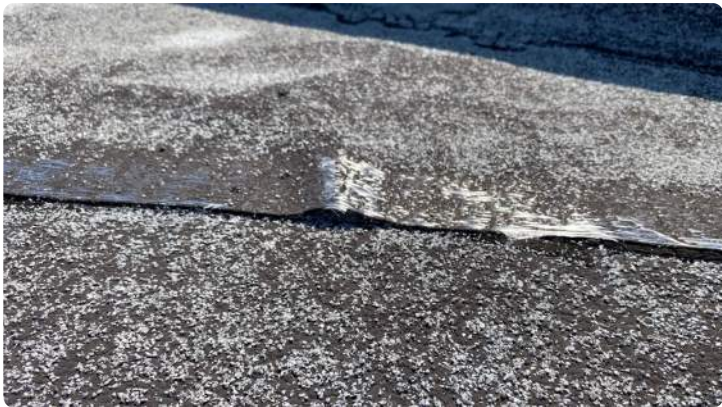
Photo showing a fishmouth in the deteriorated field and blistering.

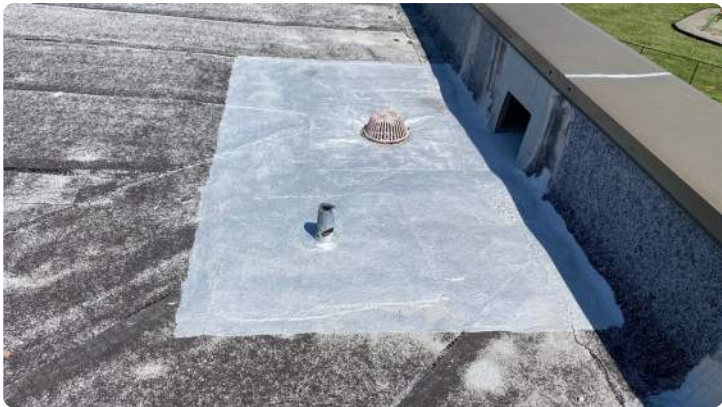
Photo showing aluminum coating around drain.

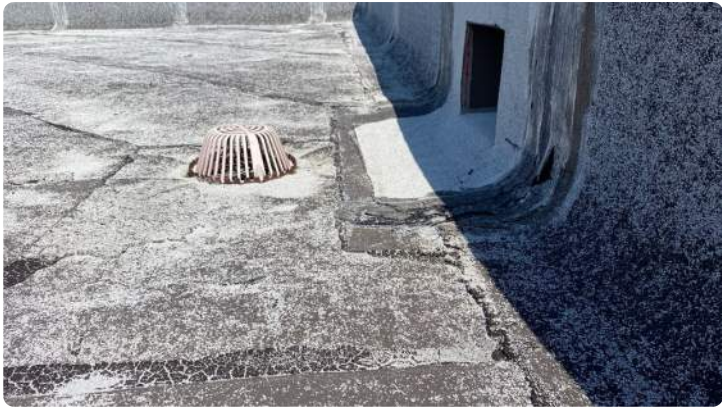
Photo showing condition of the perimeter flashings and drain.

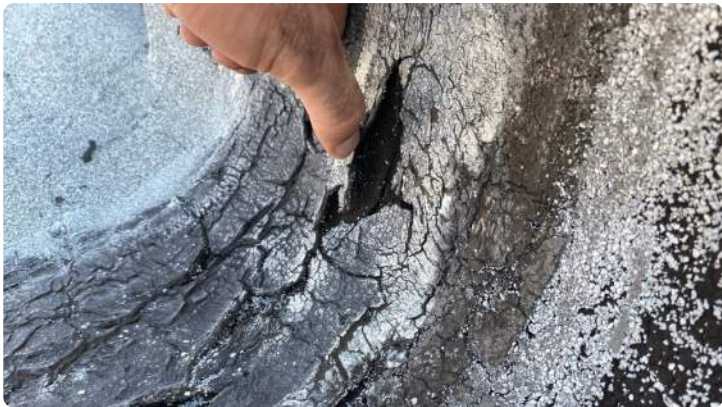
Photo showing additional hole in the perimeter flashings.

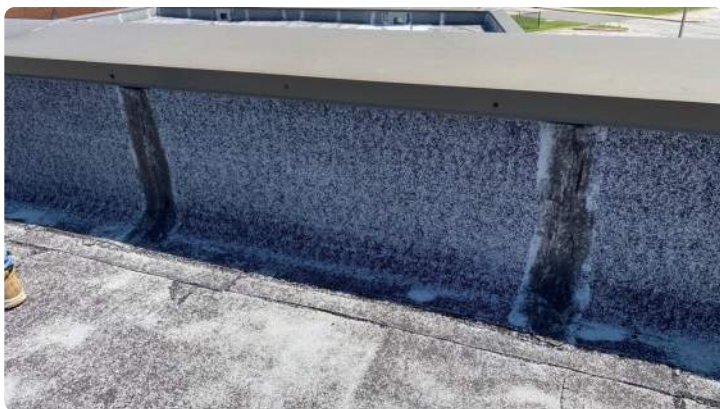
Photo showing condition of the deteriorating perimeter flashings.

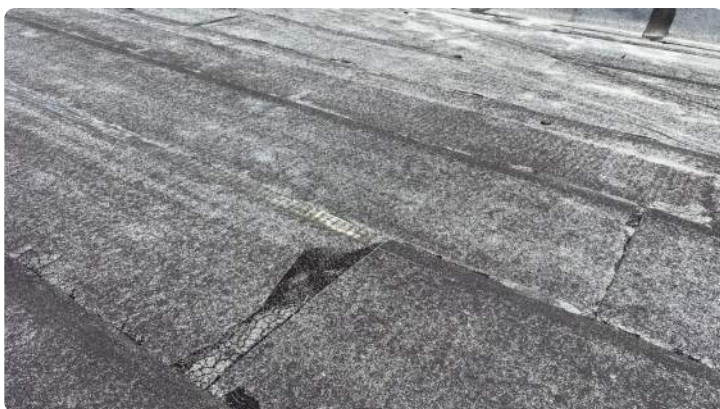
Photo showing scrim showing through deteriorated roof.

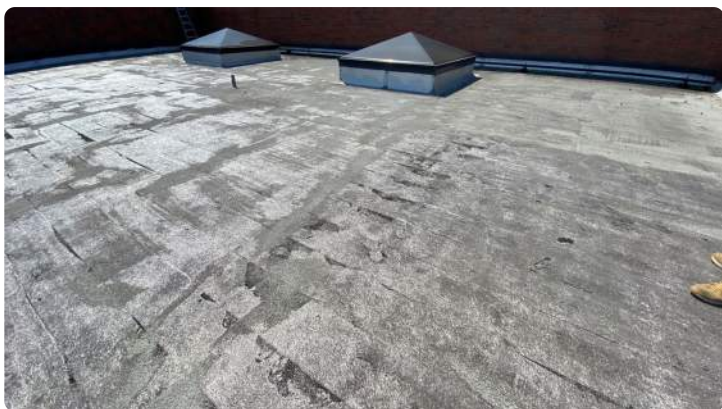
Photo showing scrim showing throughout deteriorated roof.

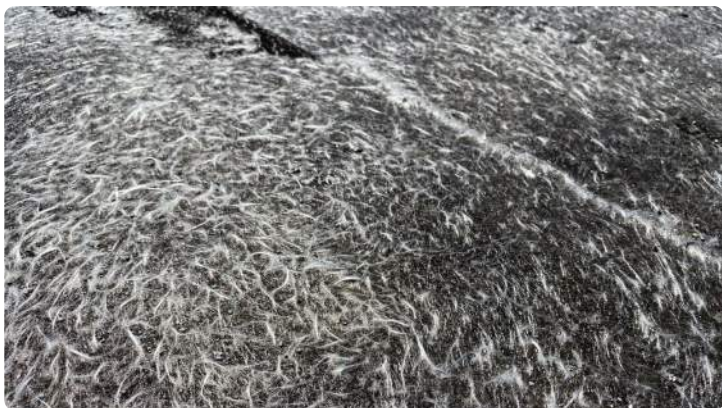
Photo showing scrim showing through deteriorated roof.

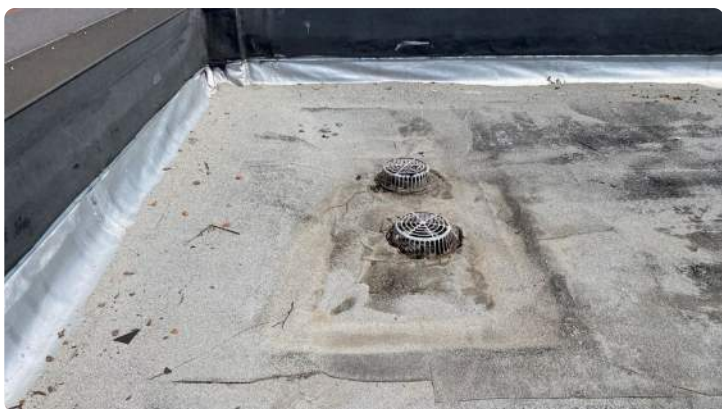
Photo showing granules from deteriorating roof piling up around drain.

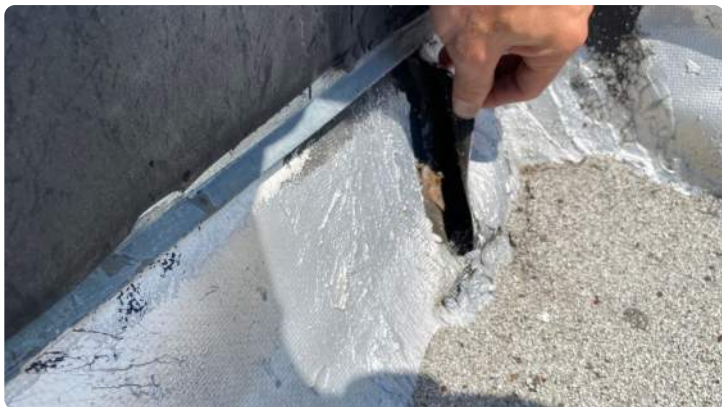
Photo showing flashings pulling loose.

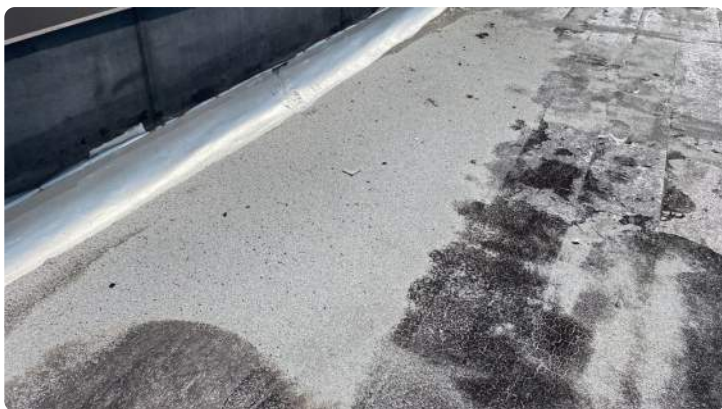
Photo showing loose granules from deteriorating roof piling up.

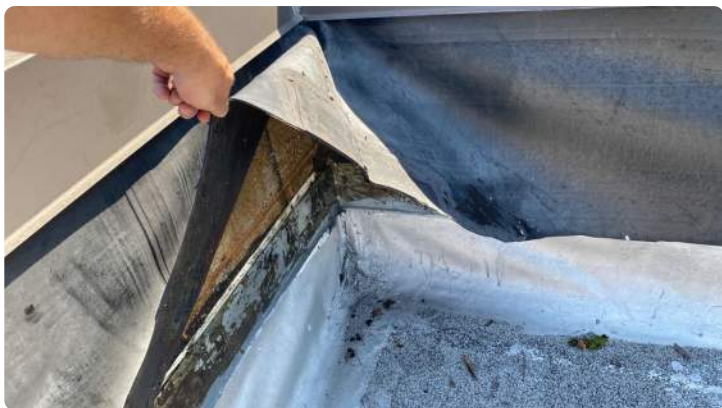
Photo showing loose perimeter flashing.

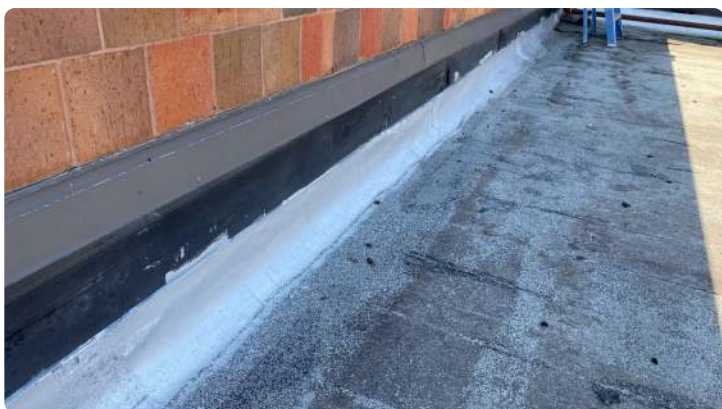
Photo showing condition of the perimeter flashings.

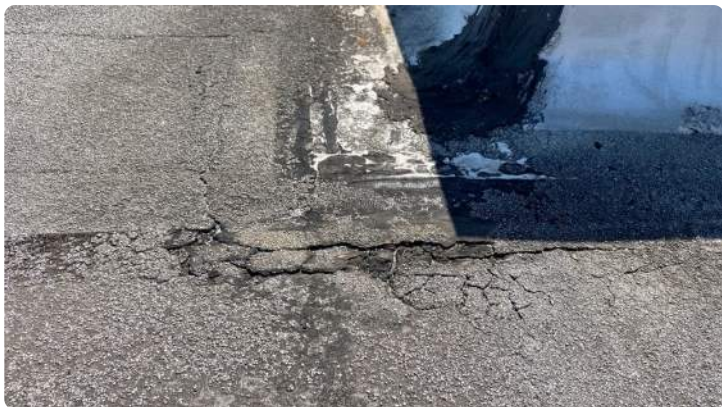
Photo showing alligatoring in the projection flashings.

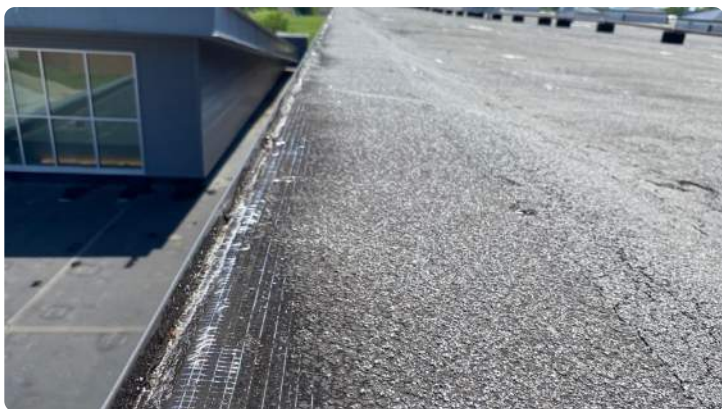
Photo showing skim showing through deteriorated roof at perimeter.

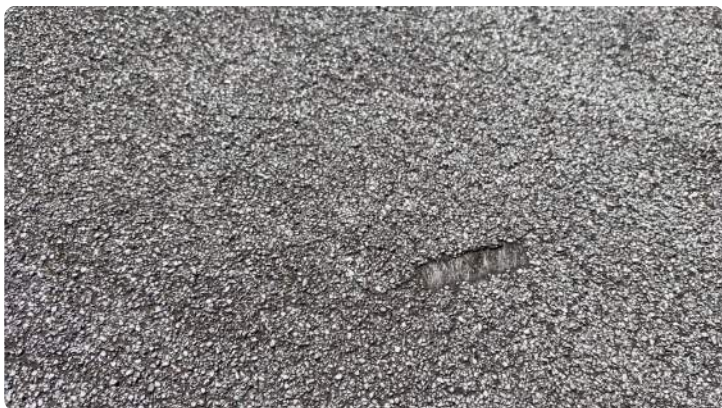
Photo showing skim showing through deteriorated roof and splitting.

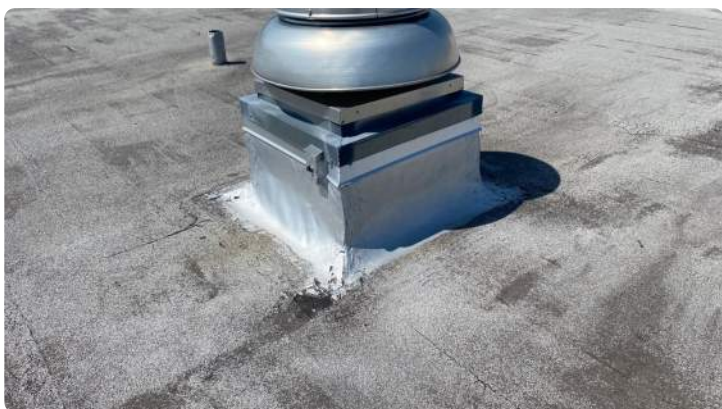
Photo showing aluminum coated projection flashings.

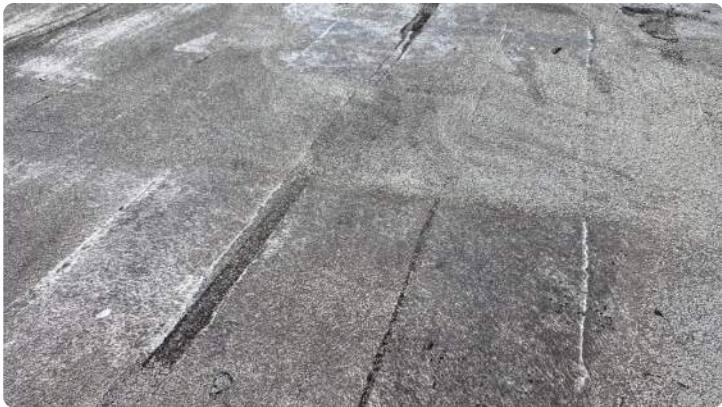
Photo showing scrim showing through deteriorated roof.

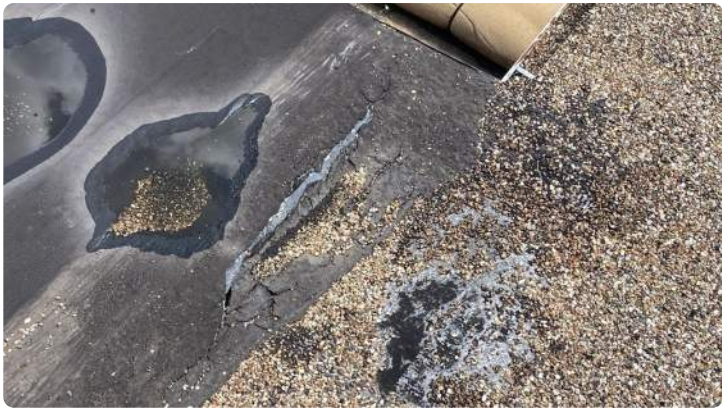
Photo showing area coated in roofing mastic beginning to crack.

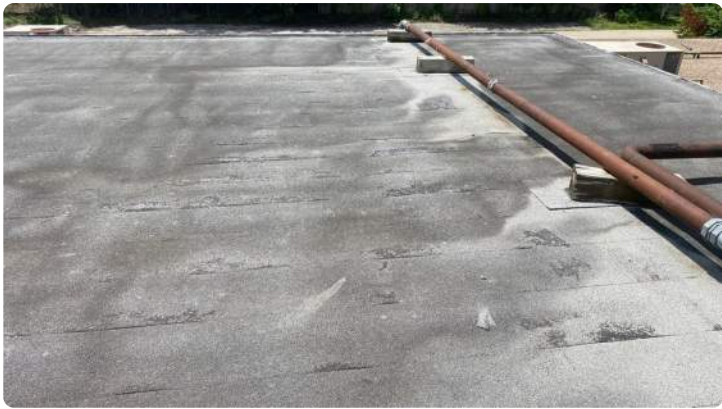
Photo showing skim showing through deteriorated roof.

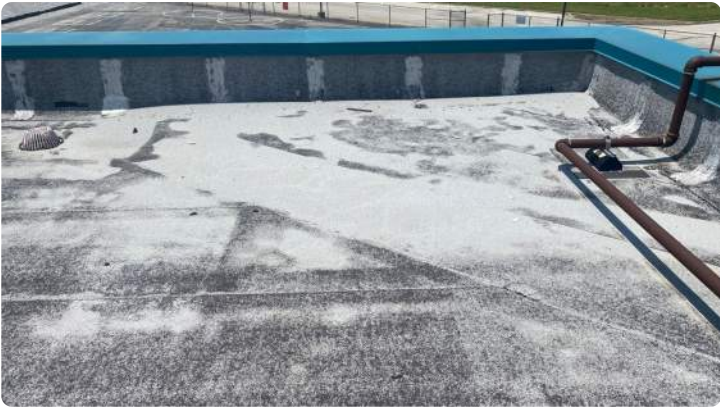
Photo showing granules piled up from deterioration.

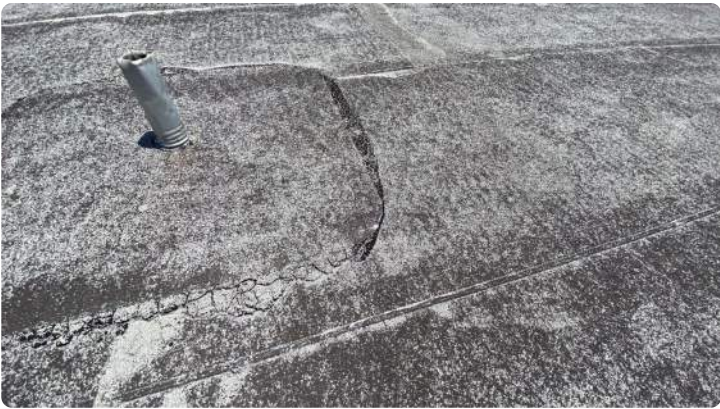
Photo showing deteriorating field.

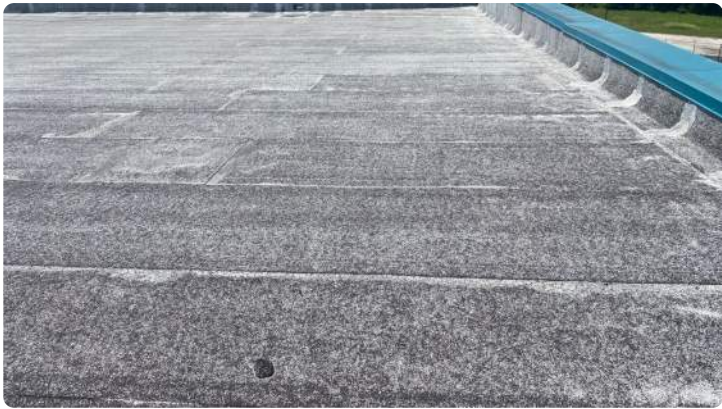
Photo showing skim visible through deteriorating field.

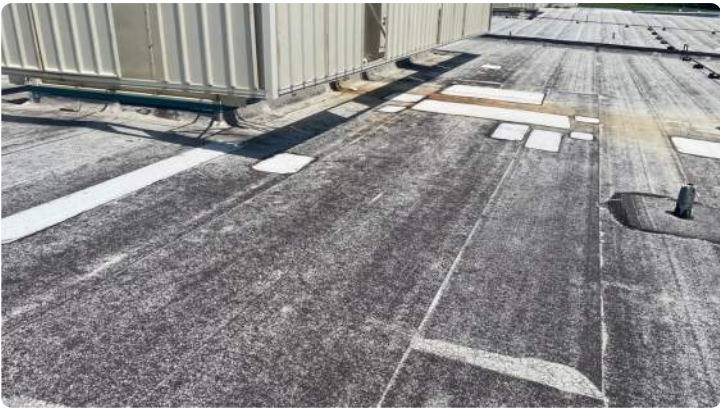
Photo showing previous coating repairs made to field around unit.

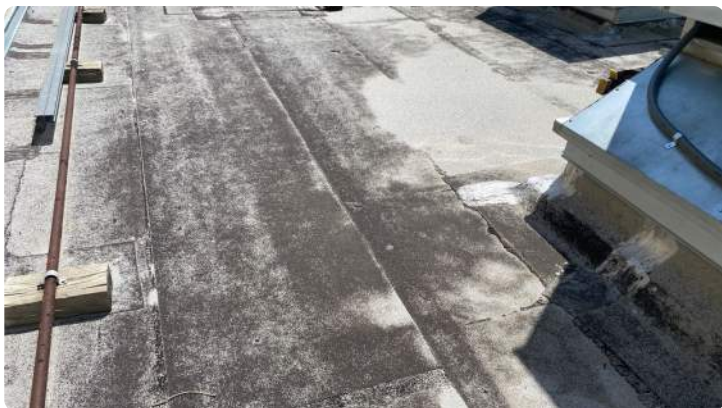
Photo showing deteriorated field.
