USD 469

Lansing

Facility Assessments

Summer 2023

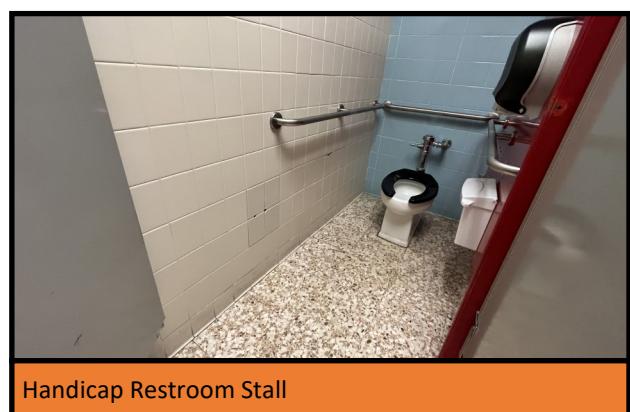
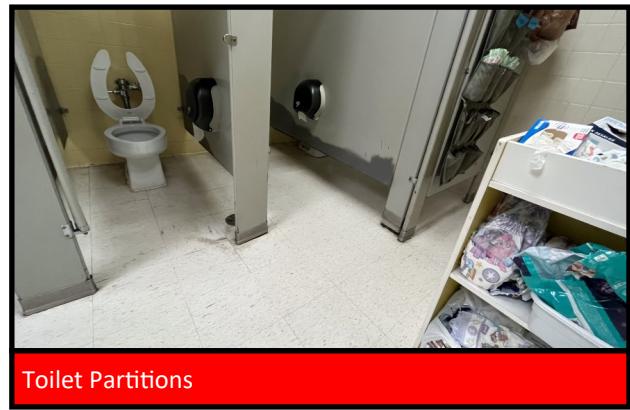
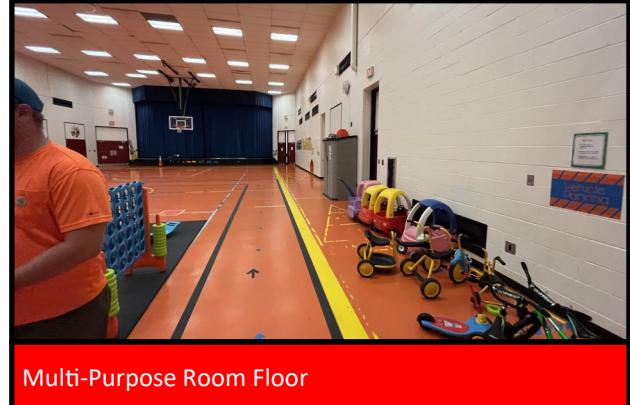
Interior Component		Comments
Accessibility	3	Accessible drinking fountains installed. Damaged wall behind.
Accessibility	3	Accessible handwashing provided. There is no low sink for kids, have a stool for access. Potential hazard.
Accessibility	2	Handicap stall with grab bars is narrow.
Accessibility	2	Handrails at ramp are located at only one side.
Accessibility	3	Small restroom with low fixtures has room for assistance of kids.
Accessibility	4	Handrails provided at stair.
Aesthetics	2	Floor finish is worn and dated.
Aesthetics	3	VCT floors appear in good condition.
Aesthetics	2	Light fixtures are damaged and discolored. Ceiling tiles are dirty at air registers.
Aesthetics	1	Toilet partitions and floors are damaged at water closet area.
Aesthetics	1	Walls, floors, and door are in poor condition. Door does not have accessible hardware.
Aesthetics	1	Floor at multi purpose play area is aged. Floor is not cushioned as recommended for children's play.

Aesthetics	1	Ceilings are damaged, discolored, and water stained.
Aesthetics	2	Floor tile and toilet partitions are damaged. VCT joints and wall transitions are dirty.
Aesthetics	2	Ceilings are damaged and light fixtures appear loose at the ceiling.

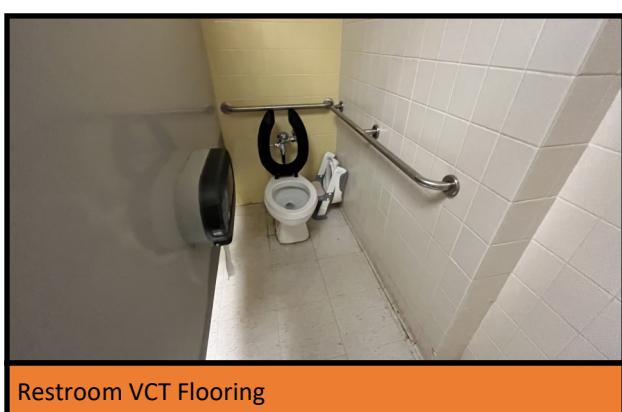
Interior Component	Comments
Floors	3 VCT floors appear in good condition. Loose rugs may be a trip hazard.
Floors	3 VCT floors and ceiling at entry appear in good condition.
Floors	3 Floor at hallway appears in good condition.
Floors	2 VCT floors are not recommended or permitted by code at bathrooms. Joints and wall transitions are dirty and unsanitary.
Floors	3 Floor is in good condition. Loose rugs may be a trip hazard.
Floors	3 Quarry tile floors are in general good condition. This type of floor is quite bumpy for transporting carts.
Floors	1 Multipurpose room floor is aged, cracking, and not cushioned.
Floors	2 Loose rug at play area is a trip hazard.
Floors	2 Floor base is damaged.
Floors	1 VCT floors are not recommended or permitted by code at toilet areas. Floor joints are dirty and unsanitary.
Floors	3 Floor appears in good condition. Loose rug may be a trip hazard.
Floors	1 Floor is damaged underneath drinking fountain.

Floors	2 VCT floor appears settled and cracked at area previously infilled.
Windows-Doors	2 Non-rated doors at hallways. Doors are not on closures or gasketed.
Windows-Doors	1 Window is inefficient single pane system.

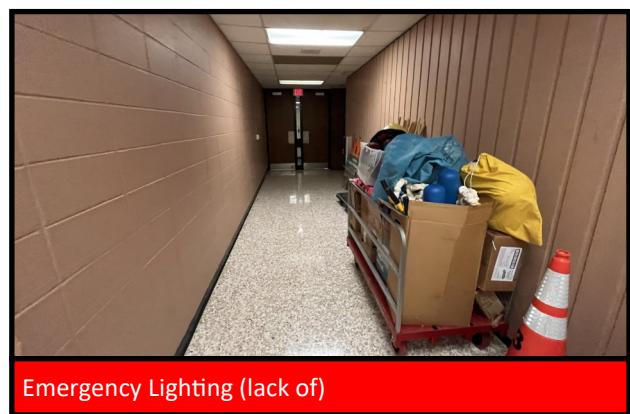
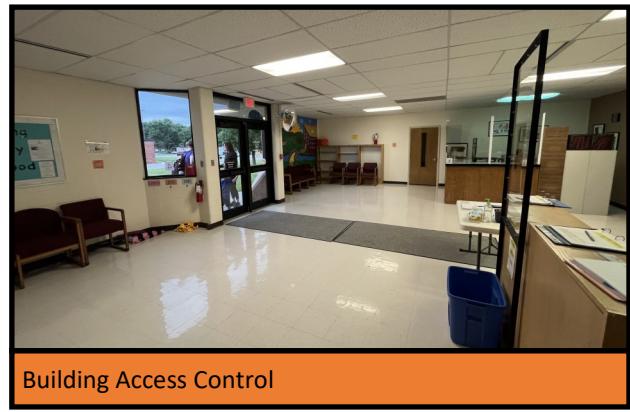
Interior Component		Comments
Windows-Doors	1	Floor is damaged at doorway. This may be due to water infiltration.
Windows-Doors	2	Floor transition is loose and uneven.
Windows-Doors	2	Bottom of door and door frame are damaged.
Life Safety	1	There appears to be no emergency lighting in long corridor.
Life Safety	4	Hood is adequately sized for kitchen equipment.
Life Safety	2	Emergency lighting does not appear to be provided.
Miscellaneous	2	There is no secure or access controlled entry at main building entrance.
Miscellaneous	2	Interior partition walls are only constructed to and supported by ceiling tile.
Miscellaneous	2	Base of wall and floor base have some minor damage.
Miscellaneous	2	Walls are constructed only to underside of ceiling. Unclear if emergency lighting is provided in several areas.
Miscellaneous	2	Countertops, sinks, and fixtures are stained and deteriorated.
Miscellaneous	1	Ceilings are stained throughout.

Miscellaneous	2	Lower section of wall has holes throughout. Appears to have been exterior wall, these may have been weep holes that have been retained. Water infiltration would cause standing water at the floor.

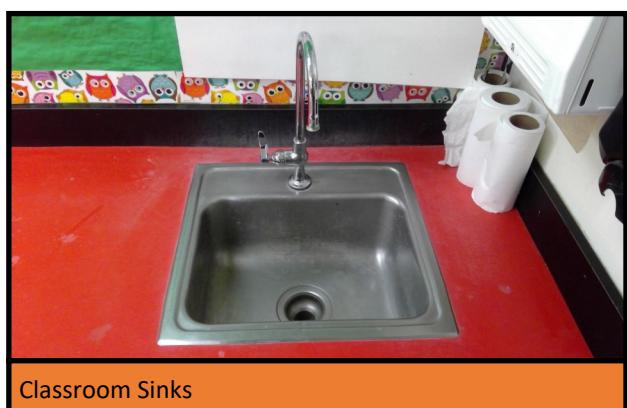
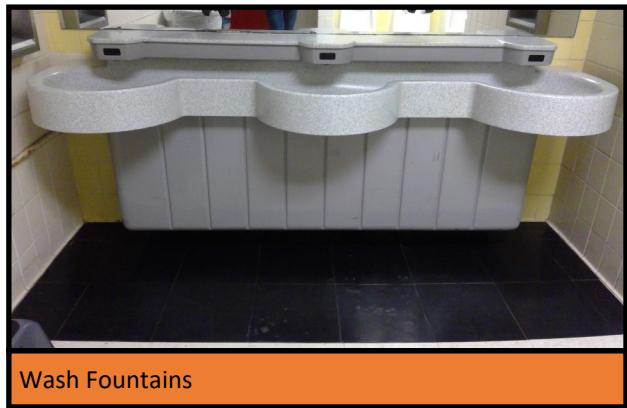
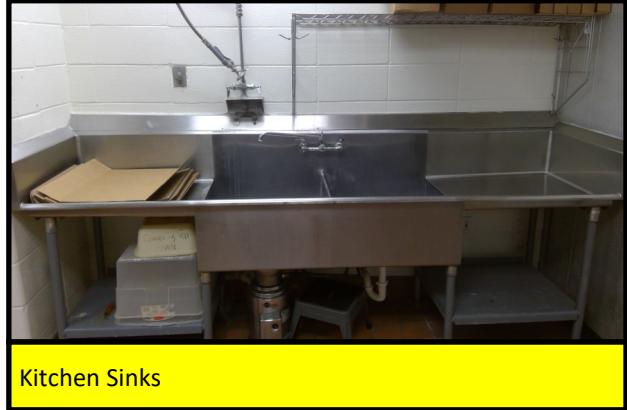
Plumbing Component	Comments
Drainage Piping	3 Cast iron and PVC piping; no known issues.
Water Piping	3 Copper piping where visible. Water in this area is quite hard and no water softener was noted on site which could lead to premature degradation of plumbing fixtures.
Gas Piping	3 Schedule 40 black steel piping.
Classroom Sinks	2 Stainless steel drop in sinks with manual faucets. Recommend replacement of faucets with lever handle for ease of use.
Wash Fountains	2 Wall hung sensor operated fixtures. Outlets exhibit extremely low flow, likely due to sediment build up.
Kitchen Sinks	3 Commercial type stainless steel sinks.
Grease Interceptor	3 Indoor grease interceptor. Location makes cleaning difficult; ensure regular maintenance for proper operation.

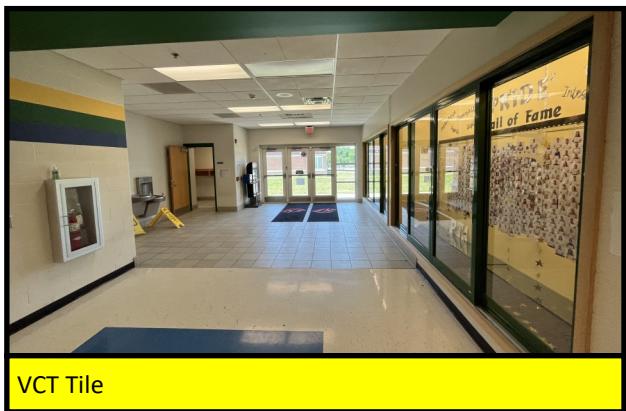
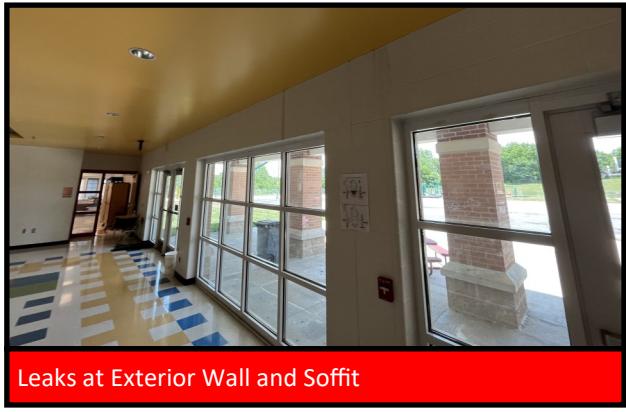
Interior Component	Comments
Floors	1 There is missing ceramic tile base at restroom floor. Discoloration, dirt, or possibly mold at the joint line in the wall.
Floors	2 There is some cracking and settlement at VCT floor outside of classroom door. This is likely at a building control or expansion joint.
Floors	3 Hallway VCT and ceramic tile is in good condition. Loose mats at doorways may be a trip hazard.
Floors	3 There is VCT floor settlement and cracking at doorway. This is likely at a building joint. This could be addressed by a floor expansion joint cover.
Windows-Doors	3 Exterior windows in classroom and office in generally good condition.
Windows-Doors	4 Hallway windows, extending to floor, are in good condition. No evidence of rusting at base of hollow metal frames.
Windows-Doors	4 Building compartment doors are fire rated.
Windows-Doors	1 There are leaks at the exterior wall and soffit at the large common area entry.

Windows-Doors	2 Window trim is loose in areas and needs minor corrective work.
Windows-Doors	2 Window trim is peeling and needs corrective work. Windows should be checked to ensure that water infiltration is not the source of this damage.
Windows-Doors	3 Ceramic tile entry floors in good condition. Loose rugs may be a trip hazard.

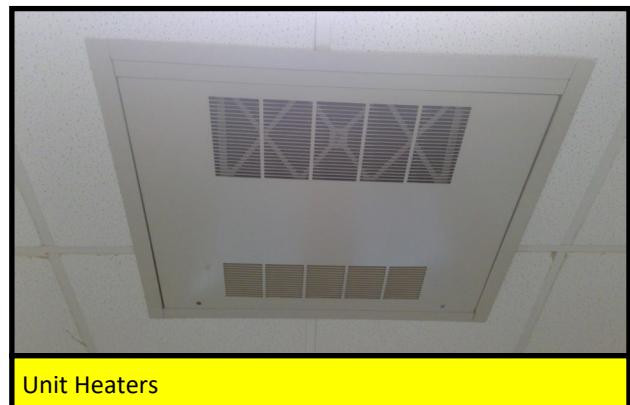
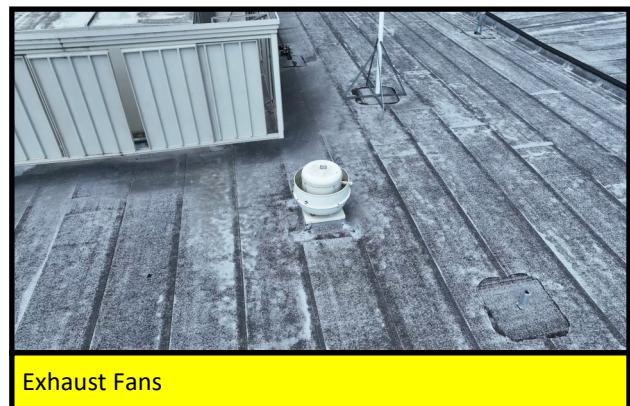
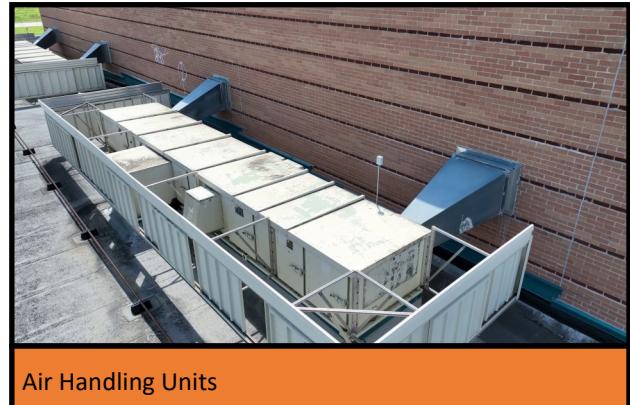
HVAC Component	Comments
Kitchen Exhaust Hoods	3 Kitchen exhaust hood with ansul system appeared to be in good condition. Heated makeup air unit on roof. Dishwasher exhaust ducted to outdoors.
Ventilation Air	3 Via air handlers.
Air Distribution Ductwork	3 Sheetmetal rectangular and double wall spiral.
Unit Heaters	3 Ceiling mounted hydronic cabinet heater.
Exhaust Fans	3 Rooftop exhaust fans in good condition.
HVAC Piping Insulation	3 Hydronic piping insulation in good condition.
Air Handling Units	2 2006 4-pipe roof mounted units at end of expected life.

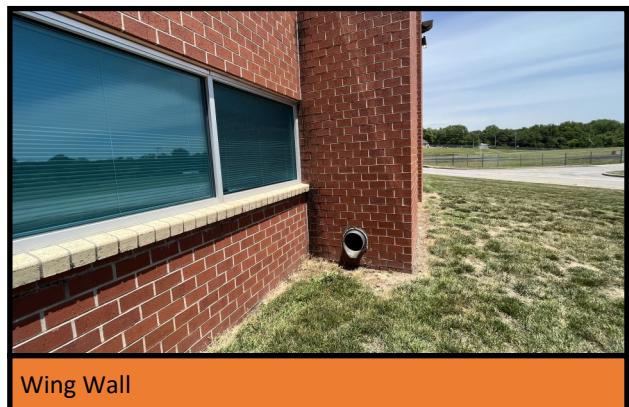
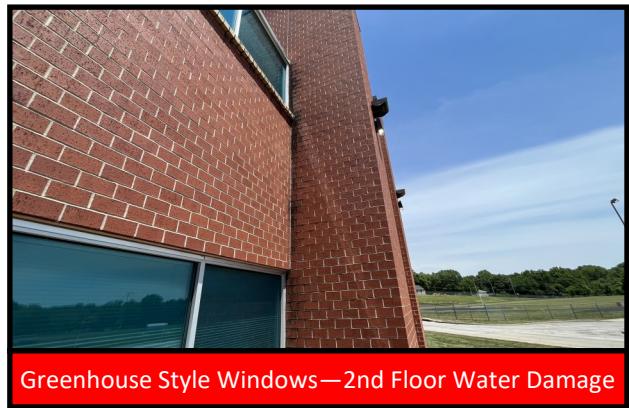
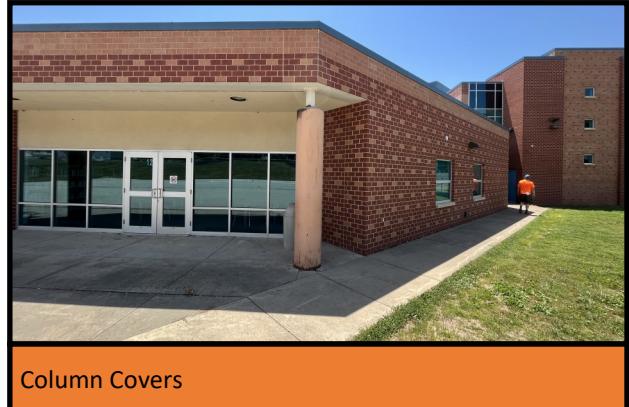
Envelope Component		Comments
Walls-Soffits	1	Water damage at entry, soffit, and overhang.
Walls-Soffits	2	Access panel is rusting.
Walls-Soffits	2	Soffit finish is de-laminating at building and trim.
Walls-Soffits	2	At wing wall adjacent to windows, there is water damage along the height of the wall. Also water damage under window sills.
Walls-Soffits	2	Masonry joints are cracked and deteriorated from water damage at underside of windowsills .
Miscellaneous	2	Building roof drains across the top of the sidewalk. This is a potential slip hazard.
Miscellaneous	2	Downspout in corner of building is damaged.
Miscellaneous	2	Water damage and de-laminating of soffit exists at building entry. Column cover is rusting at the top.
Miscellaneous	1	Water damage is evident at the second floor, greenhouse style windows, transitioning to the masonry wall .
Miscellaneous	2	There is minimal slope for water drainage away from the building and some rutting of the ground .

Miscellaneous	2	Column covers are significantly rusted and cracked concrete around columns .
Windows-Doors	2	Window lintels are rusted above windows.

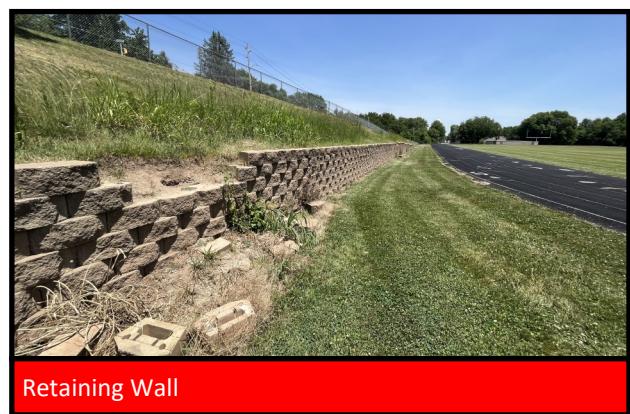
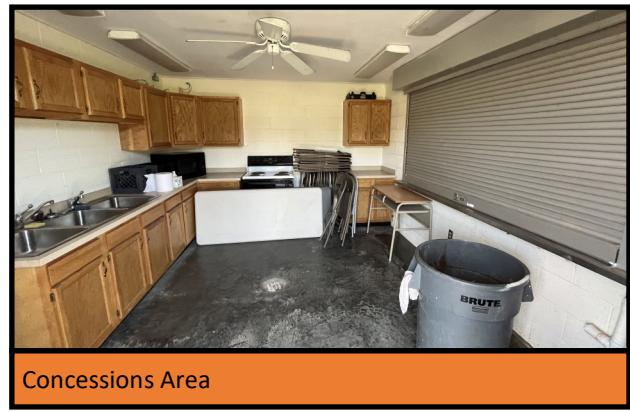
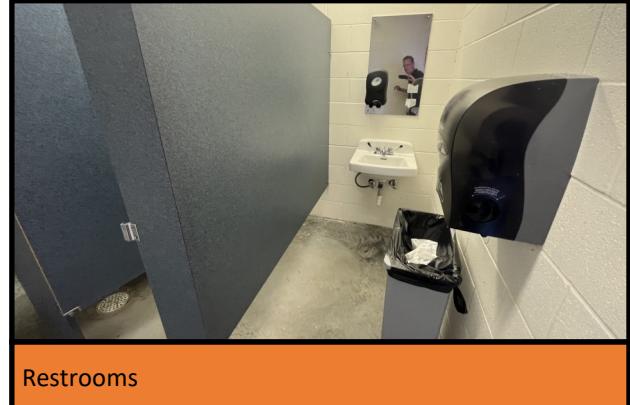
Envelope Component	Comments
Track-Field Area 1	Track surface is deteriorated and cracked.
Track-Field Area 1	Retaining wall has crumbled at north side of track.
Track-Field Area 1	Top row of retaining wall has collapsed.
Track-Field Area 1	Retaining wall has collapsed.
Track-Field Area 2	Concession area sidewalks and building systems are old, but in fair condition.
Track-Field Area 2	Minor damage around concrete concession area.
Track-Field Area 2	Concession area finishes are aged. In fair condition. There is no hood at the stove.
Track-Field Area 2	Toilet areas are not accessible.
Track-Field Area 2	There is no base at floor wall transition. Toilet partitions are delaminating.
Track-Field Area 2	Fixtures are not handicap accessible.
Track-Field Area 2	Partition doors are delaminating.
Track-Field Area 3	Handicap stall has grab bars provided. Room is not entirely ADA accessible.

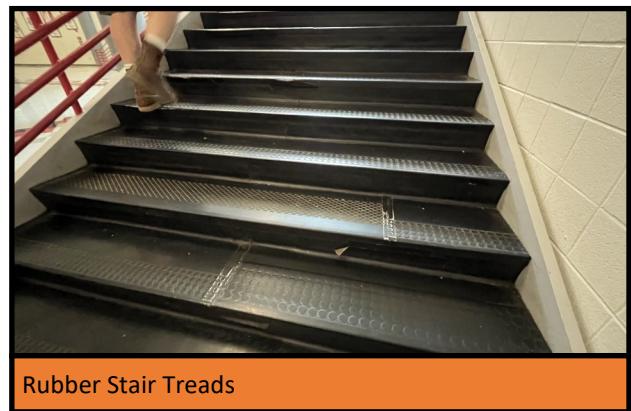
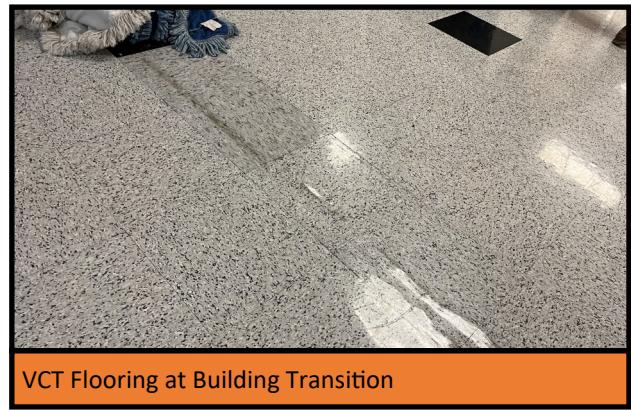
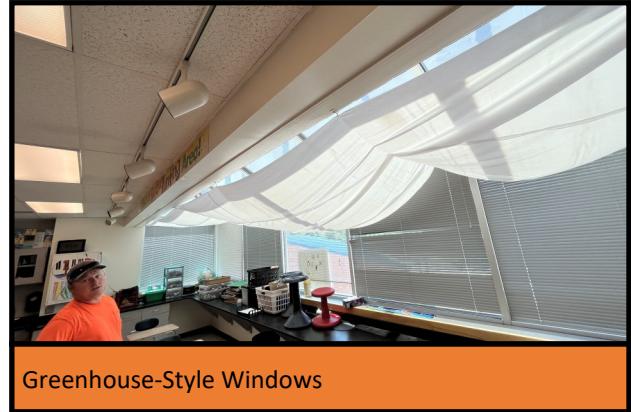
Interior Component		Comments
Floors	1	Dishwashing drains and ice machine drain do not appear to align with floor sink.
Floors	3	Kitchen serving area floor is in good condition.
Floors	1	Electrical floor boxes are not appropriately sealed.
Floors	2	Rubber treads and risers in generally good condition. Some minor repair is necessary.
Floors	2	Epoxy floor at restroom is stained. Rubber base outside restroom door is loose. Minor cracking at restroom epoxy floor.
Floors	2	Floor outlet not appropriately covered and secure tight to floor.
Floors	2	Floor movement and settling at VCT. This likely occurs over a building transition. Expansion joint cover may correct this condition.
Windows-Doors	2	Entry doors in fair condition. Floor at doorway and rug is damaged.
Windows-Doors	3	Exterior windows appear in good condition. Note, however, water damage is consistent at sills outside of building.
Windows-Doors	4	Rated doors provided at hallways.

Windows-Doors	2	All the metal doors in need of touchup. Floor transition is loose.
Windows-Doors	2	Light at greenhouse style windows is very intense and hot.
Windows-Doors	2	Some dirt collected on greenhouse style glazing. Water issues occur at window to wall transitions at exterior of building.
Windows-Doors	4	Curtainwall does appear in good condition.

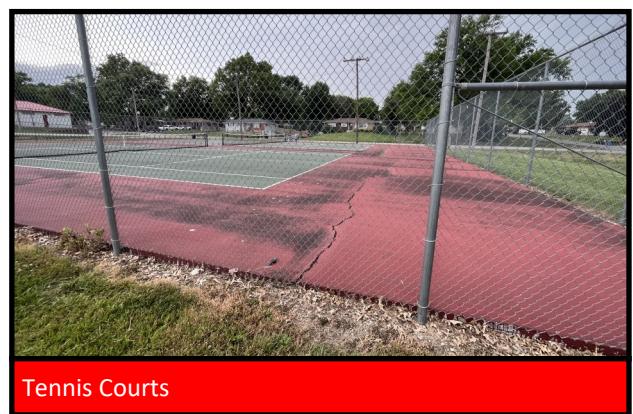
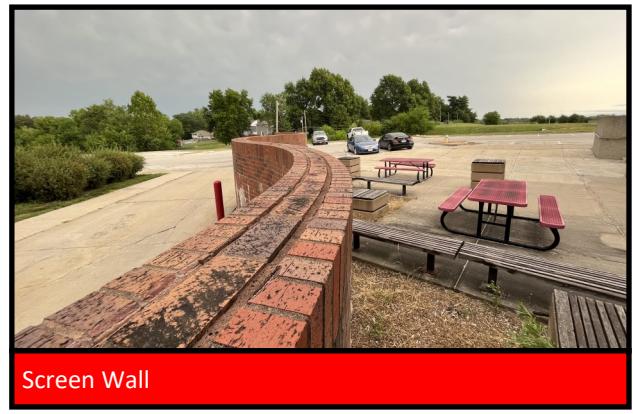
Envelope Component	Comments
Walls-Soffits	1 Outbuilding canopy is deteriorated.
Walls-Soffits	3 Control joints at brick require re-sealing.
Miscellaneous	1 Large cracks at tennis courts. Courts need a minimum patching and resurfacing.
Miscellaneous	3 New building entrance is attractive and accessible.
Miscellaneous	1 Masonry screen wall has water damage and severe effervescence.
Miscellaneous	1 Top of screen wall has water damage resulting in significant water infiltration through the wall.
Miscellaneous	2 Masonry screen walls have extensive effervescence and water damage. Concrete delivery drive is deteriorating.
Miscellaneous	4 Panic hardware is provided to allow security and safe exiting from the courtyard area.
Miscellaneous	2 There appears to be a low spot impacting drainage adjacent to the building corner.
Miscellaneous	1 The exterior door stoop at the outbuilding classroom is undersized with no handrails at steps.

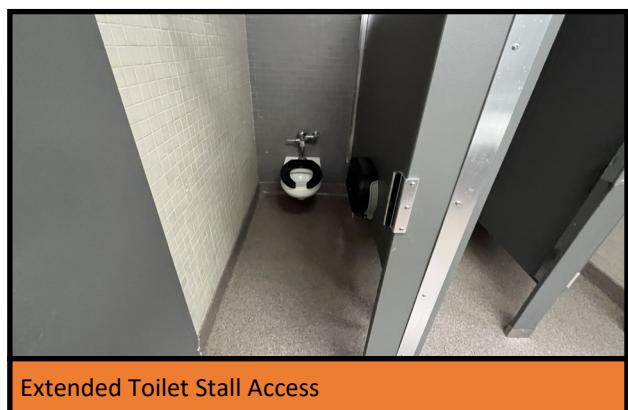
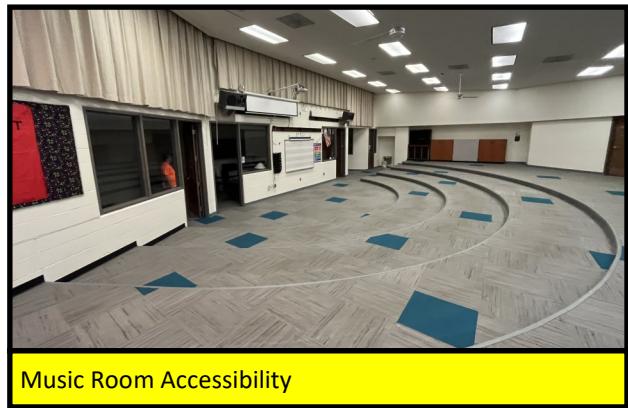
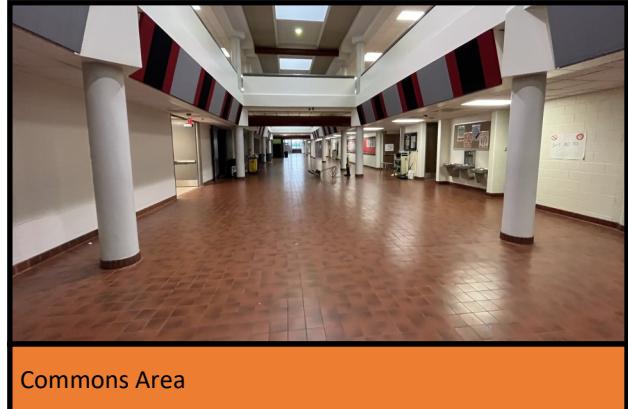
Interior Component		Comments
Accessibility	4	Handicap restroom is fully accessible.
Accessibility	4	Handicap drinking fountains are provided.
Accessibility	3	Good clear area at restroom with accessible fixtures, except toilets.
Accessibility	2	Extended depth toilet stall is not wide enough for accessibility and no grab bars.
Accessibility	3	Accessible stall is narrow with configurations similar to alternative stall layout.
Accessibility	3	Locker room restrooms are accessible. Correct insulation at handicap lavatory is necessary.
Accessibility	4	Restroom is accessible.
Accessibility	2	Handicap lift at auditorium is not properly used.
Accessibility	3	Music room is accessible from upper and lower levels. No ramp system within the room.
Accessibility	3	Accessible lavatory and urinal. Water closet is narrow.
Aesthetics	3	Office entry and reception finishes are attractive. Some minor discoloration at ceiling grids may need repair.

Aesthetics	2	Commons area floors and wall finishes are drab and dated.
Aesthetics	2	Commons area finishes and air outlets are dated.
Aesthetics	4	Updated classroom finishes appear in good condition.
Aesthetics	3	Updated hallway areas are attractive. Original quarry tile flooring is dated.

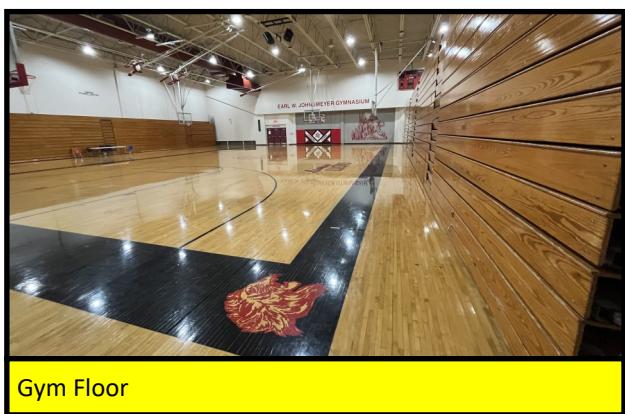
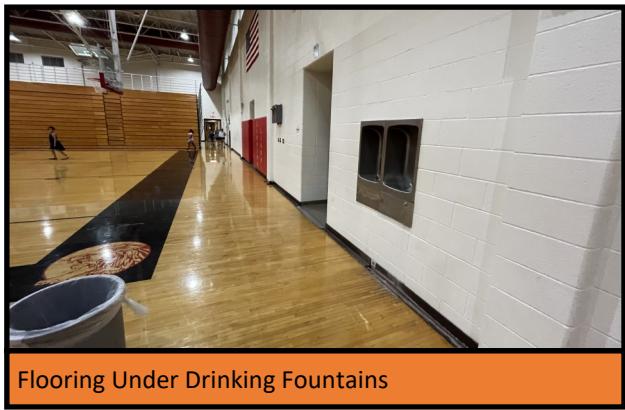
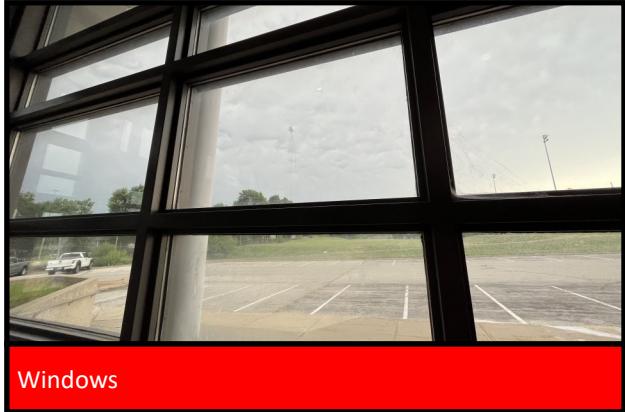
Interior Component		Comments
Flooring	2	Quarry tile floors are dated. Walk off carpet may be preferred at building entrances.
Flooring	4	Epoxy resign floors at restrooms in good condition.
Flooring	3	Wood gym floors in generally good condition. Routine maintenance required.
Flooring	3	Some spotting occurs at gym floor. Should be corrected with routine maintenance.
Flooring	2	Some water damage and floor base damage underneath drinking fountains.
Flooring	2	Rusting and discoloration evident at shower area floor.
Flooring	2	Floor staining occurs under plumbing fixtures. Maybe from water damage at leaking fixtures.
Flooring	2	Electrical floor box cover does not appear to be appropriate for the recessed box.
Flooring	2	Threshold recommended at doorway between hallway and stage floor.
Flooring	2	Quarry tile floor at second-floor has damage at tile and joints.
Windows-Doors	3	Exterior windows in generally good condition. There appears to be some wall damage at Interior sill. Recommend to determine if that is caused by water infiltration.

Windows-Doors	2	Exterior portions of hollow metal storefront/curtain wall system are heavily deteriorated. Interior portions appear to be in better condition.
Windows-Doors	3	Interior doors are non-rated at hallways.
Windows-Doors	2	Interior side of vestibule Storefront/curtain wall are in good condition. Exterior components are severely damaged.
Windows-Doors	1	Apparent bullet damage and damaged seal at glazing units.

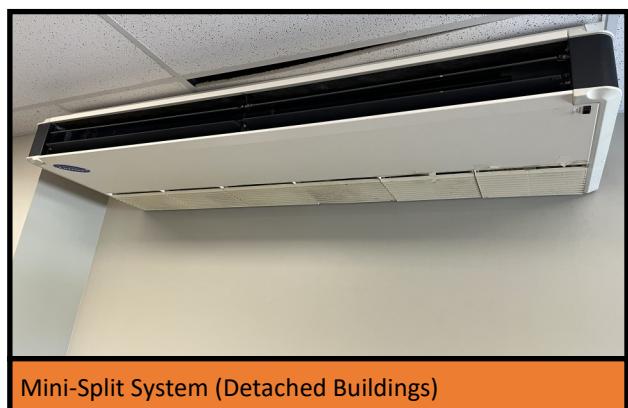
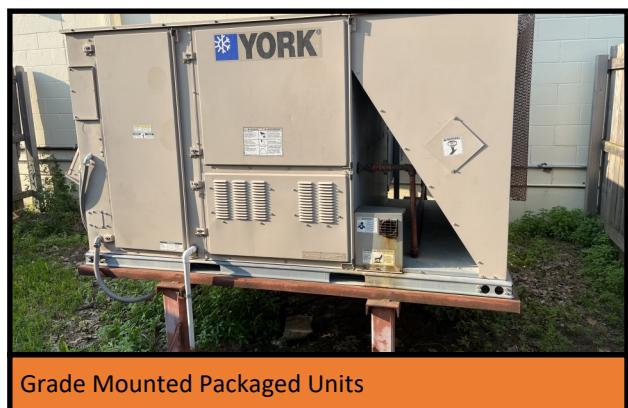
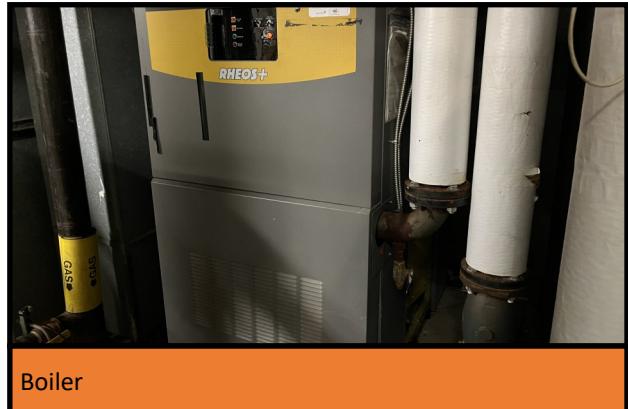
HVAC Component	Comments
Ventilation Air	3 Via RTUs and air handlers.
Air Distribution Ductwork	3 Sheetmetal rectangular and double wall spiral.
Unit Heaters	3 Ceiling mounted electric heater.
Exhaust Fans	3 Rooftop exhaust fans in good condition.
HVAC Piping Insulation	3 Hydronic piping insulation in good condition.
Split Systems (Detached Buildings)	3 2013/2015/2020 split systems in good condition. Basement unit appears to be nearing end of expected life.
Mini-Split Systems (Detached Buildings)	2 2009 Ceiling suspended indoor units serving IT closets not operating properly.
Grade Mounted Packaged Units (Detached Buildings)	2 2003 Trane and York grade mounted gas fired packaged units nearing end of expected life.
Boiler	2 LAARS RHEOS+ boiler approaching end of expected life.

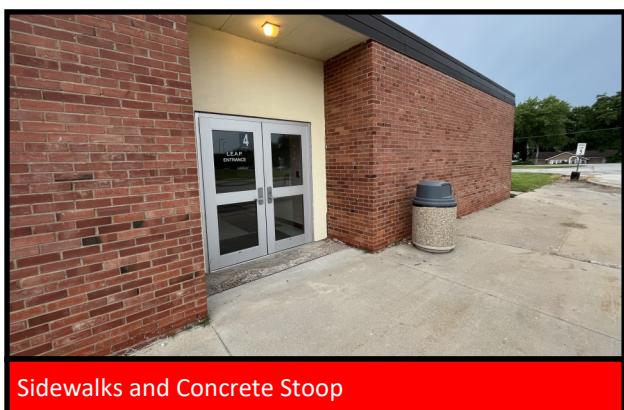
Parking Lot

Site Component	Comments
Parking	2 Parking lot needs repair and resurfacing. No handicap parking near main entrance.
Pavement-Sidewalks	2 Concrete walk is deteriorating with asphalt road topping aggregate accumulating at curb line.
Pavement-Sidewalks	1 Concrete stoop outside exterior door is deteriorated.
Pavement-Sidewalks	2 Concrete walks at west staff entrance in fair condition, adjacent parking is deteriorated and in need of repair.
Pavement-Sidewalks	1 Asphalt paving outside southside of west staff entrance is deteriorated, in need of replacement.
Pavement-Sidewalks	1 South back door, concrete stoop, and asphalt is deteriorated. Hole in paving adjacent to stairwell is large enough for animals to live.

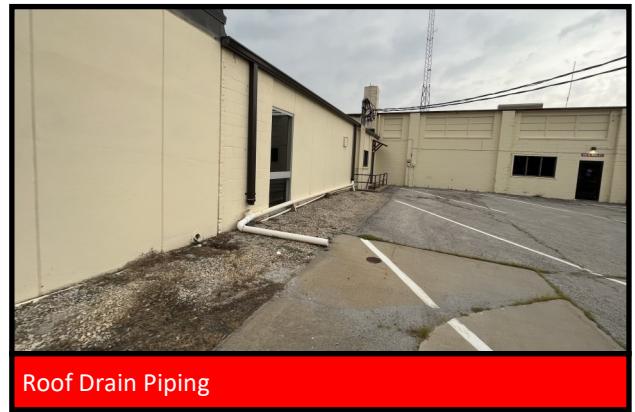
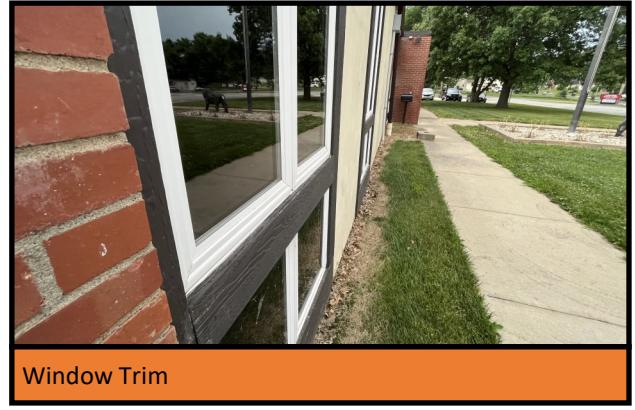
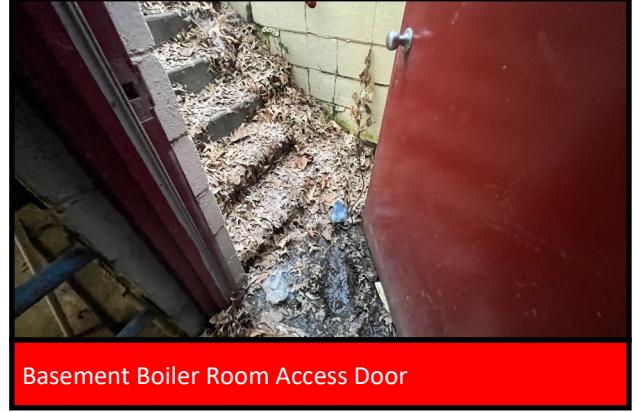
Envelope Component	Comments
Walls-Soffits	2 Brick is spalled and damaged at multiple building areas.
Walls-Soffits	2 Base of concrete wall is damaged at finish floor line.
Miscellaneous	1 Roof drain piping is damaged and disconnected along south side of building.
Miscellaneous	1 Exterior stairwell is full of debris. Masonry walls are damaged.
Windows-Doors	2 Exterior window trim is cracked and in need of repair or sealing at various areas.
Windows-Doors	3 Exterior main entry doors appear in good condition.
Windows-Doors	1 Basement boiler room access door is non-functional due to the damage and debris at the stairwell.

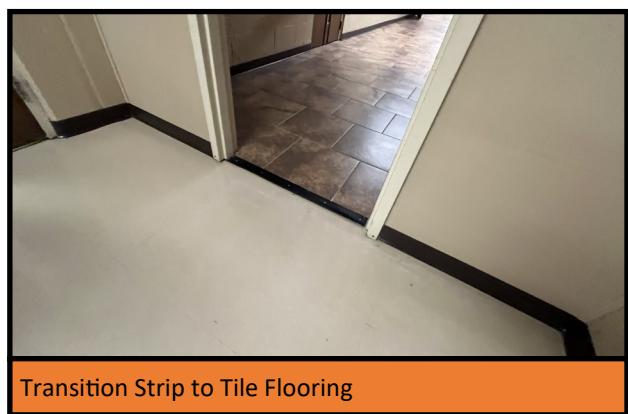
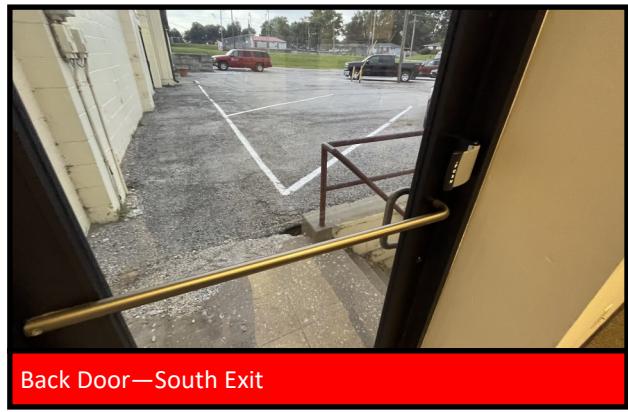
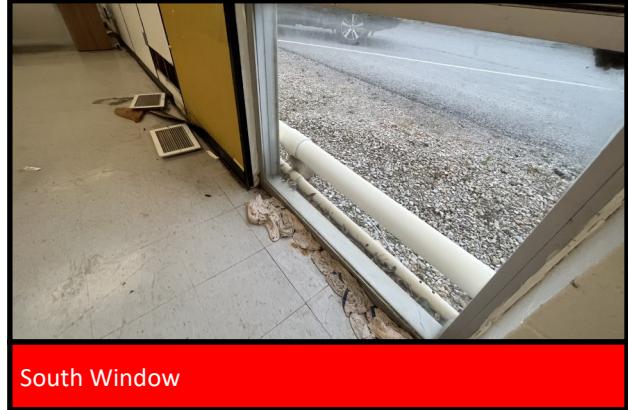
Windows-Doors	2	Exterior windows with Roto vents have deteriorated glazing.
Windows-Doors	1	Deteriorated trim and glazing at exterior window. Floor damage may be due to water infiltration at window.
Windows-Doors	3	Exterior window and shelf in generally good condition. Some wood finish repair may be required.
Windows-Doors	1	Back door, south exit adjacent to stairwell, is a hazardous condition at the stoop and asphalt transition.
Windows-Doors	1	South window has deteriorated glazing, broken glass, and water infiltration.
Windows-Doors	2	West staff entry doors are damaged and rusted at the base.

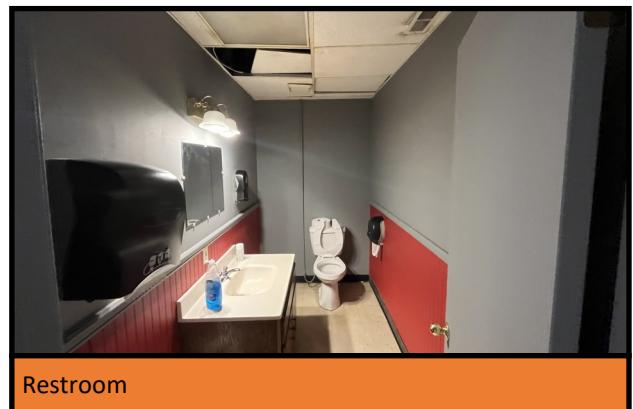
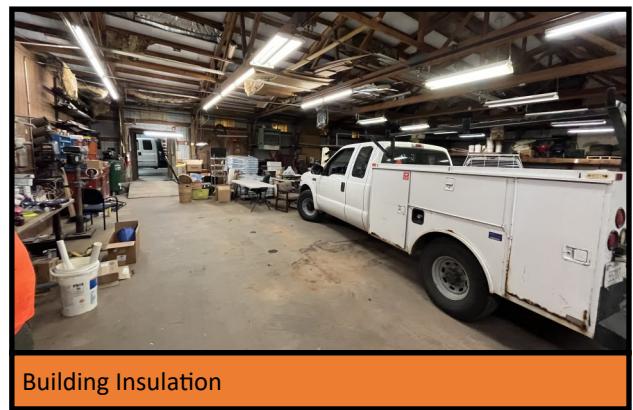
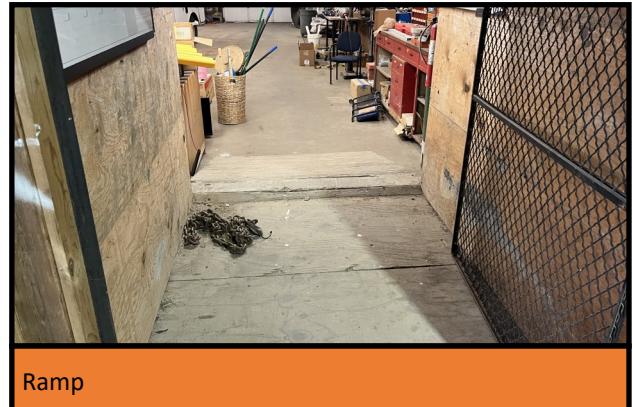
Interior Component	Comments
Interior	2 Transportation/maintenance office finishes are aged and in poor condition.
Interior	2 Restroom is not accessible. Finishes are aged and dirty. Ceiling is damaged. VCT floor not recommended for sanitation in restroom.
Interior	2 Interior finishes are aged. Door hardware is not accessible.
Interior	2 Insulation is damaged and sagging throughout building. Did not observe emergency lighting at building.
Interior	2 Floor finishes relatively good condition. Wall and liner panels and overhead doors have damage.
Interior	2 No side protection at ramp. Ramp is steep.

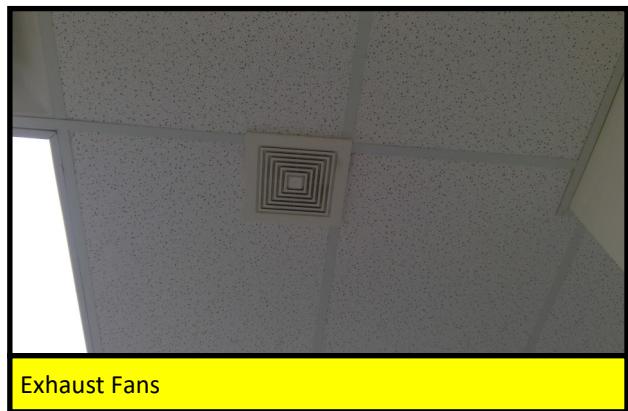
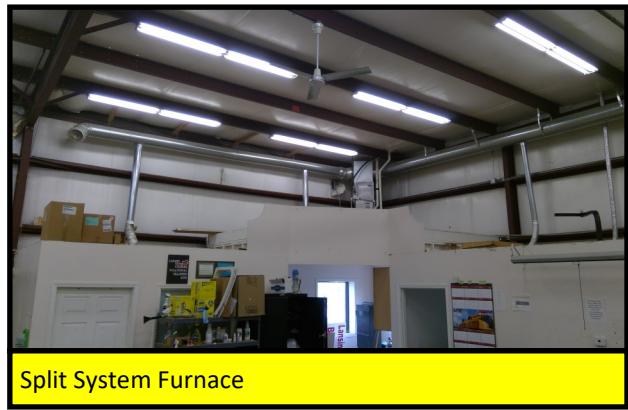
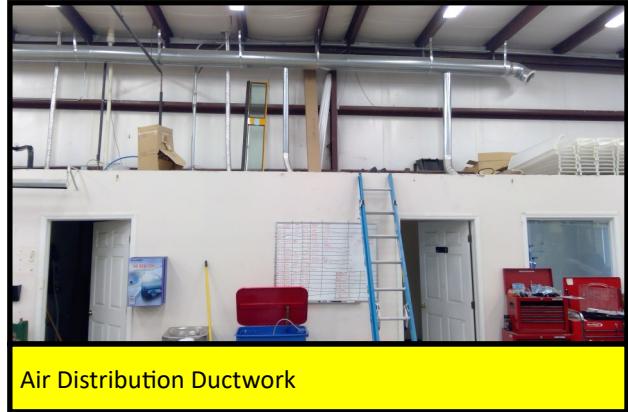
HVAC Component	Comments
Building Automation System	2 Standalone controls for fans, heaters and A/C equipment.
Packaged Rooftop Units	2 2006 Carrier gas fired rooftop units nearing end of expected life.
Exhaust Fans	3 Ceiling cabinet exhaust fan in restrooms.
Split System Furnace	3 Carrier gas fired high efficiency furnace in good condition for shop area.
Ventilation Air	3 Via RTUs.
Air Distribution Ductwork	3 Where visible ductwork was sheet metal and in good condition.
Vehicle Exhaust	1 Recommend addition of code compliant exhaust for vehicle maintenance areas.
