Structural Assessment

Campbell Lane Building – West Broad Campus

1573 West Broad, Athens, Georgia 30606

JANUARY 09, 2026

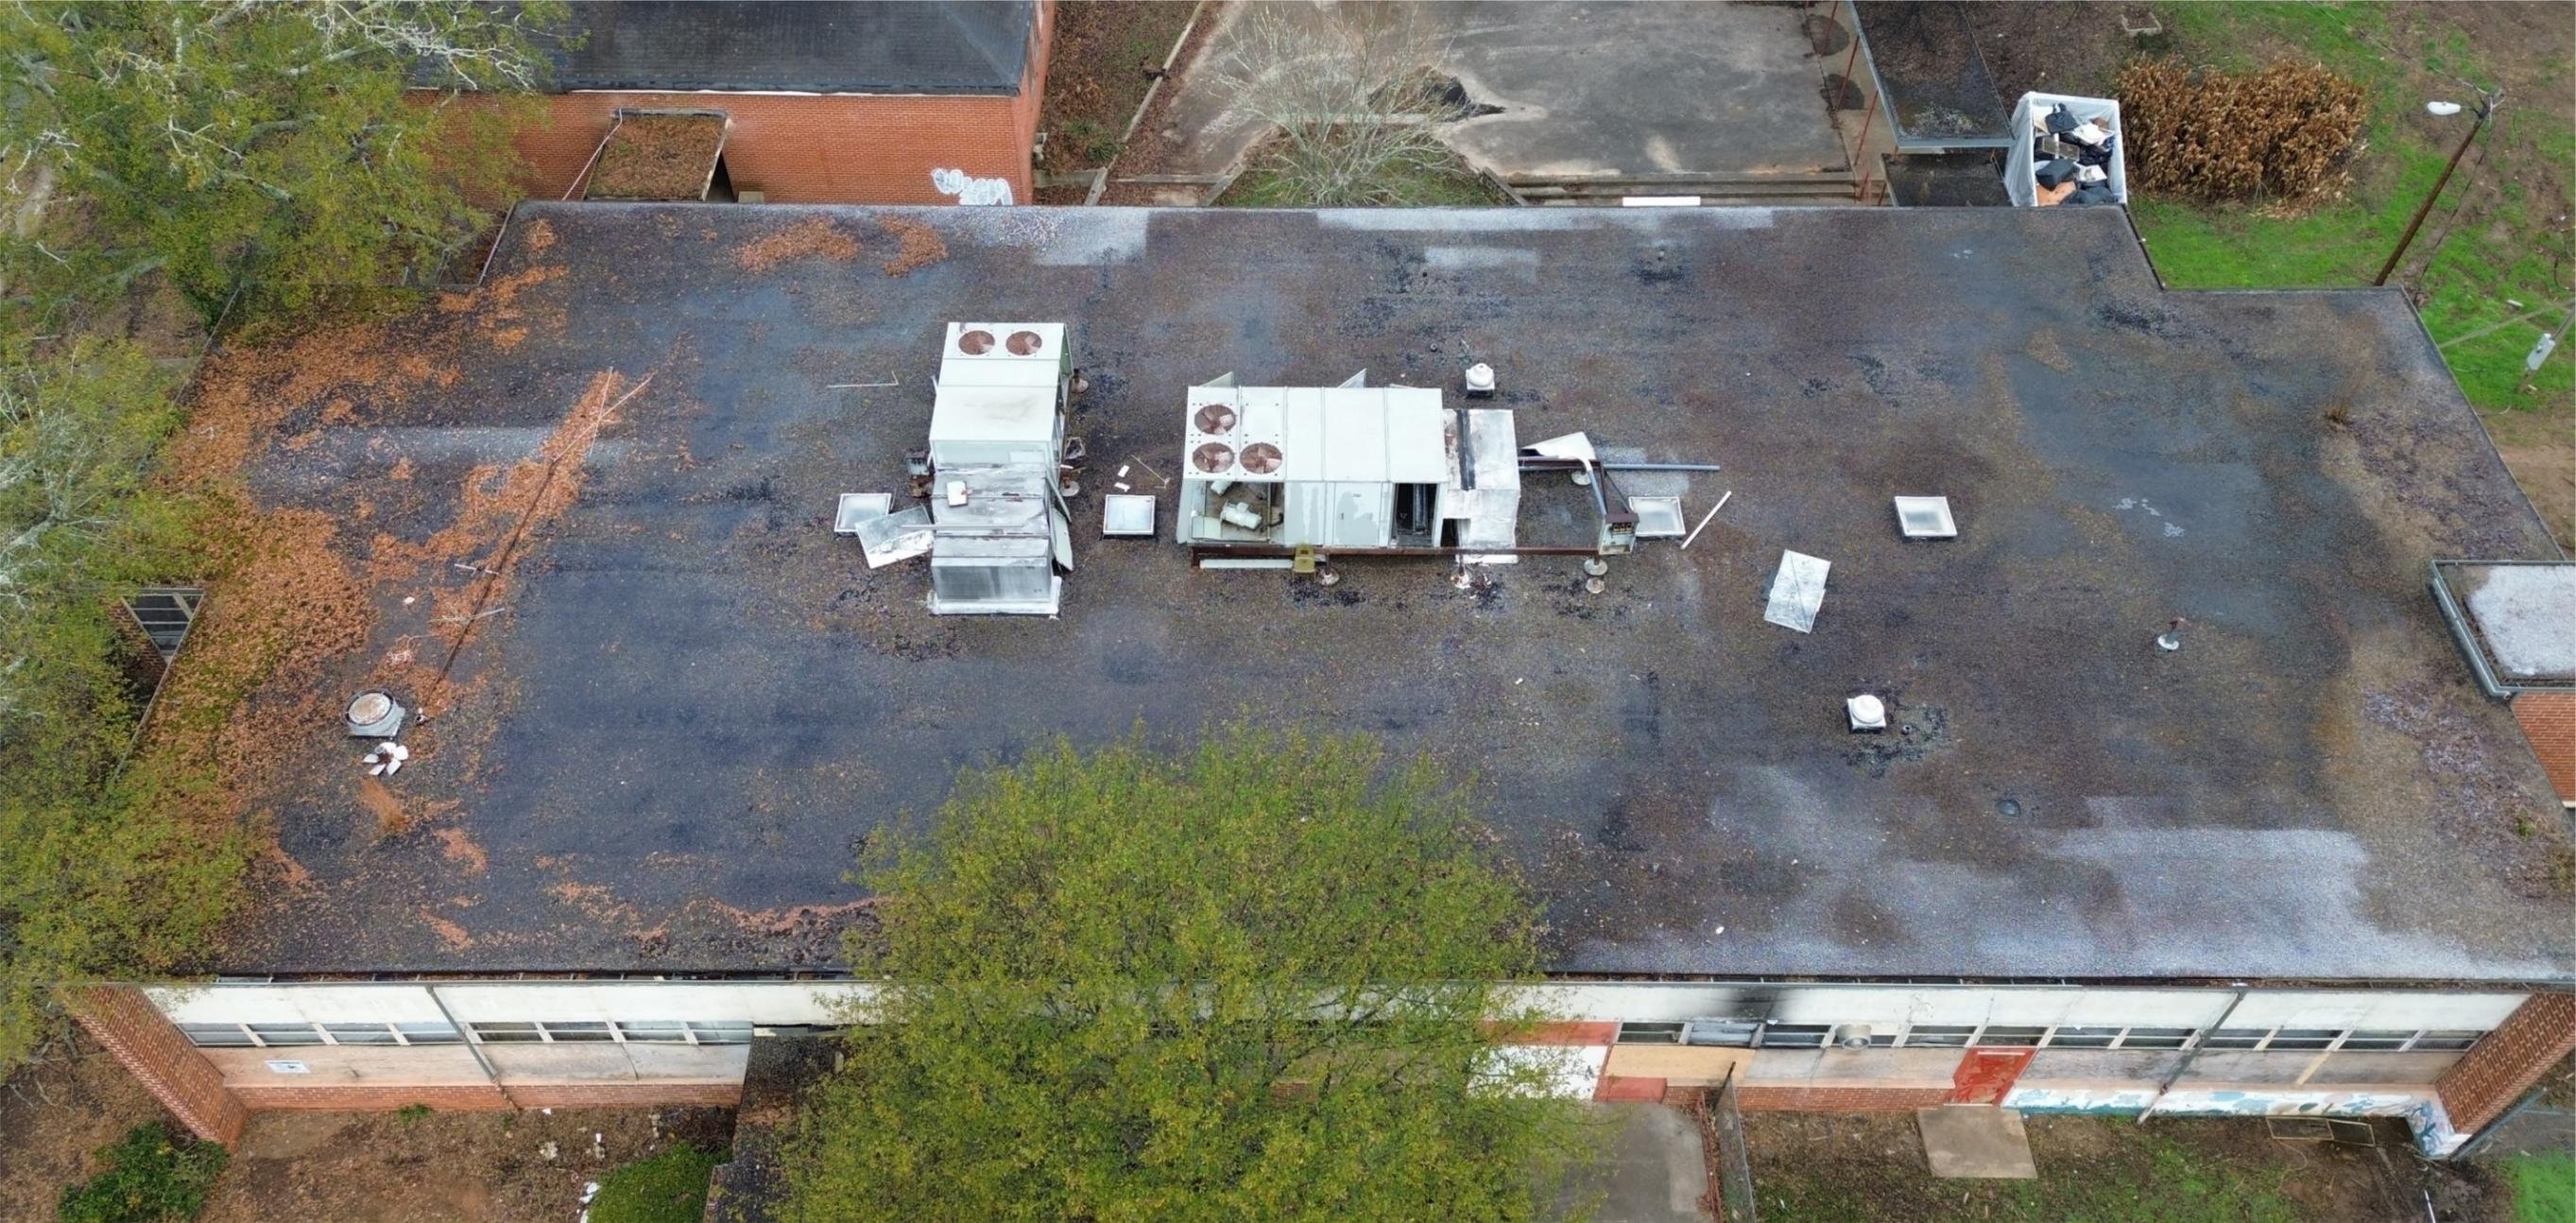
DRONE IMAGES

Access to the roof was not available at the time of the observation. Drone photos were provided for use to review. The photos show multiple areas of water and organic accumulation, many underneath the branches of mature trees. There are multiple skylights along the spine of the building and align with the corridor. Deterioration of the roof deck can be observed within the hallway at each skylight location and mechanical penetration.

The composition of the roof decking is outdated and is not used in typical modern construction. With the extent of the water infiltration and deterioration of the decking material, it is recommended to remove and replace the extents of the entire roof decking and the supporting steel bulb tees. The roof may be replaced with a minimum 1 ½” deep 18 gage Type B steel roof deck. The new deck shall be welded to all steel framing to meet design requirements.
