*Florida Department of Transportation*

April 17, 2026

Reference: Required Prompt Corrective Action Notice  
District 1 Local Government Owned Bridge Inspection Program  
Bridge ID: 034112 - Caxambas Court over Roberts Bay

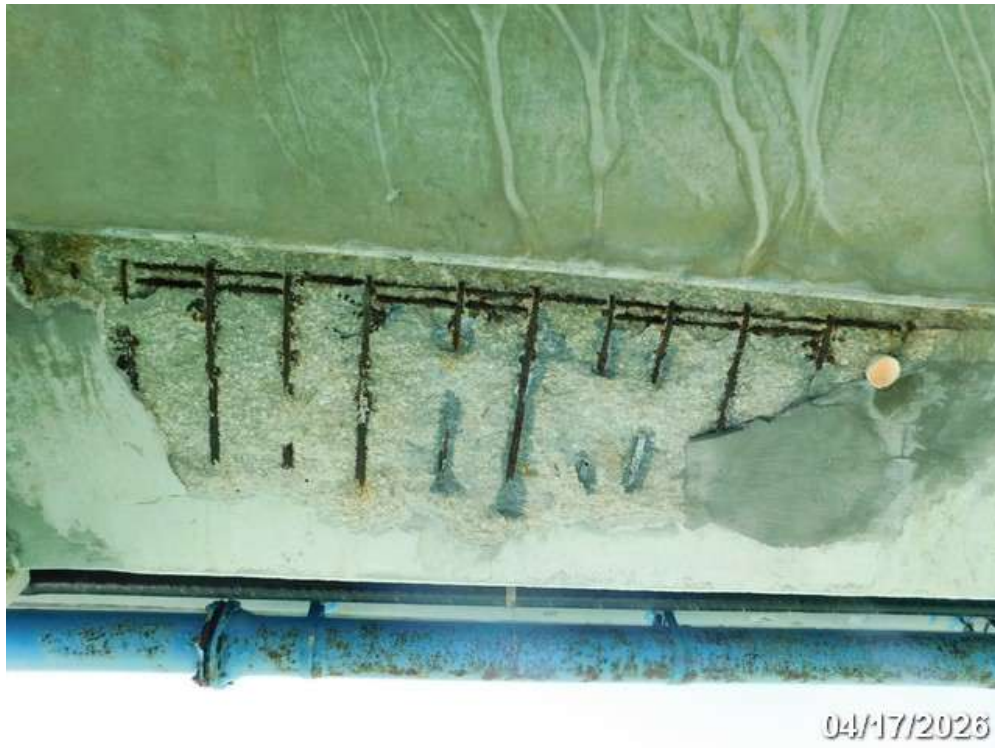
- Element 8099 Prestressed Concrete Slab (sonovoid):
  - Slab Unit 9-1 has a spall 12ft. L x 40in. W x 2-1/2in. D with (2) exposed prestressed strands and (7) exposed rebars having up to 100% section loss in areas up to 8in., in the south edge from Bent 9 to 1/3 point. (No Change since last inspection) Refer to Photo 1.

In accordance with the latest FDOT guidelines for sonovoid slabs, the section loss of the prestressed strands warrants that the bridge deck and superstructure NBI ratings are coded 3-Serious. Inspection frequency remains at 3-months.

Photo 1: General view of spall/delamination at Slab Unit 9-1 starting at Bent 9.

You are hereby notified that it is the City's responsibility to correct said deficiencies within thirty (30) days. Help us protect your federal funds and reduce your potential legal liability by expediting this requested response.

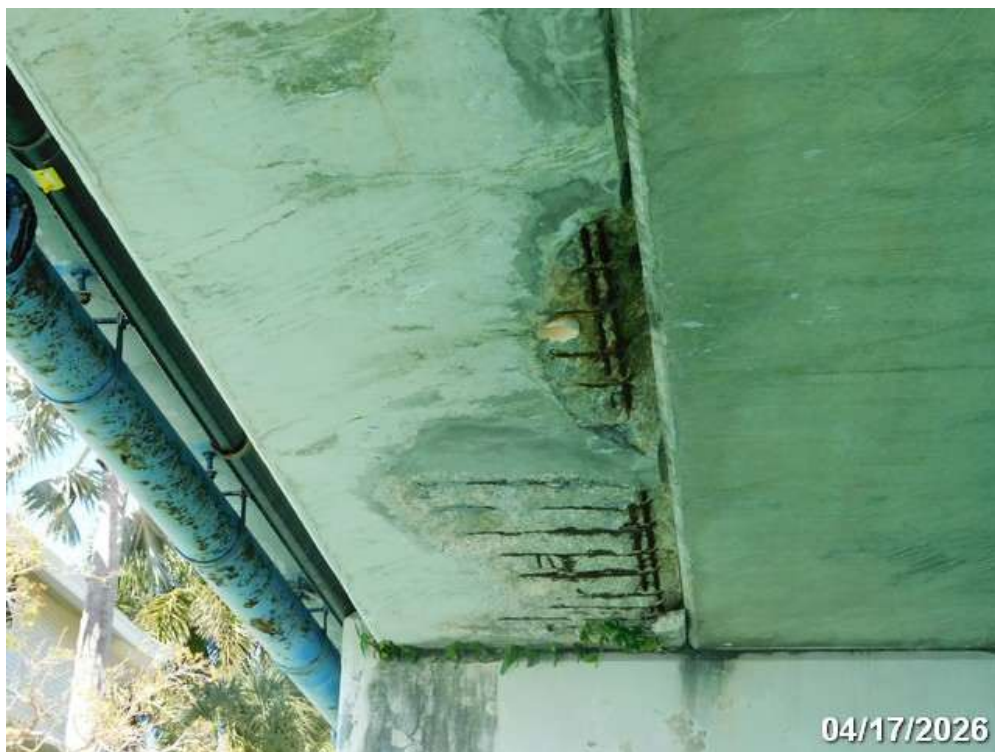
- Slab Unit 9-1 has a delaminated repair/spall 13ft. L x 40in. W x 4in. D at the center to south edge of the slab unit from the 2/3 point to Bent Cap 10 with (5) exposed prestressed strands and (13) exposed rebars. All exposed strands have up to 50% section loss throughout. Two of the five exposed strands have up to 100% section loss over 6in. long. (No Change since last inspection). Refer to Photo 2.

Photo 2: General view and close up of spall/delamination at Slab Unit 9-1 at midspan.

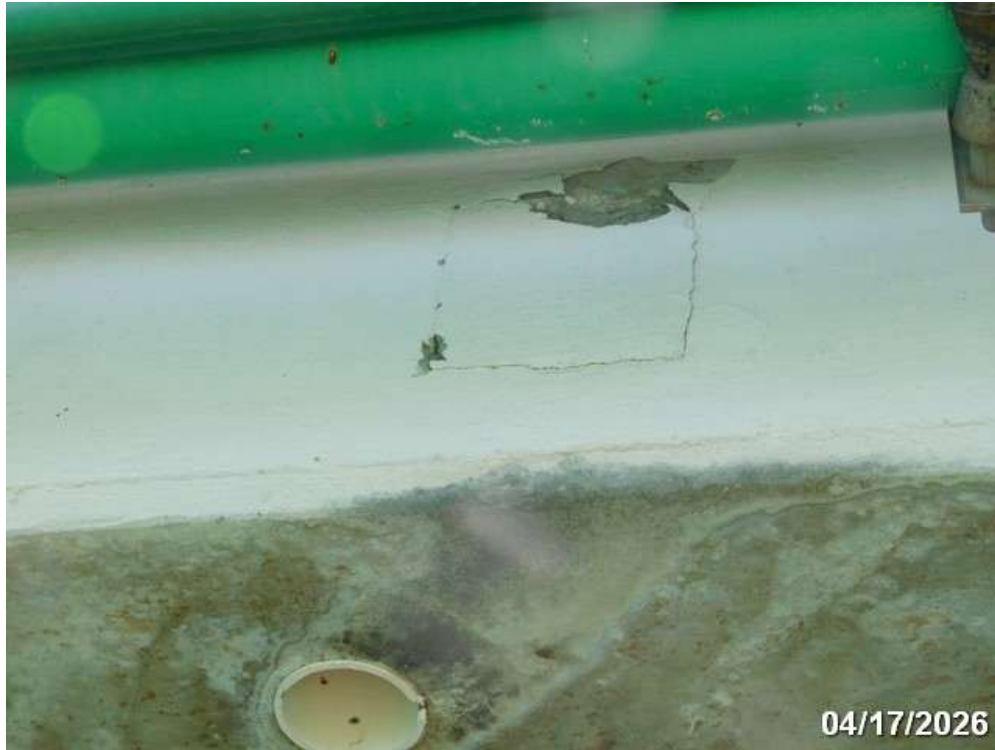
- Slab Unit 9-1 has a spall/delamination 18in. L x 18in. W x 1/4in. D in the middle of the slab at midspan. (No Change since last inspection)
  - Slab Unit 9-7 south face at the first grout patch for the transverse post tensioning rod has a spall and delamination, 8in. L x 3in. W x 1/2in D (Increase since the last inspection, now it is a spall/delamination, but it did not increase in size). Refer to Photo 3.

Photo 3: Spalled and Delaminated grout patch for the transverse post tension rod in the south face of Slab Unit 9-7

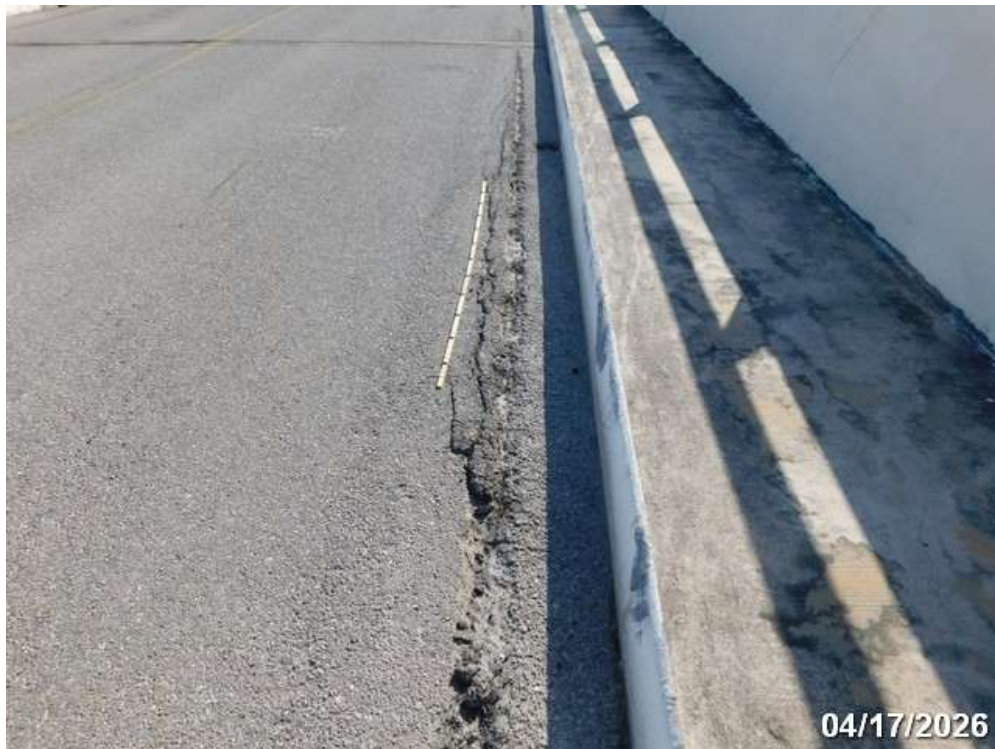
- The asphalt in Span 9 over the joint for slab Units 9-1 and 9-2 has a full length longitudinal crack up to 1/4in. wide and raveling up to 1/2 in. This condition is typical throughout other spans. (No Change since the last inspection). Refer to Photo 4.

Photo 4: Crack with upheaving in the asphalt over Slab Units 9-1 and 9-2 joint.  
[FDOTTampaBay.com](https://www.fdot.com/MyFDOT_Tampa) | [@MyFDOT\\_Tampa](https://www.facebook.com/MyFDOTTampa) | [Facebook.com/MyFDOTTampa](https://www.facebook.com/MyFDOTTampa)
