## BERLIN AREA SCHOOL DISTRICT

Facilities Assessment and  
Comprehensive Master Plan - Report Part 1  
August 24, 2022

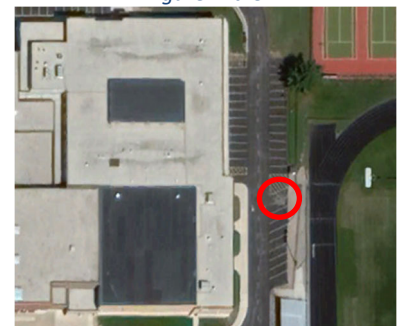
Figure Ext. 4

Maintenance may be deferred in most areas; however, one location is reported to have a potential issue. Figure Ext.4 shows the approximate location where a catch basin may be compromised, and the underground erosion is occurring. This could mean a storm pipe may be compromised and the catch basin leaking into the soil, washing soil into the storm system. This is causing the asphalt to sink around the immediate area of the catch basin (Figure Ext.5).

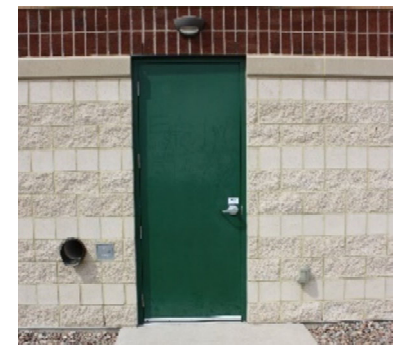
Figure Ext. 13

- Gym Storage Access: This is a hollow metal door opening used to directly access the gym storage from the exterior and as an exit from the space. It appears students have drawn on the door, but the writing is only ghosted in the chalky film that has oxidized on the paint. The balance of the door is in good condition. The sealant, seals, and sweeps are in good condition as they are new from the recent construction.
- Locker Room Access: These two doors are the mud room access for athletic teams to get to the locker rooms during outdoor sporting events. The sealant, seals, and sweeps are in good condition as they are new from the recent construction.

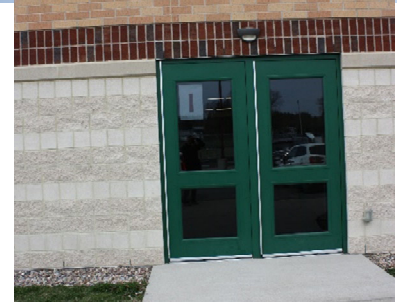
Figure Ext. 15

- Exit I: These full-lite doors are exit-only doors from the school serving as emergency exits. This is a hollow metal frame and door assembly, and there is a small amount of rust forming at the bottom of the jambs and center mullion. It is recommended to clean the rust off and touch up paint the frame to get ahead of the issue. The sealant, seals, and sweeps are in good condition as they are new from the recent construction.

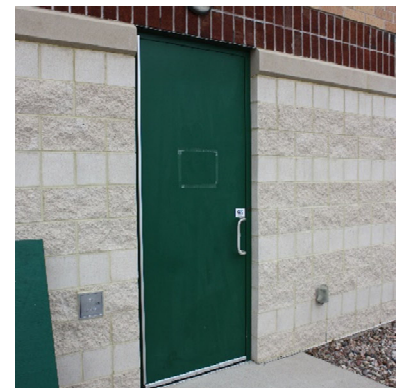
Figure Ext. 18

- Locker Room Access: This door is the mud room access for public access locker rooms. The door has some slightly chipped paint and mastic residue from previous temporary signage being applied to the exterior surface. The sealant, seals, and sweeps are in good condition as they are new from the recent construction.

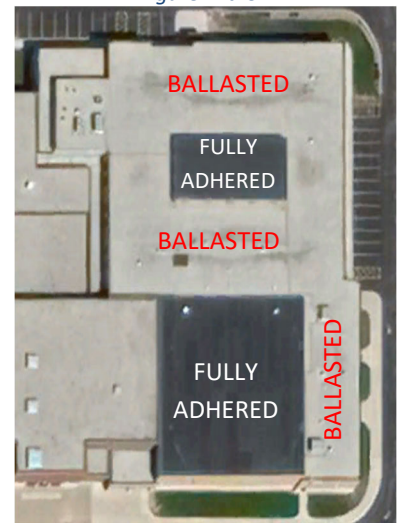
Figure Ext. 35

- Roof section Types, Ages, and conditions: The roofing was installed in 2015 when the middle school addition was constructed. Two assembly types are finished with a fully adhered membrane on the high roofs and stone ballast on a single-ply membrane for the balance of the roof (Figure Ext.35).
