# MASTER FACILITIES PLAN

MAY 2023

# CHAPTER 1: OVERVIEW

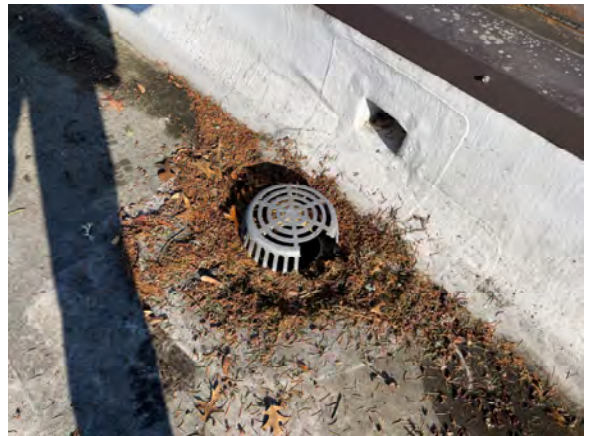
*Photo #10: Damaged Drain Strainer*

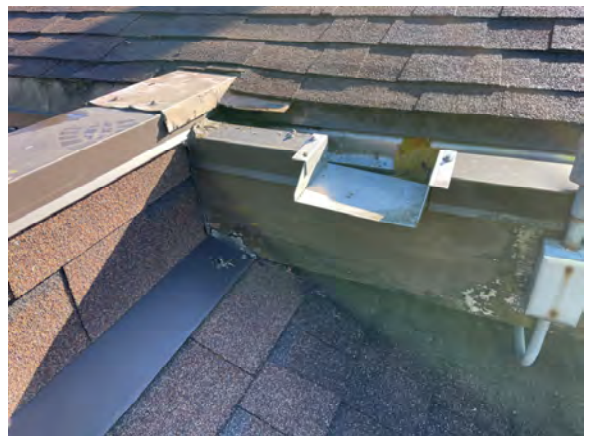
*Photo #12: Non-Industry Standard Flashings*

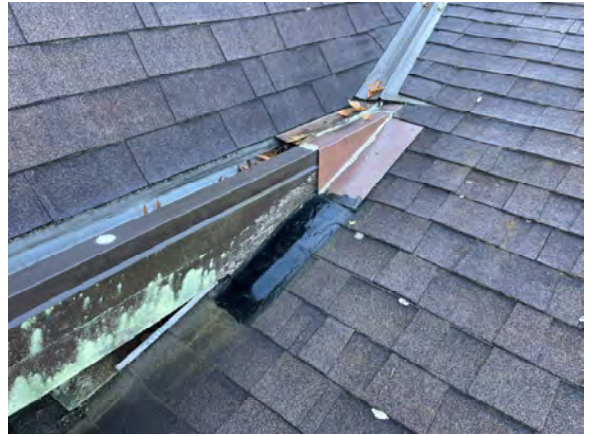
*Photo #14: In-adequate Flashing Repair*

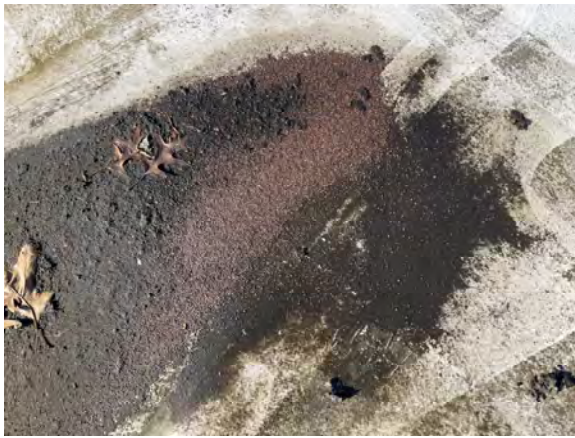
*Photo #15: Some Granule Loss Observed*

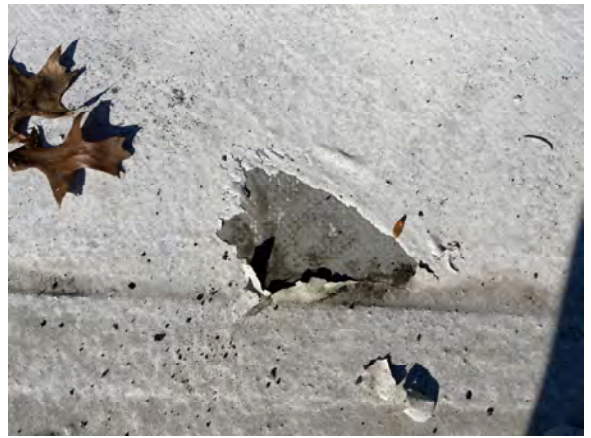
*Photo #16: Coating Failure (Typical)*

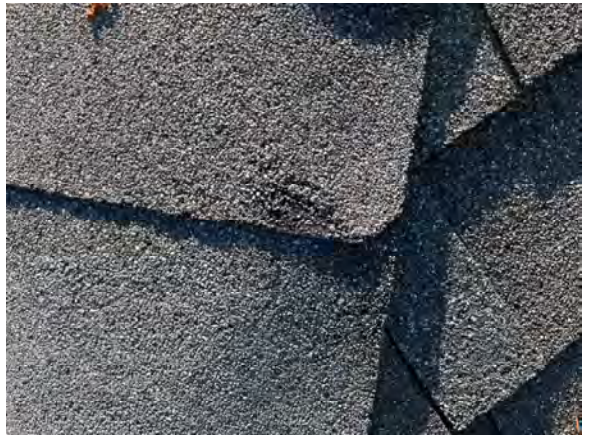
*Photo #4: Shingle Damage (Typical)*

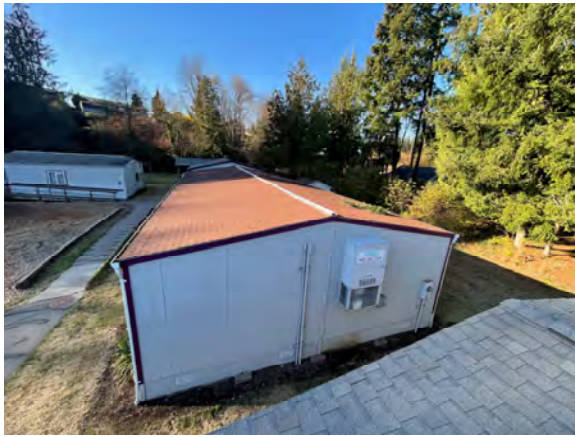
*Photo #3: Building 2 Roof [Failed]*

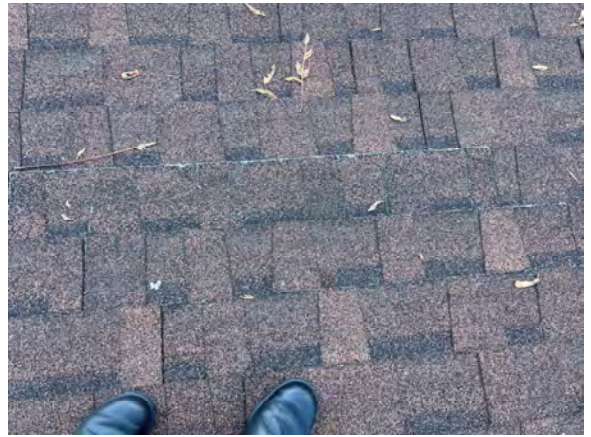
*Photo #4: Building 2 Scrim Exposure*

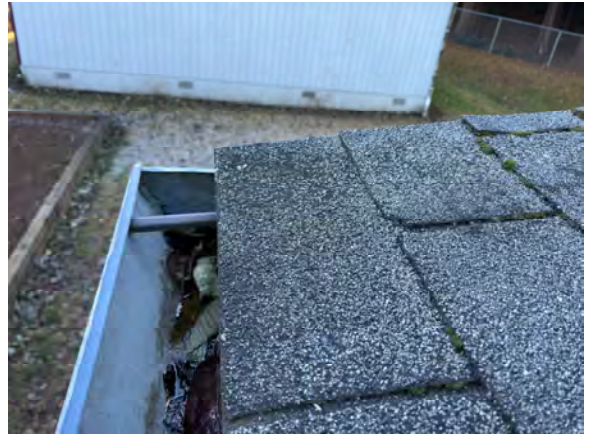
*Photo #8: Building 4 Roof Excessive Granule Loss*

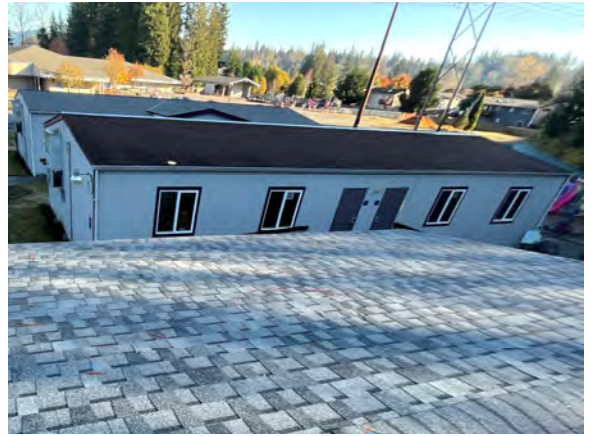
*Photo #8: Building 8 Roof [Failed]  
(Building 9 in background + Building 6 in foreground)*

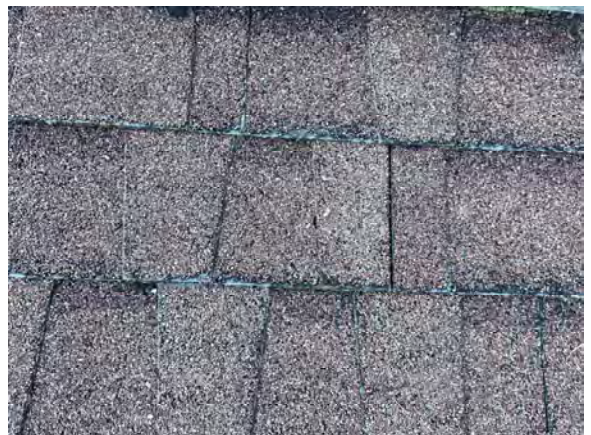
*Photo #12: Building 10 Roof [Failed]*

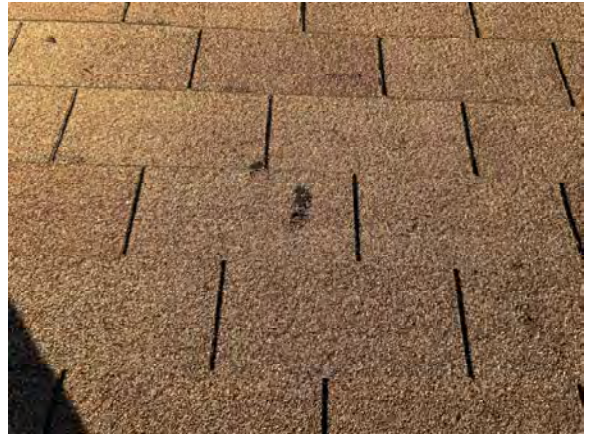
*Photo #8: Shingle Damage*

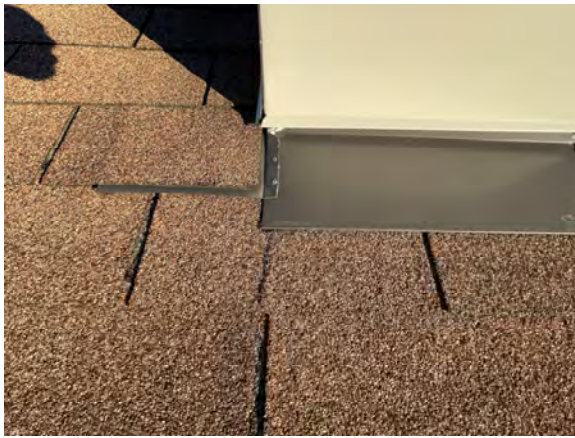
*Photo #9: Open Riveted Seam*

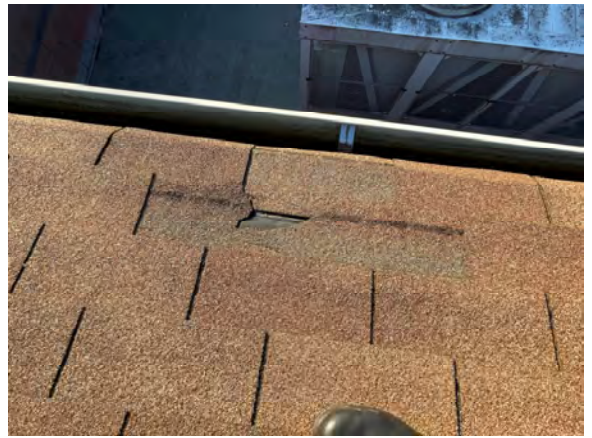
*Photo #10: Shingle Damage – Wind Blowoff*

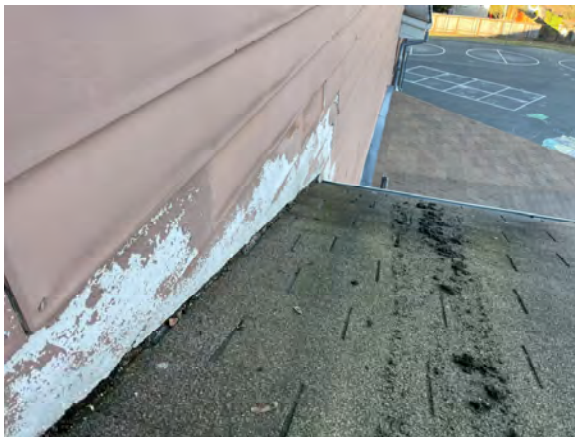
*Photo #11: Siding Damage due to Drainage*

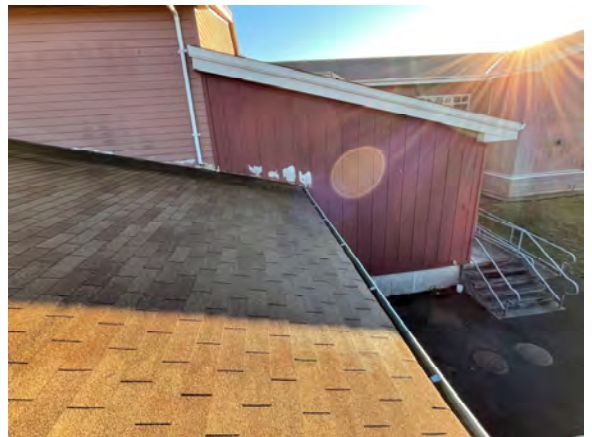
*Photo #12: Drainage onto Lower Roof*

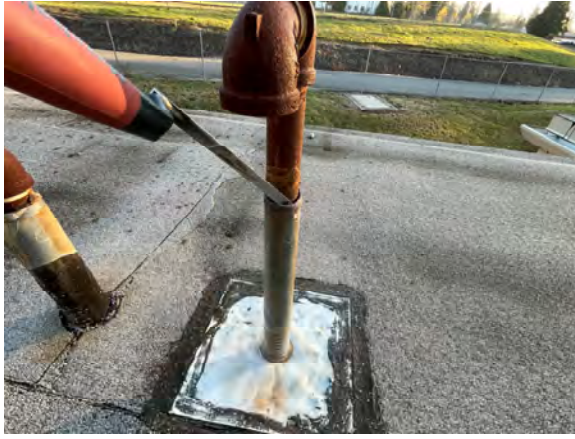
Photo #1: Open Lead Flashing

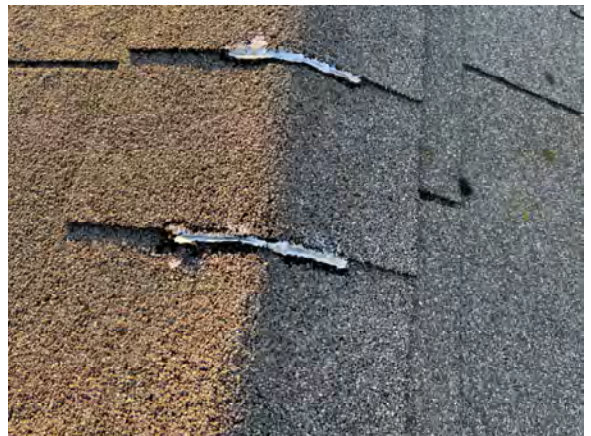
Photo #6: Non-effective Sealant Repair at Ridge

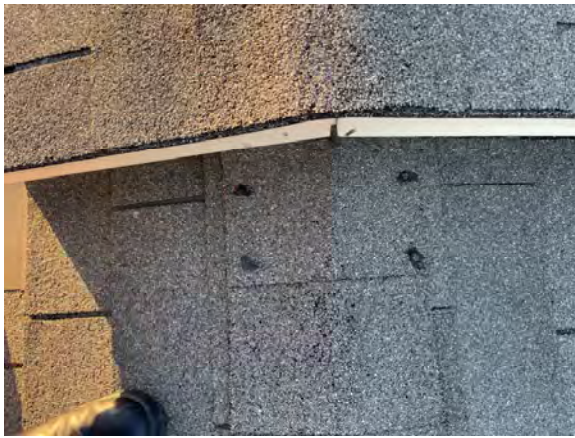
*Photo #7: Exposed Fasteners*

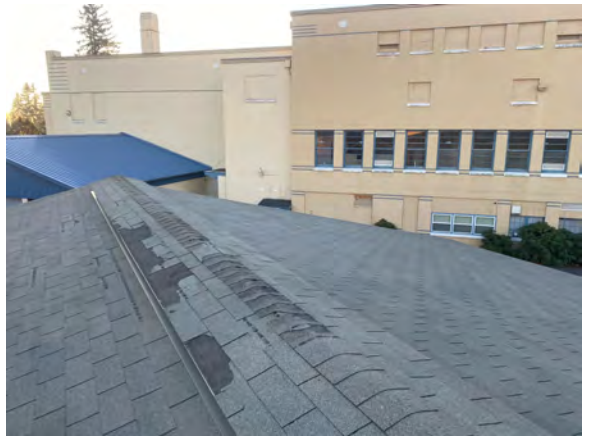
*Photo #8: Wind Damage*

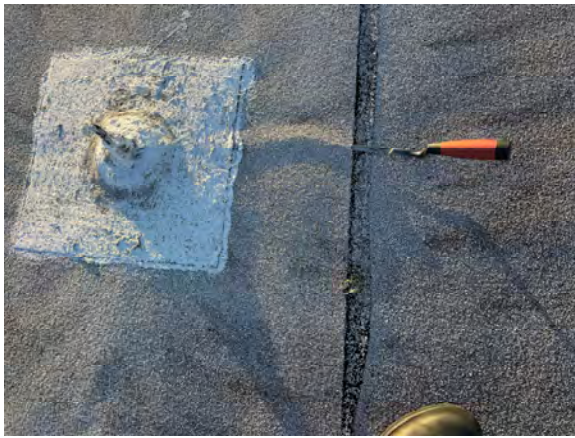
*Photo #9: Open Seam*

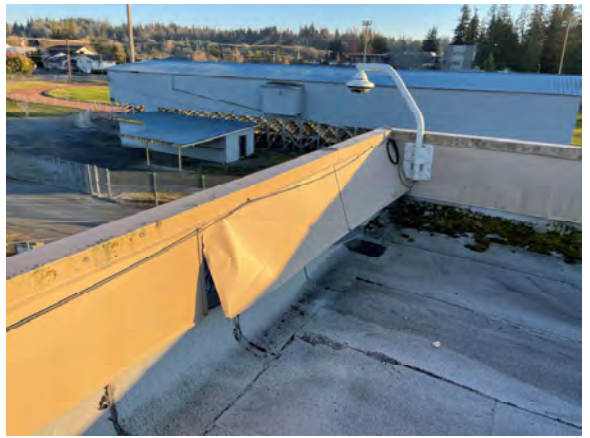
*Photo #10: Damaged Sheet Metal Base Flashing*

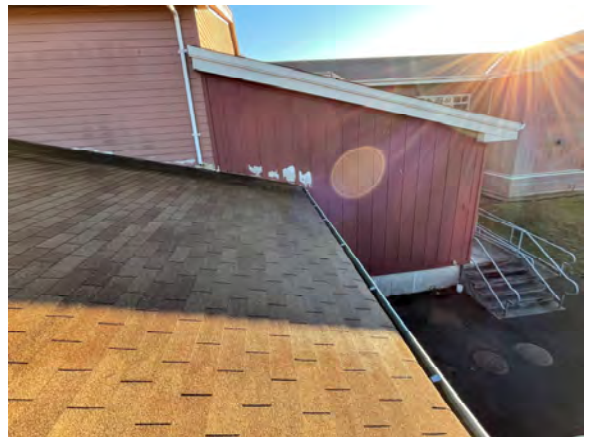
*Photo #18: Drainage onto Lower Roof*

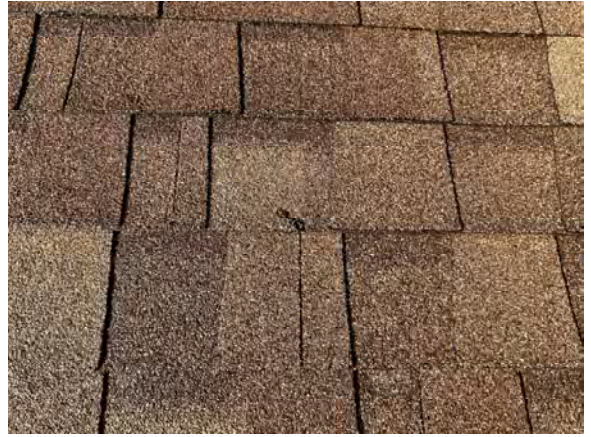
*Photo #2: Minimal Trade Damage*

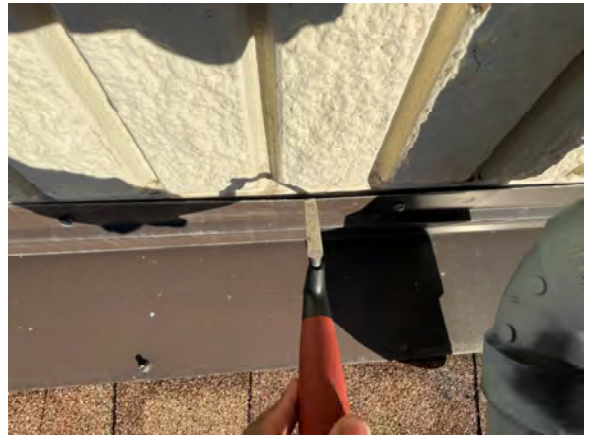
*Photo #4: Open & Failed Flashing*

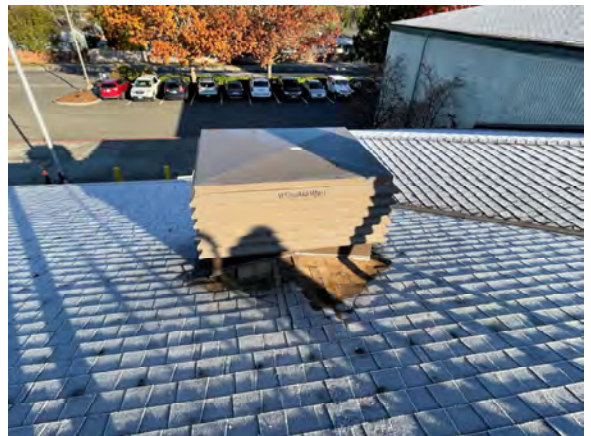
*Photo #6: Reverse Lap Stitch Valley*

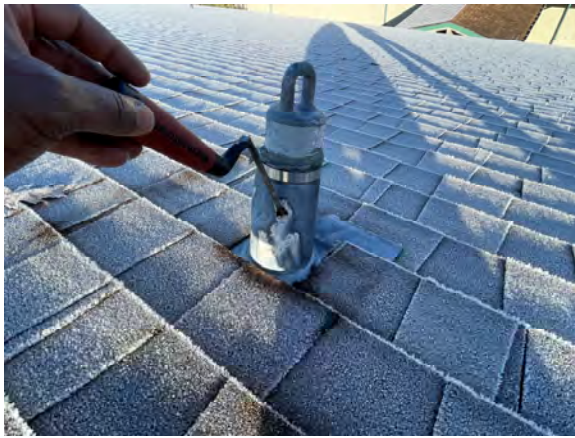
*Photo #9: Degrade Lead Flashing*

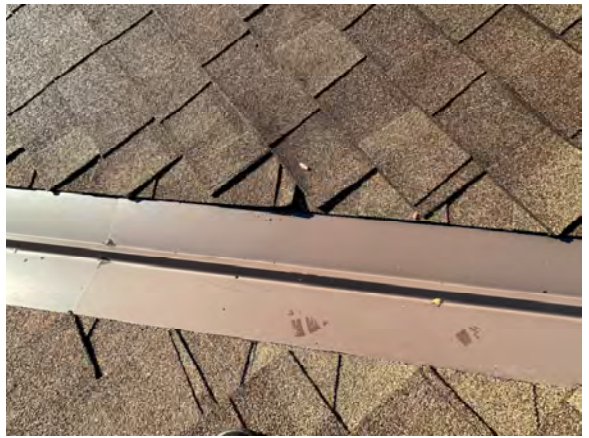
*Photo #10: Reverse Laps at Metal Valley*

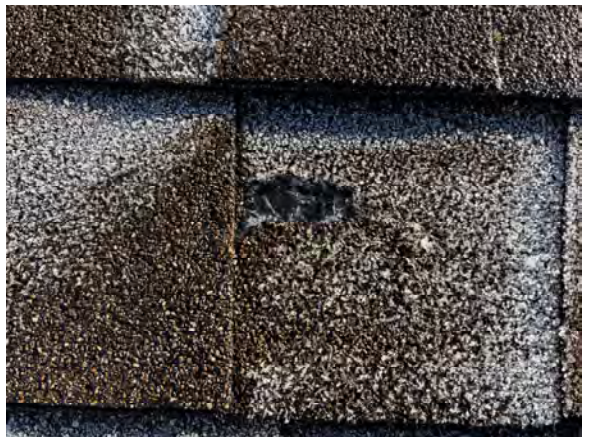
*Photo #12: Degraded Shingle*

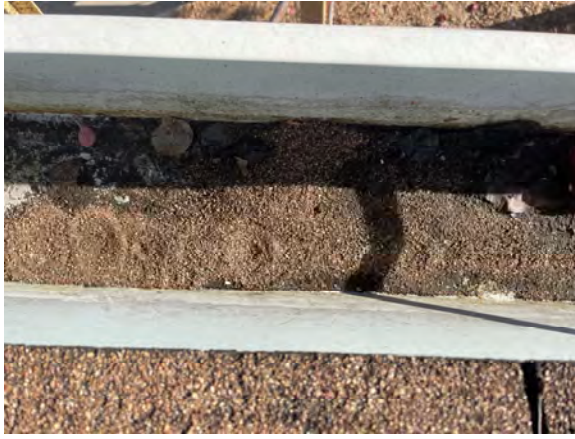
*Photo #1: Granules in Gutter*

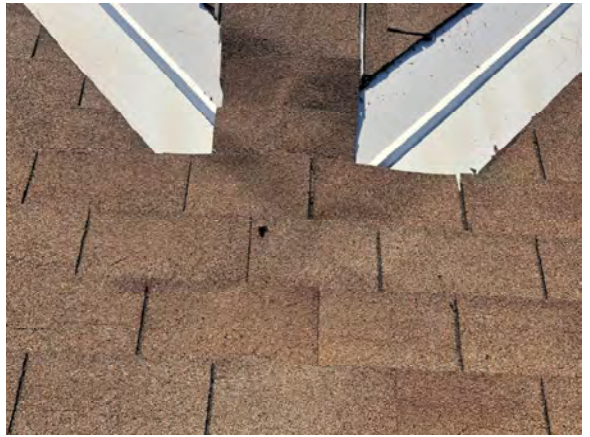
*Photo #4: Fastener Backout*

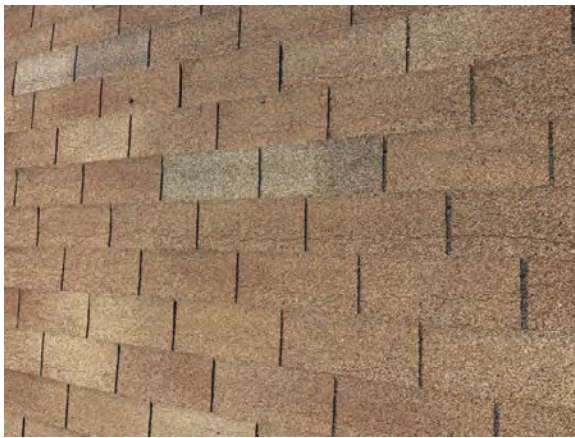
*Photo #5: Shingle Cracks and Repair*

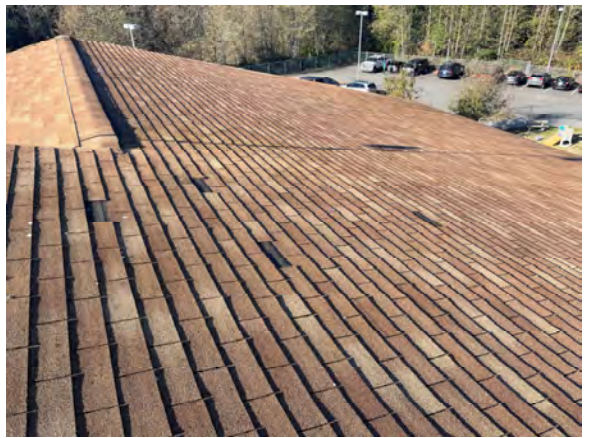
*Photo #6: Missing Shingles*

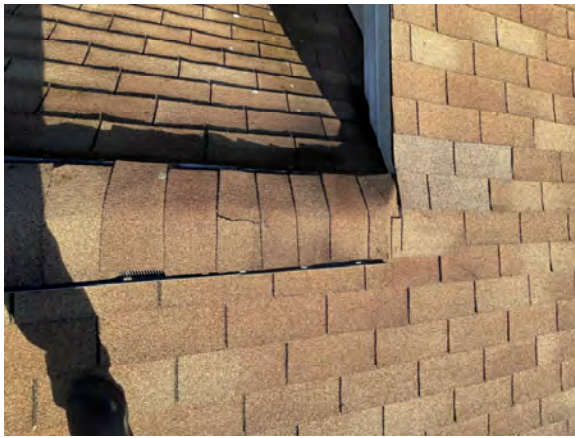
*Photo #9: Cracked Shingle*

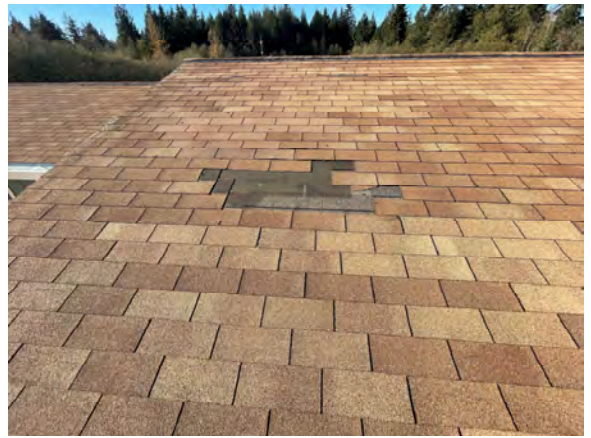
*Photo #10: Missing Shingles – Wind Blowoff*

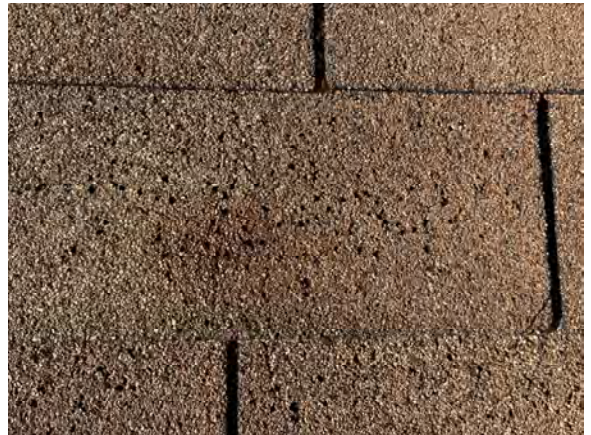
*Photo #12: Pitting of Shingles*

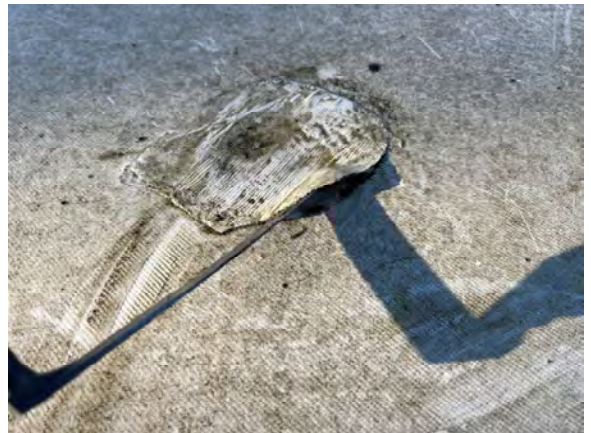
*Photo #12: (P1) Damaged Repair*

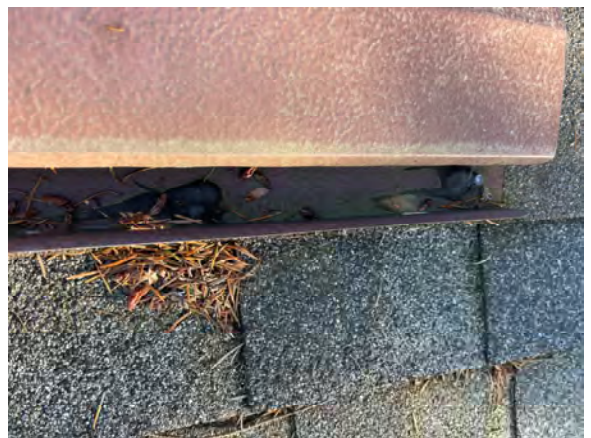
Photo #18: (P3) Fastener through Roof System

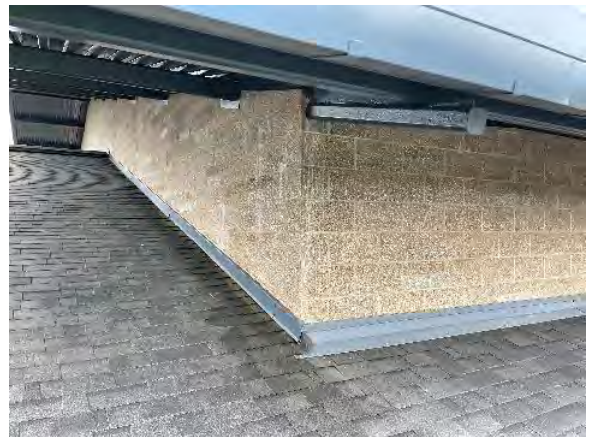
*Photo #6: Water Stains over Shingles*

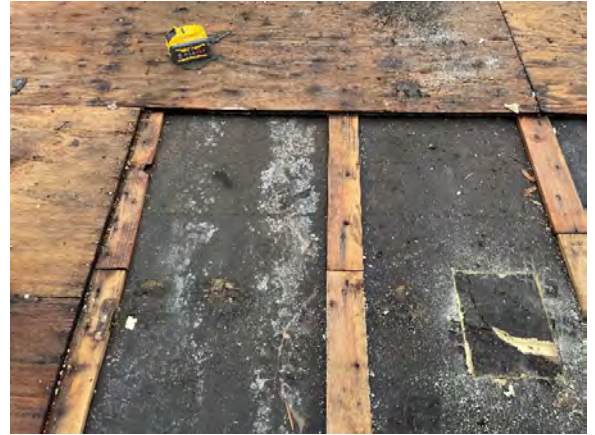
Photo #14: Apparent Mold Growth on Insulation

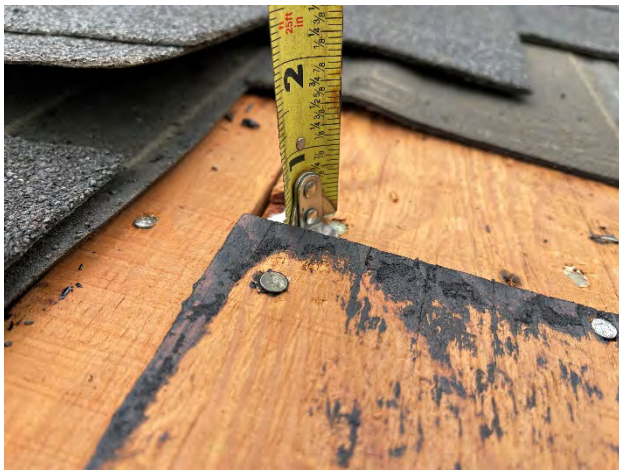
Photo #15: Proud Plywood Corner

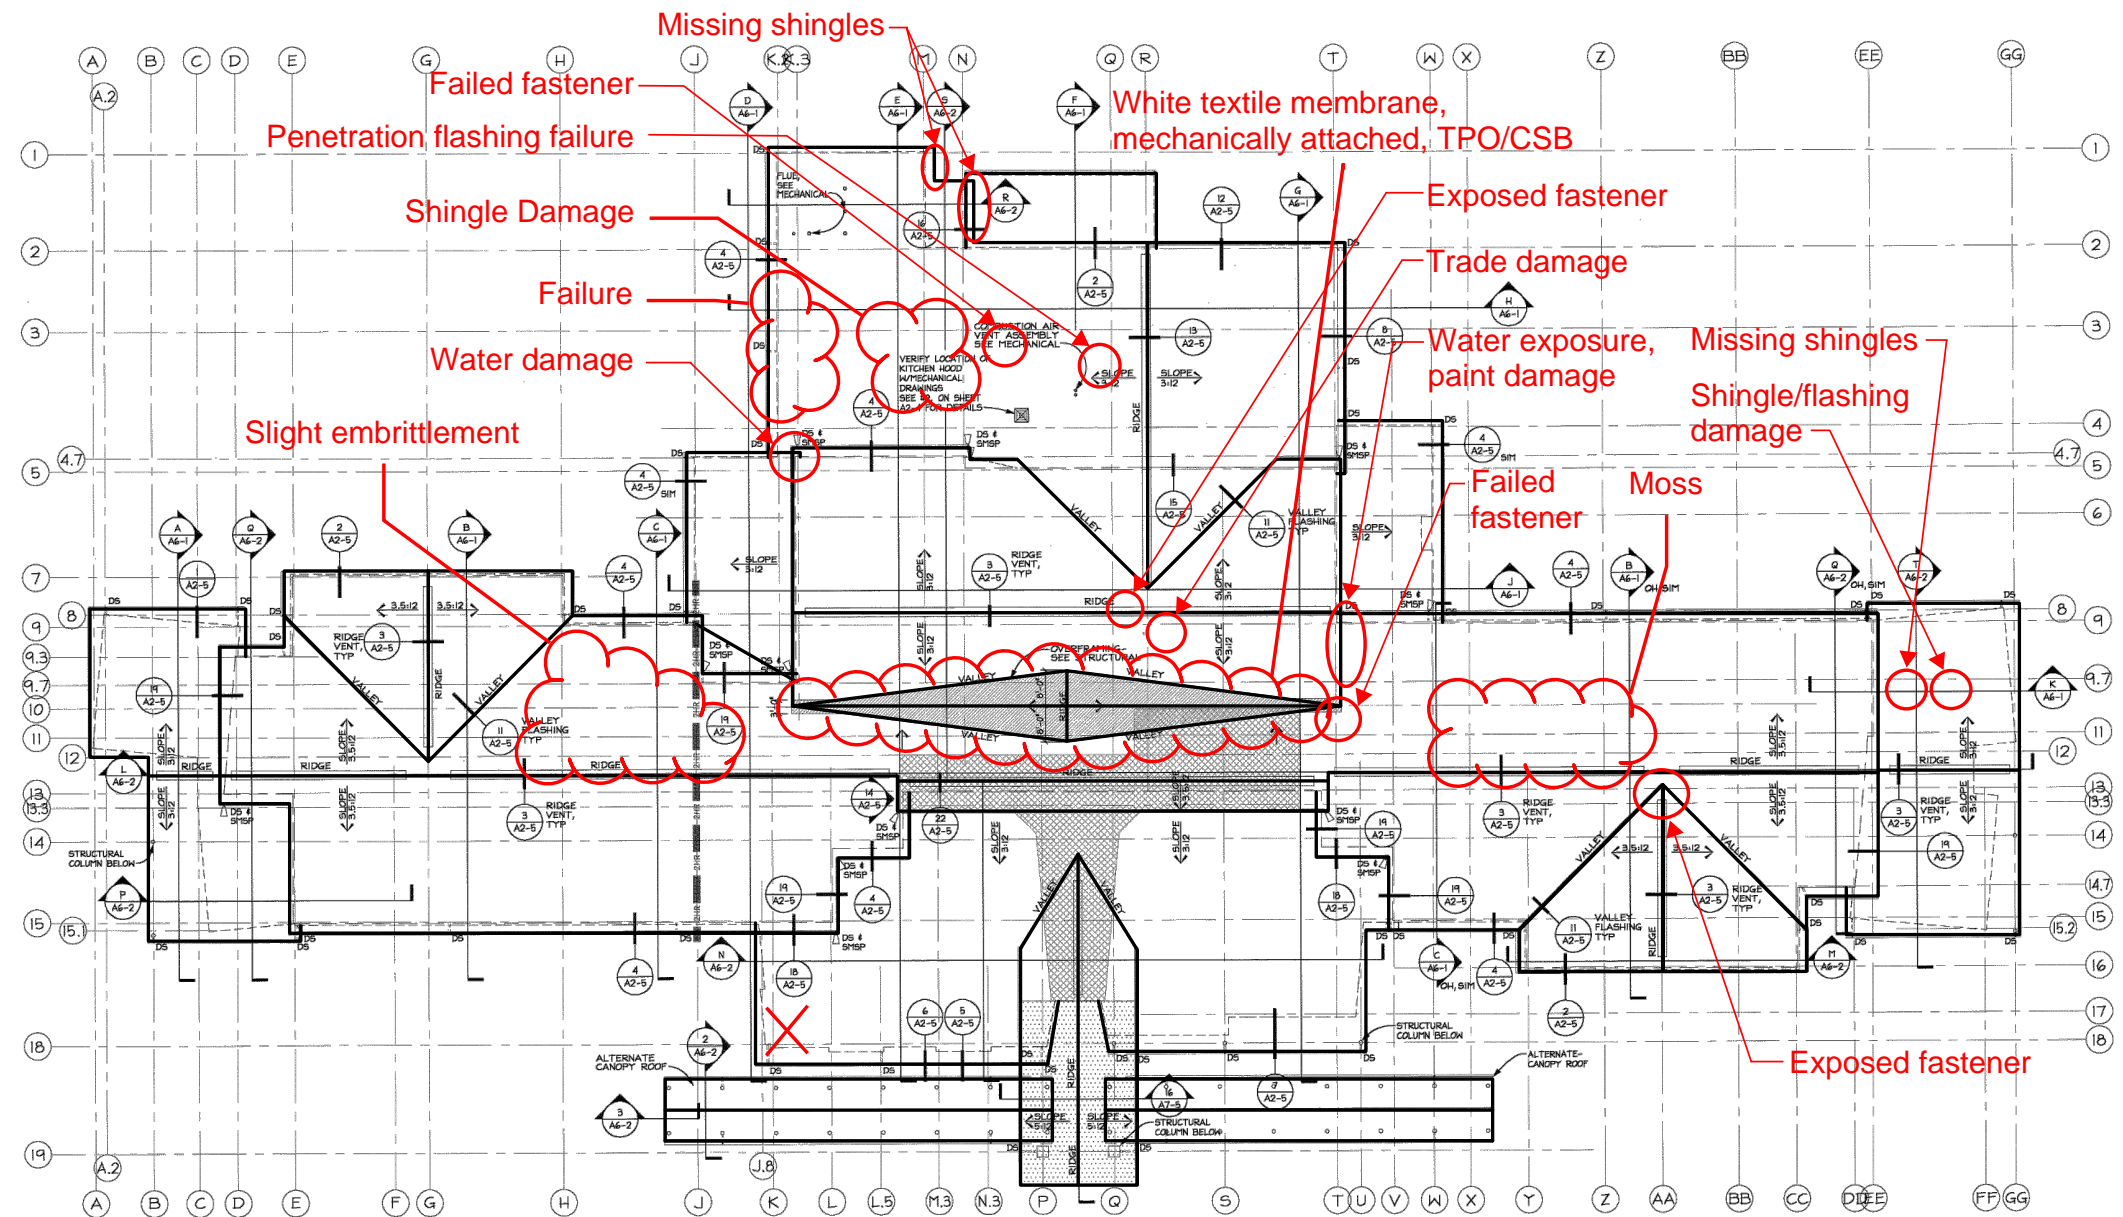
1 ROOF PLAN  
SCALE: 1/16" = 1'-0"

- 3 Tab Shingles including ridge venting:
- Roof is near failure
- curling
  - bird damage
  - excessive granule loss
  - shingle damage
  - nail penetration exposure
  - fastener exposure
  - fasteners push through shingles
  - fastener workthrough
  - general damage/failure
  - poor valley installation
  - rotten sweeps
  - shingle pitting

- Medium degranulation
- Trade damage
- Ridge shingle blowoff
- Exposed fasteners
- Cracks on shingles
- Vented ridge
- Nail exposure

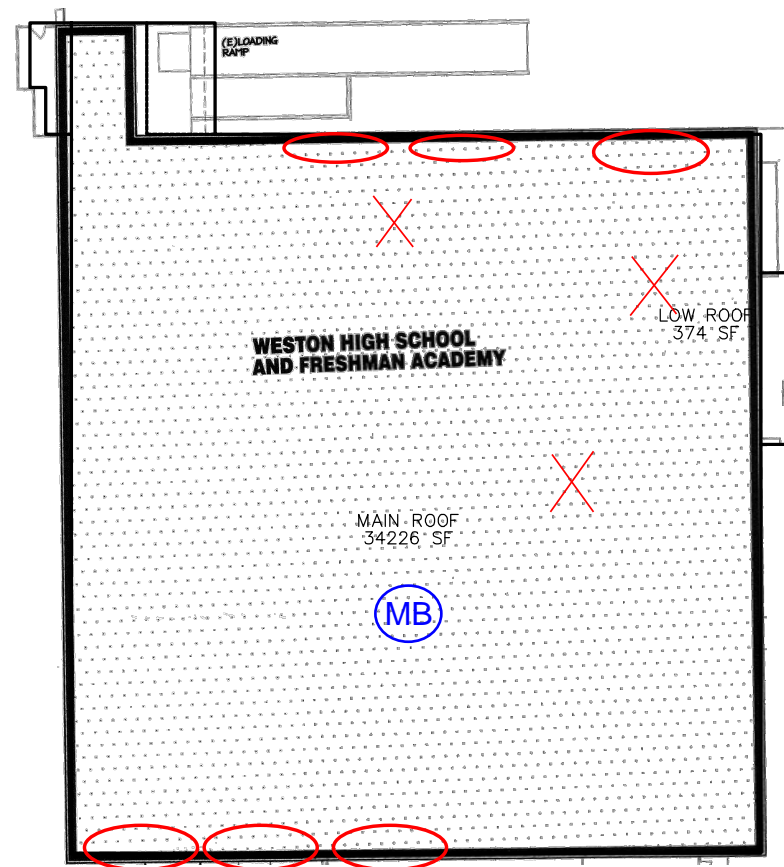
EPDM or TPO roof with coating:  
 - Coating beginning to fail

Open seams  
Sealant failure  
no crickets @ mech. units  
fallen mech. unit  
clogged drains/ponding  
Durolast PVC (mech. attached)
