North Summit School District School Board is planning to bond for a new high school and indoor pool

New High School and Aquatic Center

Process & Background

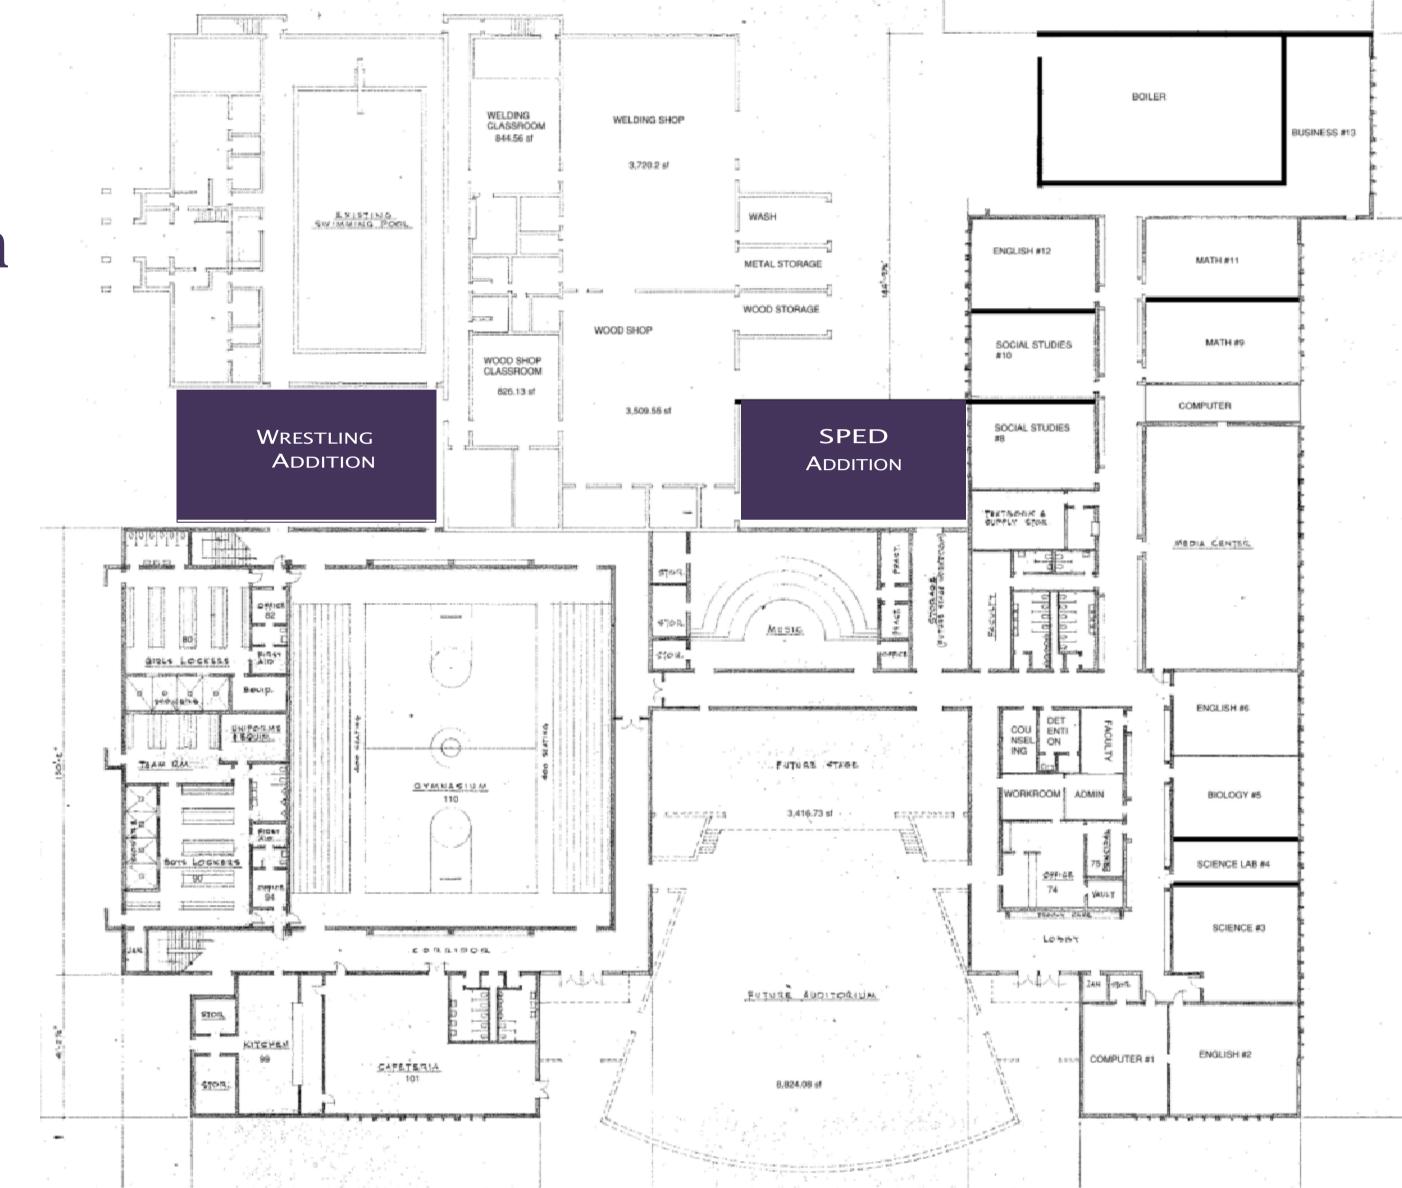
Primary load bearing walls for the building are brick masonry, except for the westernmost wall of the gymnasium, which is comprised of precast double-T members. The brick masonry appears to be multiwythe construction (multiple layers of brick placed against one another) but there is no evidence of reinforcement. Given the timeframe of construction, even if reinforcement is present, it is likely well below minimum modern standards (reinforcement amount and geometry) that would enable satisfactory performance. Without meeting minimum reinforcement standards, even reinforced walls can behave as unreinforced masonry walls. As a result, the likelihood of seismic damage is high, with a compromised ability of the walls to support the rather heavy precast concrete roof deck. Recent earthquakes (including Magna Utah, 2020) showed a preponderance of damage in assemblies such as these. A parallel issue is that the masonry walls appear to lack collar joints (masonry units within the wall oriented perpendicular to the wall to bridge across and link wythes together). With this, there is a lack of continuity between masonry layers in the walls and strong probably of wythe separation during an earthquake. This is an issue that is exacerbated by relatively high masonry wall height to thickness ratios. When wall height is large in comparison to thickness, the potential for out-of-plane wall buckling becomes greater. If wythes of masonry begin to fall away, the thickness of the wall diminishes even more and the height to thickness ratio issue is exacerbated. Such issues are deemed to be particularly problematic at areas of high roofs such as the auditorium and gymnasium of North Summit High School.

- The concrete roof of the school weighs more than 2.5 times that of a contemporary roof, and the masonry walls are not steel-reinforced, which may during an earthquake.
- The entire roof needs to be resurfaced.
- The air handlers are original, and the boilers are nearing the end of life. All systems need to be replaced.
- The waste piping is nearing failure and needs to be replaced.
- The electrical system has vulnerabilities in the service connection, main panel, and corrosion that must be addressed.

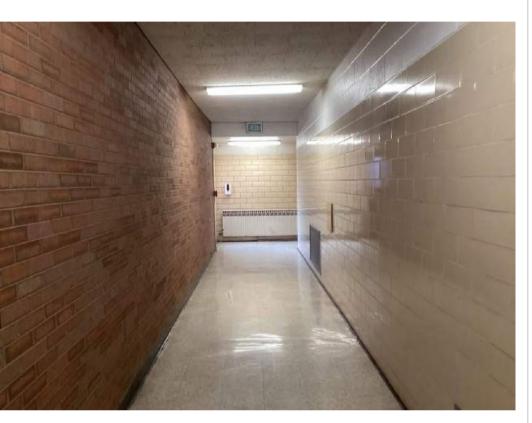
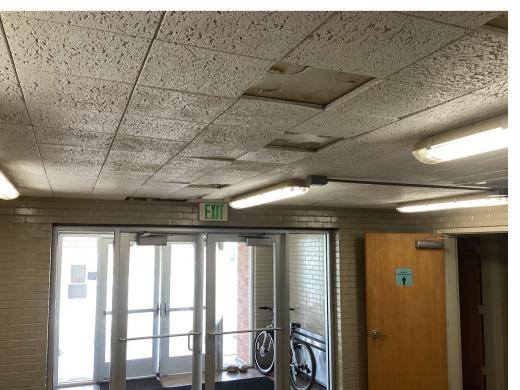
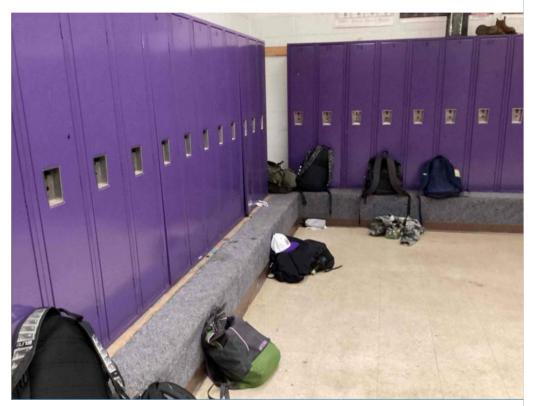
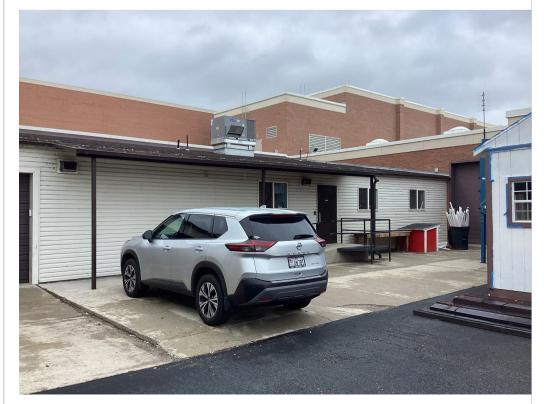
- The school does not include contemporary school security features such as a secure vestibule and wide, observable hallways, and the ability to partition areas of the school for after-hour and community use
- Multiple entryways are difficult to observe, manage, and secure
- Transparency for teachers to observe students outside of the classroom and deter bullying and inappropriate behavior is limited
- The interior finishes, including ceilings, flooring, millwork, and doors are generally in poor condition and require reinvestment
- There is no air conditioning in warm weather, and the building envelope is not insulated, which results in cold spots in the winter

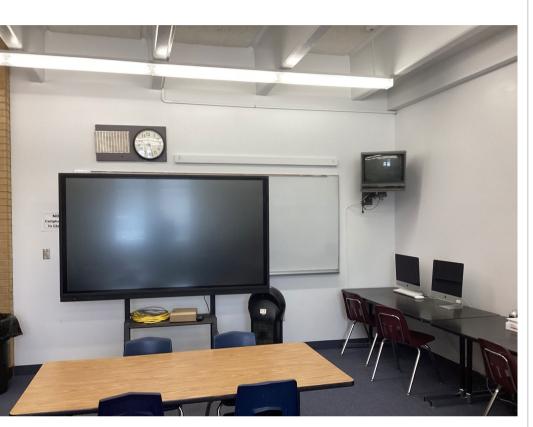
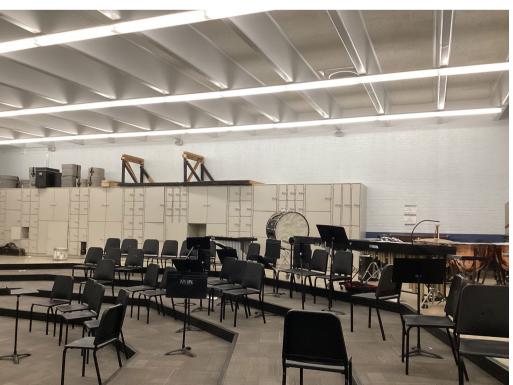
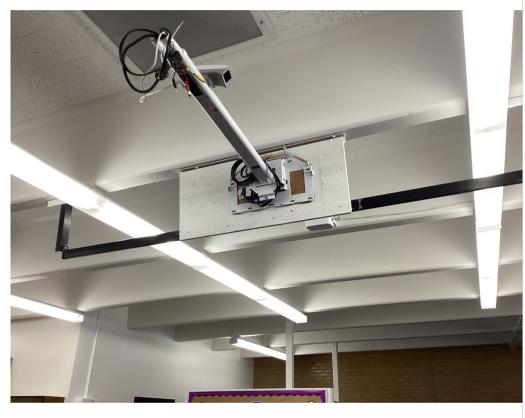
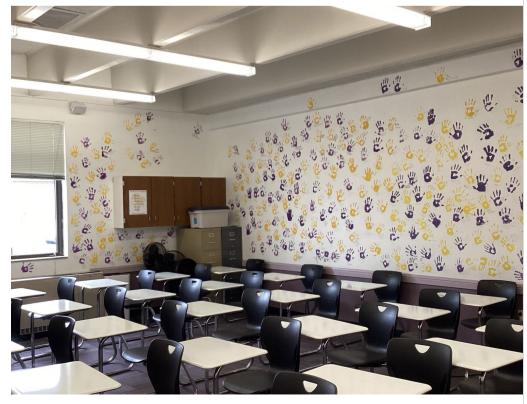
- Technology is varied and antiquated systems can be found throughout the school
- The classroom size and configuration limits the ability to teach in diverse ways
- Students do not have places to gather and collaborate outside of the library within the school environment
- Faculty are making due with the furniture and storage available

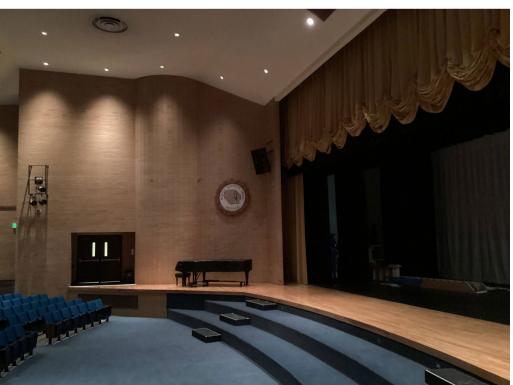
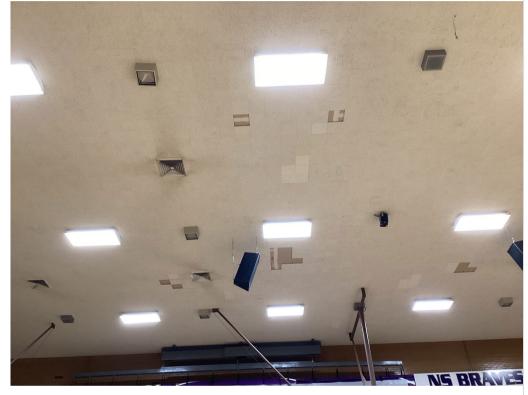
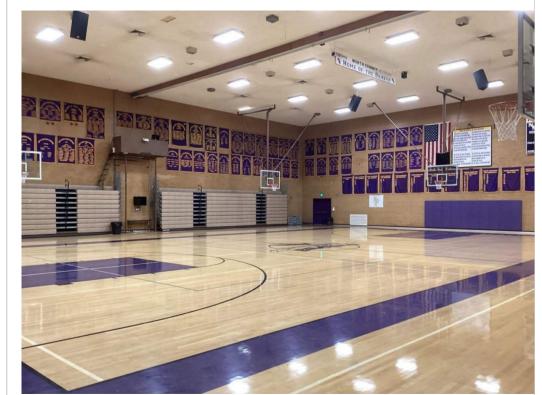
- Parking is limited and often insufficient to meet community needs for events
- Gymnasium size and configuration are limiting for large events, and floor maintenance is a challenge with where people enter the gym
- The auditorium is a wonderful community asset, but it has aged and needs new lighting and audio/visual technology systems
- The current 6-lane track is narrower than a standard 8-lane track

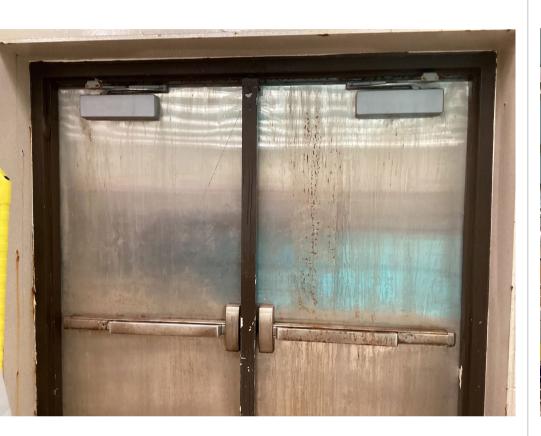
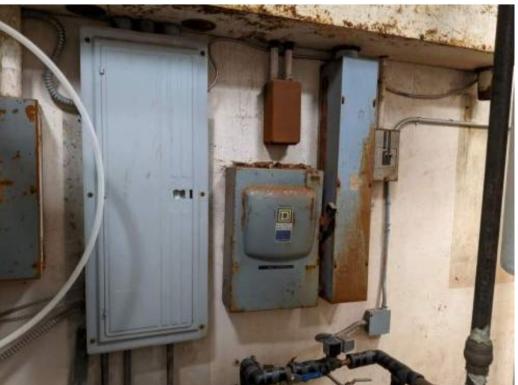
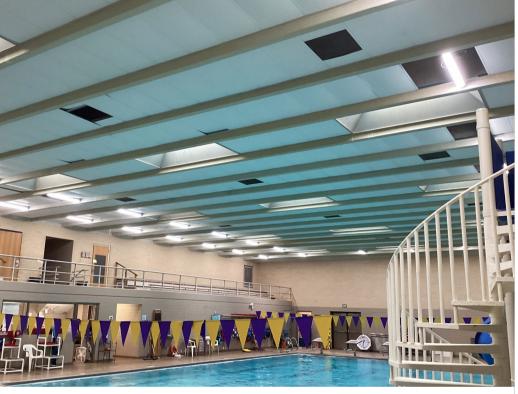
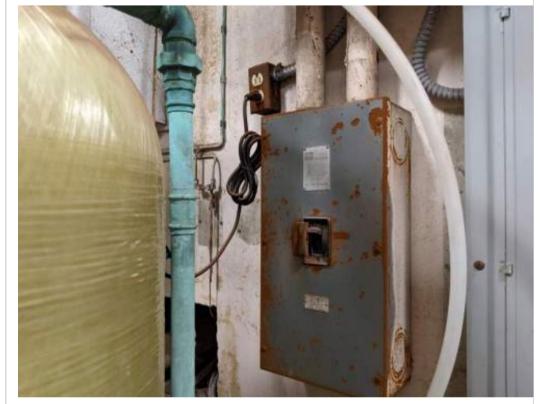
- The pool has been well-maintained, but the structure is over 50-years old, beyond the anticipated lifespan of an aluminum pool
- Humidity has caused corrosion in the materials, finishes, electrical, and mechanical systems within the pool area and adjacent spaces
- Many elements of the current pool and supporting systems are no longer code-compliant
- The pool is not regulation size for high school and USA swimming standards
- Spectator seating is insufficient to meet the needs of the community

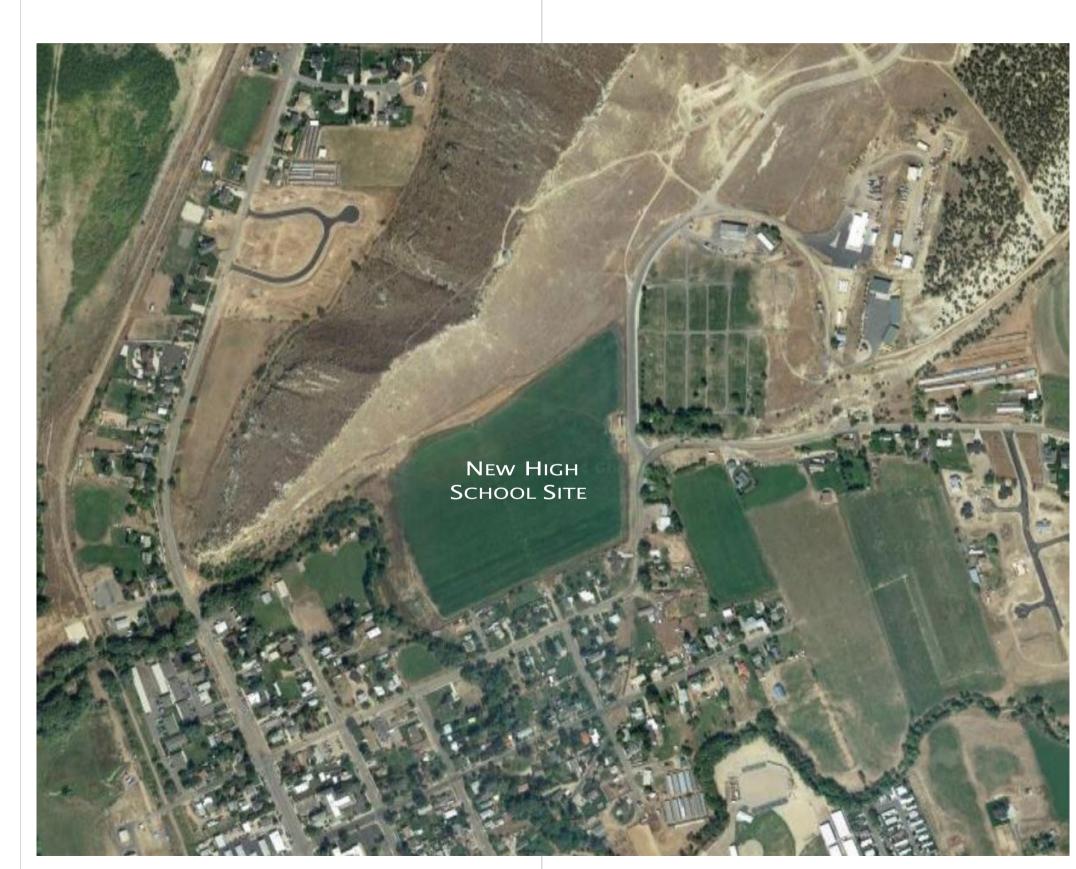
A new high school would be constructed on the districtowned property southwest of the Coalville Cemetery

- The new high school would have a 640-student capacity with the ability to expand to meet future needs
- The site is large enough to accommodate:
 - The new high school
 - A competition and auxiliary gym
 - A new auditorium
 - Space for growth
 - A new football stadium with 8-lane track, practice field, baseball diamond, softball diamond and outdoor courts
 - Ample parking for the school and events

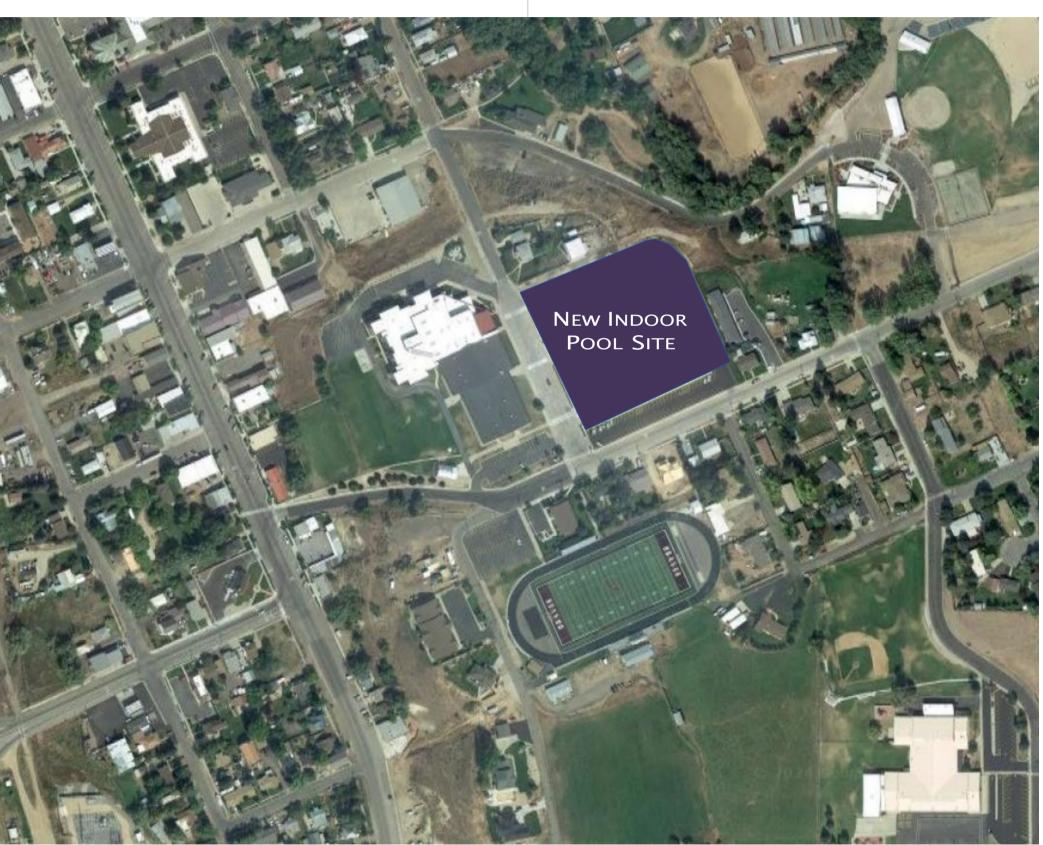
The existing high school would be demolished, and a new aquatic center would be built in the location of the existing high school

- Space for a future recreation center would be preserved on this site to meet future community needs
- Track, football field, and baseball diamond to remain for school district and community use
