# Floresville Independent School District

## 2023 Strategic Facility Plan

March 2024

**Sledge Engineering, LLC**  
TBPE Firm Registration #F-7769  
481 Tucek Road  
Taylor, Texas 76574  
512.365.1888  
sledge.biz

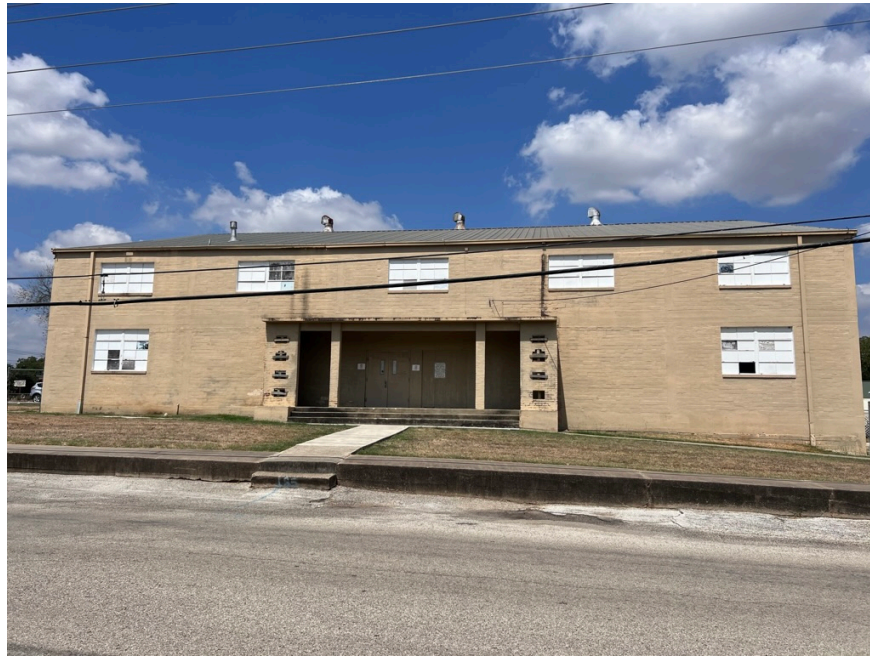
**A Street Gym**

While there are a few older buildings in Floresville ISD there is not necessarily historical significance to these buildings to justify the cost of renovation. The A Street Gym and the Lawhon Gym are the two oldest buildings in the district and have exceeded their useful life. (see below photos)

Typical issues with older facilities is absence of adherence to modern building and fire codes, little handicap accessibility, lack of meeting TEA standards, and barriers to expansion. This concept and options will be explored further in **Section 4 - Summary of Facilities and Recommended Improvements**.

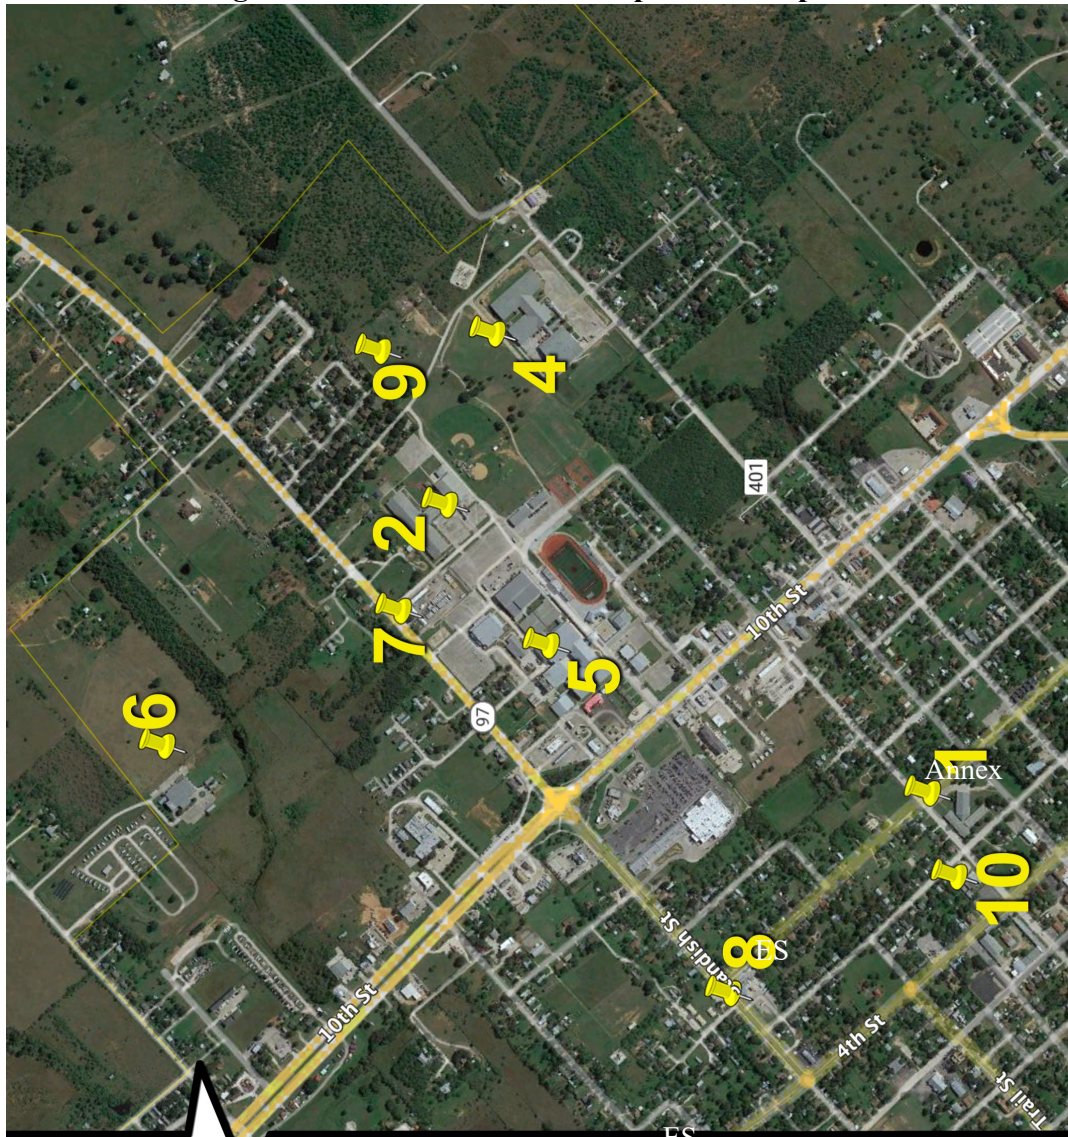
Figure 6 - District Facilities Map – All Campuses

As previously noted, all of the District's facilities were included under the scope for the 2023 Strategic Facility Plan (see **Figure 6**). This section summarizes the findings from the record reviews and on site observations. This section also provides priority list of improvements for each site/building. In general, the priorities listed herein represent a timeline of: a) Priority 1 = 0-5 Years Timeline, b) Priority 2 = 5-10 Years Timeline, and c) Priority 3 = 10+ Years Timeline.

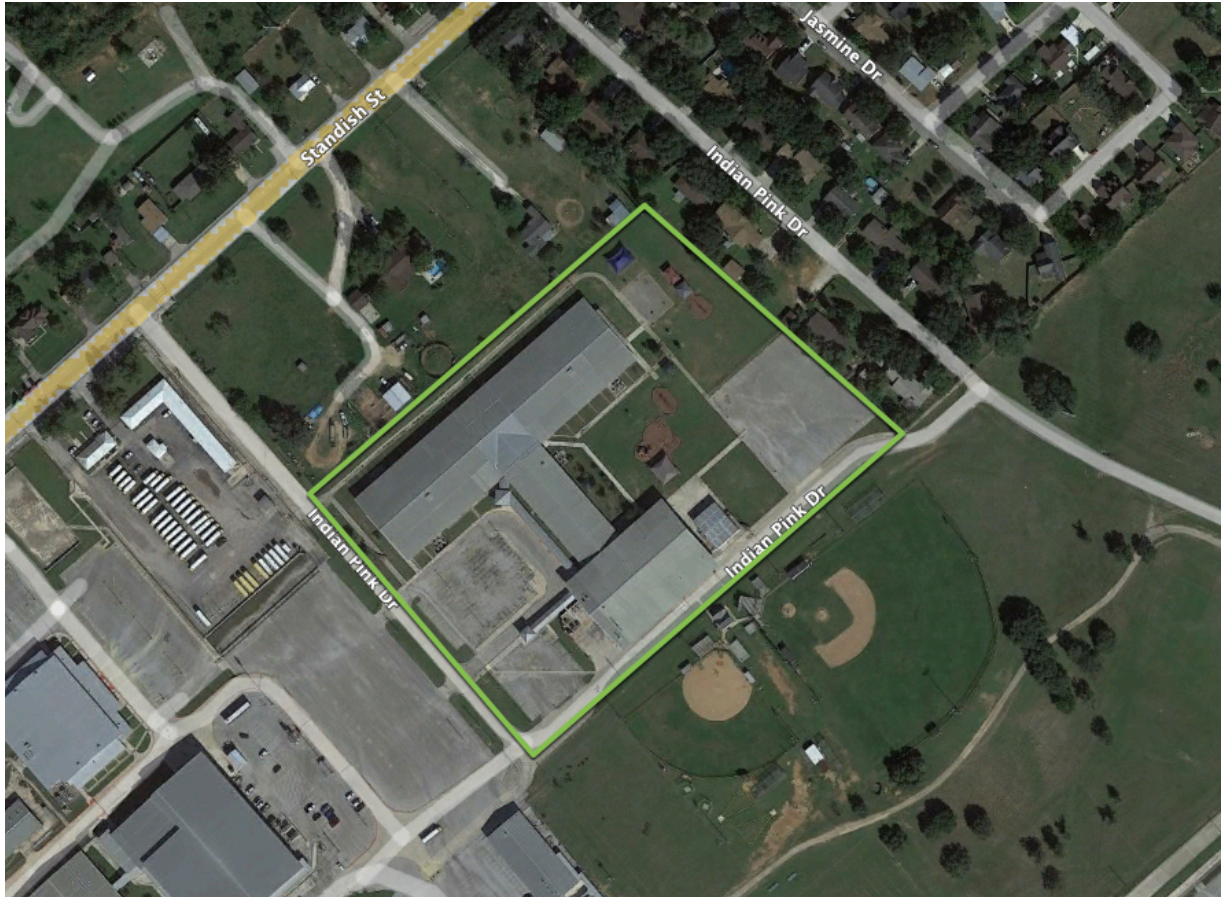
**Figure 13 – South Elementary School Campus**

The campus is identified in **Figure 13**.

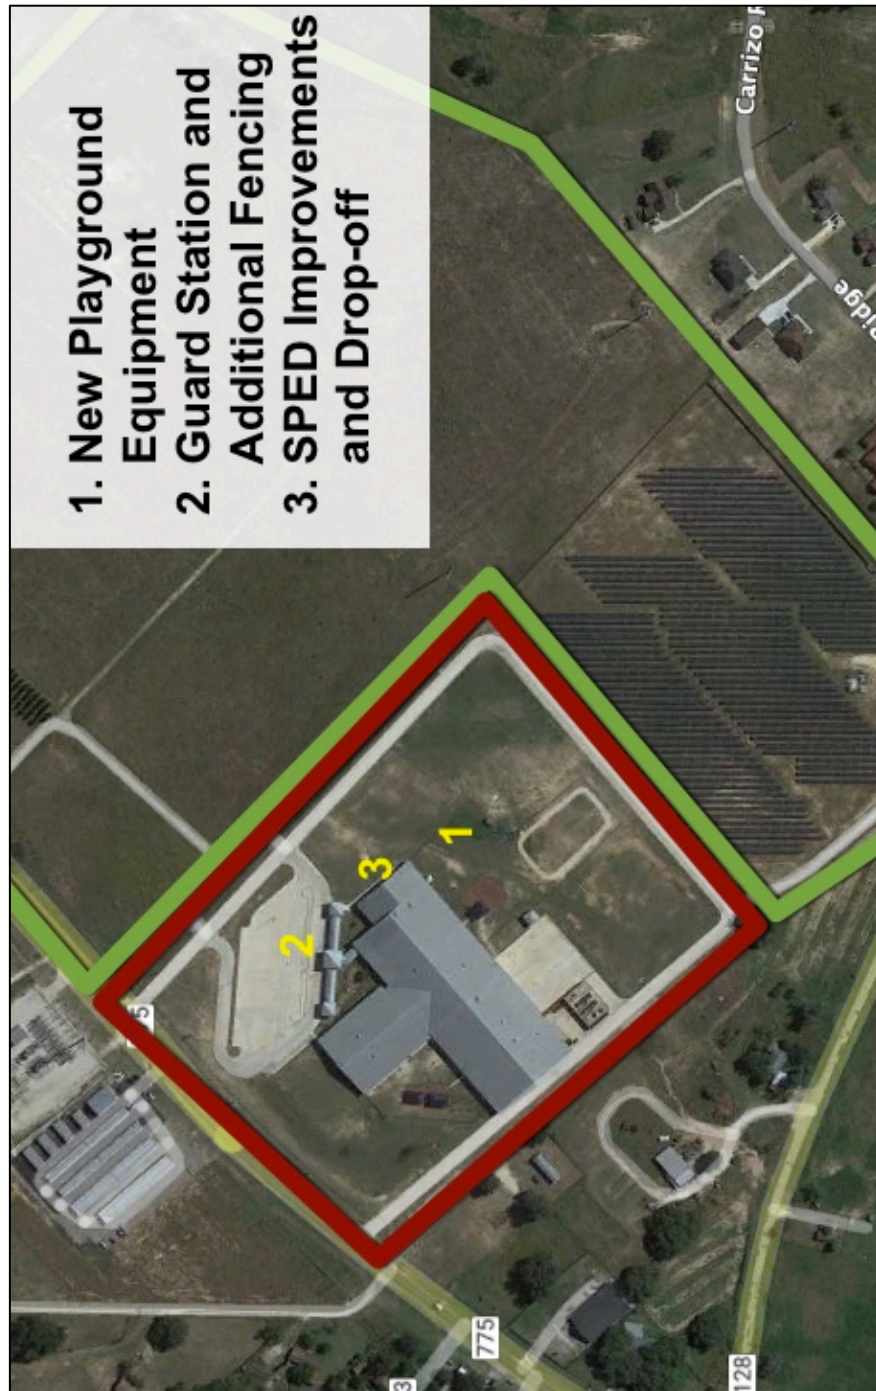
Figure 15 – Floresville South Elementary Proposed Improvements

The improvements for Floresville South Elementary are associated campus usability and long term maintenance of the campus. The options are shown for the ES campus below.

The opinion of total probable cost to implement the improvements shown in **Figure 9** plus the various capital-type deficiency items identified in **Section 4.2.2** are shown in

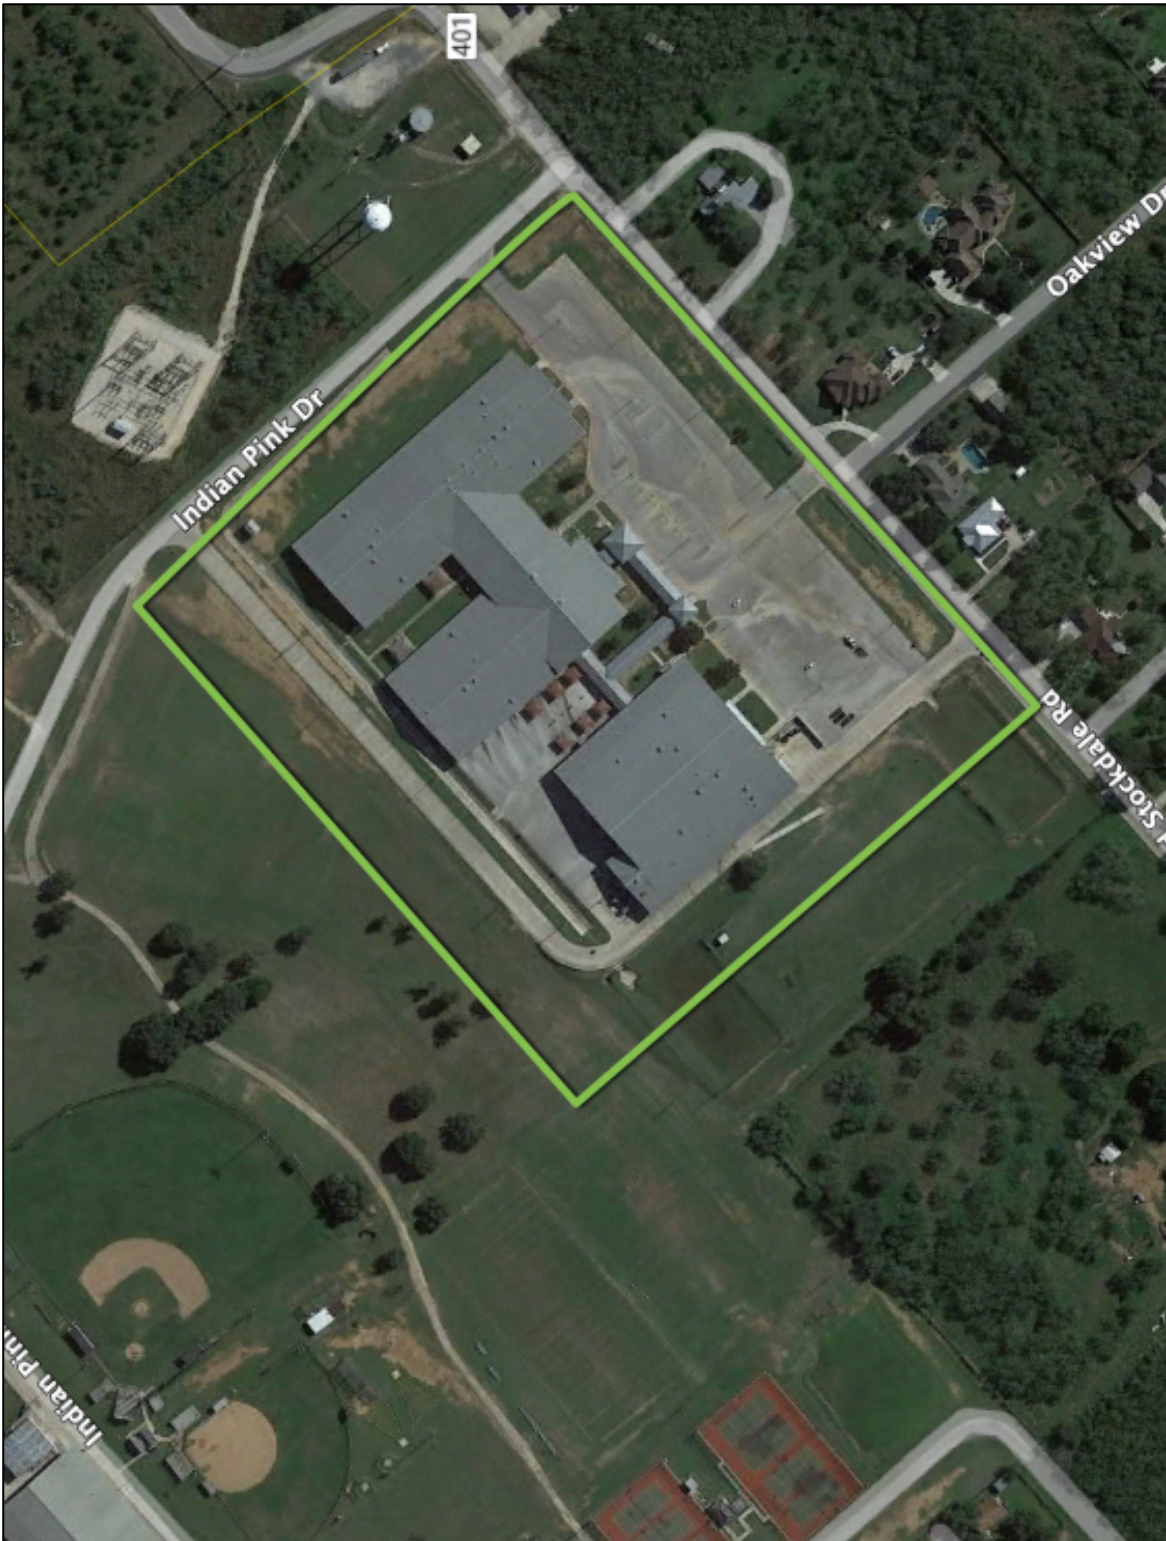
Figure 16 - Floresville Middle School Existing Site

The site aerial of the Middle School Campus is adjacent to the High School and South Elementary School and can be seen in **Figure 16**. The current floorplans for the Floresville Middle School building is provided in **Figure 17**.

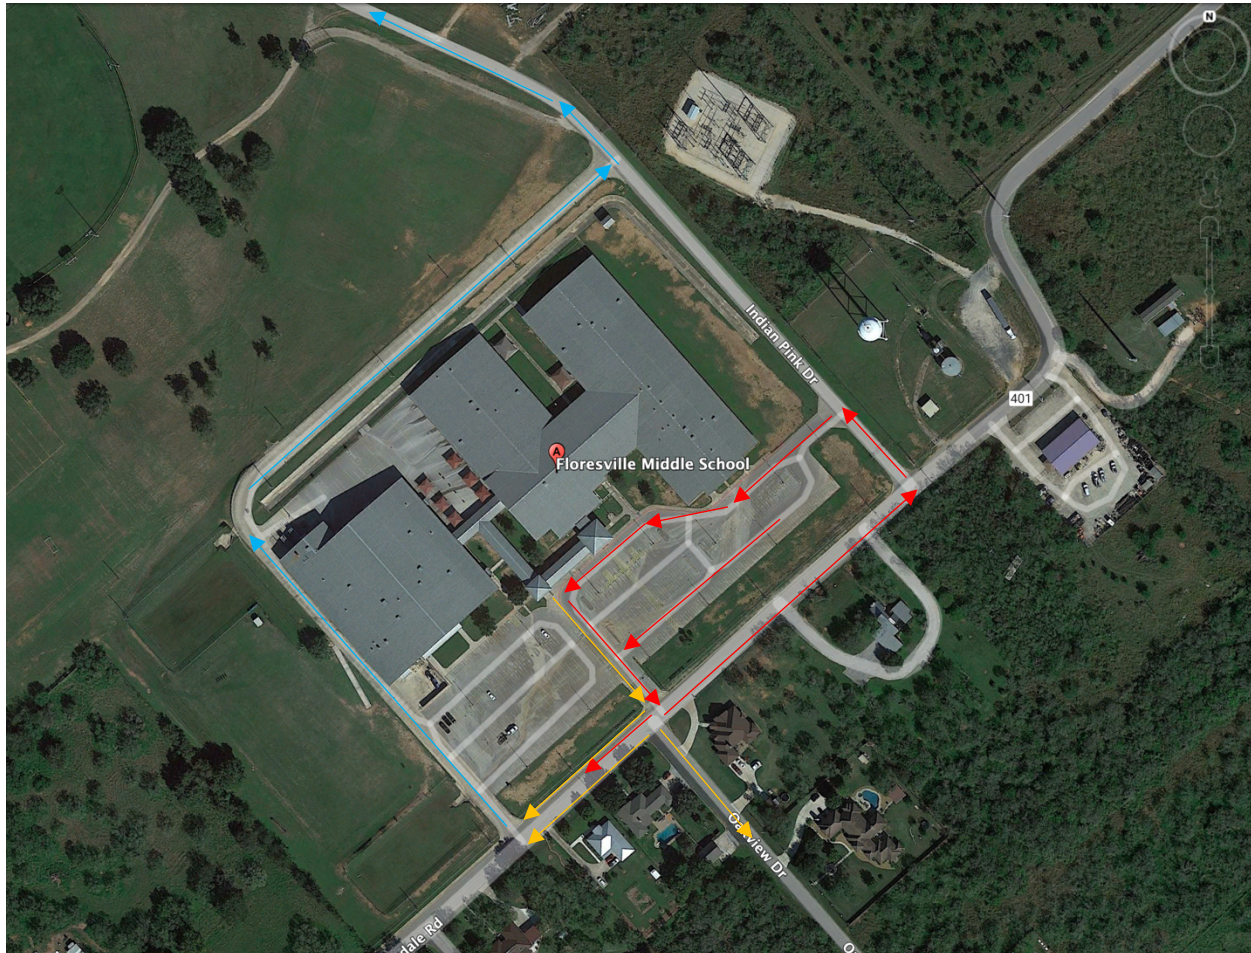
9.19.2023 afternoon traffic watch

While the MS and HS are located on one overall campus, the traffic is mostly separated. General observations of the traffic at the MS campus during late 2023 observations of pick-up follow:

- Bus traffic ———
- Parent traffic ———
- Walkers ———

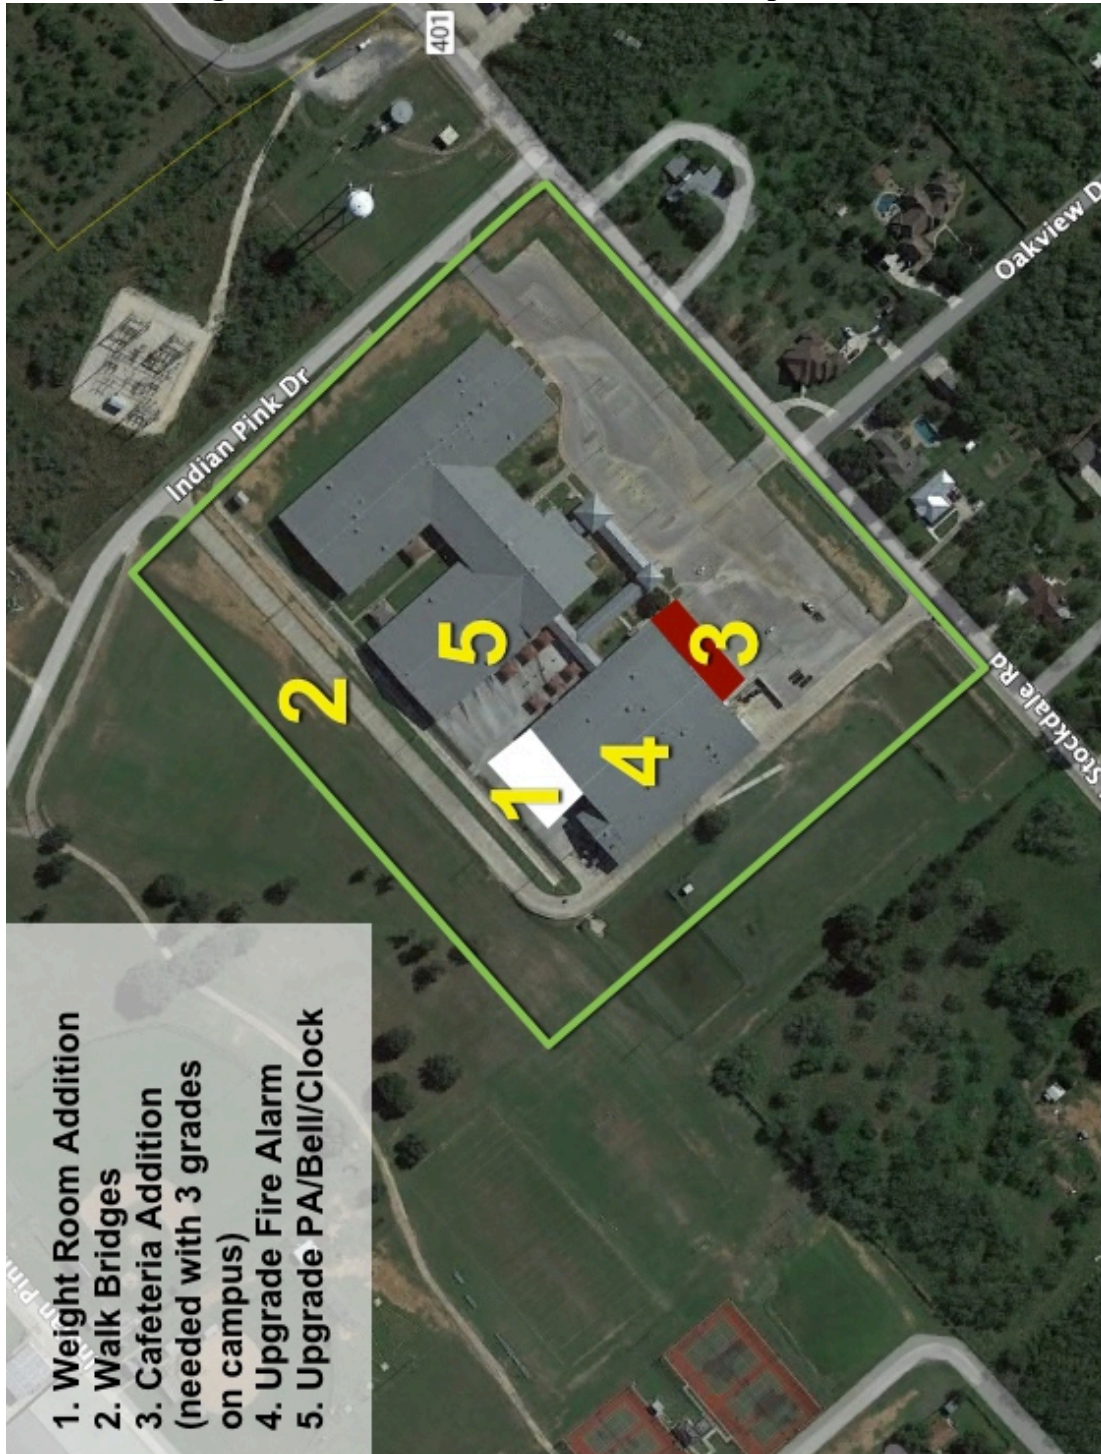
**Figure 18 – Middle School Recommend Improvements**

The improvements for Floresville Middle School are associated with addressing general safety and usability concerns as well as updating finishes where needed. Opinion of total probable cost to make these upgrades are shown in **Table 6**.

<b>Description</b>	<b>Priority 1</b>	<b>Priority 2</b>	<b>Priority 3</b>
New Weight Room	\$1,820,000		
Walk Bridges and Fence for Safer Emergency Drills / Exit	\$260,000		
Fire Alarm Upgrades	\$156,000		
PA / Bell / Clock	\$677,000		
<b>Opinion of Cost Per Priority</b>	<b>\$2,913,000</b>	<b>\$0</b>	<b>\$0</b>
<b>Total for Facility</b>			<b>\$2,913,000</b>

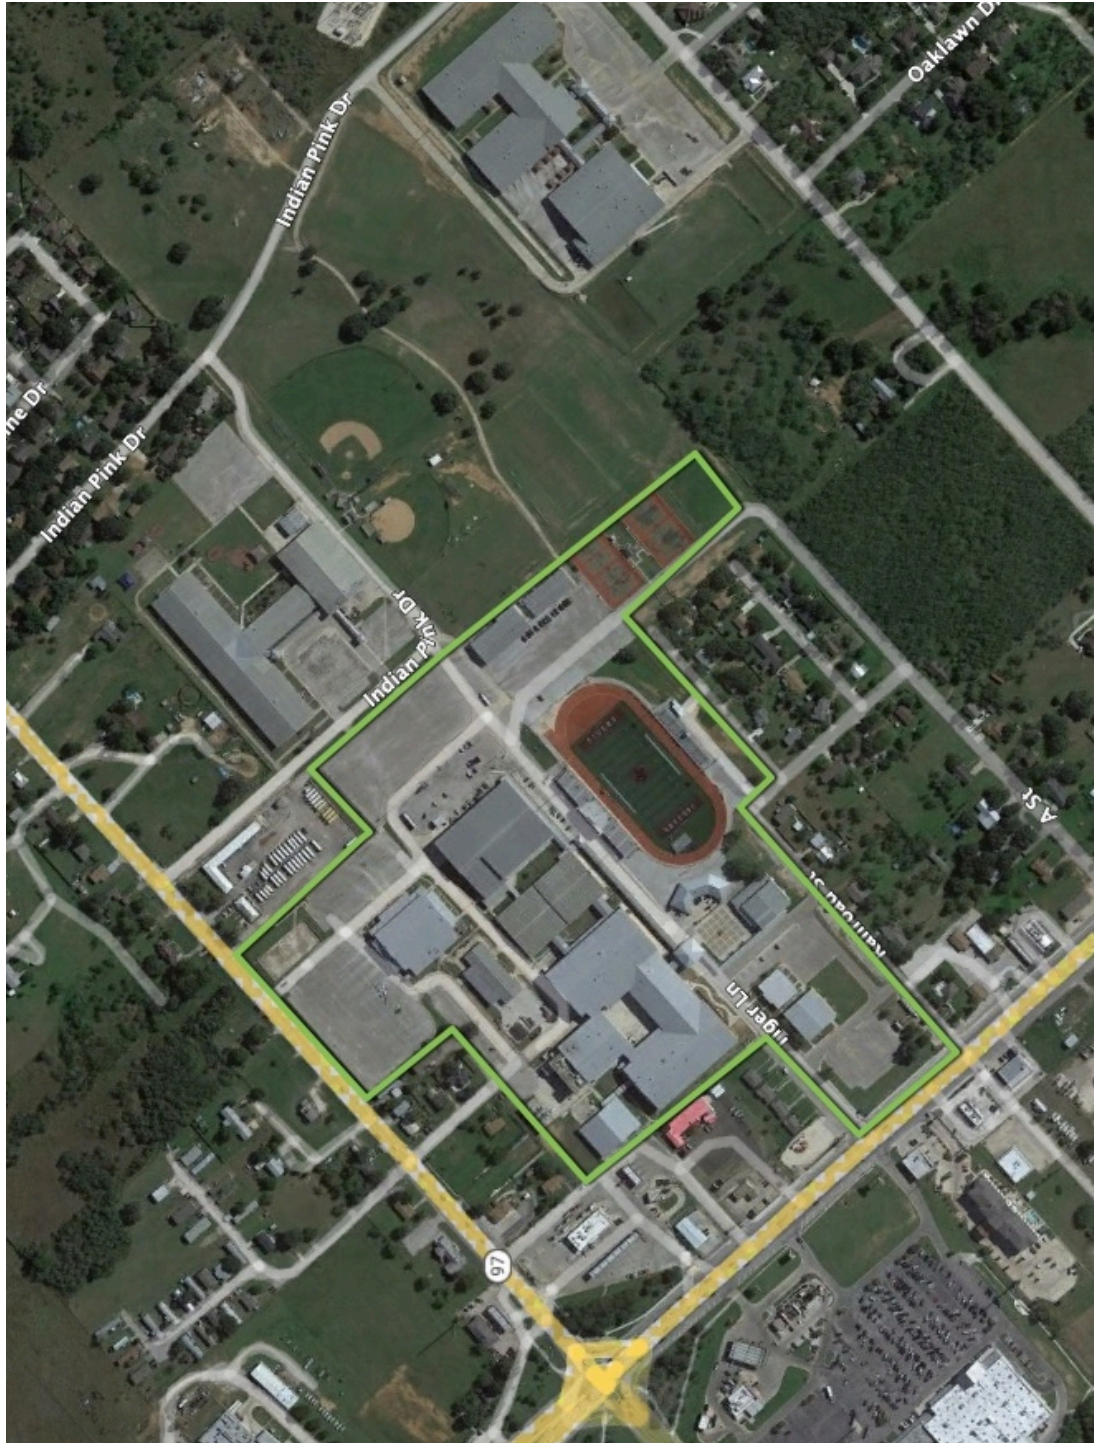
**Figure 19 – High School Campus**

For the purposes of the 2023 Strategic Facility Plan, the high school site is considered to include the buildings shown in **Figure 19**.

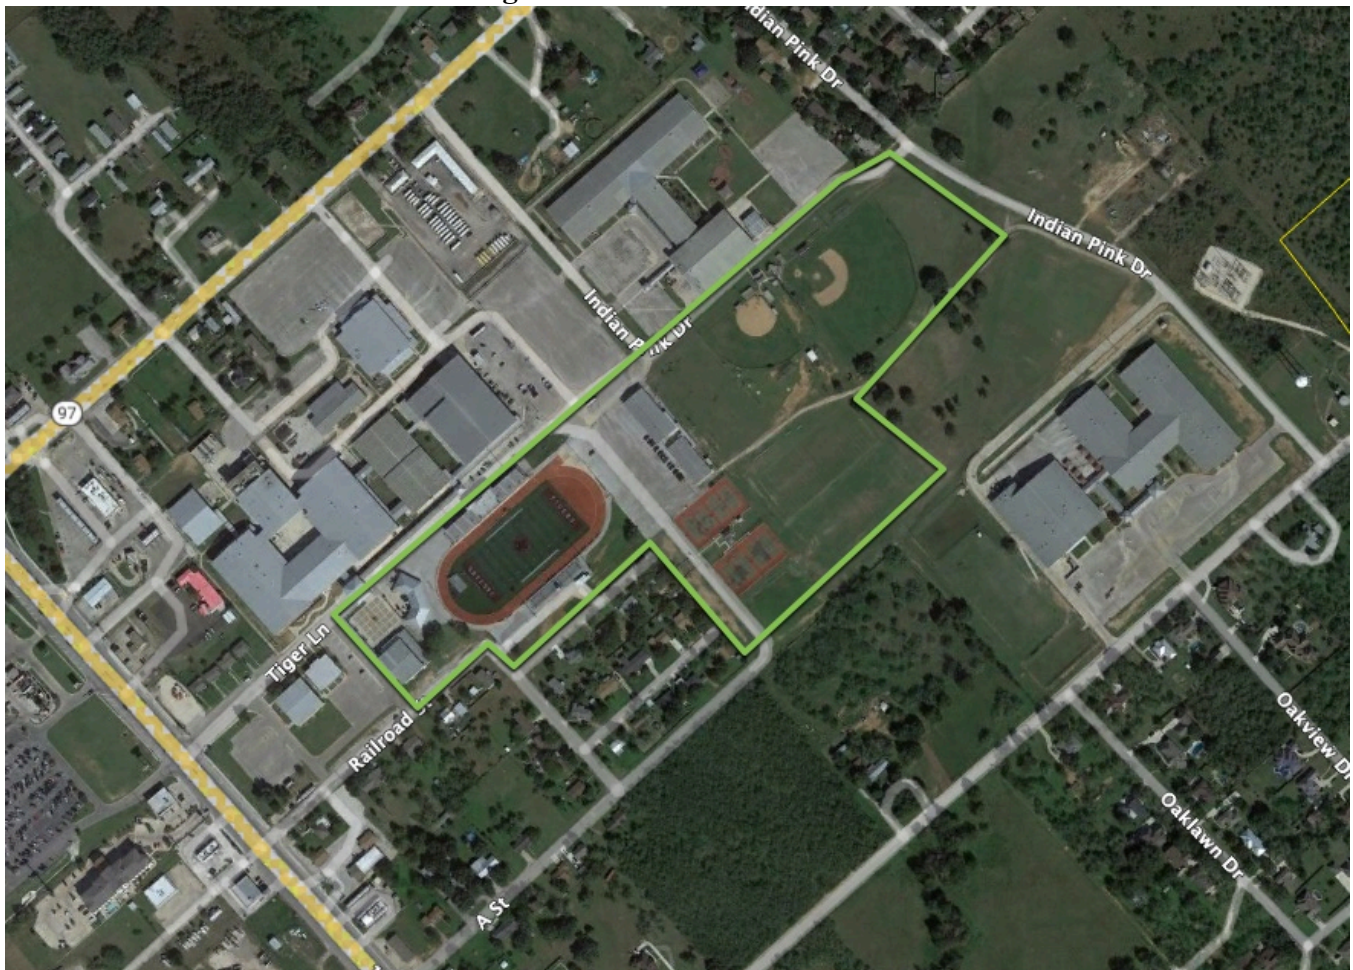
Figure 22 – Athletic Facilities

Figure 22 illustrates key outdoor athletic facilities.

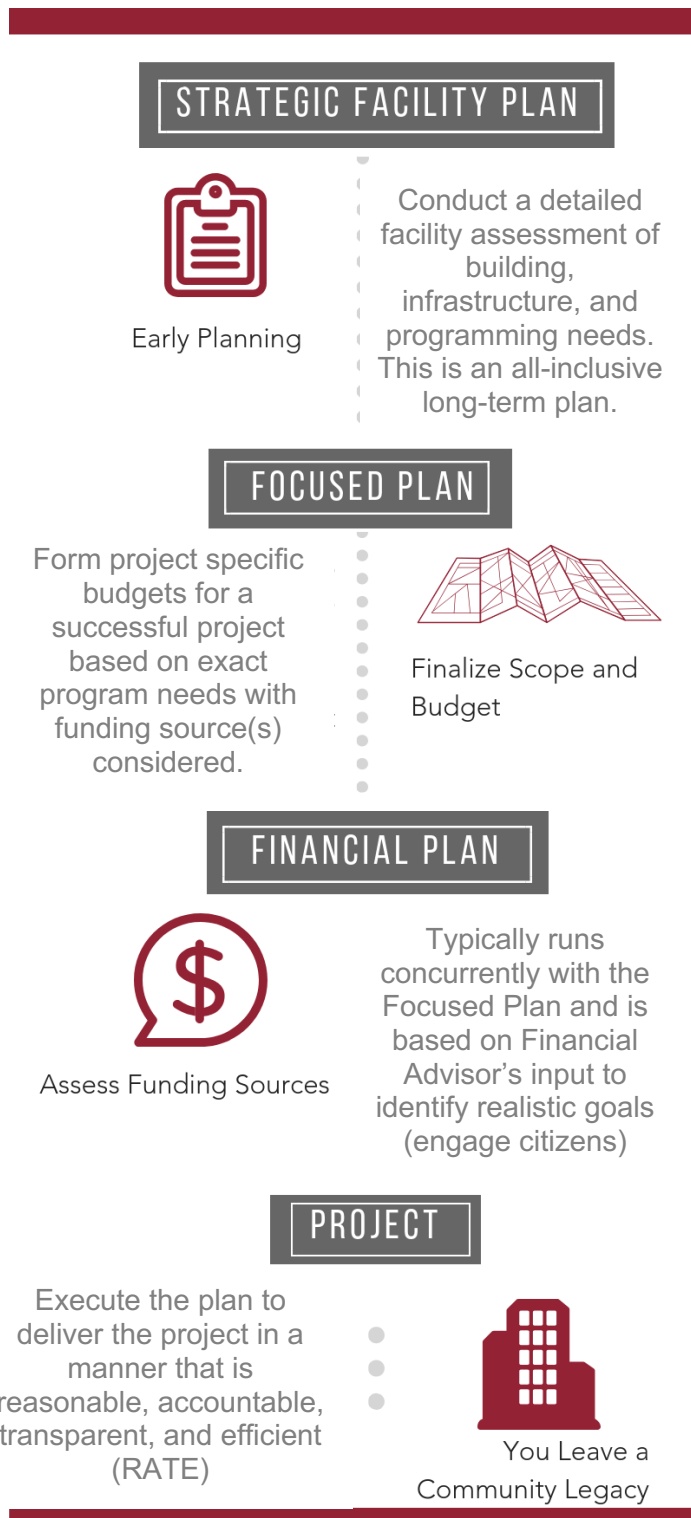
Figure 27 - Planning to Project Implementation Cycle (source: Sledge Engineering)

The costs presented in this 2020 Strategic Facility Plan are all based on current dollars. They do not account for future inflation or changing market conditions. Prior to implementing any project or developing detail budgets for financing (such as local or bond funding), all costs should be reviewed and adjusted based on the project elements to be included, size of the resulting project, and proper inflation factors. The planning to project implementation process is illustrated in **Figure 27**. Implementing the proper process will ensure project success!
