# MANCHESTER ELEMENTARY SCHOOL

N.C.G.S. 115C-72 Study for Proposed  
School Closure

## School Closing Evaluation

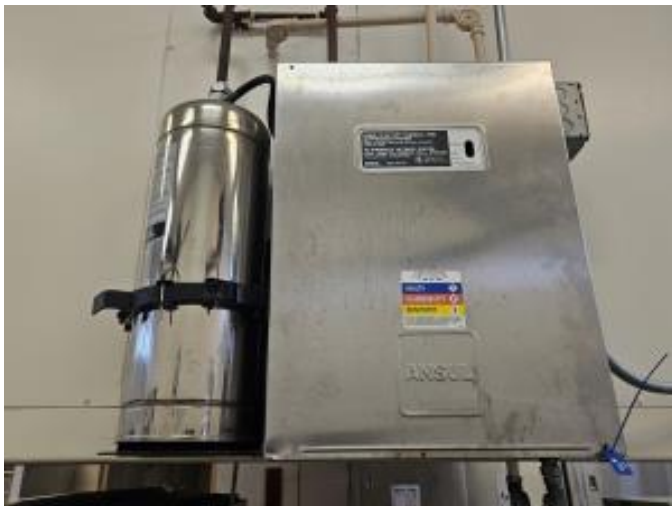
#### System: D4090 - Hood Fire Suppression

**Location:** Kitchen  
**Distress:** Beyond Design Life  
**Category:** Safety  
**Priority:** 2 - Potentially Critical (Years 1-2)  
**Correction:** Renew System  
**Qty:** 1.00  
**Unit of Measure:** Ea.  
**Estimate:** \$5,961.00  
**Assessor Name:** Alexander Gomez  
**Date Created:** 02/14/2024

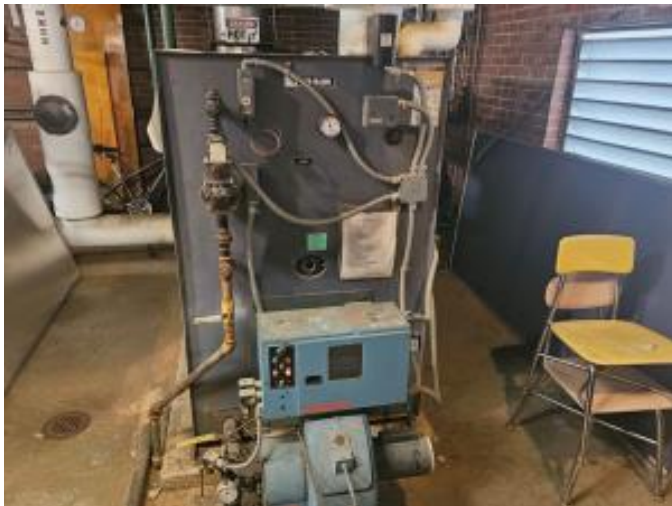
**System: D3020 - Heat Generating Systems**

**Location:** Mechanical Room  
**Distress:** Beyond Design Life  
**Category:** System/Component Integrity  
**Priority:** 3 - Necessary/Not Yet Critical (Years 3-5)  
**Correction:** Renew System  
**Qty:** 25,734.00  
**Unit of Measure:** S.F.  
**Estimate:** \$172,675.00  
**Assessor Name:** Alexander Gomez  
**Date Created:** 02/14/2024

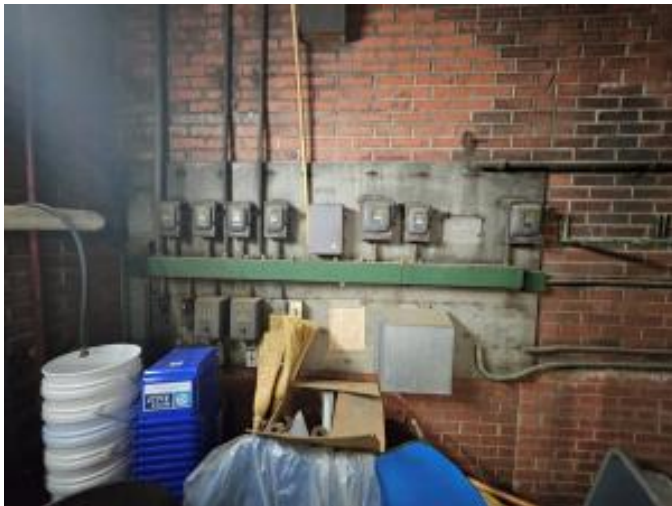
**System: D5020 - Branch Wiring**

**Location:** Throughout building  
**Distress:** Inadequate  
**Category:** System/Component Integrity  
**Priority:** 3 - Necessary/Not Yet Critical (Years 3-5)  
**Correction:** Renew System  
**Qty:** 12,867.00  
**Unit of Measure:** S.F.  
**Estimate:** \$149,038.00  
**Assessor Name:** Alexander Gomez  
**Date Created:** 02/14/2024

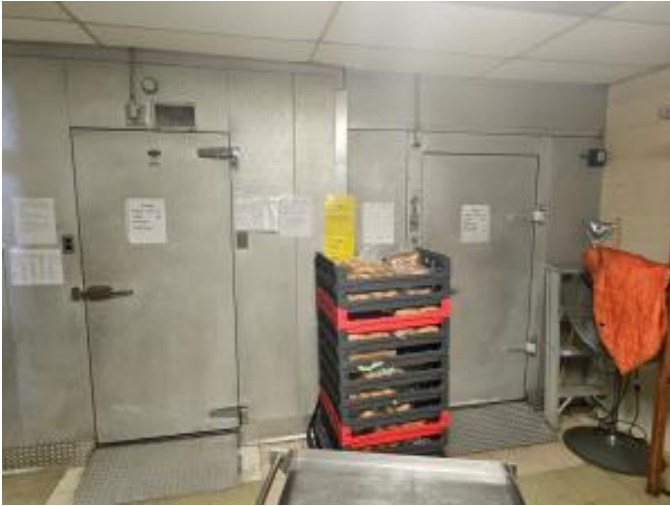
**System: E1090 - Refrigerator - Walk-in**

**Location:** Kitchen  
**Distress:** Beyond Design Life  
**Category:** Deferred Renewal  
**Priority:** 3 - Necessary/Not Yet Critical (Years 3-5)  
**Correction:** Renew System  
**Qty:** 1.00  
**Unit of Measure:** Ea.  
**Estimate:** \$70,965.00  
**Assessor Name:** Alexander Gomez  
**Date Created:** 02/14/2024

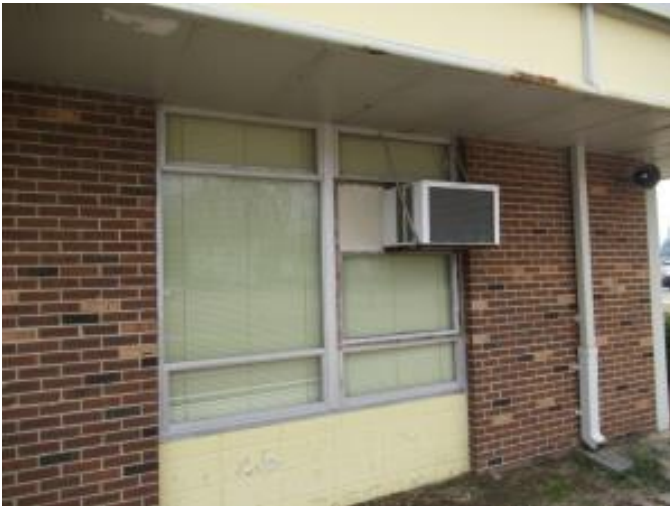
**System: B2020 - Exterior Windows**

**Location:** Exterior  
**Distress:** Beyond Design Life  
**Category:** Conservation Opportunity  
**Priority:** 4 - Recommended (Years 6-10)  
**Correction:** Renew System  
**Qty:** 25,734.00  
**Unit of Measure:** S.F.  
**Estimate:** \$326,101.00  
**Assessor Name:** Arturo Moyeda  
**Date Created:** 01/29/2024

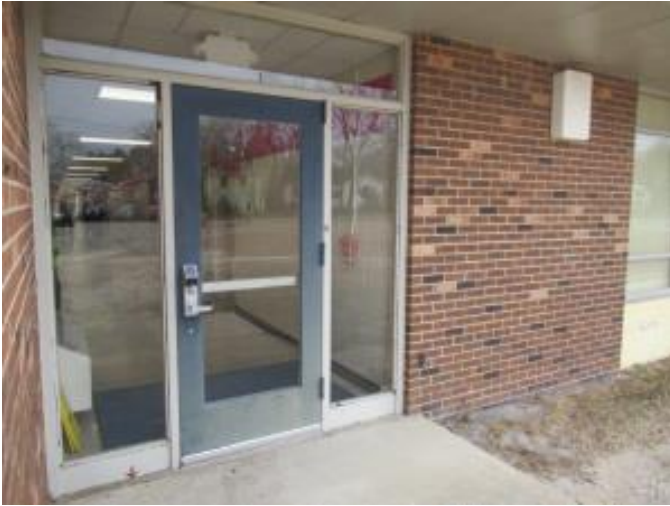
**System: B2030 - Exterior Doors**

**Location:** Exterior  
**Distress:** Beyond Design Life  
**Category:** Appearance  
**Priority:** 4 - Recommended (Years 6-10)  
**Correction:** Renew System  
**Qty:** 25,734.00  
**Unit of Measure:** S.F.  
**Estimate:** \$56,049.00  
**Assessor Name:** Arturo Moyeda  
**Date Created:** 01/29/2024

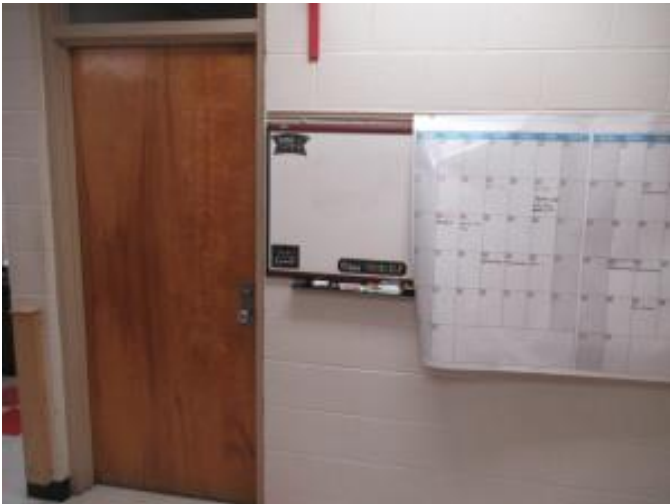
**System: C1020 - Interior Doors**

**Location:** Interior  
**Distress:** Beyond Design Life  
**Category:** Appearance  
**Priority:** 4 - Recommended (Years 6-10)  
**Correction:** Renew System  
**Qty:** 25,734.00  
**Unit of Measure:** S.F.  
**Estimate:** \$104,171.00  
**Assessor Name:** Arturo Moyeda  
**Date Created:** 01/29/2024

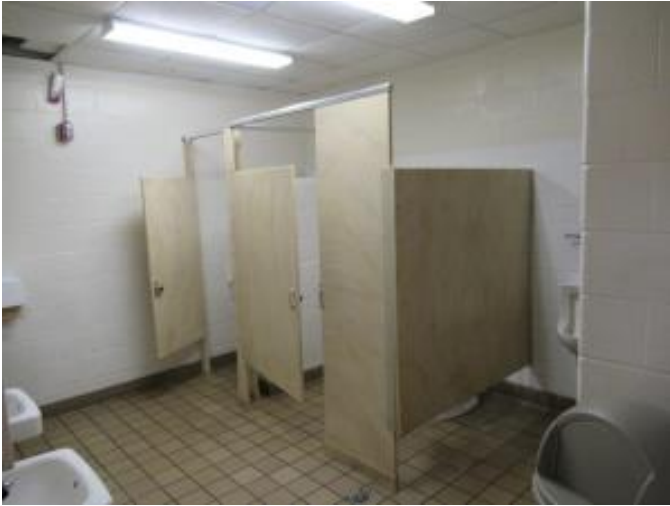
**System: C1030 - Fittings**

**Location:** Interior  
**Distress:** Beyond Design Life  
**Category:** Appearance  
**Priority:** 4 - Recommended (Years 6-10)  
**Correction:** Renew System  
**Qty:** 25,734.00  
**Unit of Measure:** S.F.  
**Estimate:** \$61,144.00  
**Assessor Name:** Arturo Moyeda  
**Date Created:** 01/29/2024

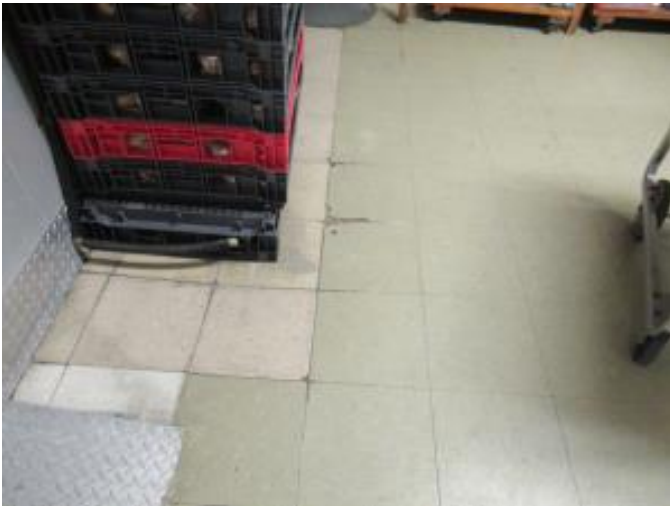
**System: C3020412 - VCT**

**Location:** Interior  
**Distress:** Beyond Design Life  
**Category:** Appearance  
**Priority:** 4 - Recommended (Years 6-10)  
**Correction:** Renew System  
**Qty:** 20,049.00  
**Unit of Measure:** S.F.  
**Estimate:** \$117,988.00  
**Assessor Name:** Arturo Moyeda  
**Date Created:** 01/29/2024

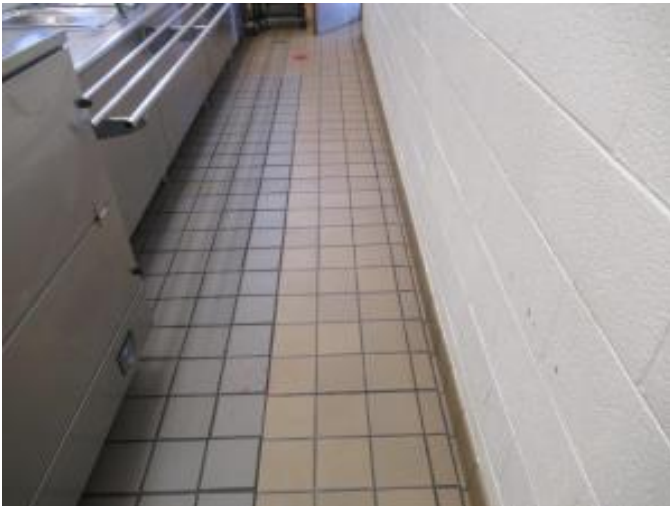
**System: C3020420 - Ceramic Tile**

**Location:** Interior  
**Distress:** Beyond Design Life  
**Category:** Appearance  
**Priority:** 4 - Recommended (Years 6-10)  
**Correction:** Renew System  
**Qty:** 1,950.00  
**Unit of Measure:** S.F.  
**Estimate:** \$34,749.00  
**Assessor Name:** Arturo Moyeda  
**Date Created:** 01/29/2024

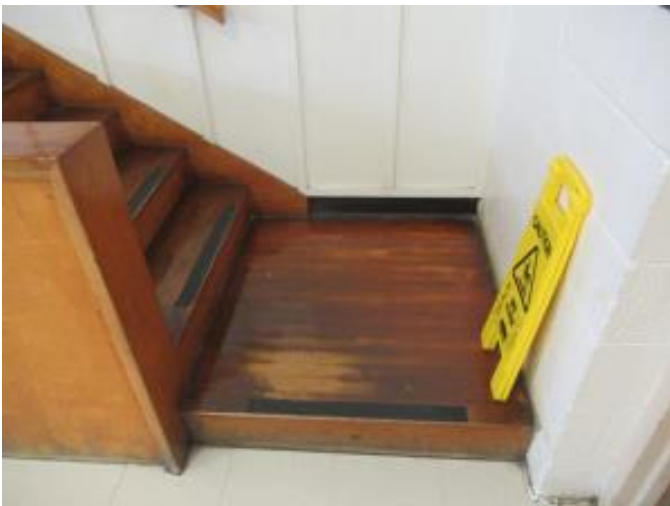
**System: C3020472 - Wood**

**Location:** Interior  
**Distress:** Beyond Design Life  
**Category:** Appearance  
**Priority:** 4 - Recommended (Years 6-10)  
**Correction:** Renew System  
**Qty:** 1,351.00  
**Unit of Measure:** S.F.  
**Estimate:** \$44,137.00  
**Assessor Name:** Arturo Moyeda  
**Date Created:** 01/29/2024

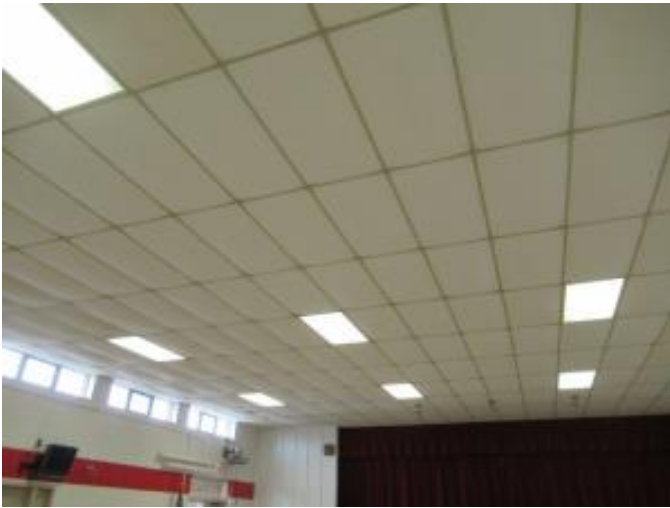
**System: C3030 - Ceiling Finishes**

**Location:** Interior  
**Distress:** Stained/Dirty  
**Category:** Appearance  
**Priority:** 4 - Recommended (Years 6-10)  
**Correction:** Renew System  
**Qty:** 25,734.00  
**Unit of Measure:** S.F.  
**Estimate:** \$580,585.00  
**Assessor Name:** Arturo Moyeda  
**Date Created:** 01/29/2024

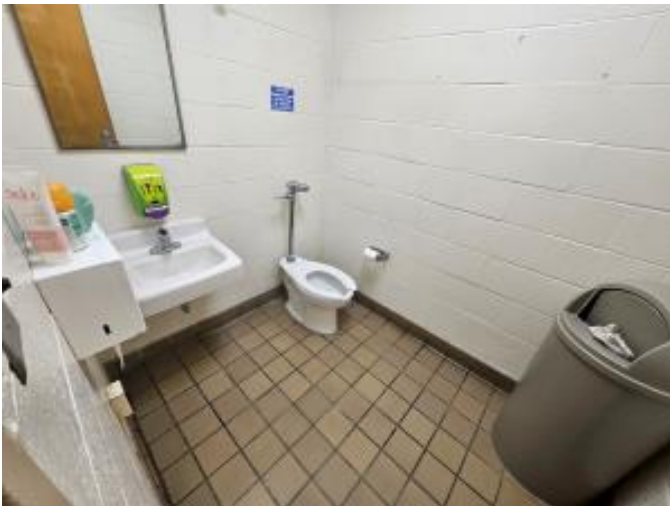
**System: D2010 - Plumbing Fixtures**

**Location:** Throughout building  
**Distress:** Beyond Design Life  
**Category:** Conservation Opportunity  
**Priority:** 4 - Recommended (Years 6-10)  
**Correction:** Renew System  
**Qty:** 25,734.00  
**Unit of Measure:** S.F.  
**Estimate:** \$451,786.00  
**Assessor Name:** Lawrence Lewis  
**Date Created:** 01/30/2024

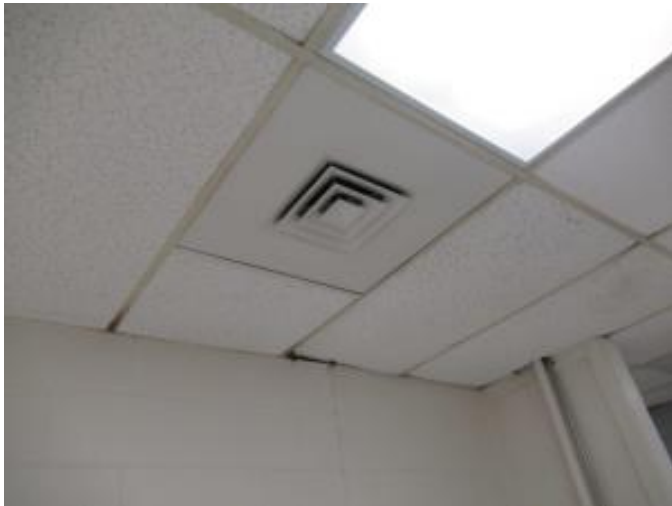
#### System: B3010120 - Single Ply Membrane

**Location:** Roof  
**Distress:** Leaks  
**Category:** System/Component Integrity  
**Priority:** 2 - Potentially Critical (Years 1-2)  
**Correction:** Renew System  
**Qty:** 17,274.00  
**Unit of Measure:** S.F.  
**Estimate:** \$274,190.20  
**Assessor Name:** Arturo Moyeda  
**Date Created:** 01/29/2024

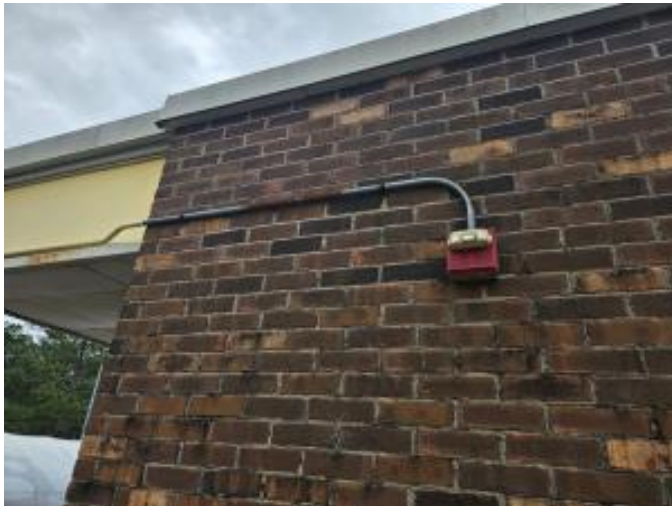
#### System: D5030910 - Fire Alarm Systems

**Location:** Throughout building  
**Distress:** Beyond Design Life  
**Category:** Safety  
**Priority:** 2 - Potentially Critical (Years 1-2)  
**Correction:** Renew System  
**Qty:** 17,274.00  
**Unit of Measure:** S.F.  
**Estimate:** \$82,846.10  
**Assessor Name:** Alexander Gomez  
**Date Created:** 02/14/2024

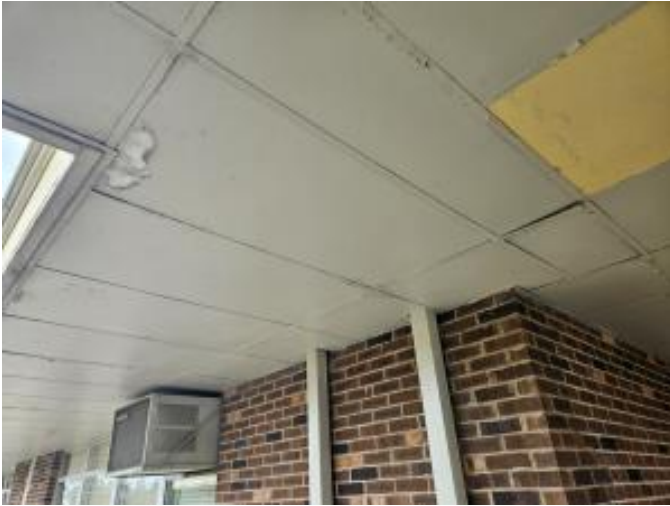
**System: D3050 - Terminal & Package Units**

**Location:** Throughout building  
**Distress:** Beyond Design Life  
**Category:** System/Component Integrity  
**Priority:** 3 - Necessary/Not Yet Critical (Years 3-5)  
**Correction:** Renew System  
**Qty:** 17,274.00  
**Unit of Measure:** S.F.  
**Estimate:** \$279,890.62  
**Assessor Name:** Lawrence Lewis  
**Date Created:** 01/30/2024

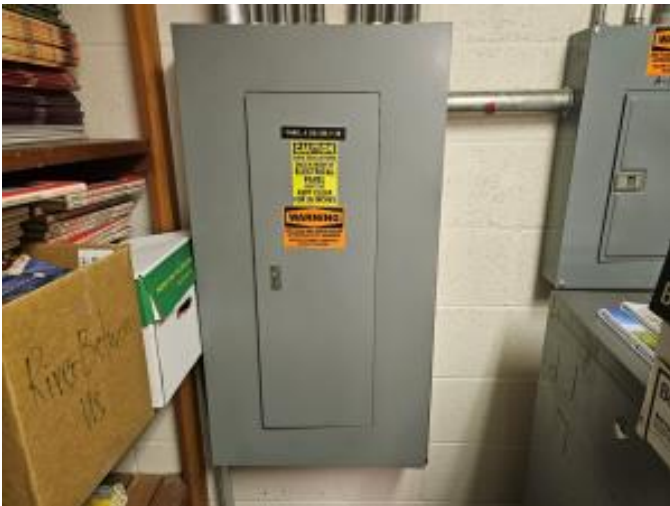
**System: D5010 - Electrical Service/Distribution**

**Location:** Throughout building  
**Distress:** Inadequate  
**Category:** System/Component Integrity  
**Priority:** 3 - Necessary/Not Yet Critical (Years 3-5)  
**Correction:** Renew System  
**Qty:** 17,274.00  
**Unit of Measure:** S.F.  
**Estimate:** \$48,073.54  
**Assessor Name:** Lawrence Lewis  
**Date Created:** 01/30/2024

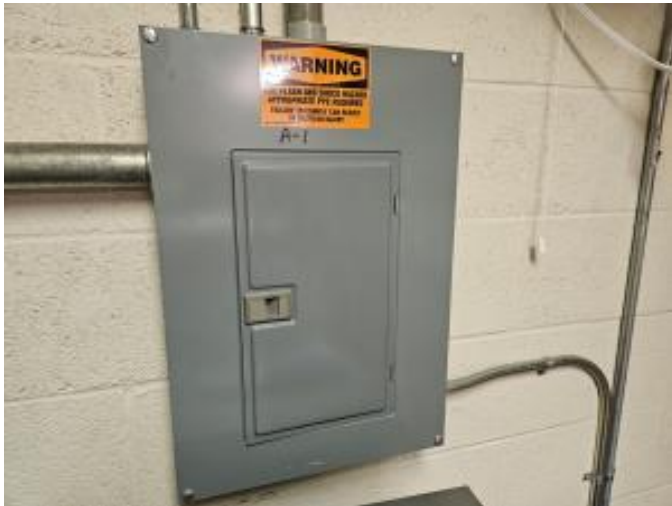
**System: D5020 - Branch Wiring**

**Location:** Throughout building  
**Distress:** Beyond Design Life  
**Category:** System/Component Integrity  
**Priority:** 3 - Necessary/Not Yet Critical (Years 3-5)  
**Correction:** Renew System  
**Qty:** 13,820.00  
**Unit of Measure:** S.F.  
**Estimate:** \$160,077.06  
**Assessor Name:** Lawrence Lewis  
**Date Created:** 01/30/2024

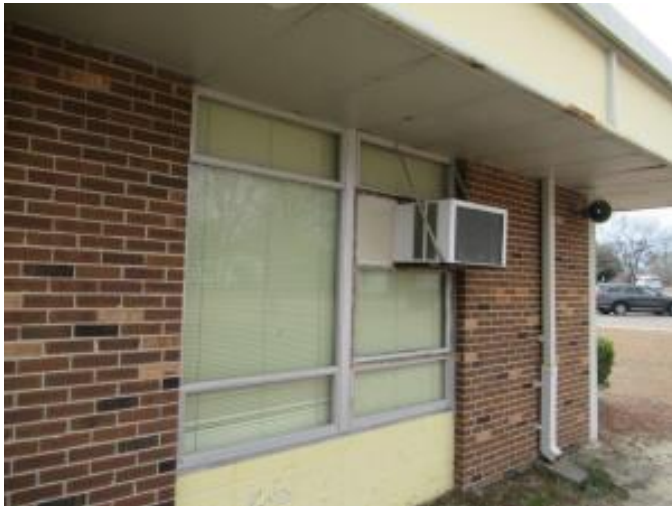
**System: B2020 - Exterior Windows**

**Location:** Exterior  
**Distress:** Beyond Design Life  
**Category:** Conservation Opportunity  
**Priority:** 4 - Recommended (Years 6-10)  
**Correction:** Renew System  
**Qty:** 17,274.00  
**Unit of Measure:** S.F.  
**Estimate:** \$218,896.13  
**Assessor Name:** Arturo Moyeda  
**Date Created:** 01/29/2024

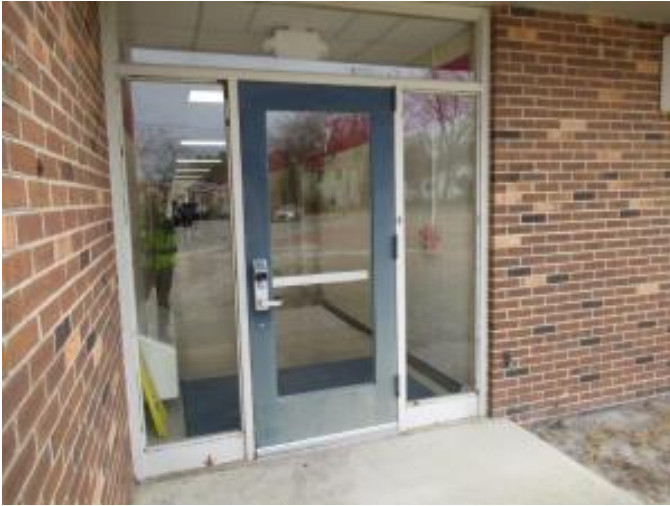
**System: B2030 - Exterior Doors**

**Location:** Exterior  
**Distress:** Beyond Design Life  
**Category:** Appearance  
**Priority:** 4 - Recommended (Years 6-10)  
**Correction:** Renew System  
**Qty:** 17,274.00  
**Unit of Measure:** S.F.  
**Estimate:** \$37,622.77  
**Assessor Name:** Arturo Moyeda  
**Date Created:** 01/29/2024

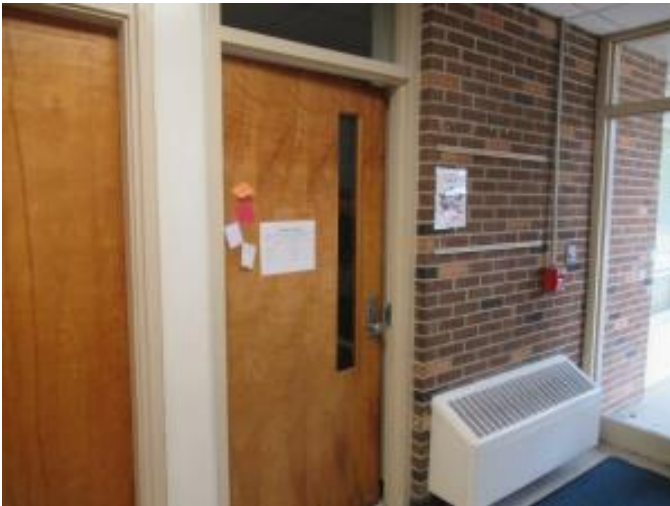
**System: C1020 - Interior Doors**

**Location:** Interior  
**Distress:** Beyond Design Life  
**Category:** Appearance  
**Priority:** 4 - Recommended (Years 6-10)  
**Correction:** Renew System  
**Qty:** 17,274.00  
**Unit of Measure:** S.F.  
**Estimate:** \$69,925.15  
**Assessor Name:** Arturo Moyeda  
**Date Created:** 01/29/2024

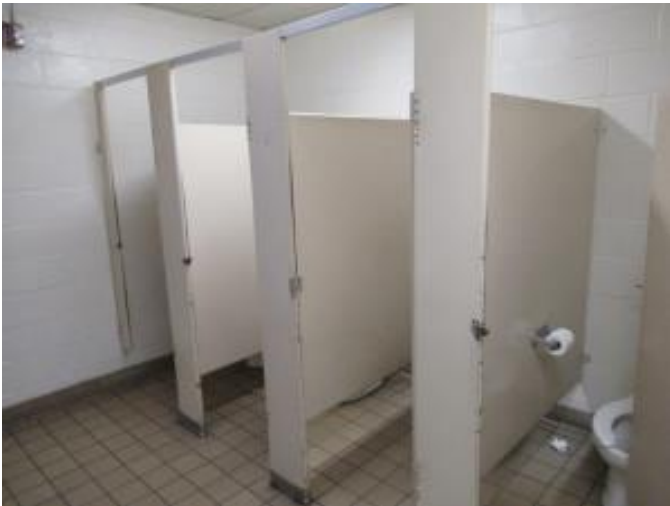
**System: C1030 - Fittings**

**Location:** Interior  
**Distress:** Beyond Design Life  
**Category:** Appearance  
**Priority:** 4 - Recommended (Years 6-10)  
**Correction:** Renew System  
**Qty:** 17,274.00  
**Unit of Measure:** S.F.  
**Estimate:** \$41,043.02  
**Assessor Name:** Arturo Moyeda  
**Date Created:** 01/29/2024

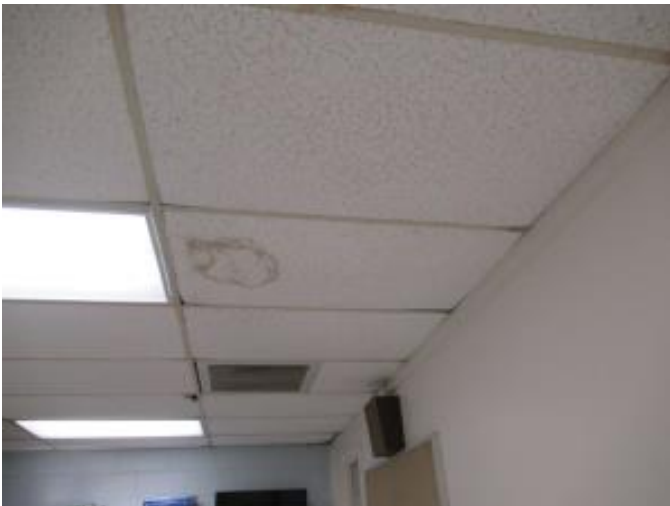
**Location:** Interior  
**Distress:** Stained/Dirty  
**Category:** Appearance  
**Priority:** 4 - Recommended (Years 6-10)  
**Correction:** Renew System  
**Qty:** 17,274.00  
**Unit of Measure:** S.F.  
**Estimate:** \$389,718.71  
**Assessor Name:** Arturo Moyeda  
**Date Created:** 01/29/2024

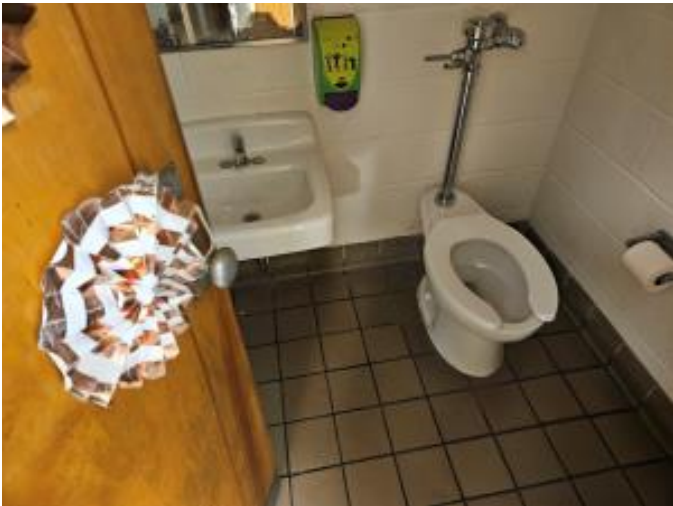
**Location:** Throughout building  
**Distress:** Beyond Design Life  
**Category:** Conservation Opportunity  
**Priority:** 4 - Recommended (Years 6-10)  
**Correction:** Renew System  
**Qty:** 17,274.00  
**Unit of Measure:** S.F.  
**Estimate:** \$303,262.34  
**Assessor Name:** Lawrence Lewis  
**Date Created:** 01/30/2024

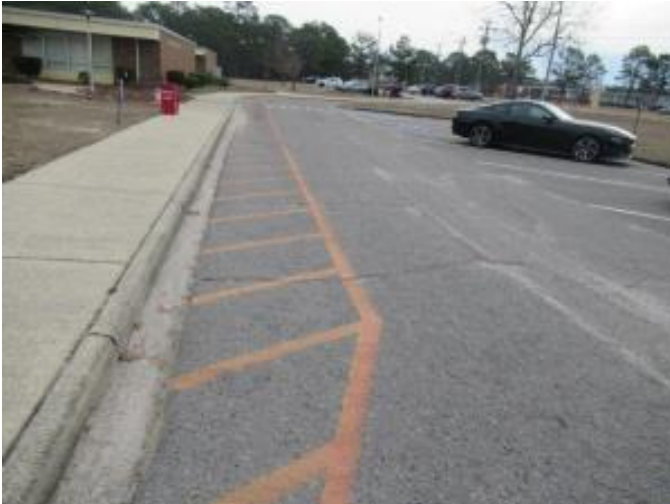
**Location:** Exterior  
**Distress:** Beyond Design Life  
**Category:** System/Component Integrity  
**Priority:** 4 - Recommended (Years 6-10)  
**Correction:** Renew System  
**Qty:** 44,448.00  
**Unit of Measure:** S.F.  
**Estimate:** \$131,522.00  
**Assessor Name:** Arturo Moyeda  
**Date Created:** 01/29/2024

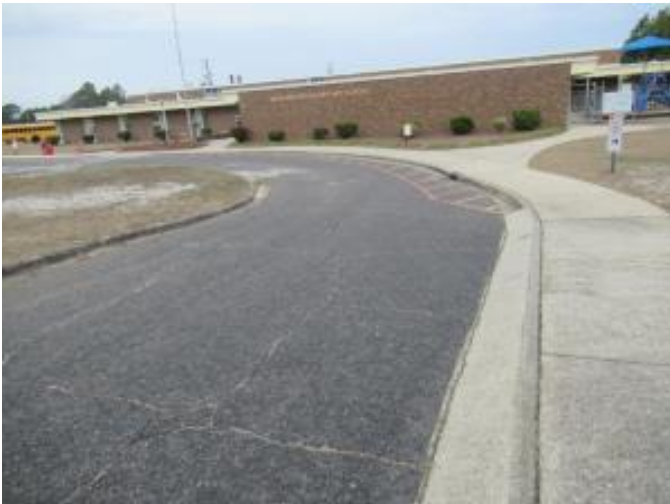
**Location:** Exterior  
**Distress:** Beyond Design Life  
**Category:** System/Component Integrity  
**Priority:** 4 - Recommended (Years 6-10)  
**Correction:** Renew System  
**Qty:** 44,448.00  
**Unit of Measure:** S.F.  
**Estimate:** \$739,748.00  
**Assessor Name:** Arturo Moyeda  
**Date Created:** 01/29/2024

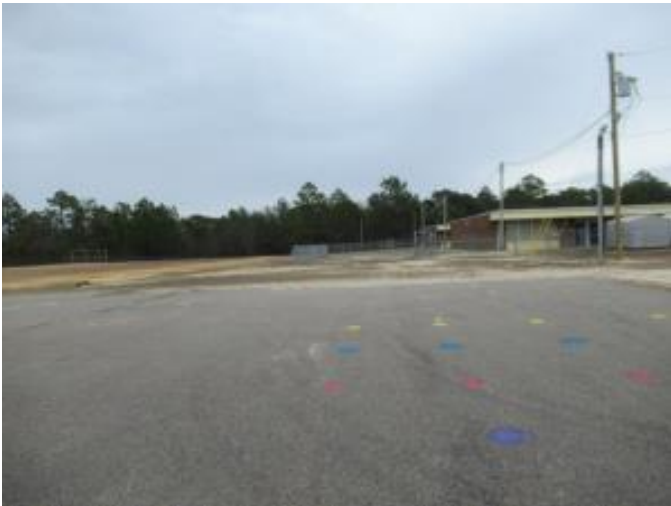
**Location:** Exterior  
**Distress:** Beyond Design Life  
**Category:** System/Component Integrity  
**Priority:** 4 - Recommended (Years 6-10)  
**Correction:** Renew System  
**Qty:** 1.00  
**Unit of Measure:** Ea.  
**Estimate:** \$96,578.00  
**Assessor Name:** Arturo Moyeda  
**Date Created:** 01/29/2024
