Facility Infrastructure Safety & Repairs

Lakeview Junior
High School

Prairieview
Elementary School

Health Life Safety Survey

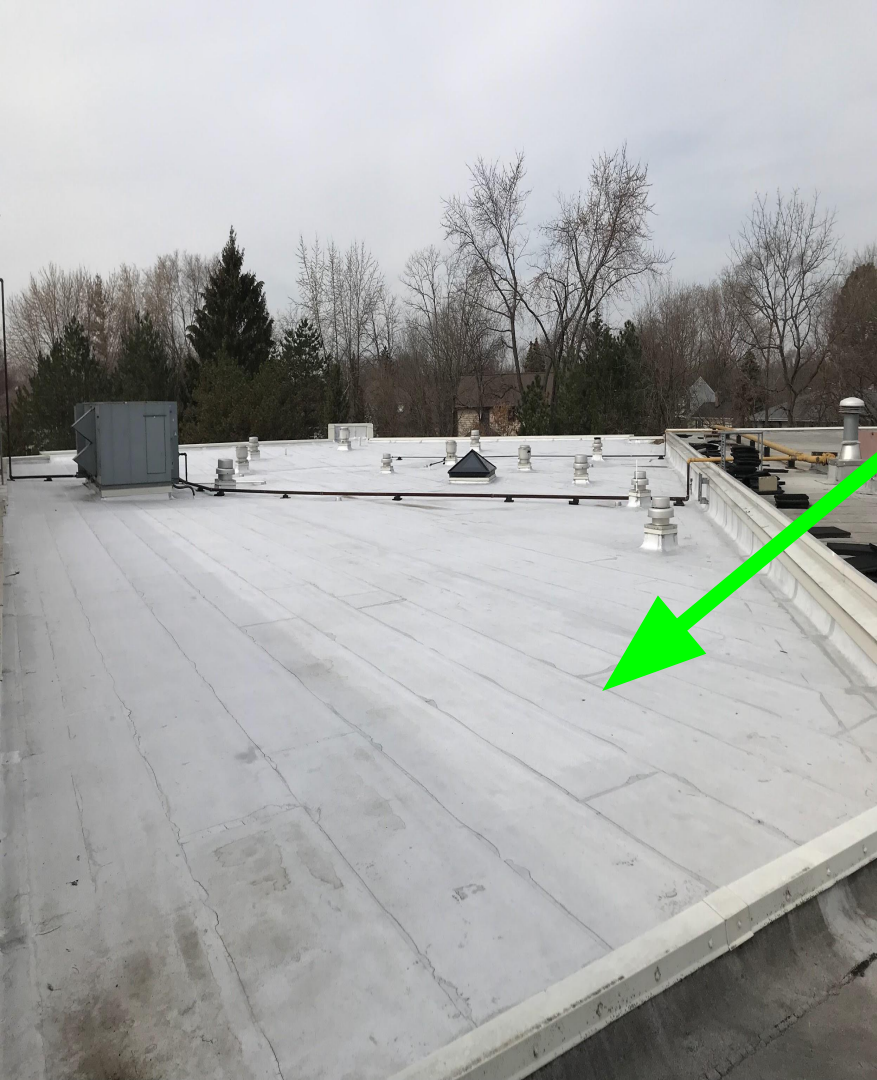
On the Right-
heavily degraded
section of surface
coating.

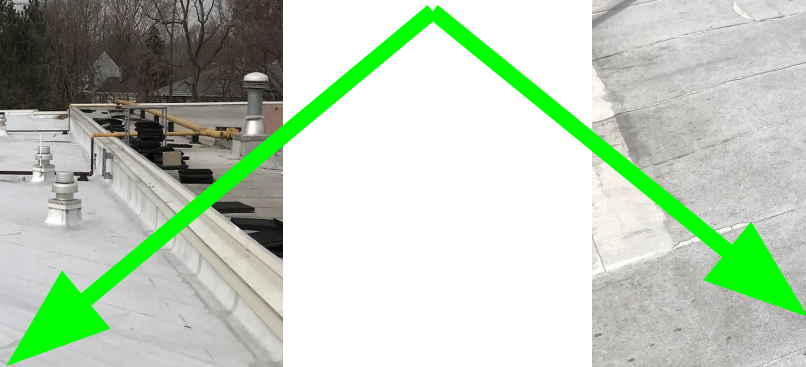
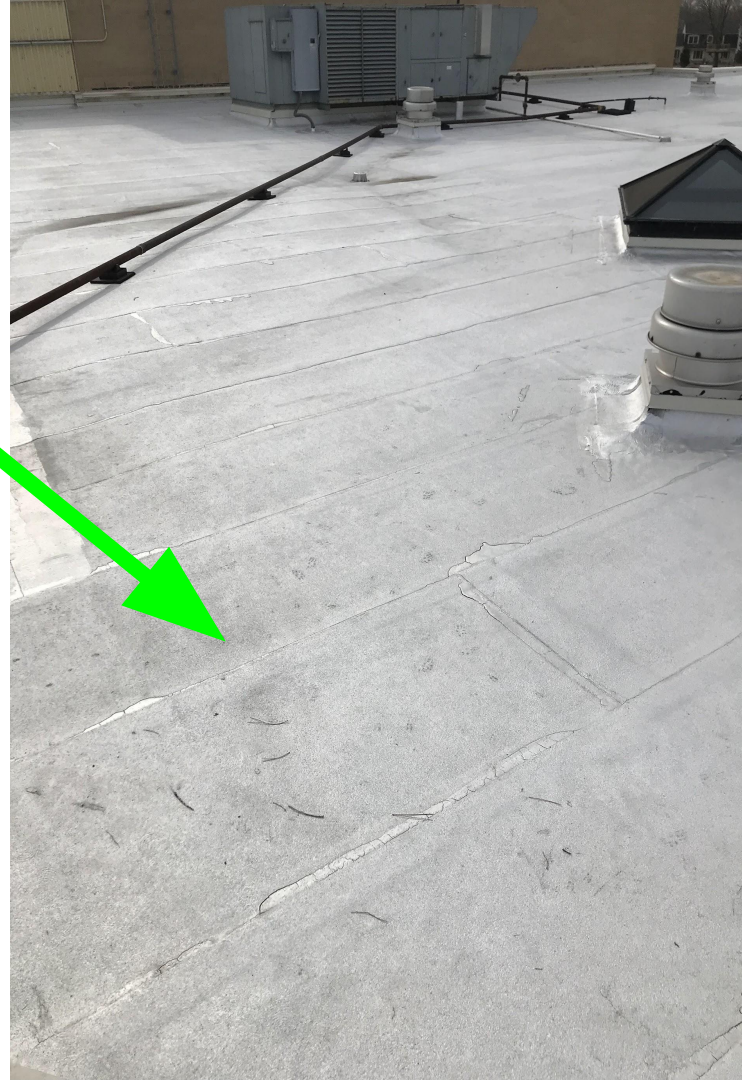
Newly
replaced
section 4 & 5.
Summer 2021

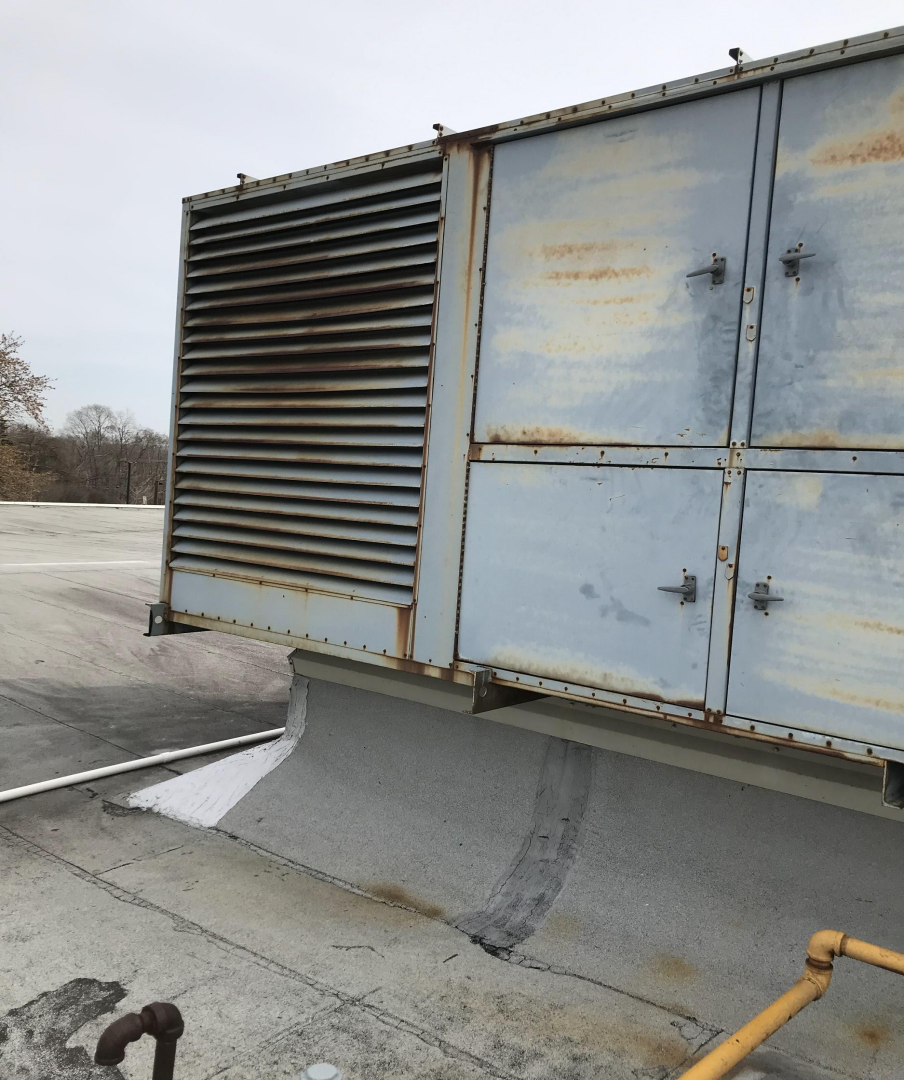
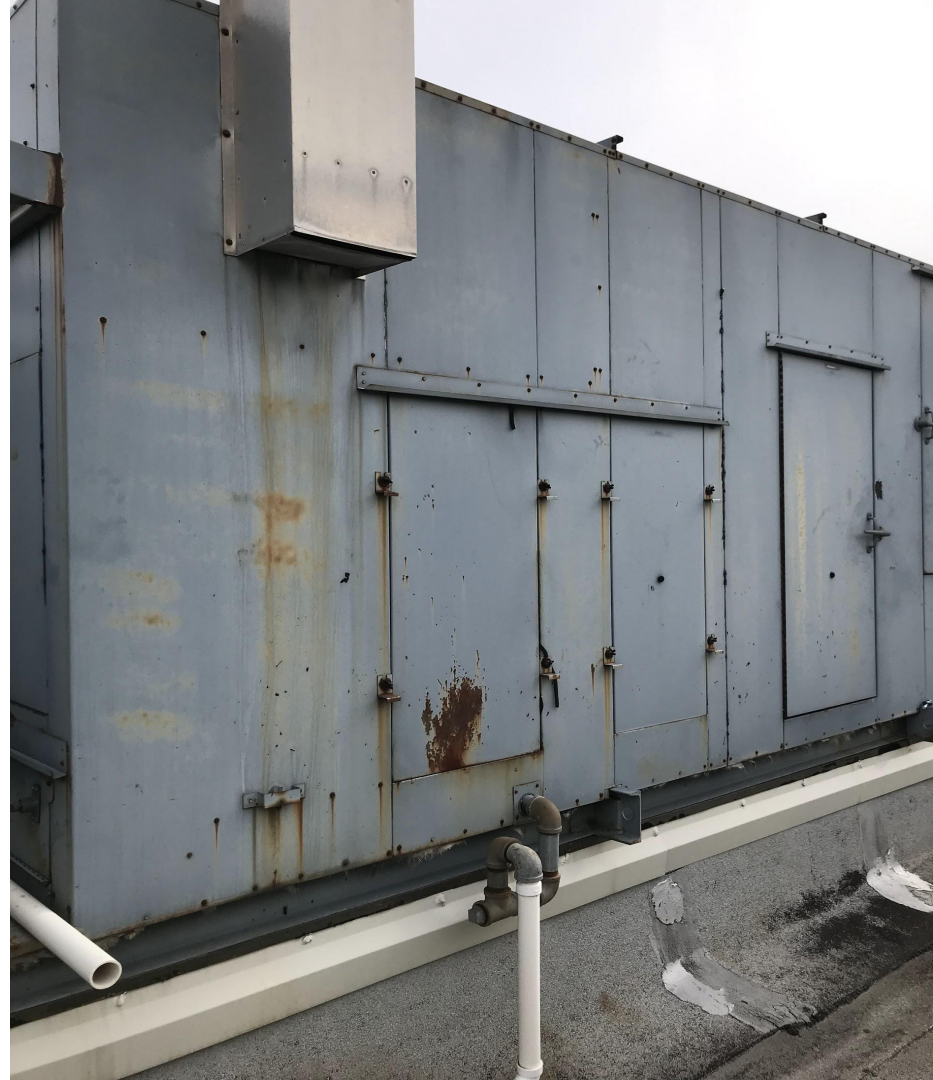
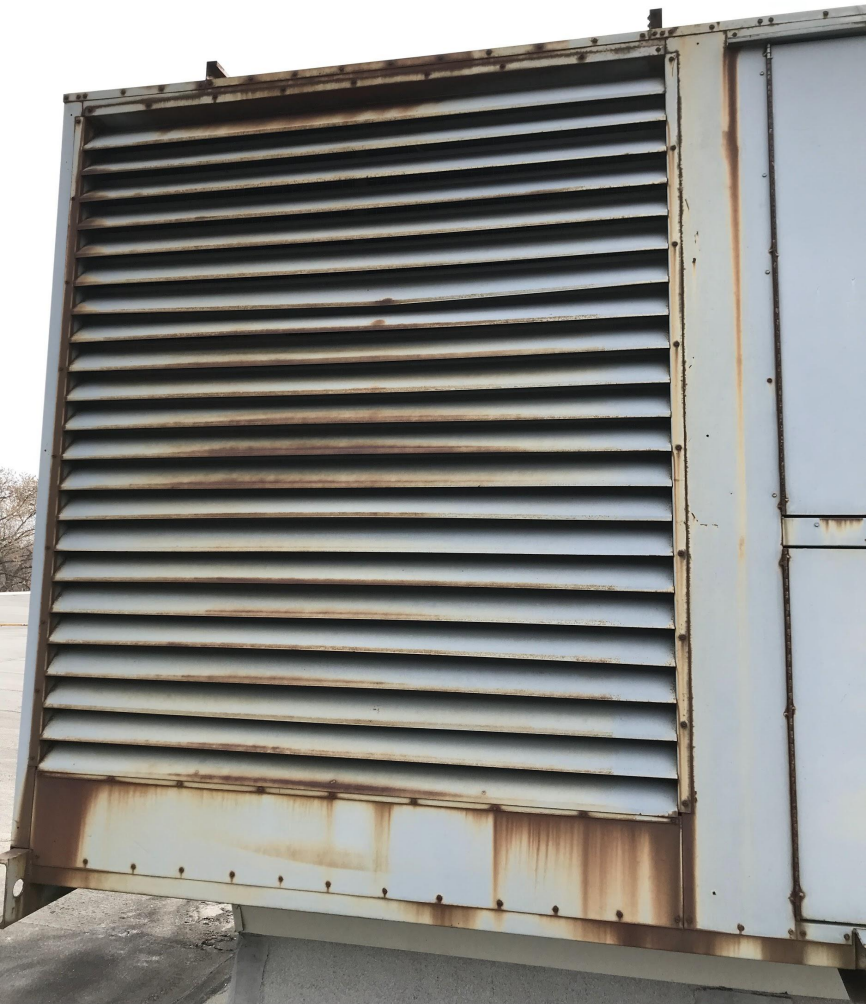
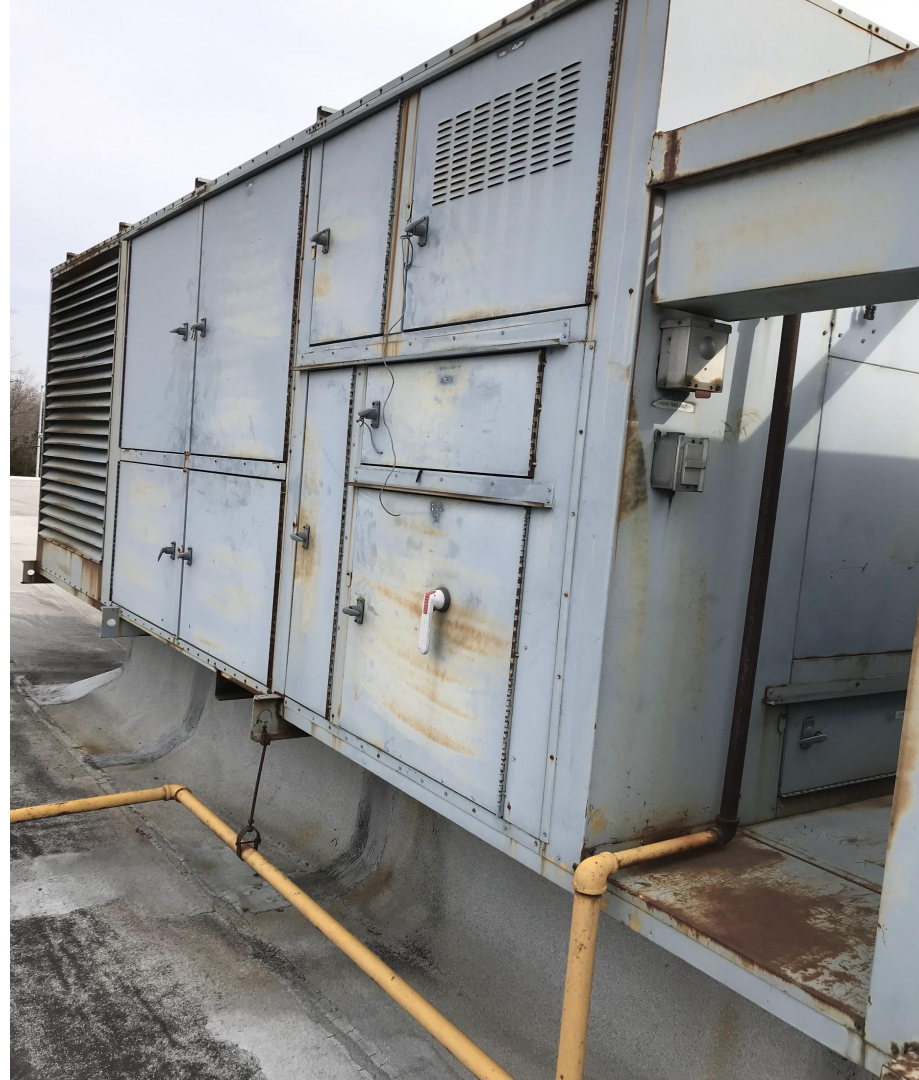
- 7 total RTU's (Roof Top Units)
- Multi Zoned air handler
- Units heat & cool (not simultaneously)
- All 7 units have been on Master facility plan reports since 2014 (LEGAT architects)
- Units undergo quarterly filter changes and semi annual coil cleaning.

***Units have outlived their useful life according to ASHRAE standards.*-HLS**

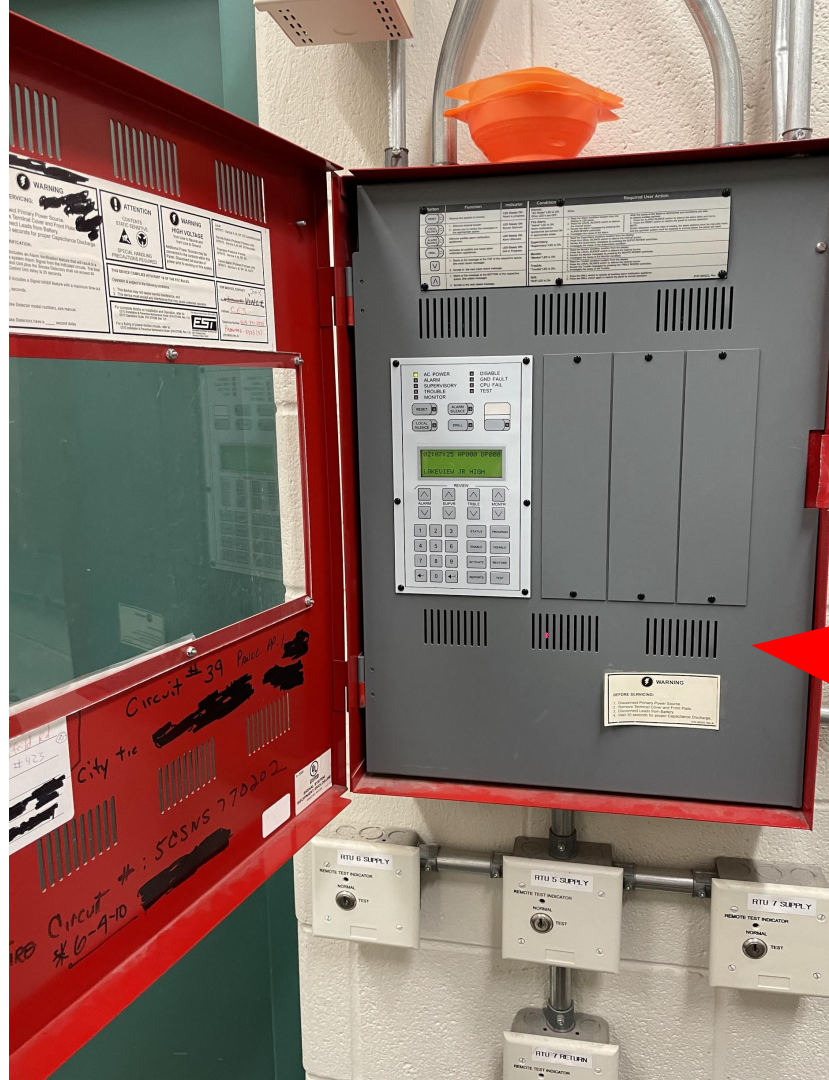
Lakeview, Prairieview & Elizabeth Ide- Fire Alarm System

- IDE system age- approximately 25 yrs
- LV system age- approximately 22 yrs
- PV system age- approximately 22 yrs.

- Replacement components for each panel are no longer supported from manufacturer (Edwards & Simplex) without upgrading panel to current supported models.

***Fire alarm system is aged with frequent failure. Failures are unpredictable and pose safety risk in the event of emergency*-HLS**

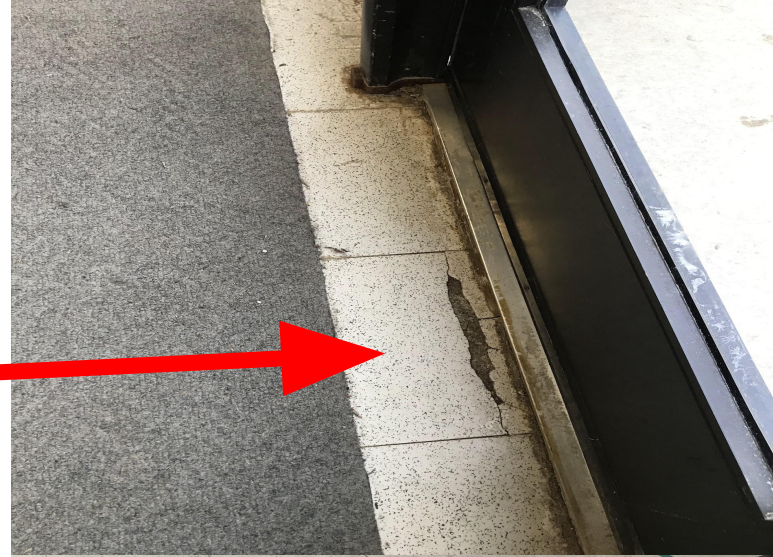
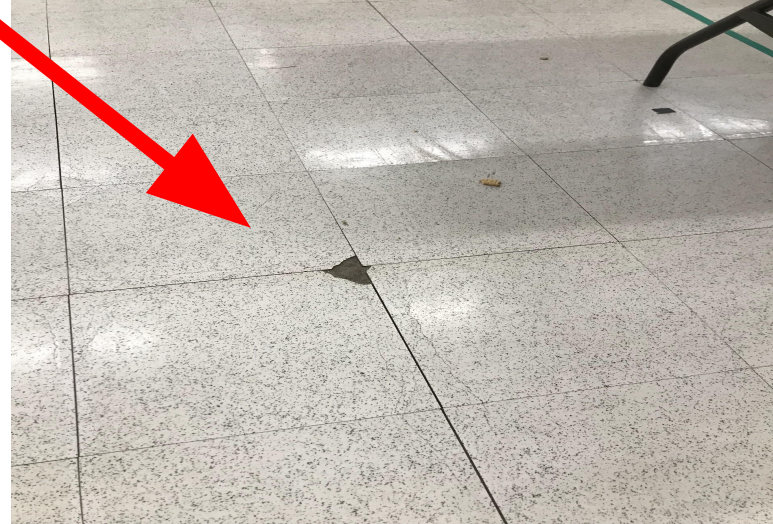
Prairieview
cracked floor tiles.

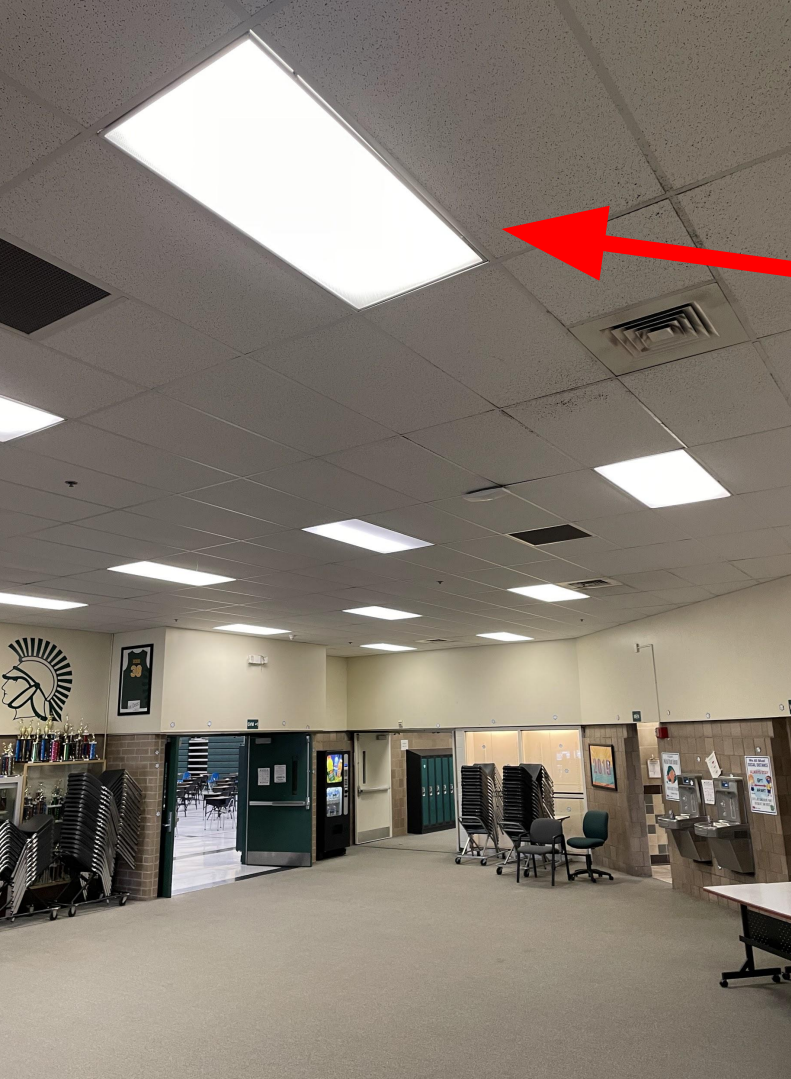
On the Left-
Halogen T5
lighting.
(majority of
Lakeview).

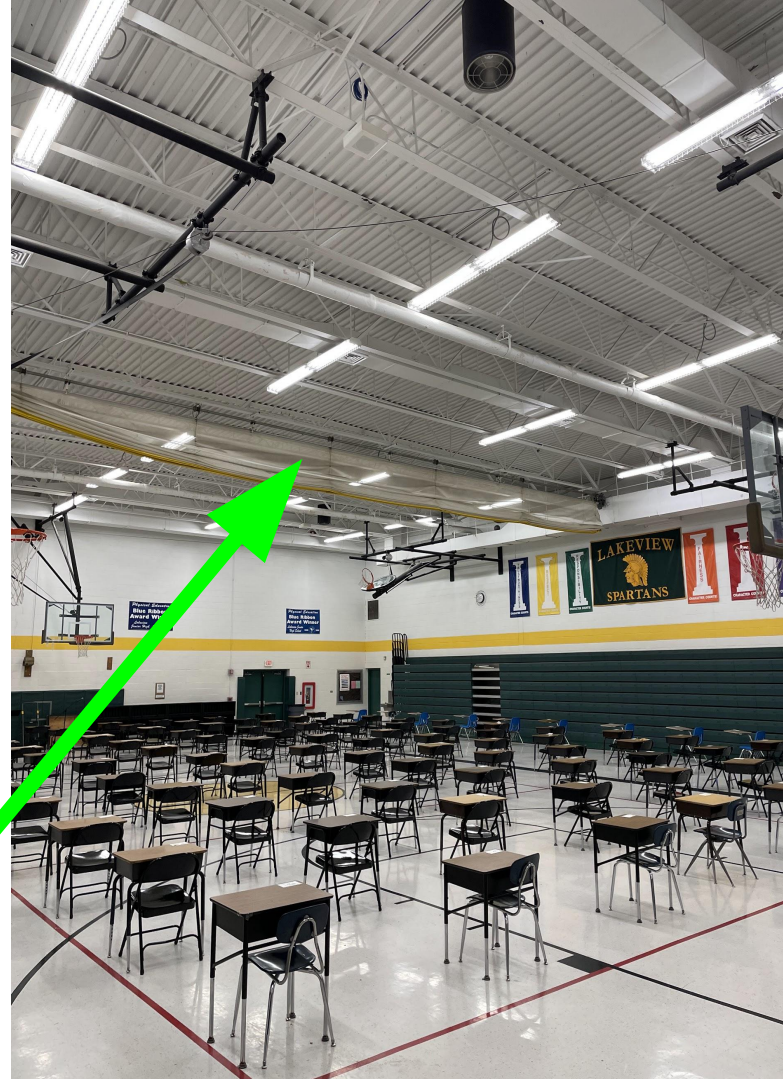
**On The
Right-**
LED
upgraded
lighting.(done
in house)
