## Halifax Area School District

Elementary School Facilities Assessment  
January 24, 2017

Halifax Area School District  
Existing Facilities Report – Enders-Fisherville Elementary School  
791 Enders Road, Halifax, PA 17032

## Halifax Area School District Existing Facilities Report – Halifax Elementary School 3940 Peters Mountain Road, Halifax, PA 17032

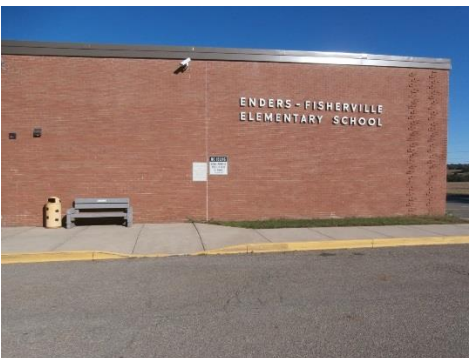
*Front of school with bus drop-off area*

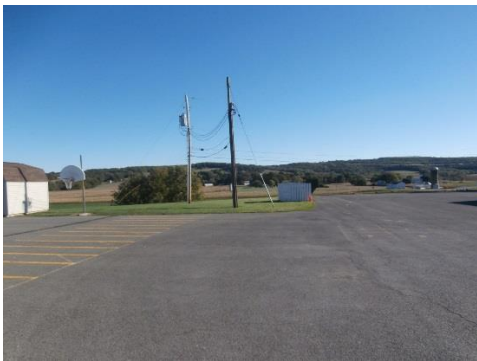
Play Areas: A large “soft surface” play area with multiple pieces of play equipment is located on the east side of the school. The equipment and the overall state of the play area appears to be in good condition (note that there is no fence surrounding this play area). A “hard surface” play area is located between the soft surface play area and the school (note that this area is also used for daily parent drop-off/pick-up and appears to accommodate overflow parking for large events). This paved area is in satisfactory condition with two basketball hoops and backboards on either end. There is a utility pole and guy wire located just off the edge of the south side of this play area that can present safety concerns for students at play.

*Hard surface play area and utility pole*

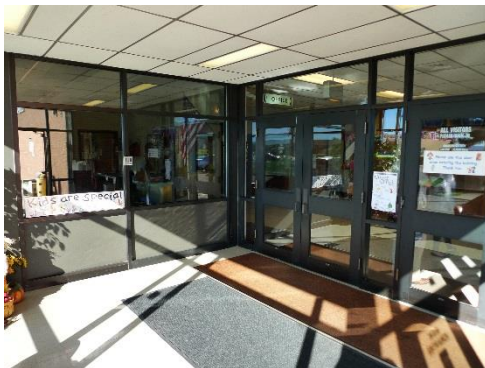
Entrance vestibule opens directly to corridor

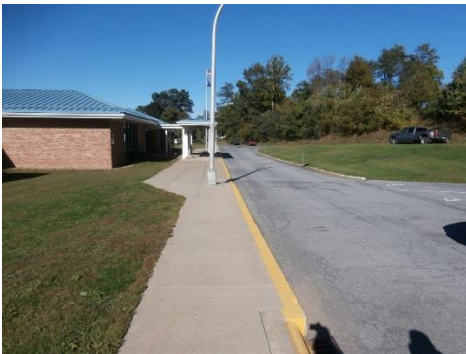
The bus pick-up/drop-off area is located along the east side of the building with buses lining up "single file" in front of the building. It appears that there is not enough space for all of the buses to line up in this area (stacking back onto School Street) and that students/parents cross in-between the buses traveling to/from parked vehicles along the eastern edge of School Street. This is a significant safety concern.

*Bus drop off area*

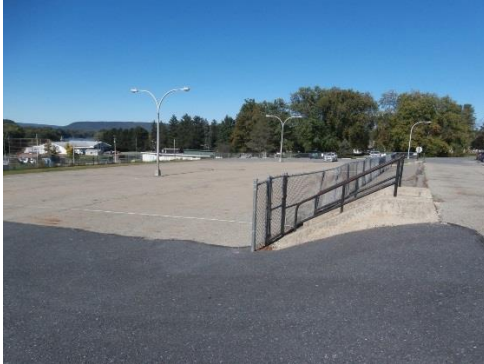
Student drop-off occurs on the back (west) side of the building in an area that is not very well defined. Drivers make a counterclockwise loop through the "hard surface" play area at the rear of the school and traverse some very steep grades. It was also noted that parents line up for this pick-up area as much as 30-40 minutes in advance of dismissal causing

*Hard surface play area and parent drop off*

concerns with stacked vehicles in the hard surface play area which may still be in use by students.

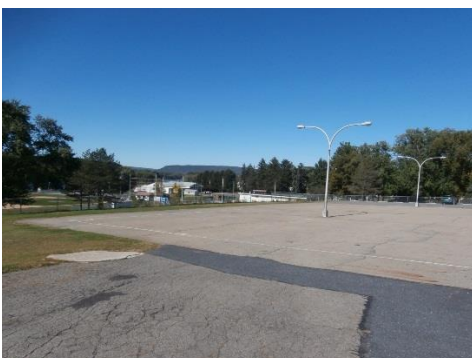
Hard surface play area

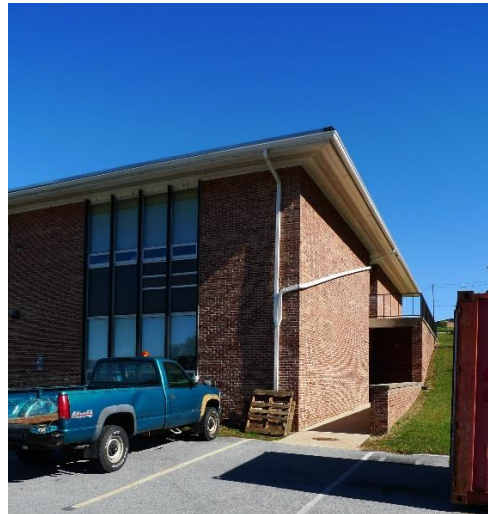
Downspouts and exterior glazing

- HES.EX.05 Replace damaged exterior doors.
- HES.EX.06 Replace exterior glazing system.

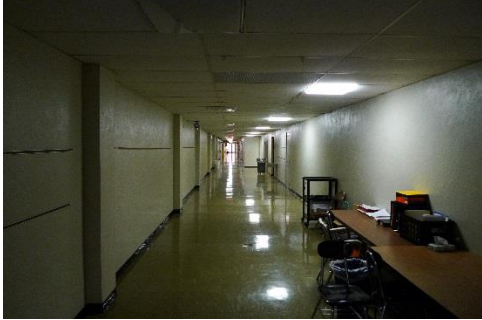
Lower level ceiling and original flooring

**HES.BI.01 Repair damaged flooring and base.**

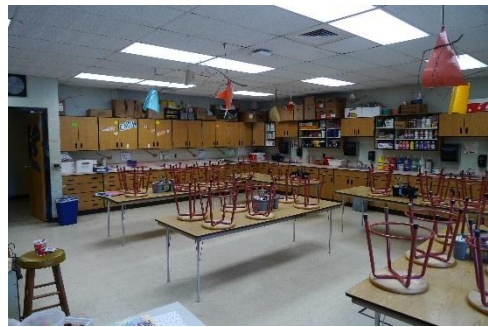
Art classroom

Music/Art: There is currently one room for art, one room for music, and one room for band. Art is currently taught in a typical classroom space with storage and sinks that are not accessible. Music and band are located in windowless rooms on the lower level. Circulation in the band room was noted to be difficult due to the room size and the number of chairs.

HES.ED.07 Create accessible storage and sinks in art room.

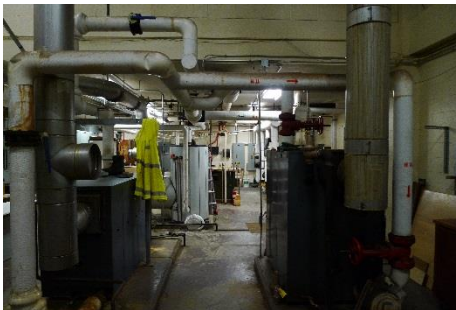
The existing distribution system is a 2-pipe changeover system. This system allows heating and cooling HVAC water distribution through the same piping but not simultaneously. Constant volume zone pumps distribute the water through the building in insulated steel and copper piping. The zones are currently separated into the following groups: Pre-1987 classrooms, offices, multipurpose rooms, and Post-1987 classrooms. Vertical piping contained in concealed locations or drops within existing block walls may be original to the building. The ASHRAE Median Service Life for the pumps is 20 years.

*Existing mechanical room*

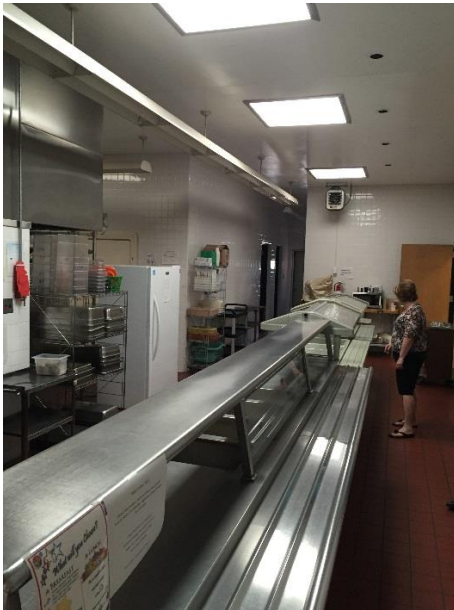
*Existing kitchen*

The kitchen has a single-sided exhaust hood backed up against a common partition wall. Make-up air is transferred in from the adjacent multi-purpose room. Each kitchen hood is exhausted by an upblast fan on the roof. An ANSUL fire suppression system is present for portions of the hood as required by code. The dishwasher is exhausted through two direct connections and discharges through a rooftop upblast exhaust fan. The ASHRAE Median Service Life for the exhaust fans is 15 years

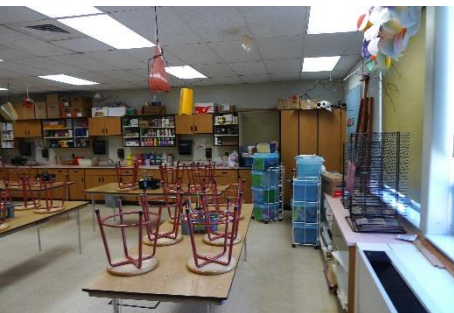
*Existing art rooms*

In addition to the kitchen (described above), toilet spaces, select storage spaces, mechanical room, and janitor's closets are exhausted through ductwork to rooftop exhaust fans. The art classroom does not have exhaust provisions which is required for International Mechanical Code compliance. A majority of the fans were replaced during the renovations but several pieces are existing to the building and are candidates for replacement. The ASHRAE Median Service Life for exhaust fans is 20 years.

HES.HVAC.03 Exhaust fans and terminal heating devices that are original to the building have well exceeded their expected lives and should be replaced.

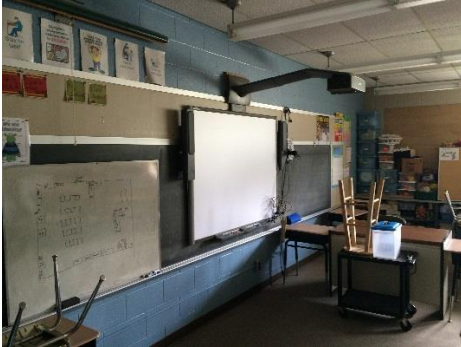
The typical classroom has what appears to be an abandoned token-ring network drops with a patch cord between the two wall-mounted drops. The current building solution utilizes Cat. 5E, Ethernet with WiFi access device on the ceiling and two data drops in one corner. Patch cords were observed in many locations to extend data from the corner drop to another location in the room. It was also noted that many of the data drop were installed in surface mounted boxes missing covers allowing for additional stress on the data cable punch-down connections.

Existing classroom technology
