## 2024 LANSING PUBLIC SCHOOL CONDITION MAP

## Lansing KS Financial Summary Overview

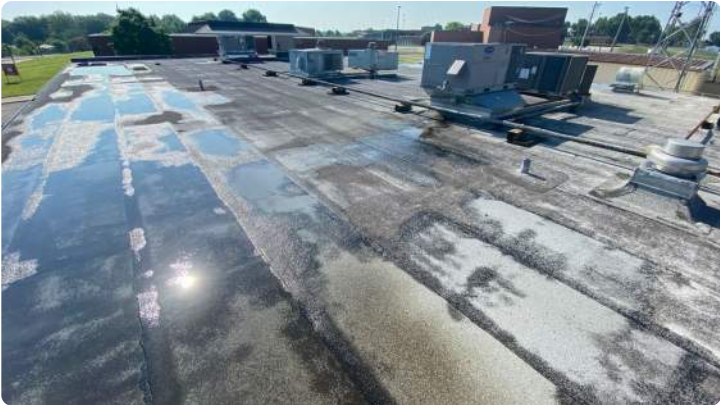
Poor condition

Ponding, skrim exposed, minor blistering, fish mouths

Photo showing overview of Area 01 roof.

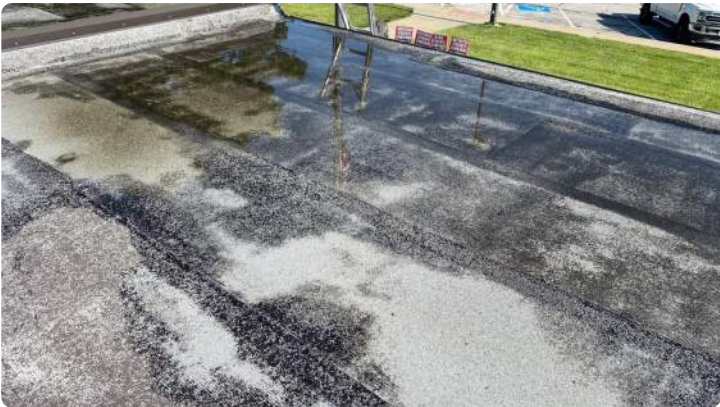
Photo showing ponding water along perimeter.

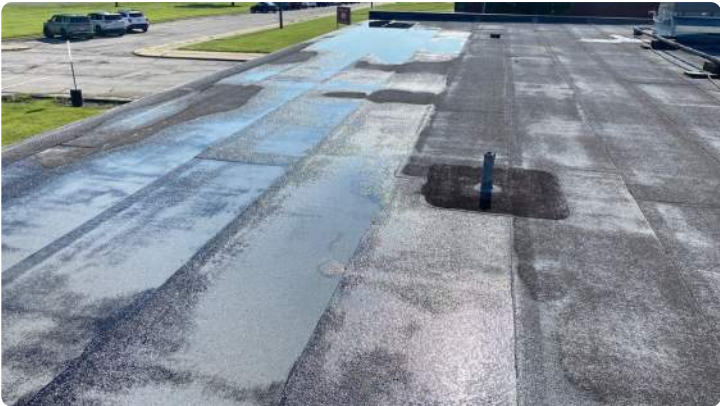
Photo showing additional ponding water.

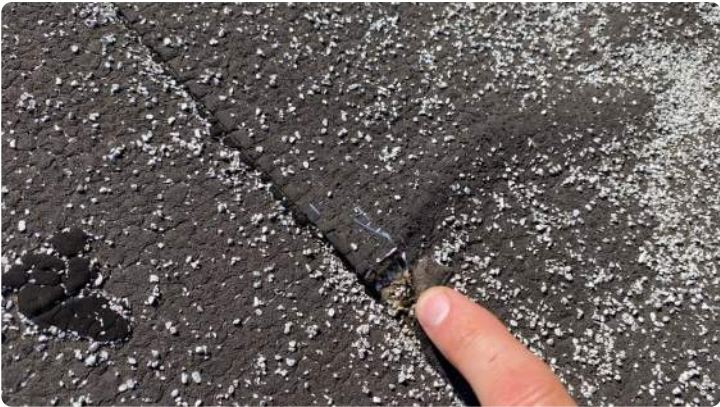
Photo showing hole in the field membrane. Repaired as part of the maintenance agreement.

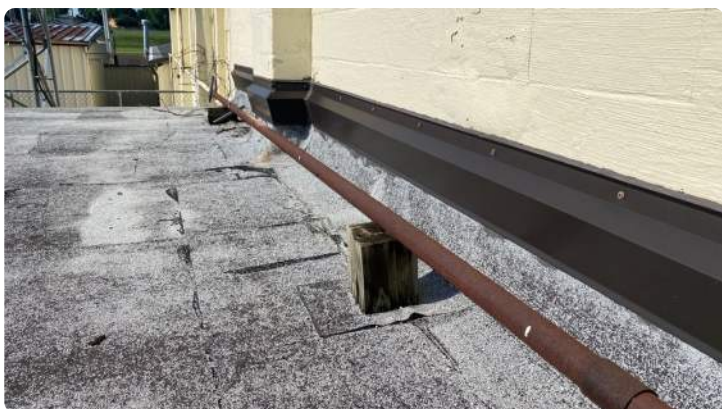
Photo showing blistering in the perimeter flashings.

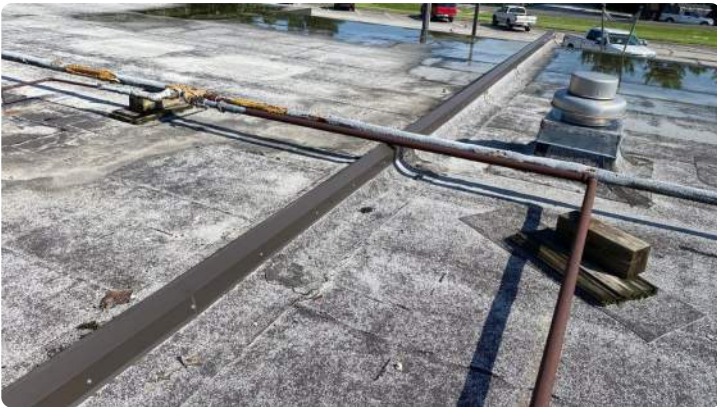
Photo showing condition of the expansion joint.

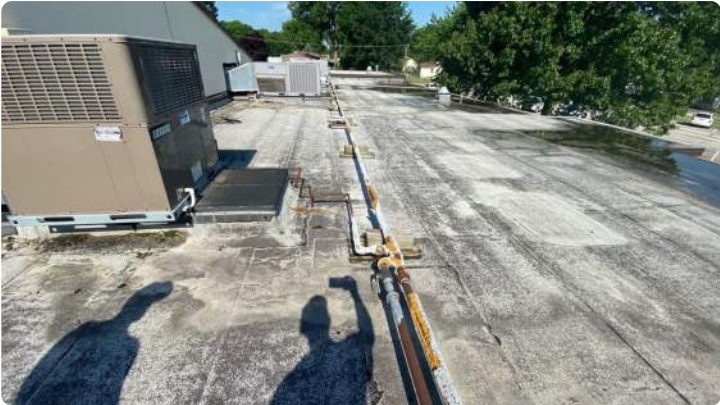
Poor condition

Ponding, minor blistering, skein showing, vent stacks open (patched), fish mouths

Photo showing overview of Area 02 roof.

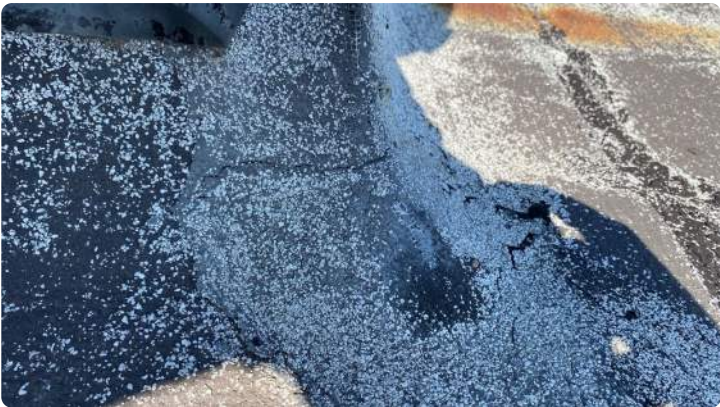
Photo showing cracking and deteriorating projection flashings.

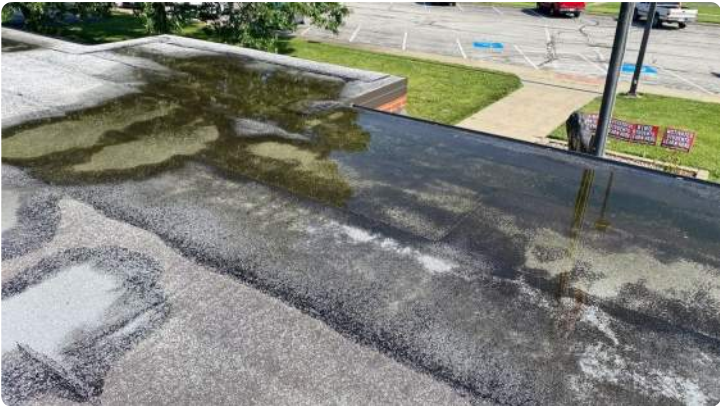
Photo showing ponding water along perimeter.

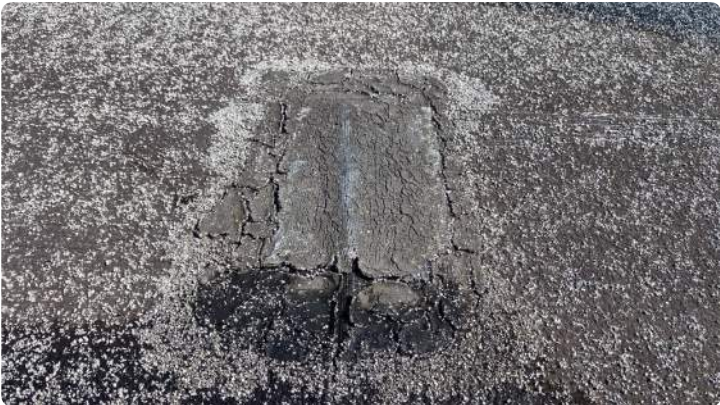
Photo showing deteriorating existing patch.

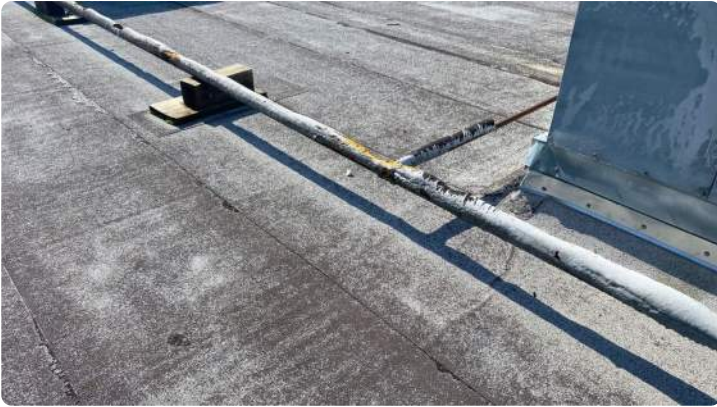
Photo showing deteriorating field.

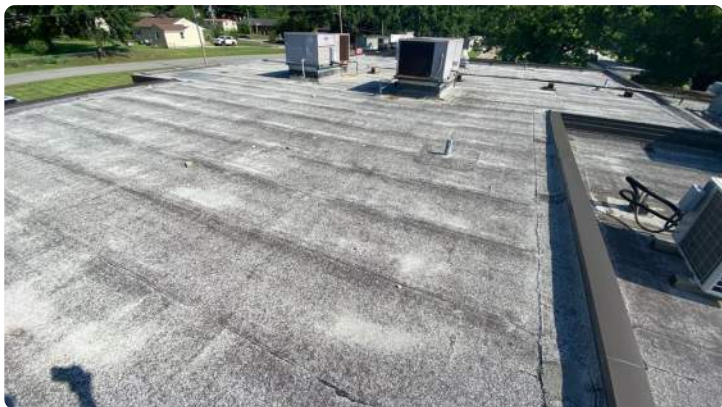
Poor condition

Skrim showing, vents open (patched), minor blistering, fish mouths

Photo showing overview of Area 03 roof.

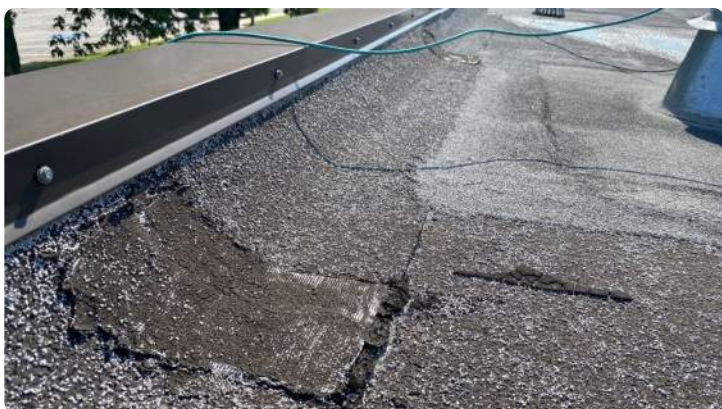
Photo showing condition of the perimeter flashings.

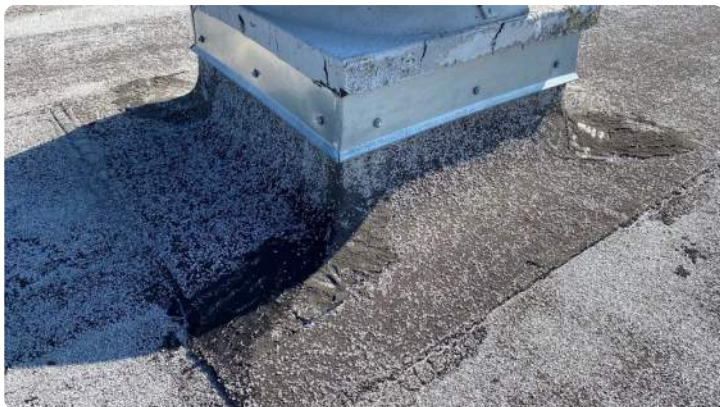
Photo showing condition of the projection flashings.

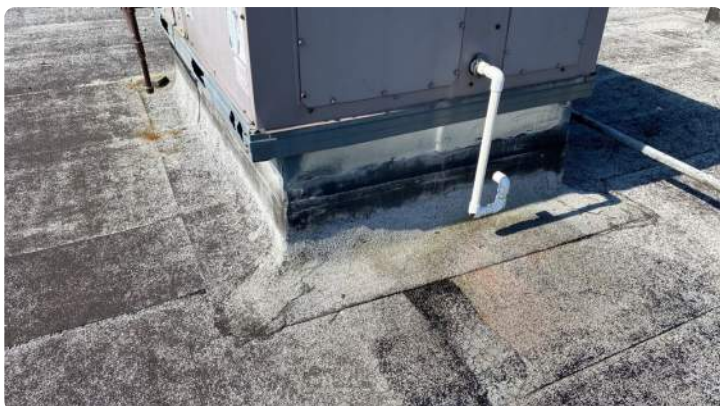
Photo showing deterioration under unit condensation line.

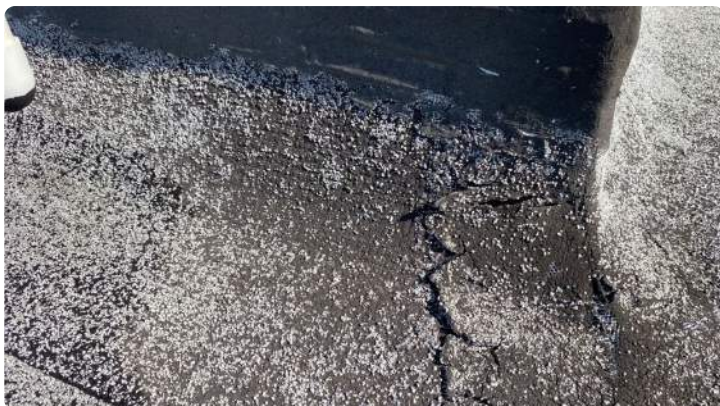
Photo showing skim exposed in cracking projection flashings.

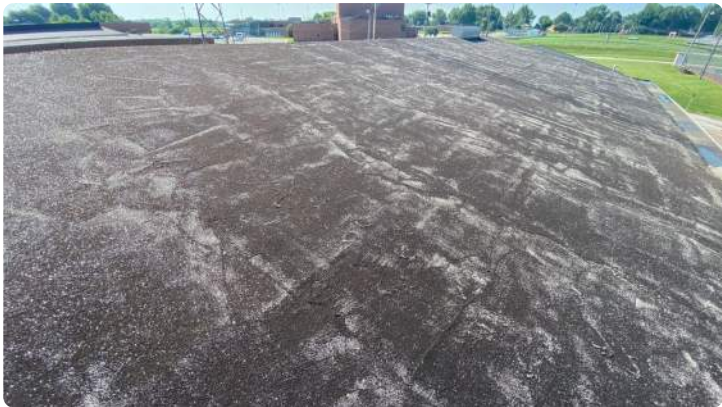
Poor condition

Deteriorating coating

Photo showing overview of Area 04 roof.

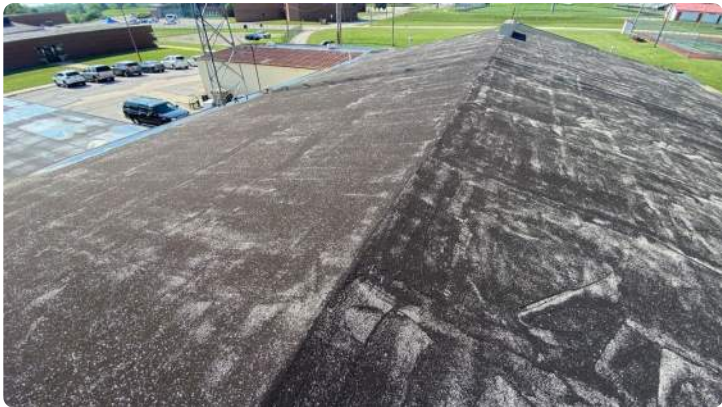
Photo showing additional overview of Area 04 roof.

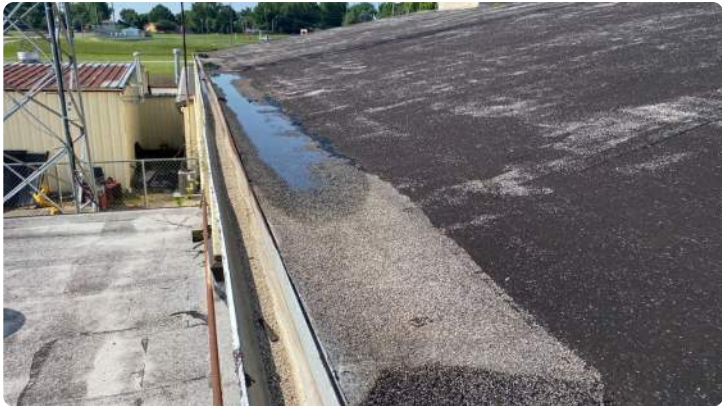
Photo showing condition of the perimeter gutter.

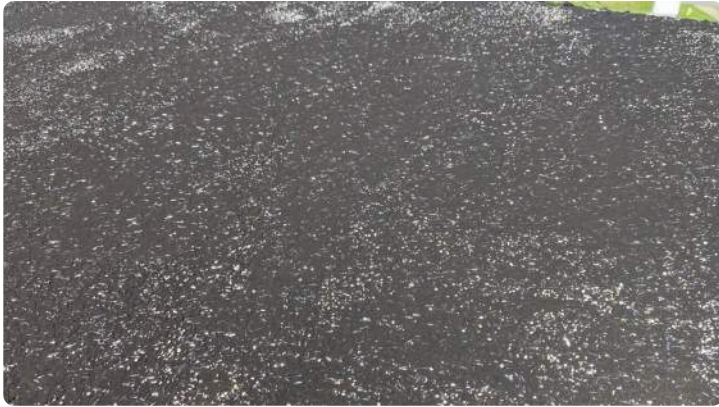
Photo showing deterioration of the coating.

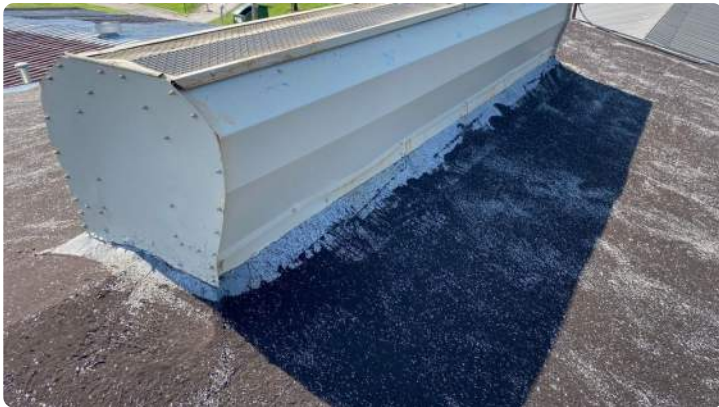
Photo showing condition of the projection flashings.

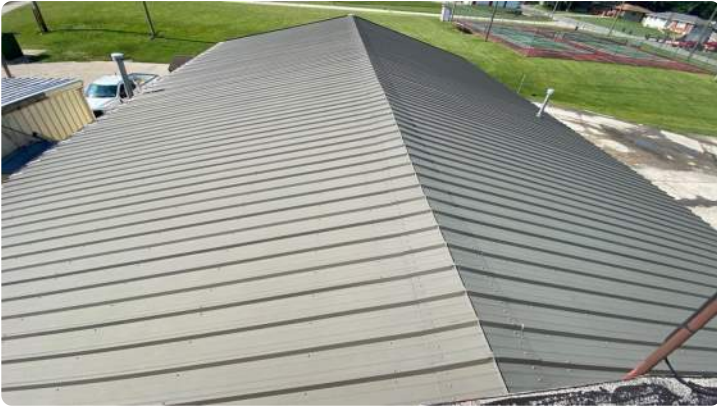
Good condition

Photo showing overview of Area 05 roof.

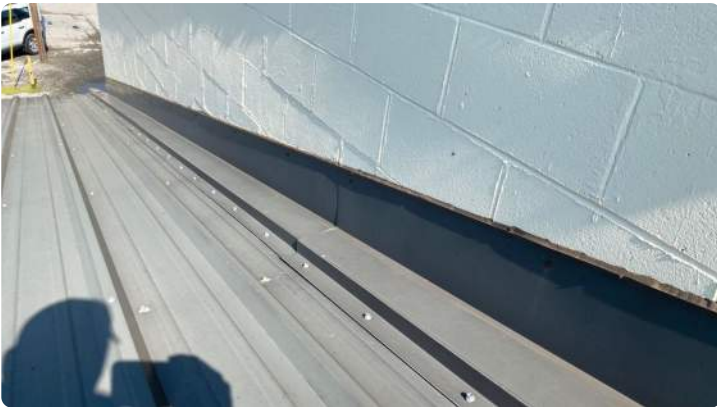
Photo showing condition of the perimeter flashings.

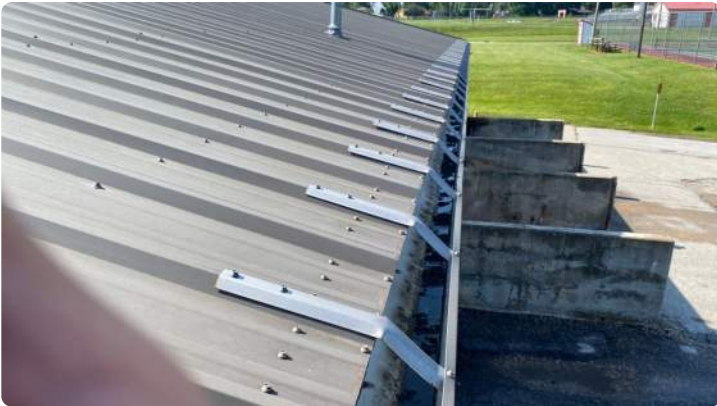
Photo showing condition of the gutter edge.

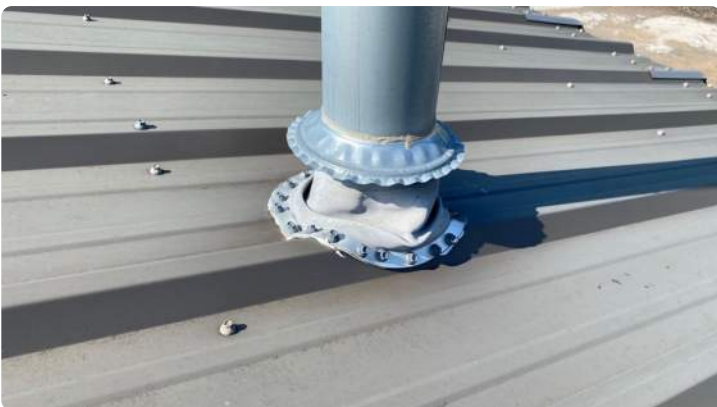
Photo showing condition of the projection flashing.

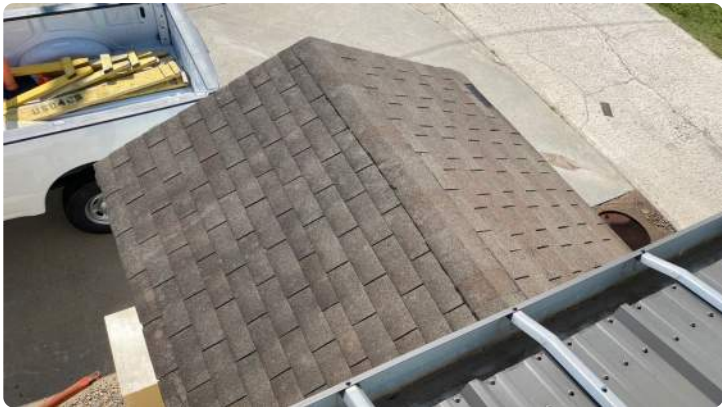
Photo showing adjacent shingle roof.

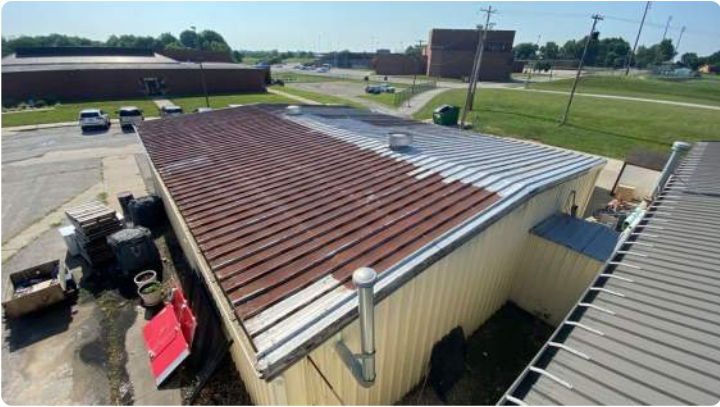
Poor condition

Rust, deterioration

Photo showing overview of Area 06 roof.

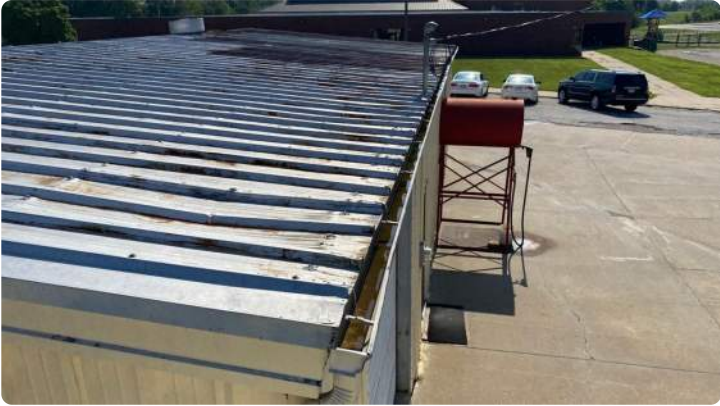
Photo showing condition of the gutter edge.

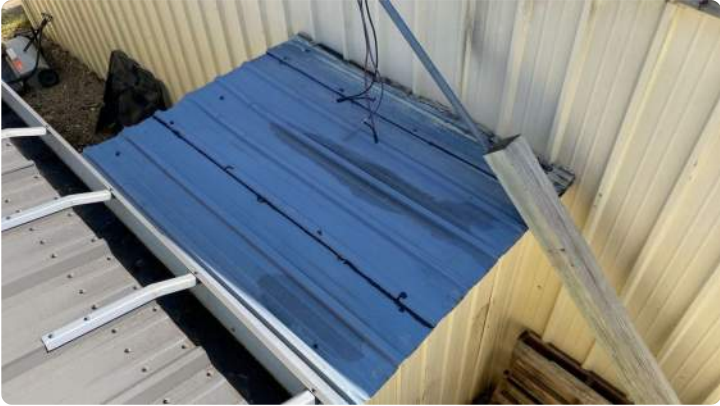
Photo showing condition of adjacent metal roof.

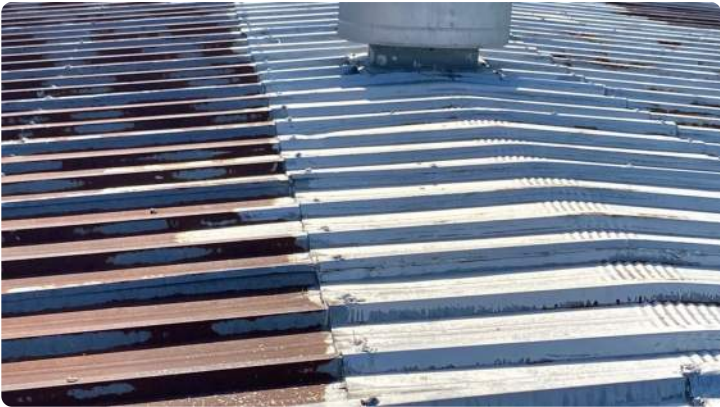
Photo showing deterioration of metal roof.

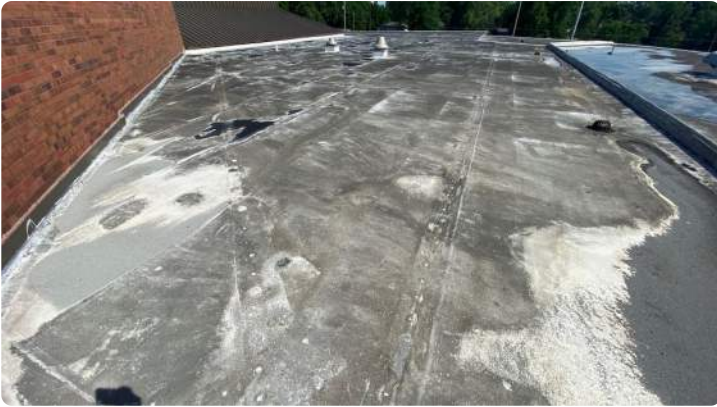
Poor condition

Coating is peeling up and field is ponding water

Photo showing overview of Area 01 roof.

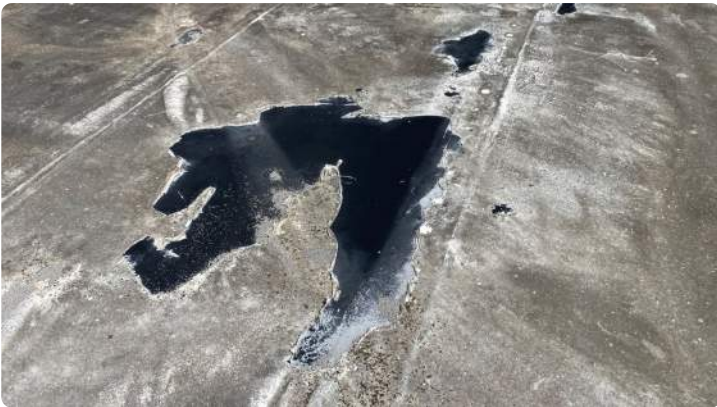
Photo showing deteriorating coating.

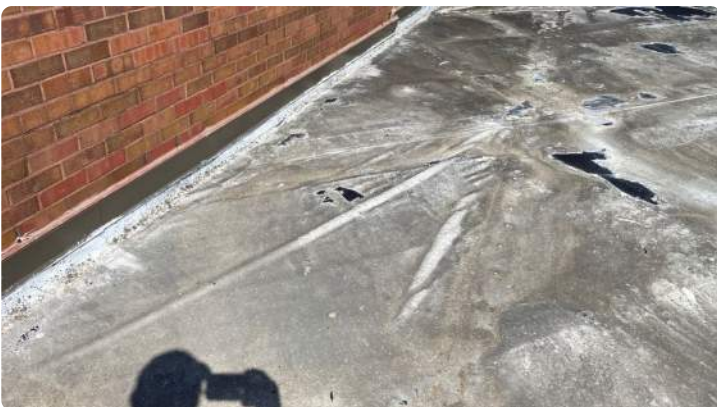
Photo showing deteriorating coating and loose membrane.

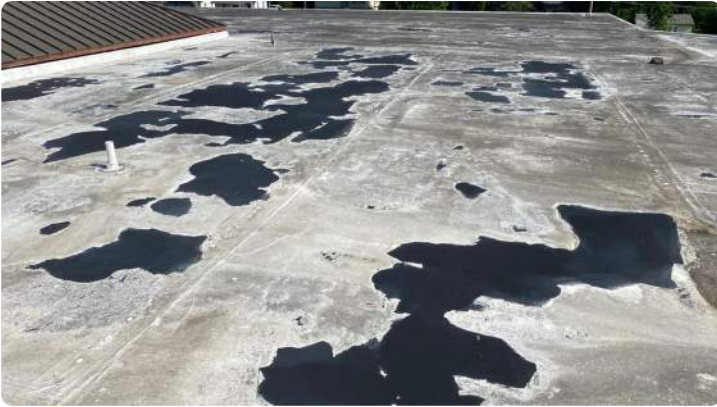
Photo showing deteriorating coating.

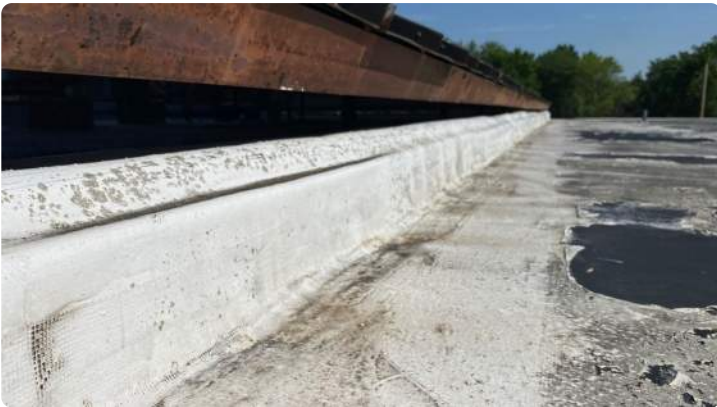
Photo showing condition of the perimeter flashings.

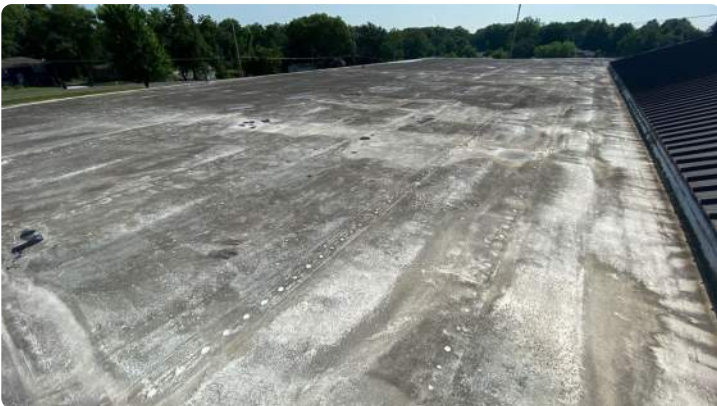
Photo showing additional overview of Area 01 roof.

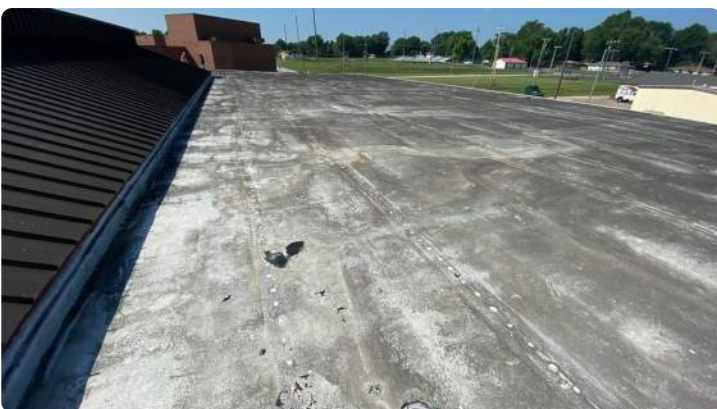
Photo showing additional overview of Area 01 roof.

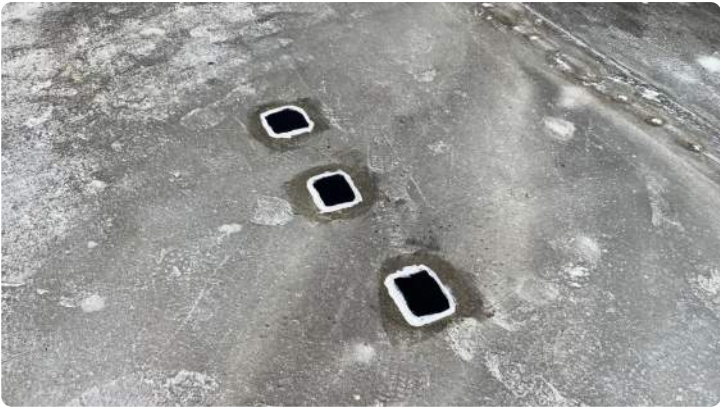
Photo showing repairs made to the field membrane.

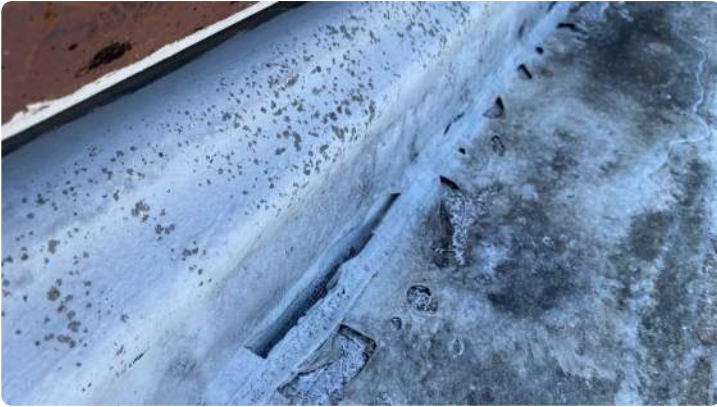
Photo showing coating deteriorating along the perimeter flashings.

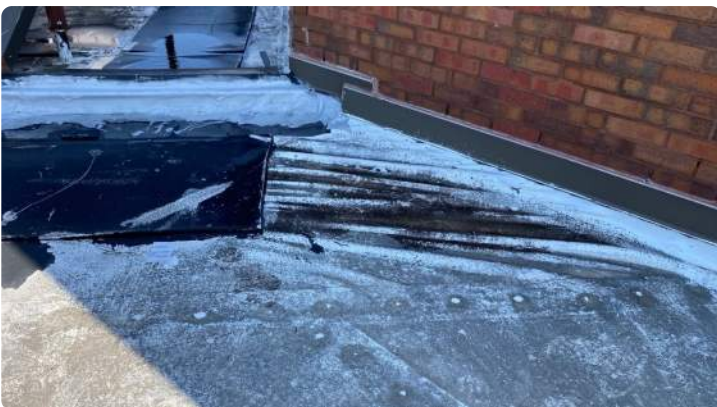
Photo showing coating deteriorating and loose membrane.

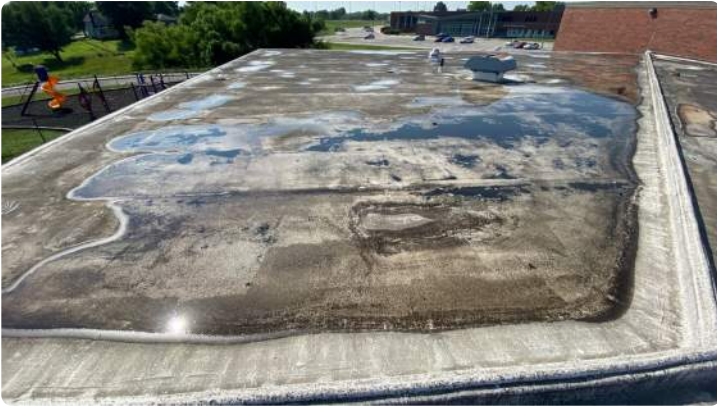
Coating is peeling up and field is ponding water

Photo showing overview of Area 02 roof.

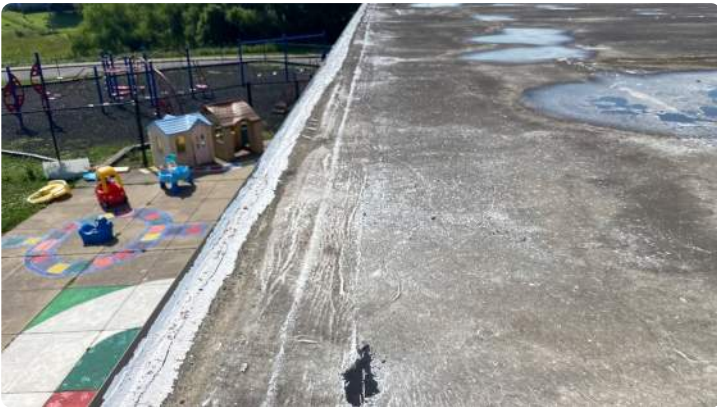
Photo showing condition of the perimeter flashings.

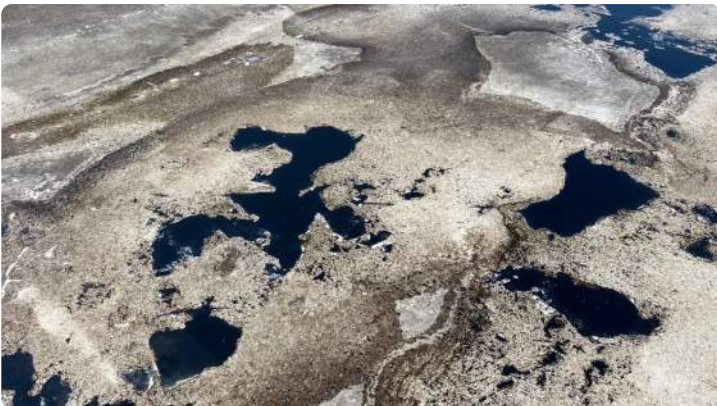
Photo showing deteriorating coating.

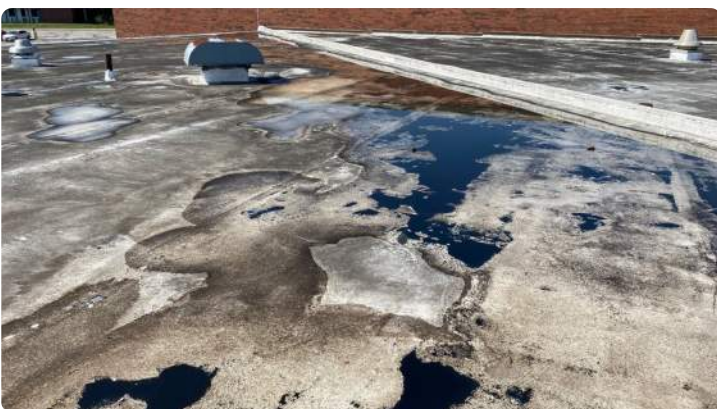
Photo showing deteriorating coating.

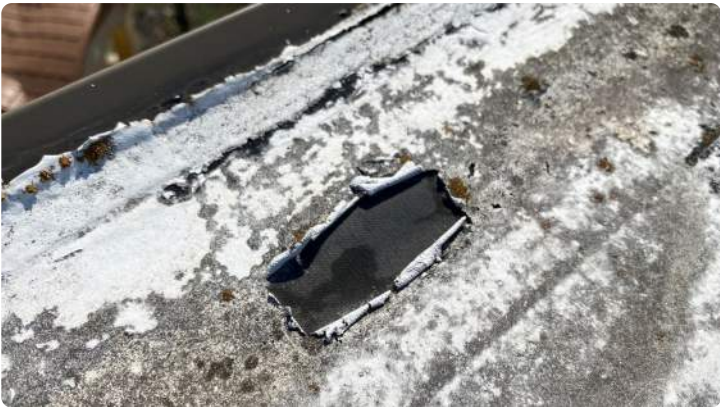
Photo showing deteriorating coating.

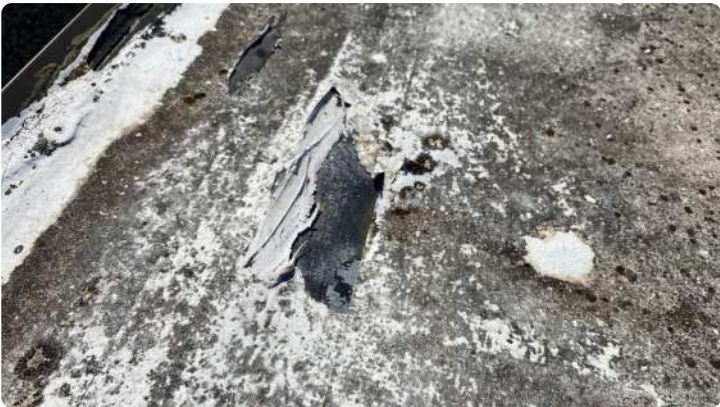
Photo showing deteriorating coating.

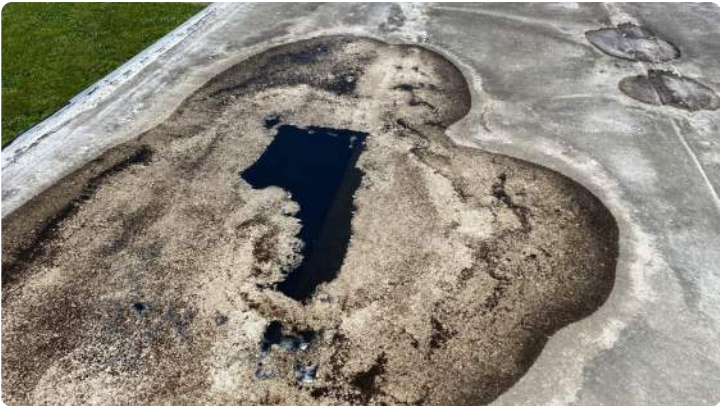
Photo showing deteriorating coating.

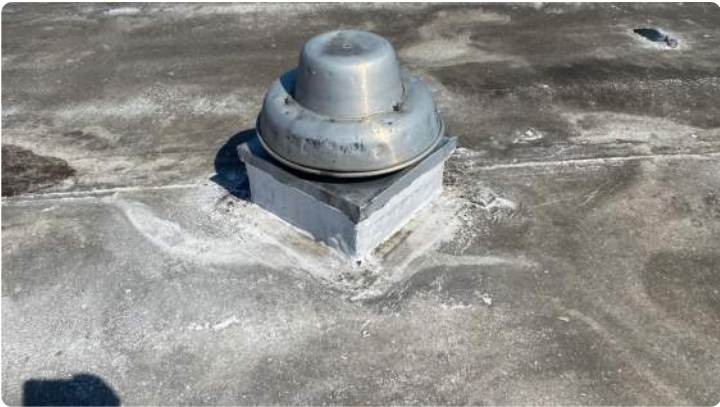
Photo showing condition of the projection flashings.

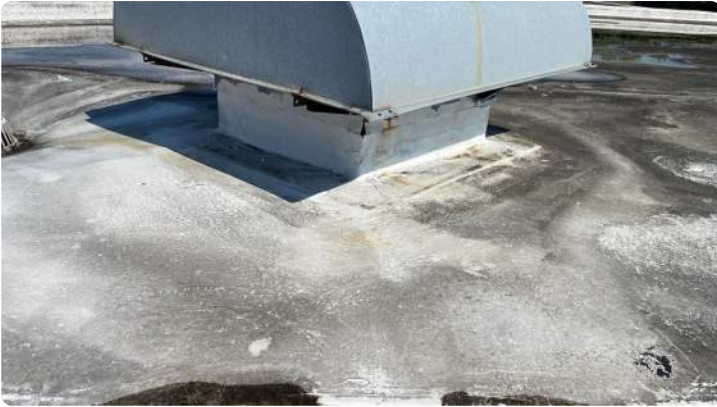
Photo showing condition of the projection flashings.

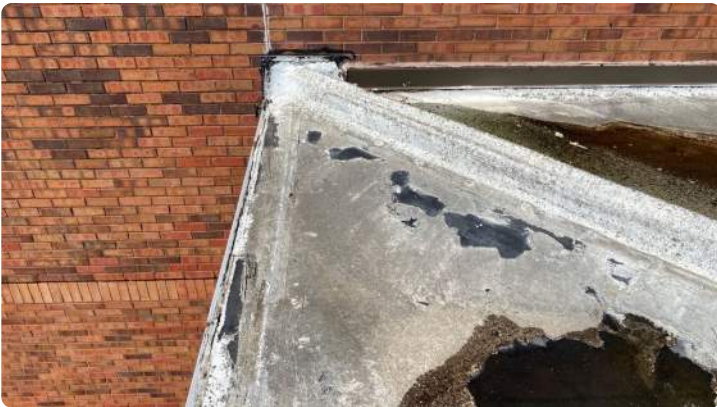
Photo showing condition of the perimeter flashings.

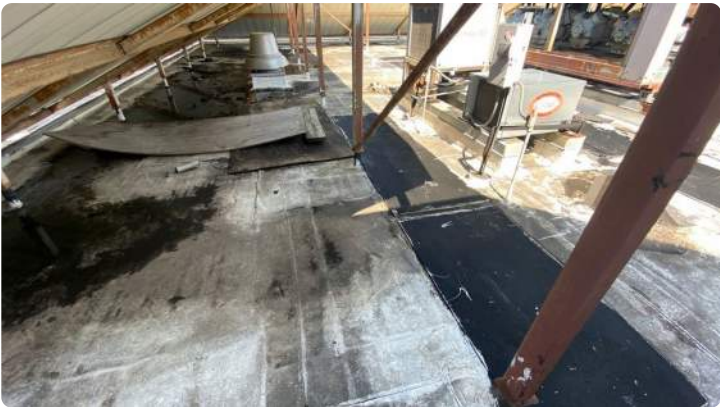
Coating is peeling up and the field is ponding water under the metal panels

Photo showing overview of Area 03 roof.

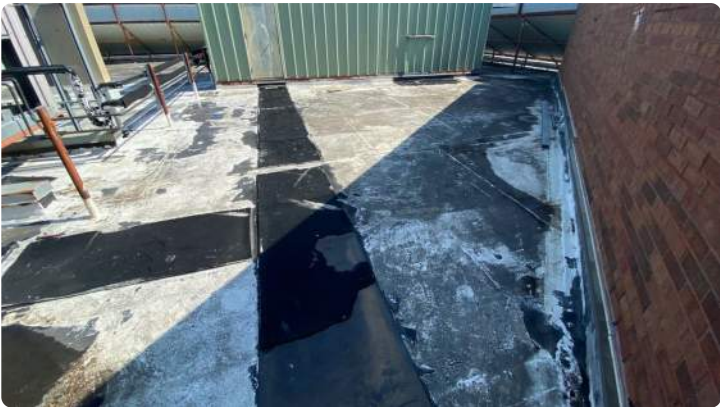
Photo showing area with loose membrane.

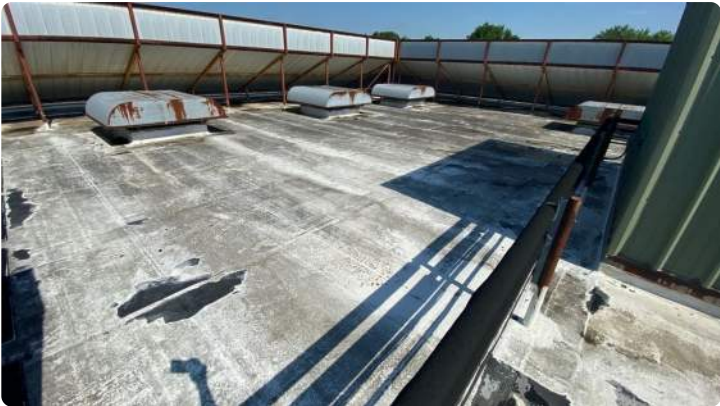
Photo showing additional overview of Area 03 roof.

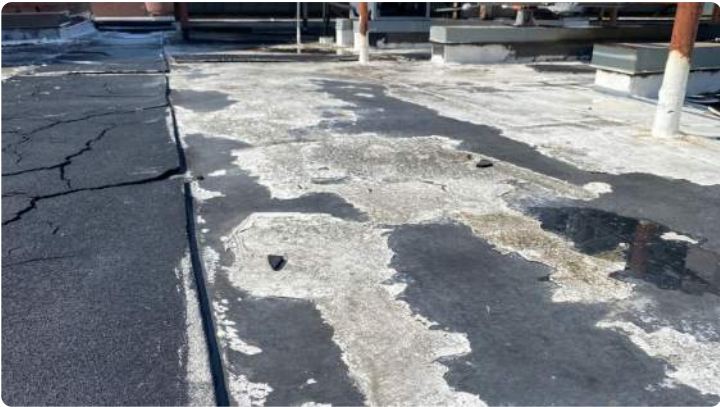
Cover board pushing up

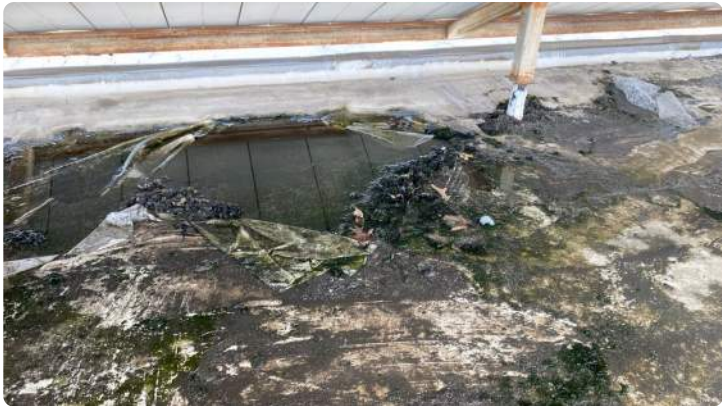
Photo showing coating deteriorating under awning.

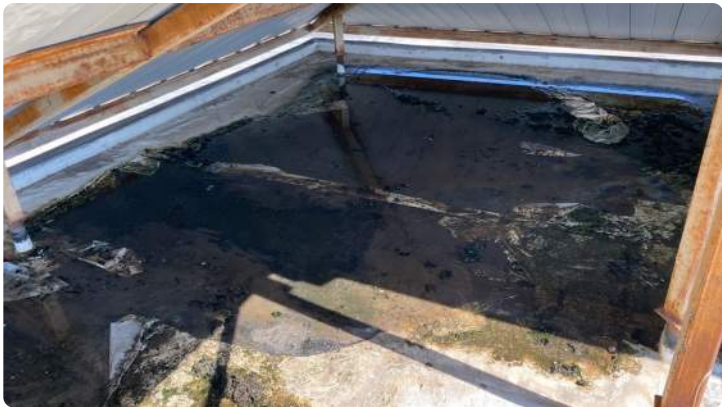
Photo showing ponding water under awning.

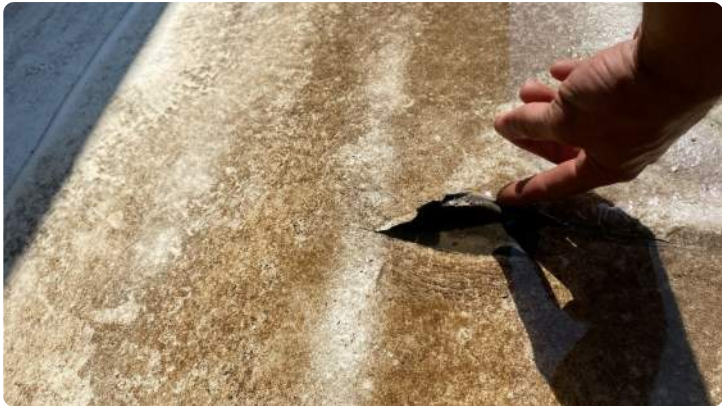
Photo showing coating pulling up.

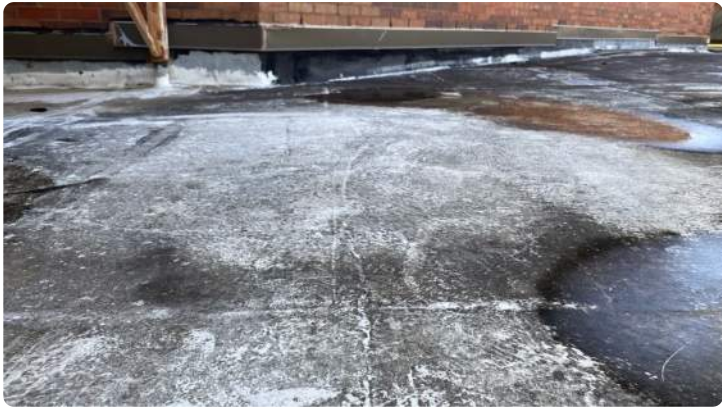
Cover board pushing up

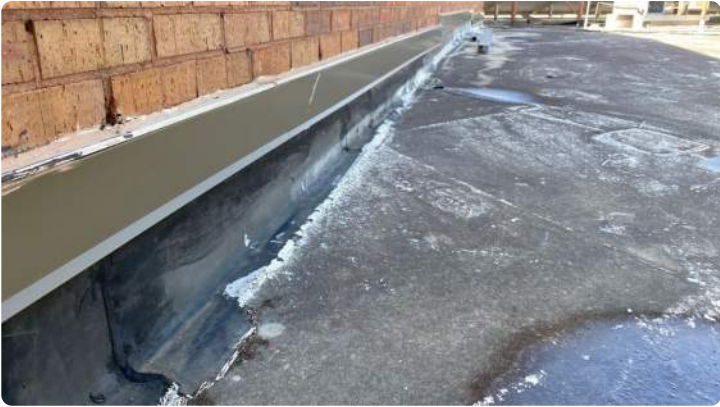
Photo showing condition of the perimeter flashings.

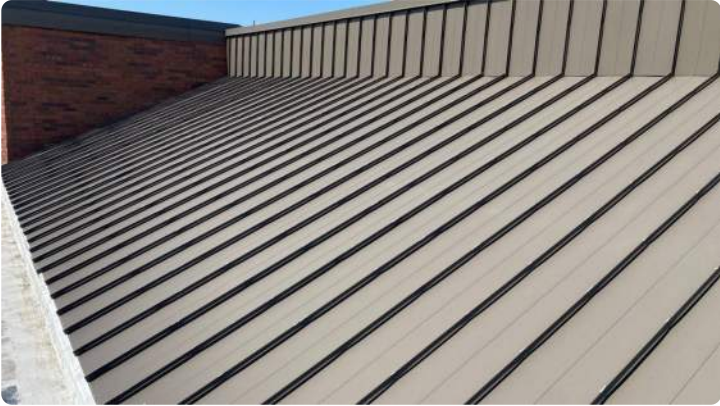
Photo showing condition of the metal awning.

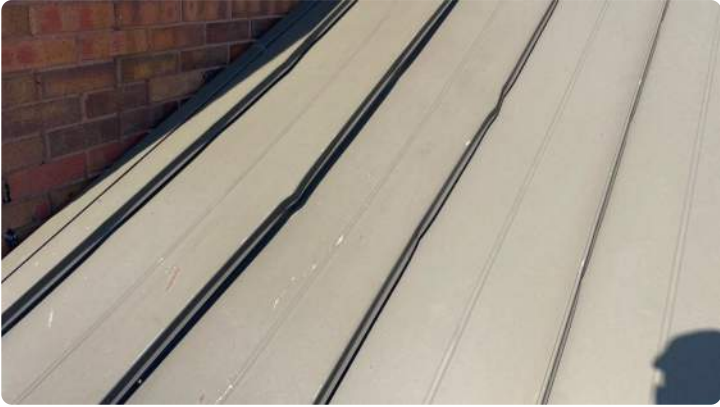
Photo showing additional condition of the metal awning.

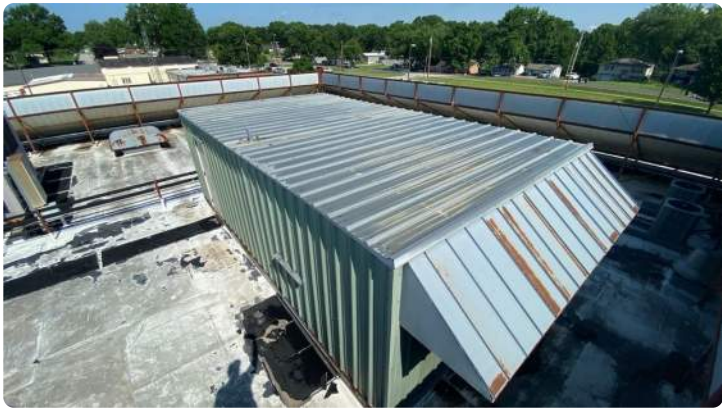
Photo showing condition of the central metal penthouse.

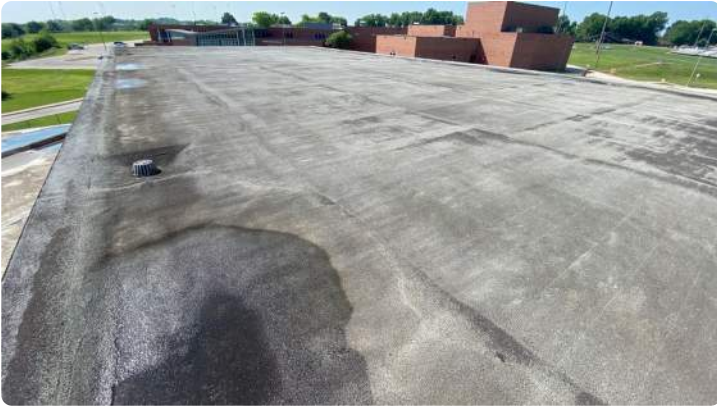
This roof is nearing the end of its useful life but appears to be performing currently

Photo showing overview of Area 04 roof.

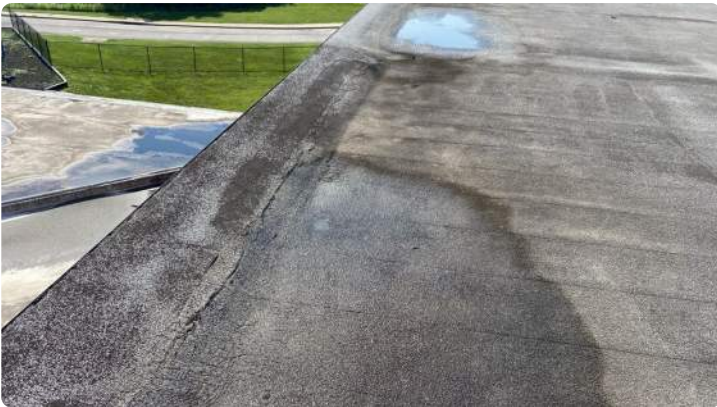
Photo showing condition of the perimeter flashings.

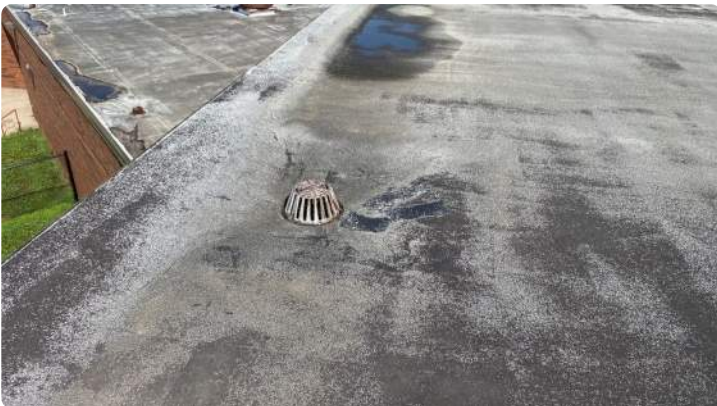
Photo showing condition of the drain.

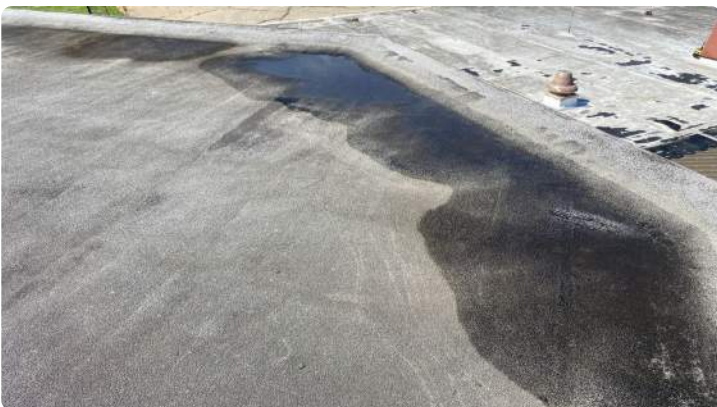
Photo showing minor ponding water along perimeter.

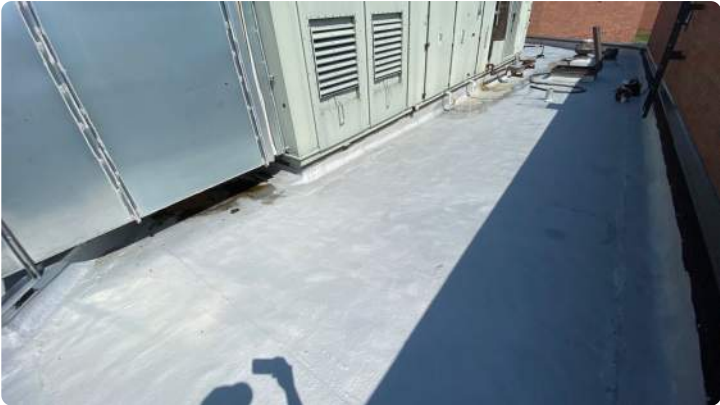
Minor bubbles in coating

Photo showing overview of Area 01 roof.

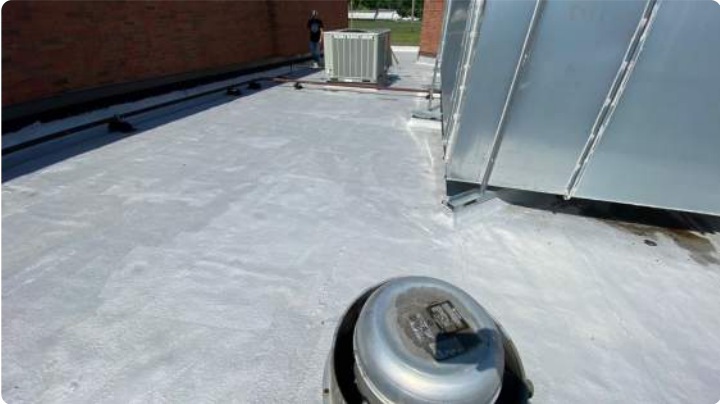
Photo showing additional overview of Area 01 roof.

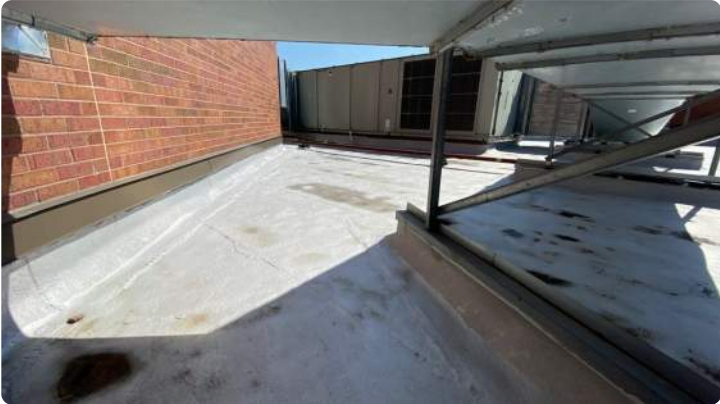
Photo showing condition of the perimeter flashings.

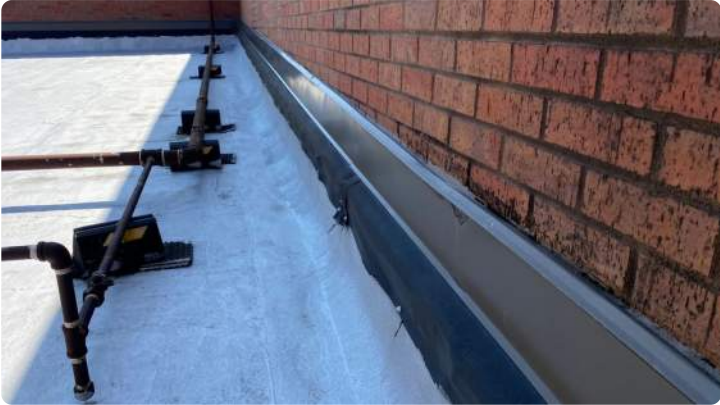
Photo showing minor blistering in field.

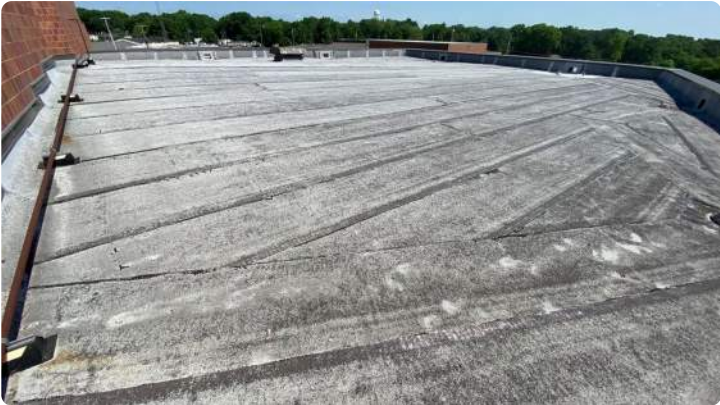
Photo showing skim showing through deteriorated roof.

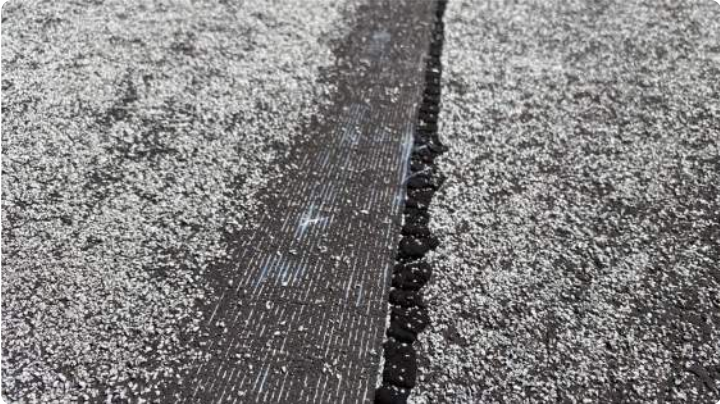
Additional photo showing skim showing through deteriorated roof.

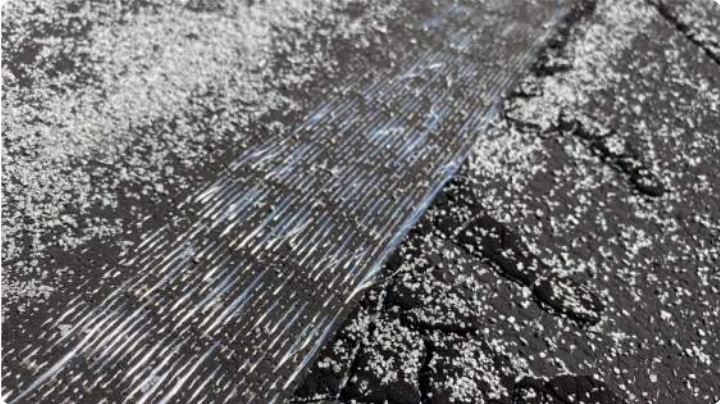
Photo showing wrinkles around drain and deteriorated field.

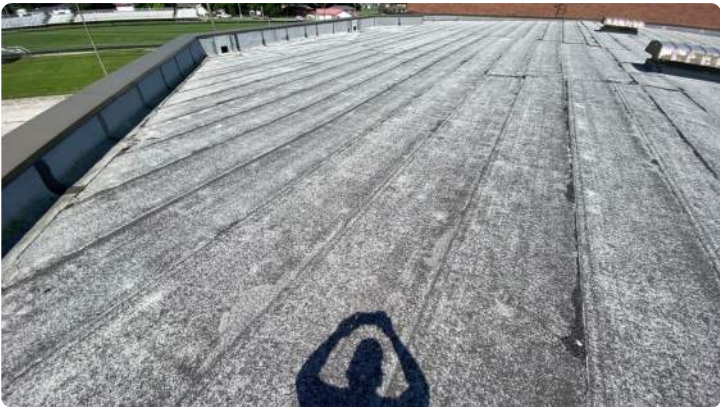
Photo showing skrim showing through deteriorated roof at seams.

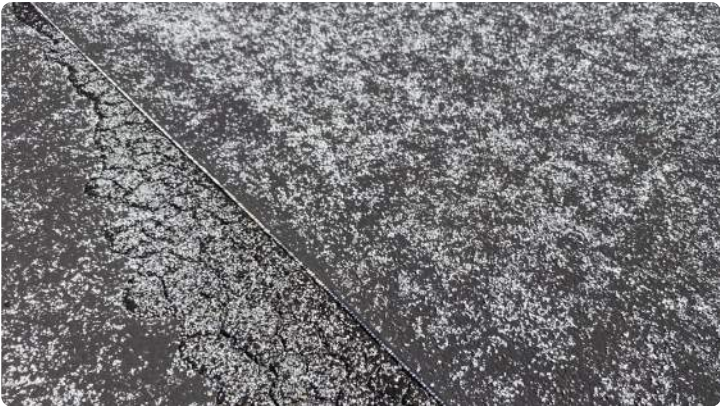
Photo showing skrim showing through deteriorated roof.
