## 2024 LANSING PUBLIC SCHOOL CONDITION MAP

## Lansing KS Financial Summary Overview

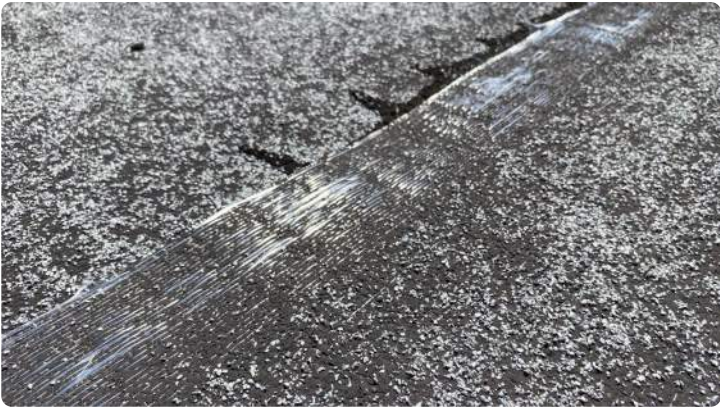
Photo showing granules from deteriorated roof piling up around drain.

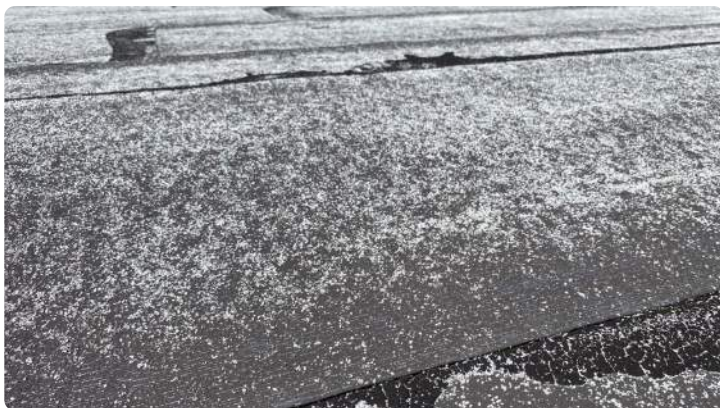
Photo showing scrim showing through deteriorated roof.

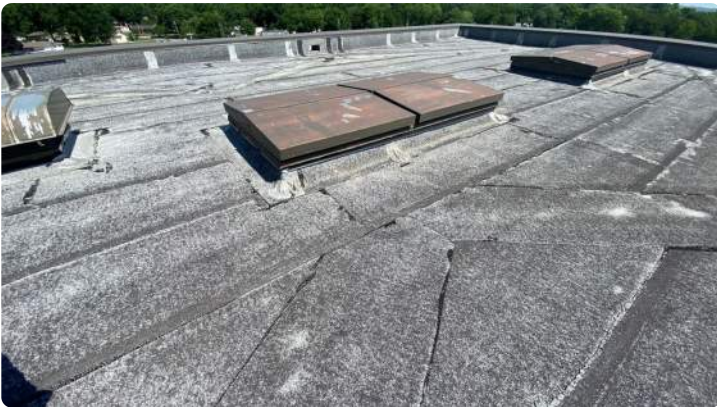
Photo showing scrim showing through deteriorated roof.

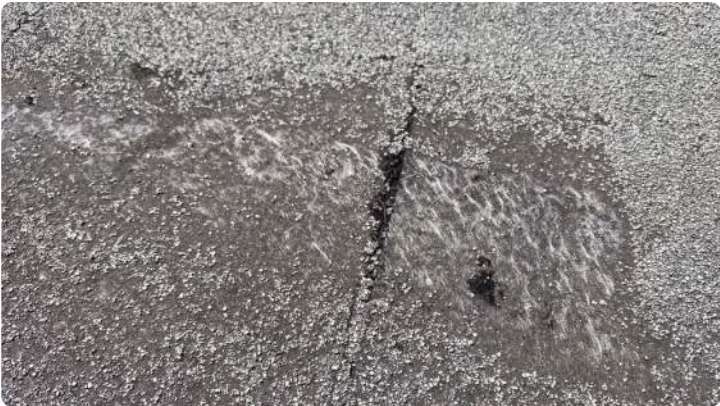
Photo showing scrim showing through deteriorated roof.

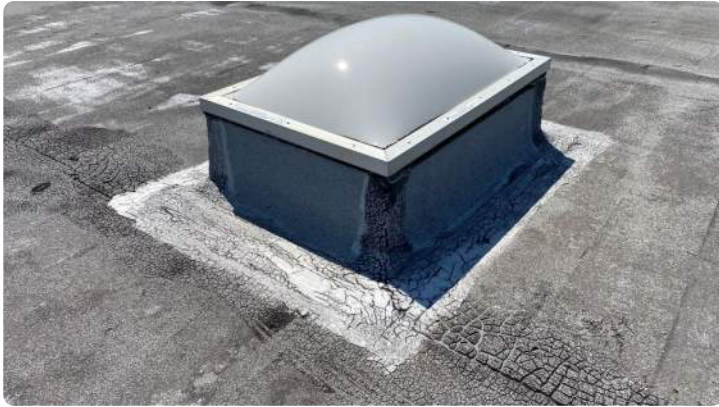
Photo showing condition of projection flashings.

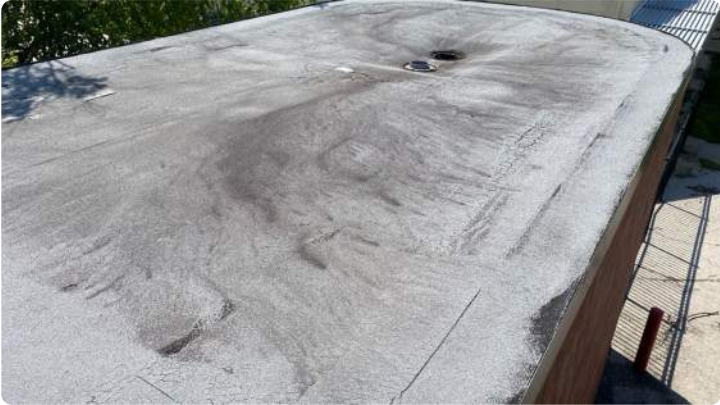
Photo showing alligatoring and a hole in the field.

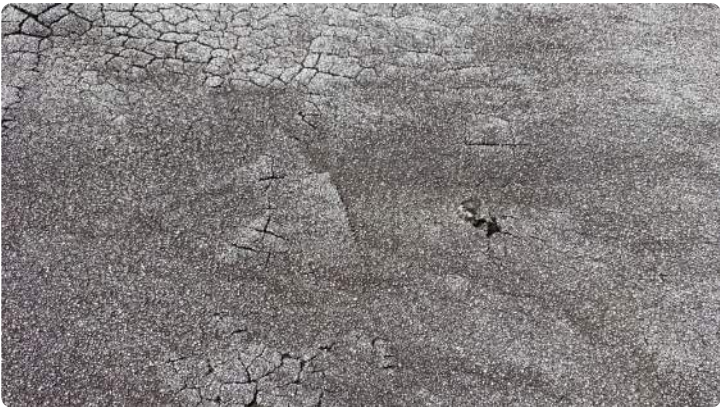
Photo showing condition of drain in small section.

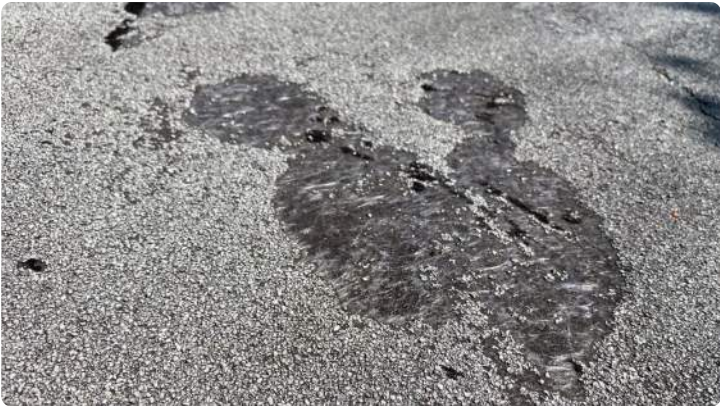
Photo showing skim showing through deteriorated roof.

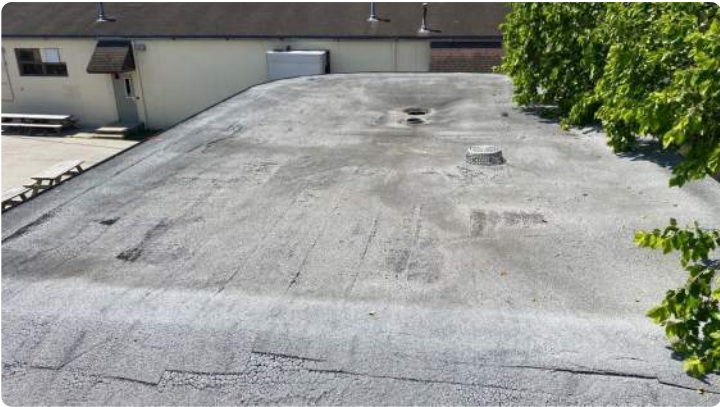
Photo showing overview of small roof section.

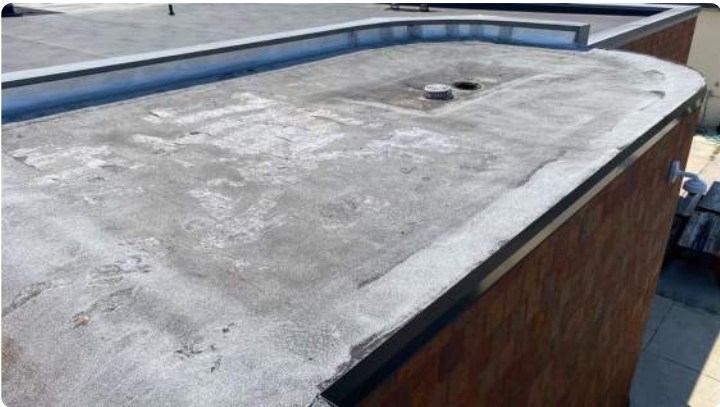
Photo showing overview of additional small roof section.

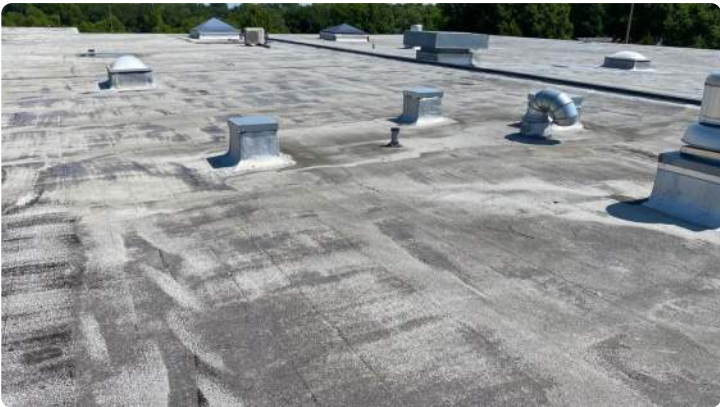
Photo showing skim showing through deteriorated roof.

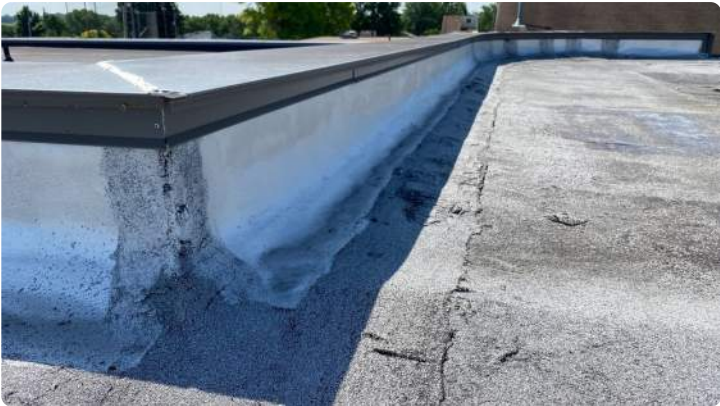
Photo showing condition of the perimeter flashings.

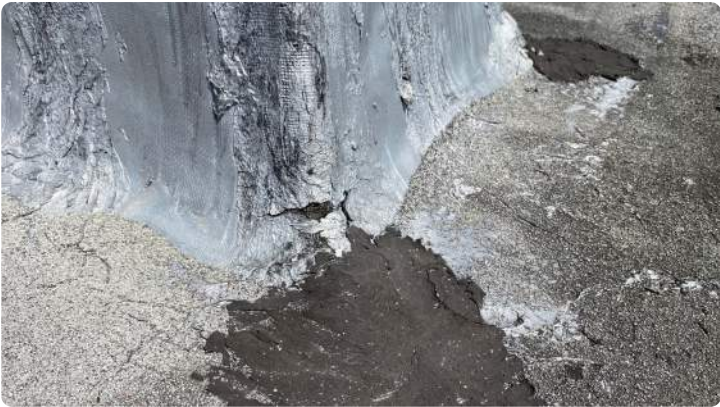
Photo showing deteriorating projection flashings.

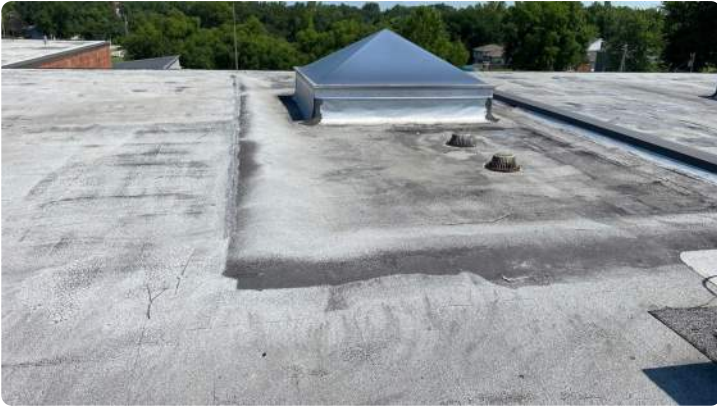
Photo showing condition of small expansion joint section.

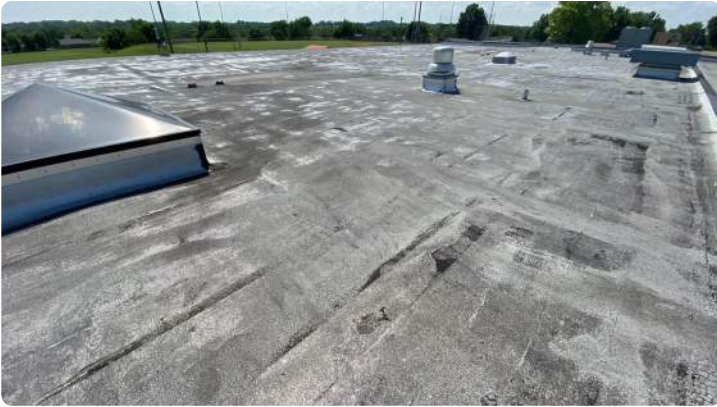
Poor condition, high priority

Skrim showing, cap sheet deteriorating, good slope, blistering, Hypalon flashings failing

Photo showing overview of Area 08 roof.

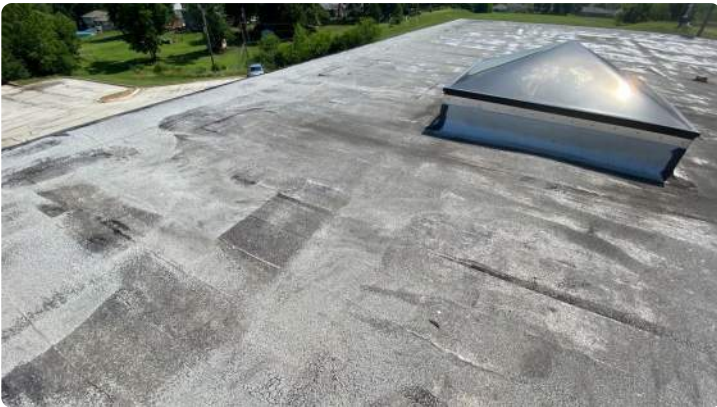
Photo showing additional overview of Area 08 roof.

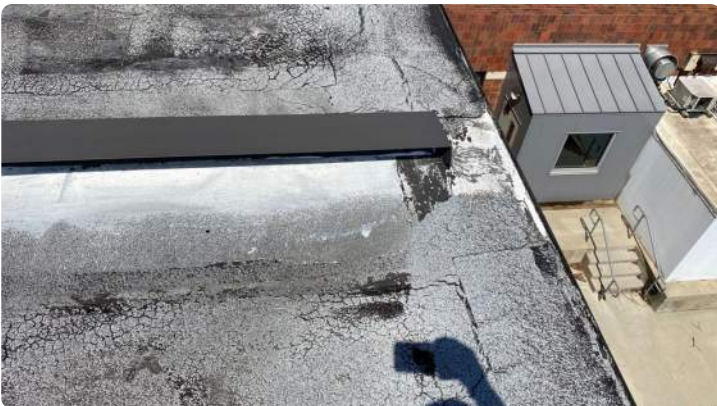
Photo showing condition of expansion joint.

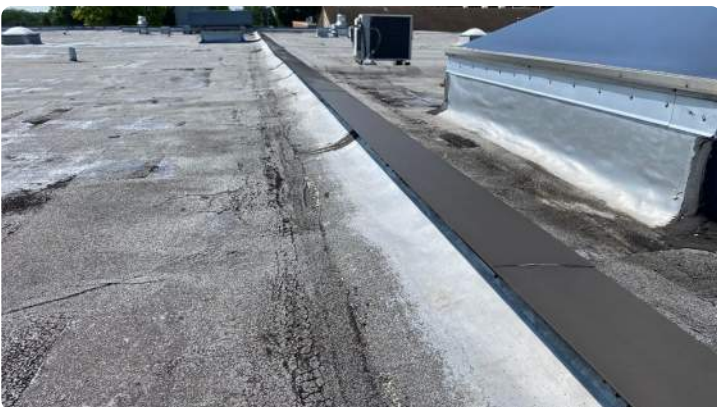
Photo showing condition of the perimeter flashings.

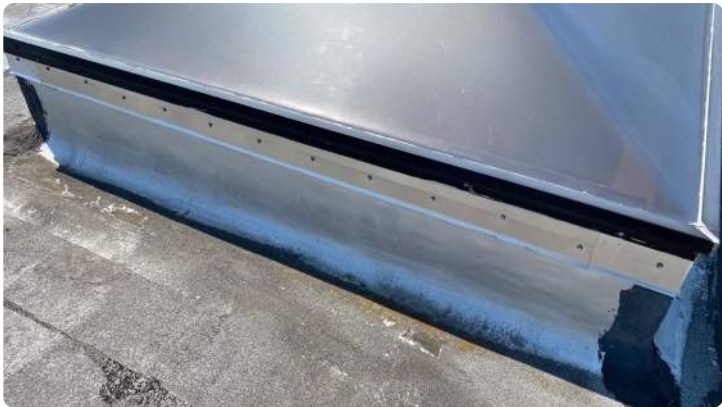
Photo showing condition of the skylight flashings.

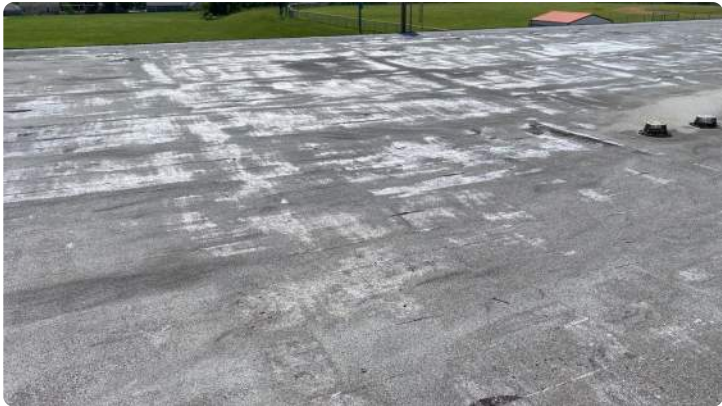
Photo showing scrim showing through deteriorated roof.

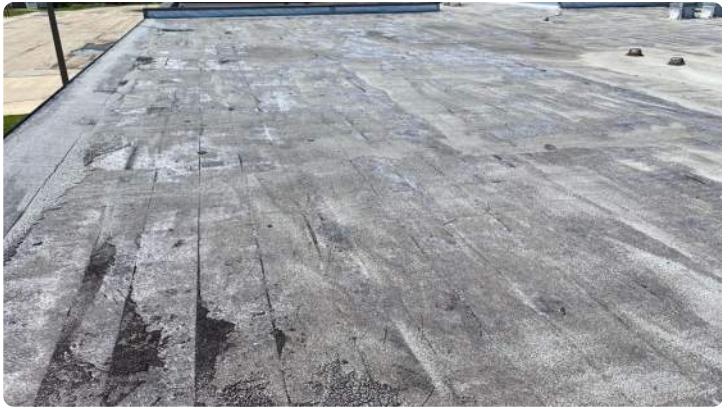
Photo showing scrim showing through deteriorated roof.

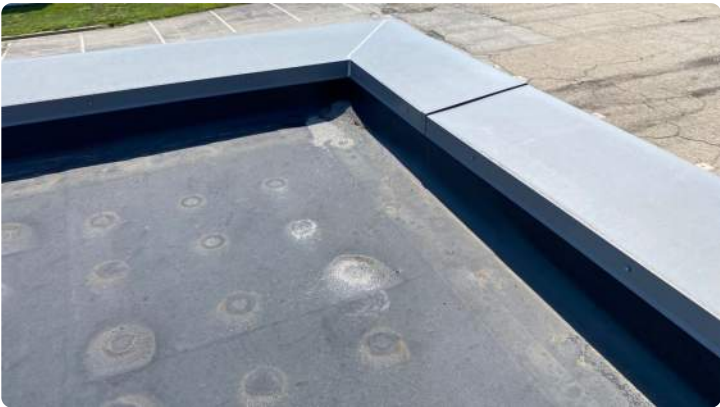
Minor delaminating along perimeter flashings

Photo showing condition of the perimeter flashings.

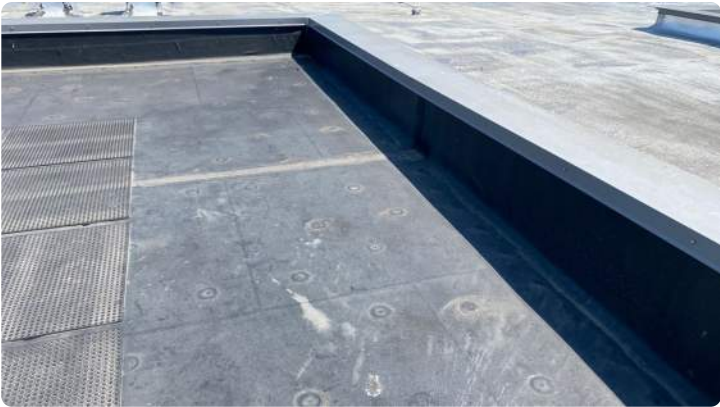
Photo showing condition of the perimeter flashings.

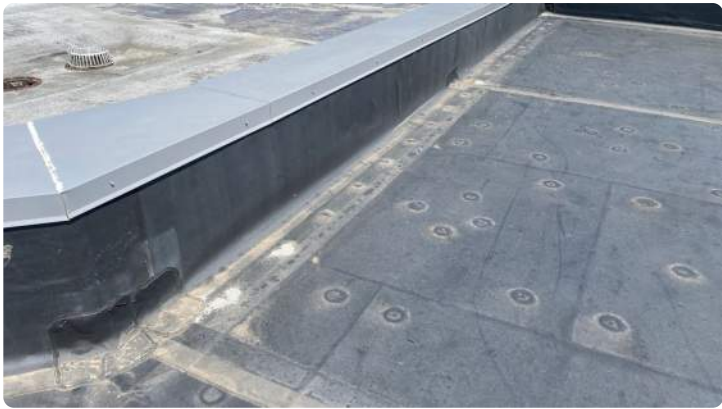
Photo showing condition of the perimeter flashings.

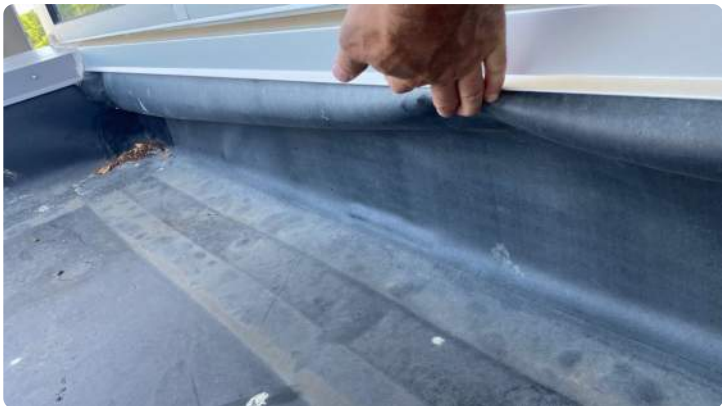
Minor delamination in perimeters, multiple previous holes patched

Photo showing loose membrane along perimeter.

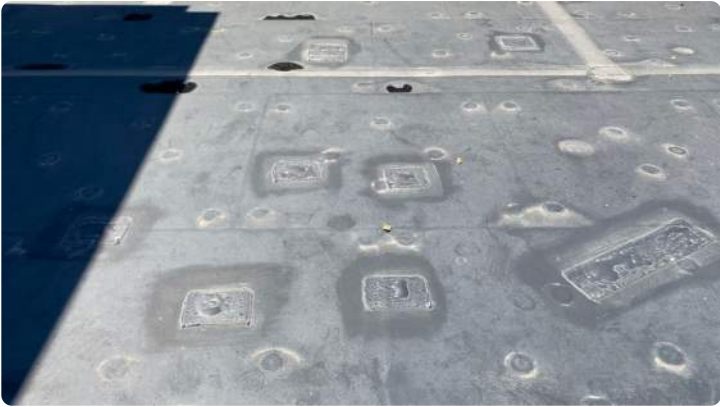
Photo showing multiple patches from previous holes.

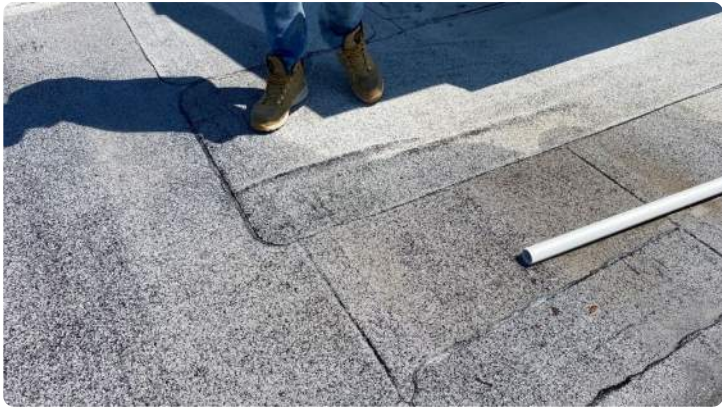
Good slope, minor blistering and ponding from unit condensation

Photo showing blistering near condensate pipe.

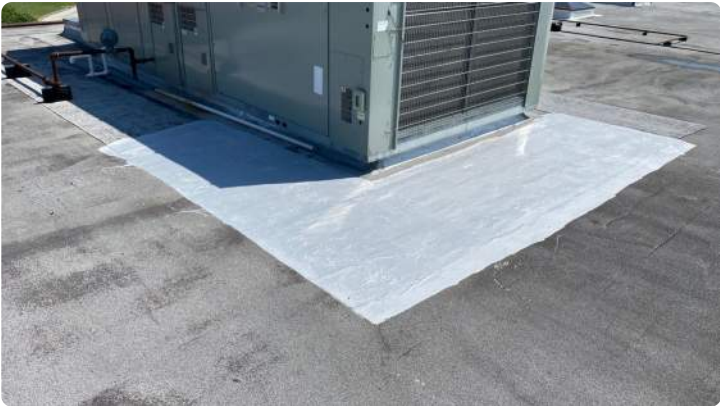
Photo showing aluminum coated area around projection.

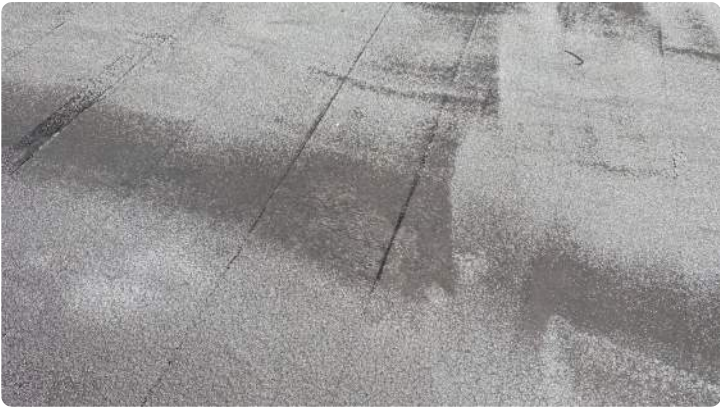
Photo showing scrim showing through deteriorated roof and loose granules piling up from deteriorated roof.

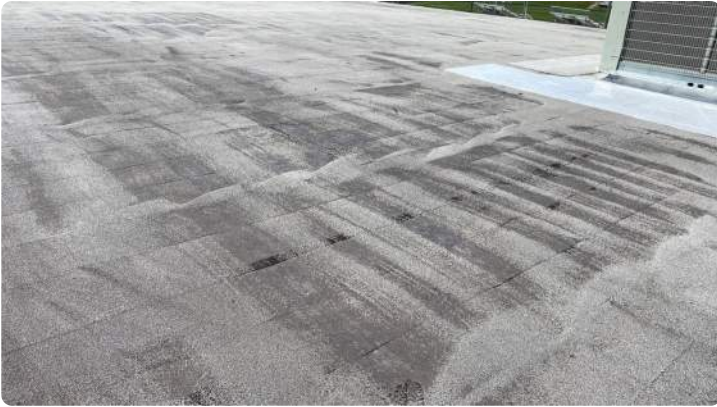
Photo showing scrim showing through deteriorated roof.

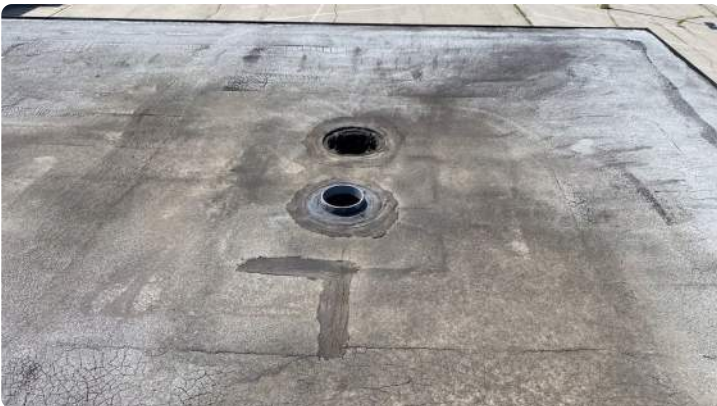
Photo showing drain with and overflow drain cap.

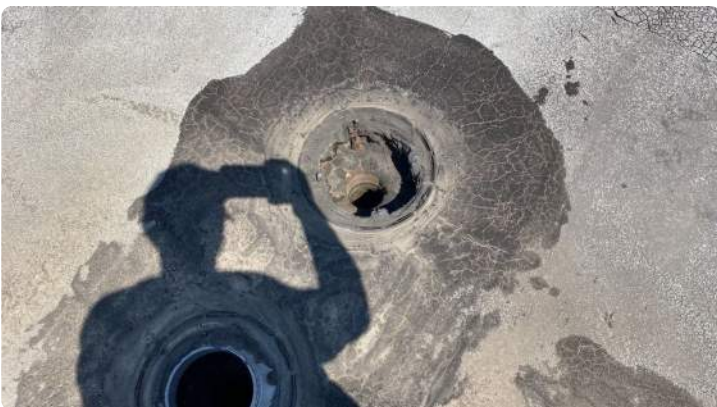
Photo showing condition of the drain missing a strainer.

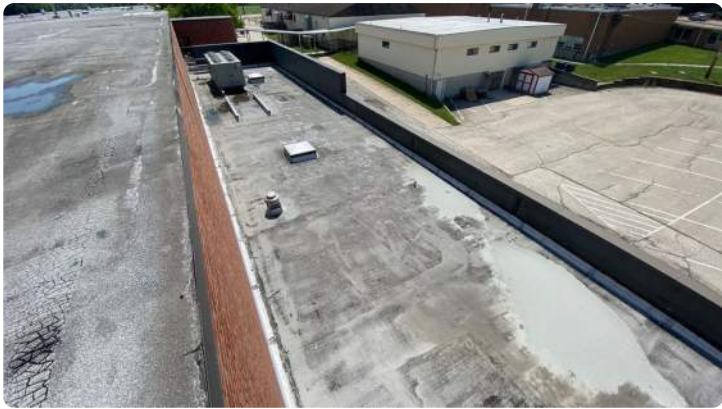
Poor condition

Skrim showing, cap sheet deteriorating, granules piling up in drain valley, good slope, blistering, Hypalon flashings failing

Photo showing overview of Area 14 roof.

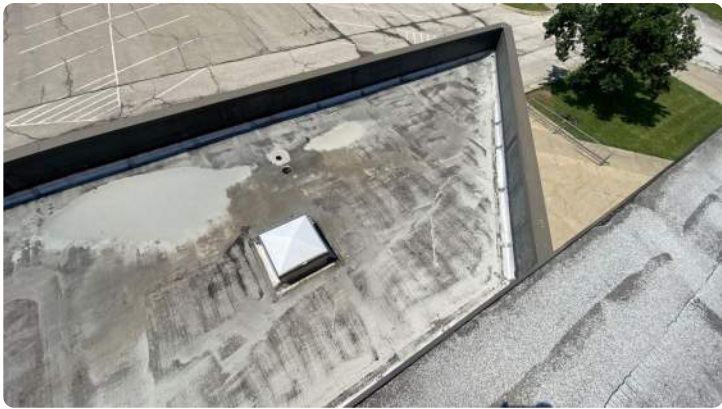
Photo showing additional overview of Area 14 roof.

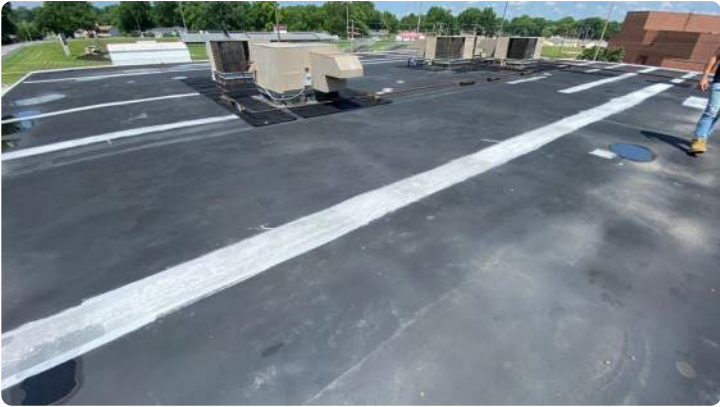
Poor condition

This roof does not appear to be performing well

Photo showing overview of Area 15 roof.

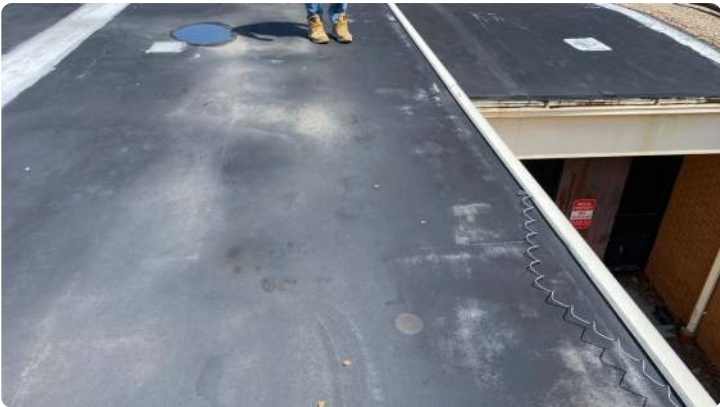
Photo showing area of EPDM pushing up.

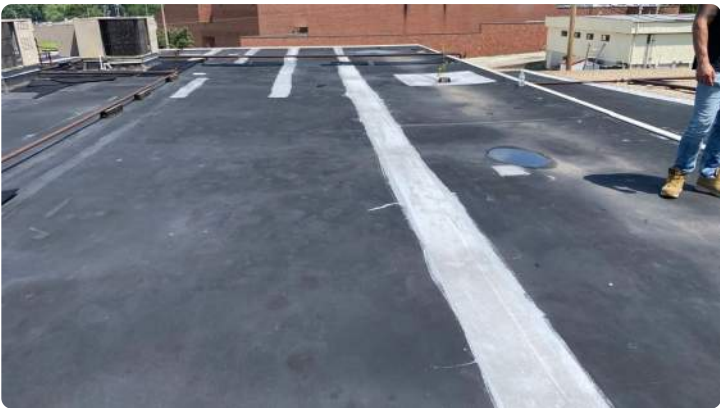
Photo showing a seam coated on EPDM membrane.

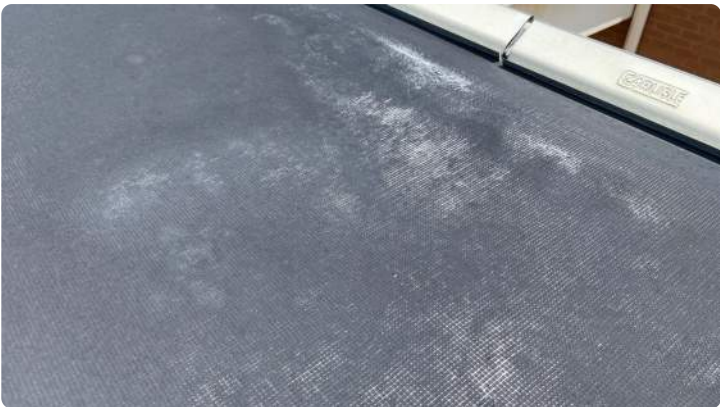
Photo showing skrum showing through deteriorated roof membrane.

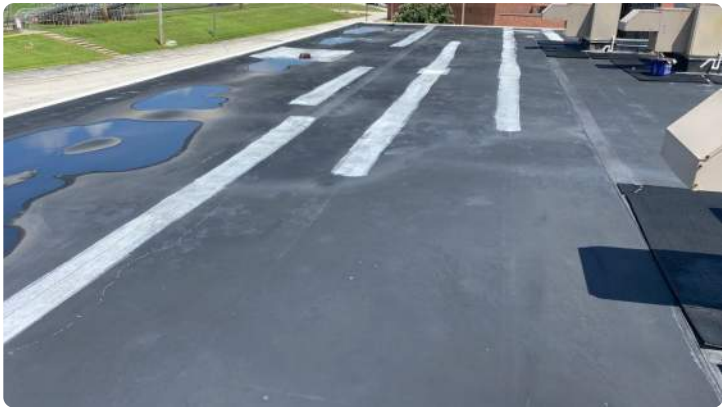
Photo showing additional coated seams.

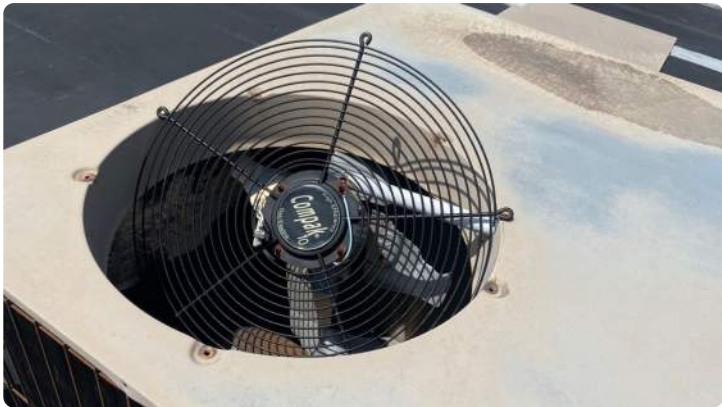
Photo showing fan on HVAC unit that is dislodged.

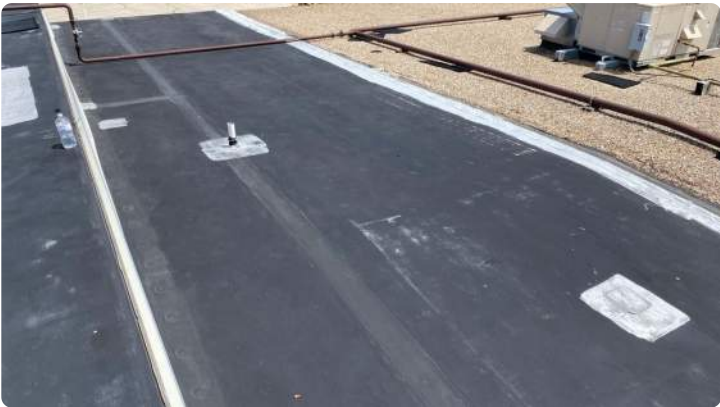
Poor condition

This roof does not appear to be performing well

Photo showing overview of Area 16 roof.

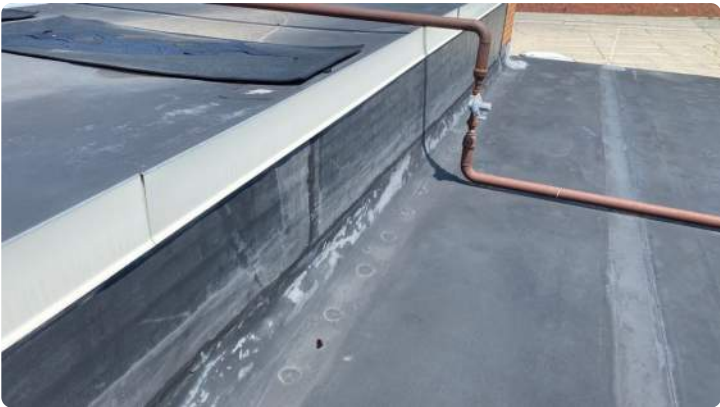
Photo showing condition of the perimeter flashings.

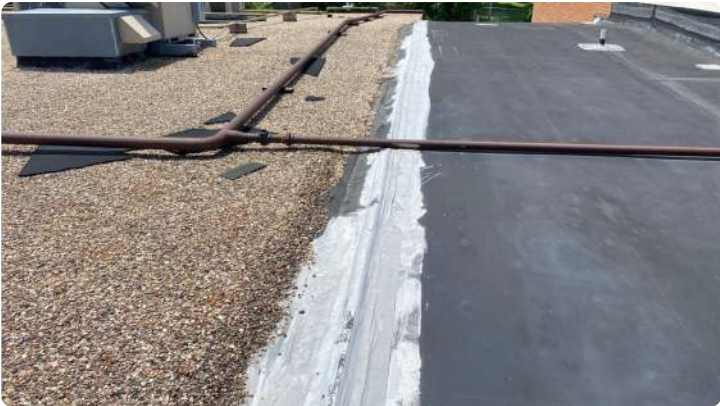
Photo showing connection from EPDM overlay with gravel BUR area.

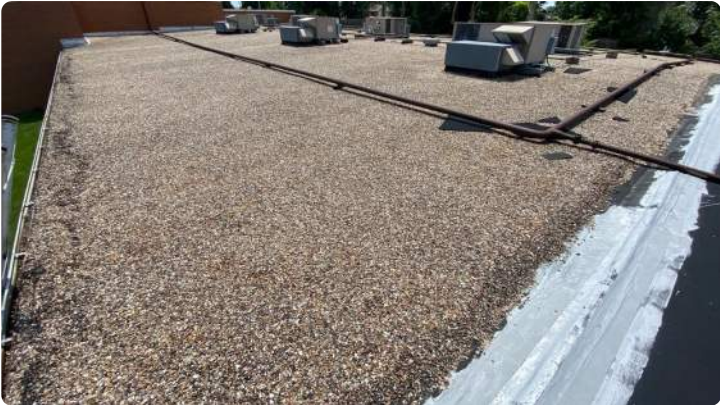
Poor condition

This roof does not appear to be performing well

Photo showing overview of Area 17 roof.

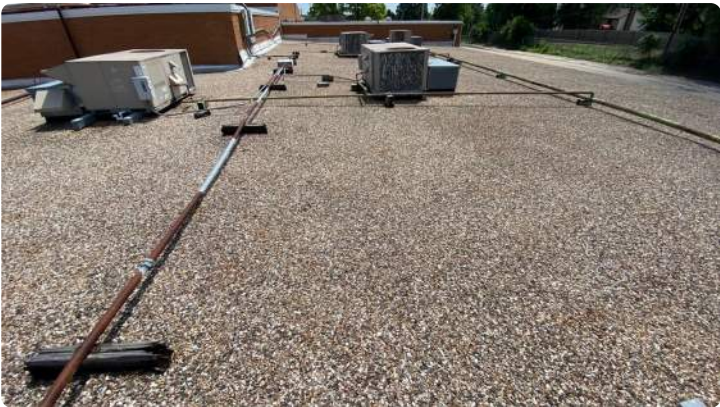
Photo showing additional overview of Area 17 roof.

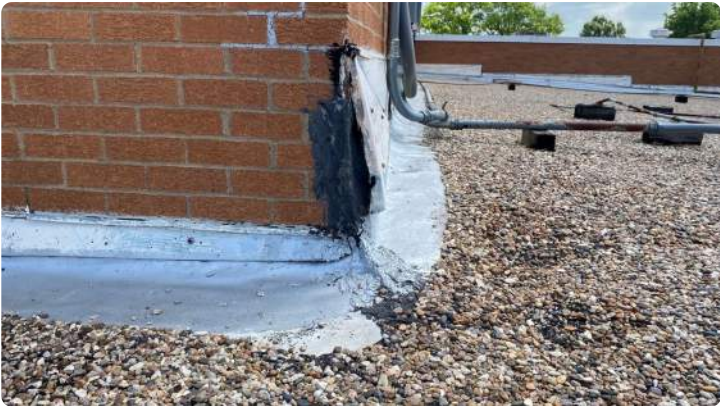
Photo showing a corner flashing that is beginning to open up.

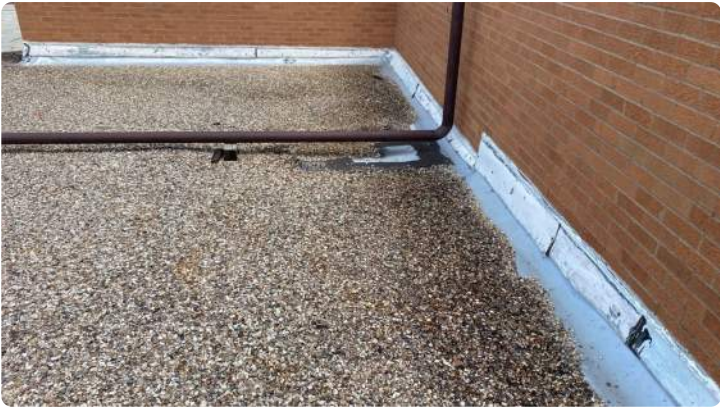
Photo showing condition of the perimeter flashings.

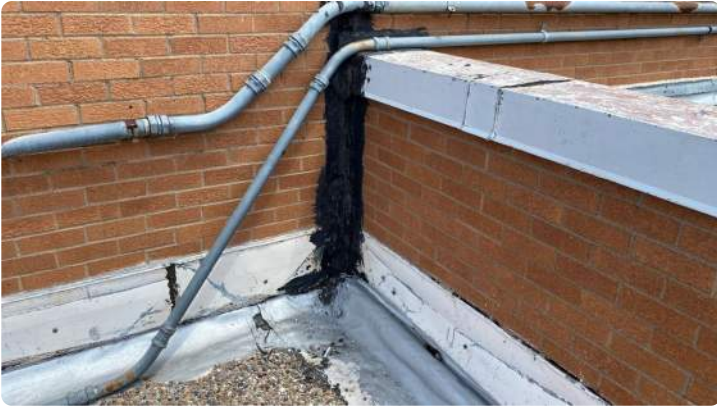
Photo showing a repair made to the corner with roofing mastic.

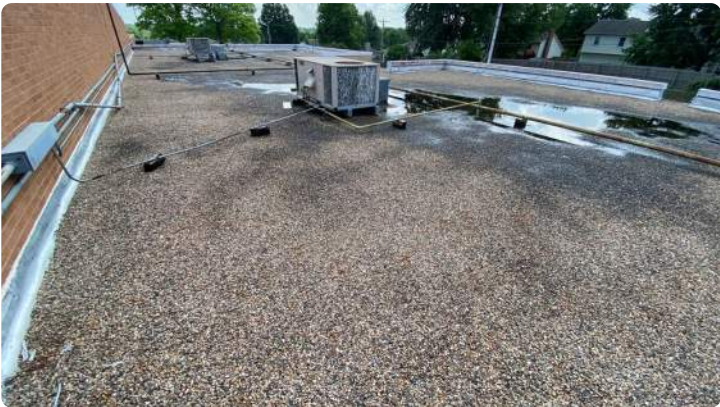
Poor condition

This roof does not appear to be performing well

Photo showing overview of Area 18 roof.

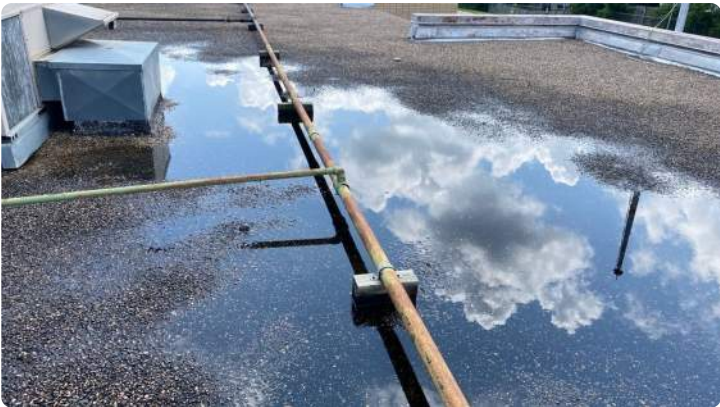
Photo showing ponding water.

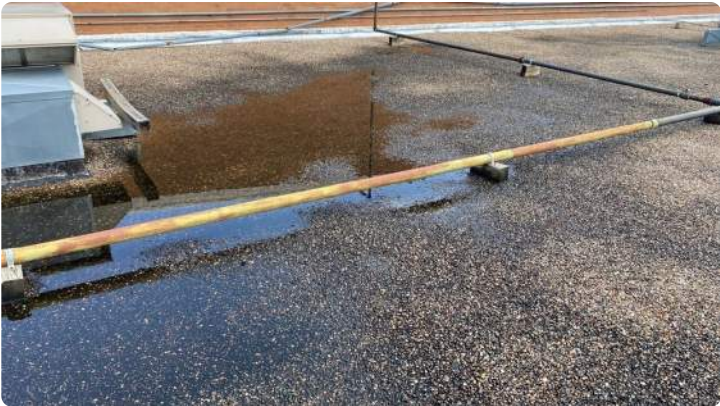
Photo showing additional ponding water.

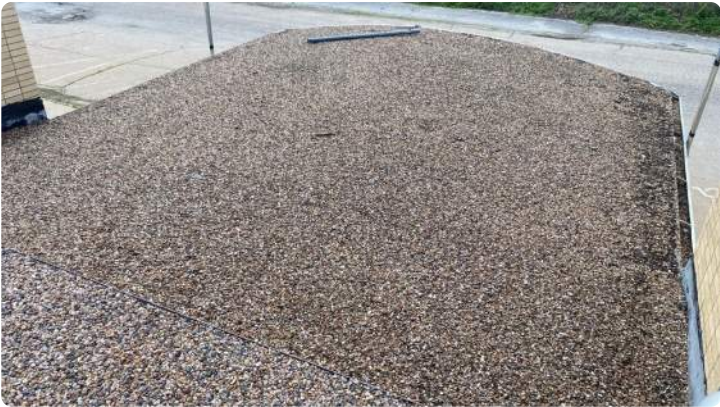
Photo showing overview of smaller section of roof.

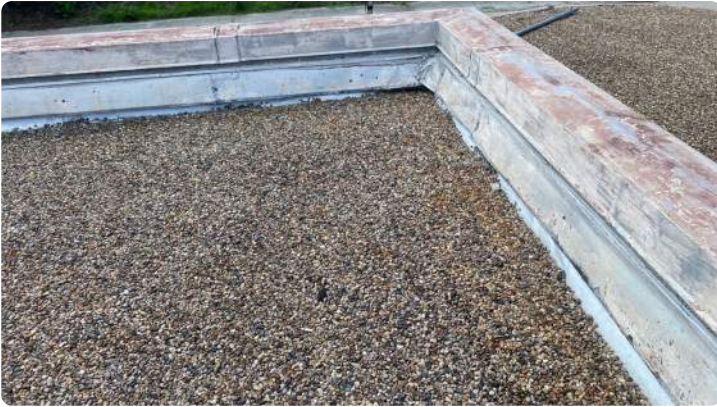
Photo showing condition of the perimeter flashings.

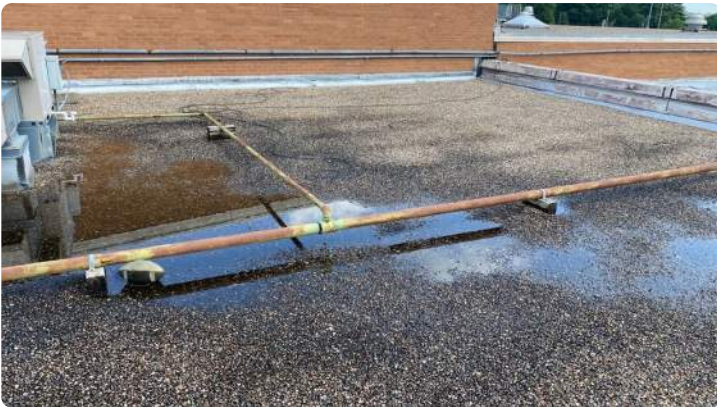
Photo showing additional ponding water.

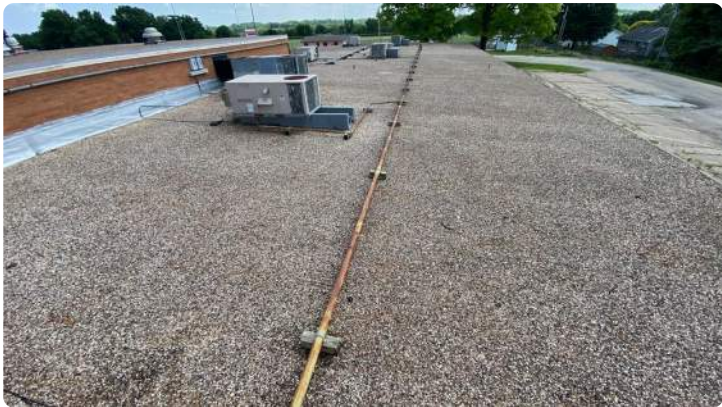
Poor condition

This roof does not appear to be performing well

Photo showing overview of Area 19 roof.

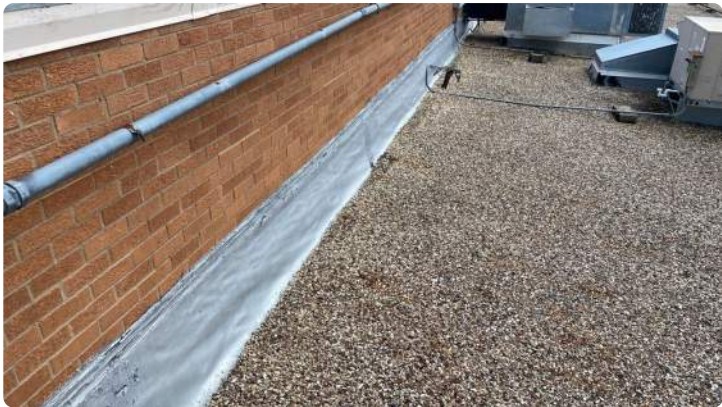
Photo showing condition of the perimeter flashings.

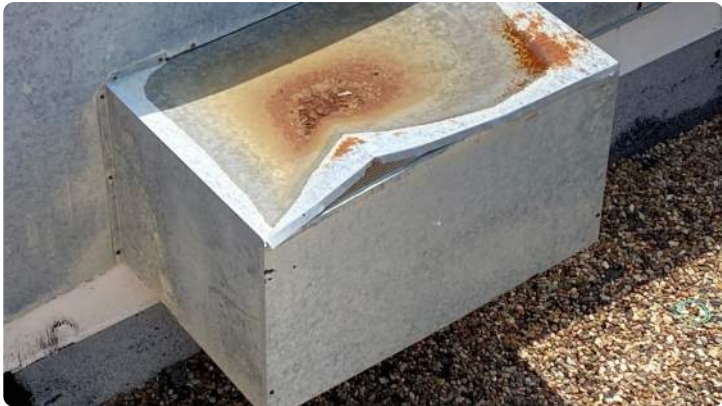
Photo showing ductwork with damaged wall open to elements.

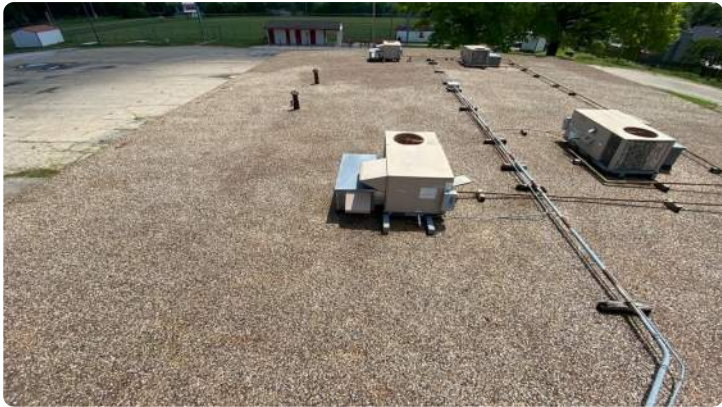
Photo showing additional overview of Area 19 roof.

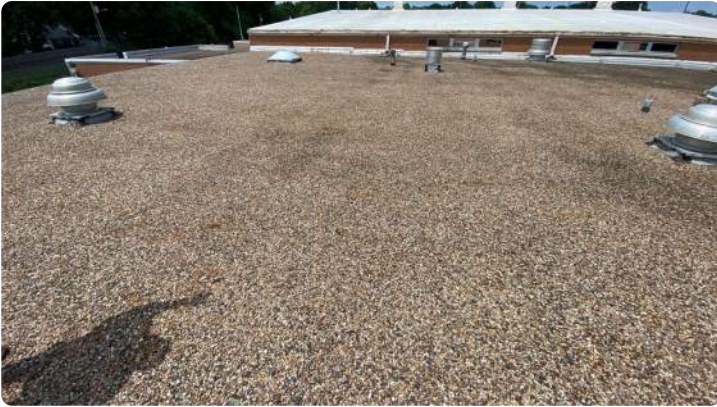
Poor condition

This roof does not appear to be performing well

Photo showing overview of Area 20 roof.

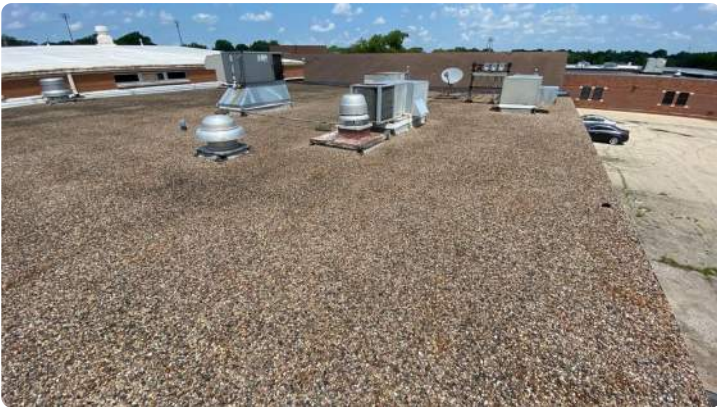
Photo showing additional overview of Area 20 roof.

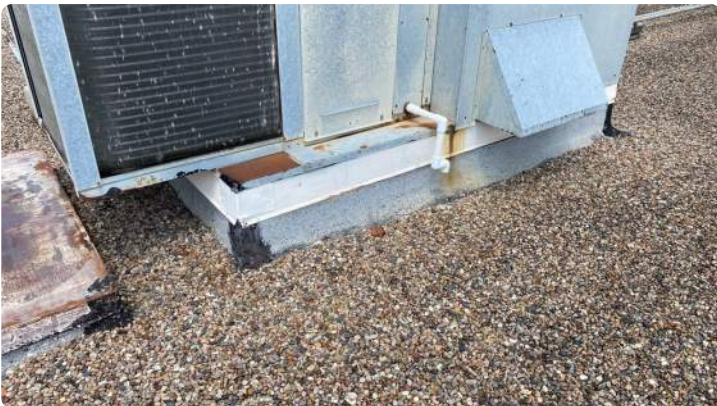
Photo showing condition of projection flashings.

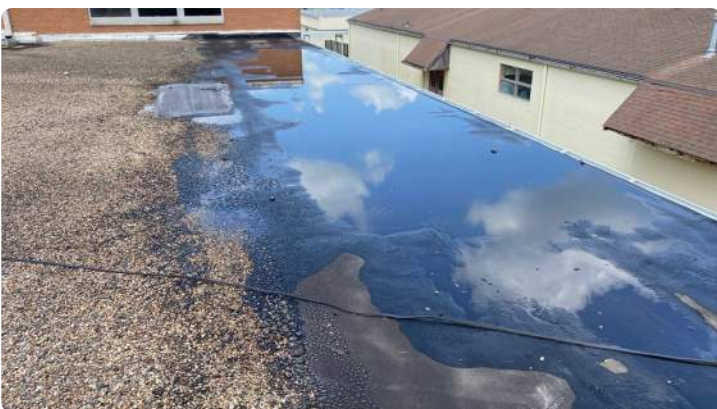
Photo showing ponding water.

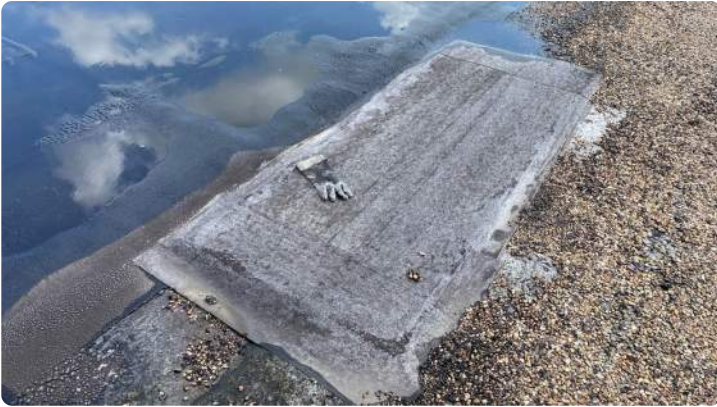
Photo showing area of gravel BUR repaired with base sheet.

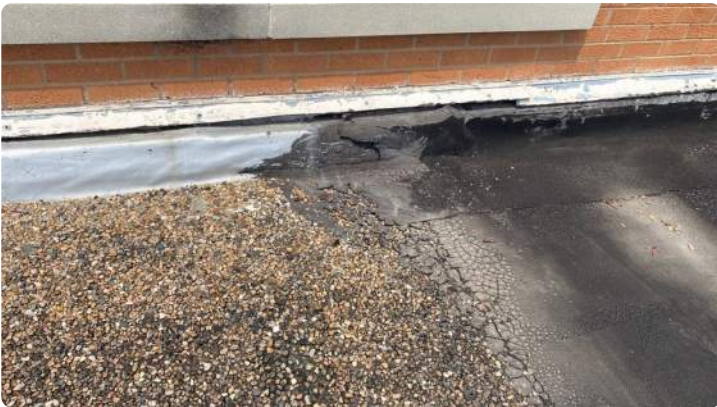
Photo showing perimeter flashing transition coated in deteriorating roofing mastic.

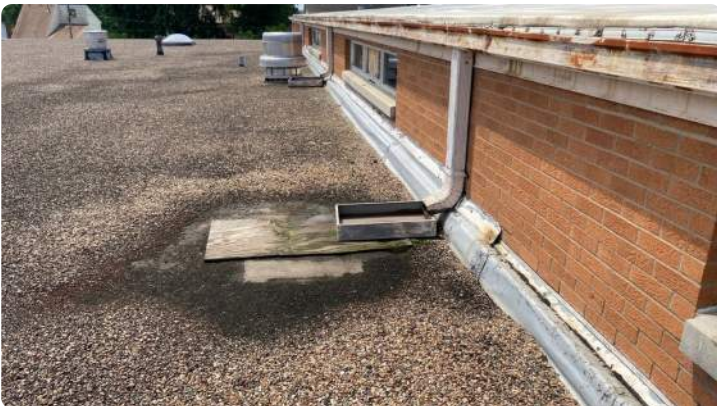
Photo showing condition of the perimeter flashings.

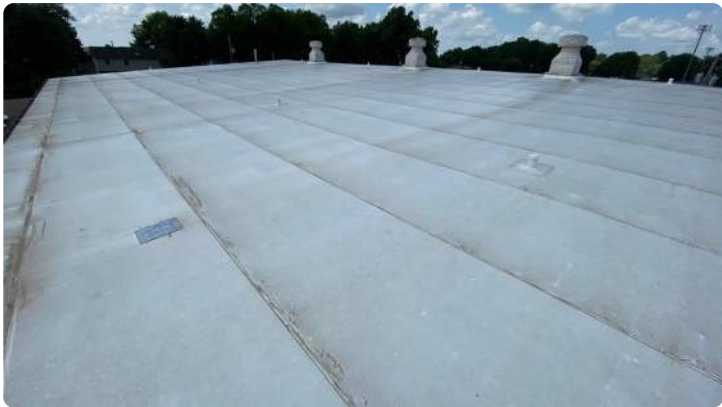
Poor condition

This roof does not appear to be performing well

Photo showing overview of Area 21 roof.

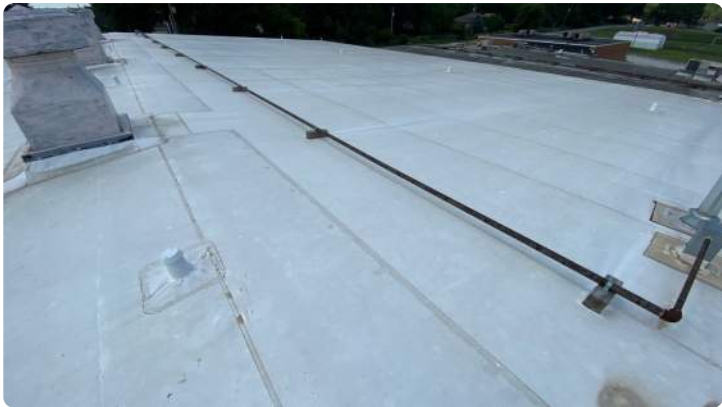
Photo showing overview of Area 21 roof.

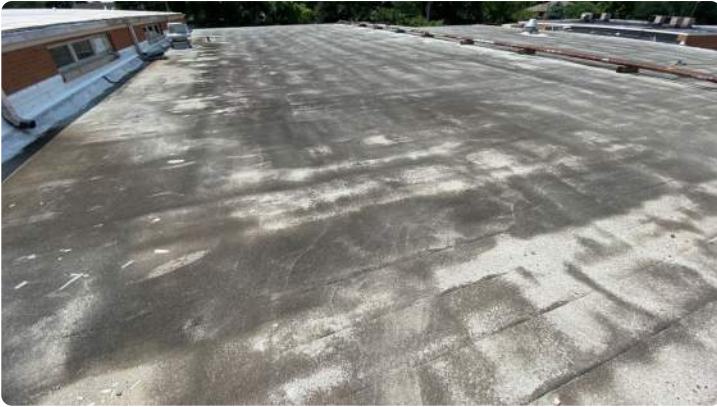
Photo showing overview of Area 22 roof.

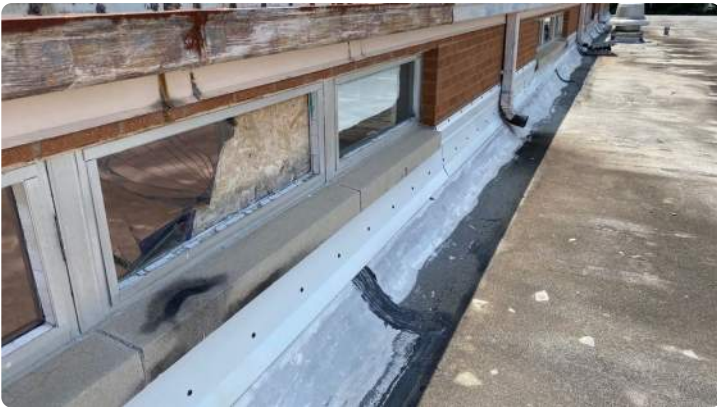
Photo showing condition of the perimeter flashings.

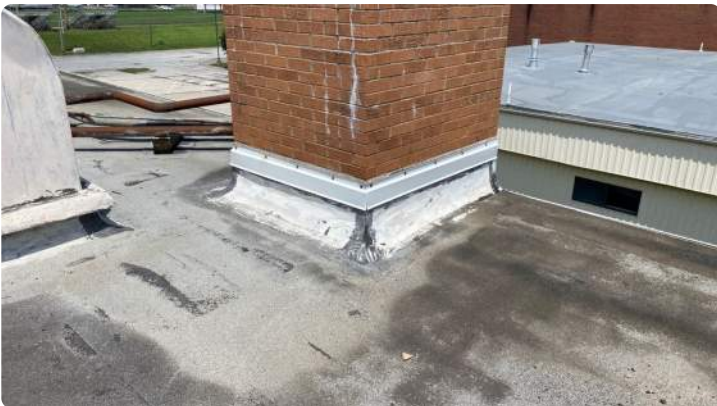
Photo showing condition of projection flashings.

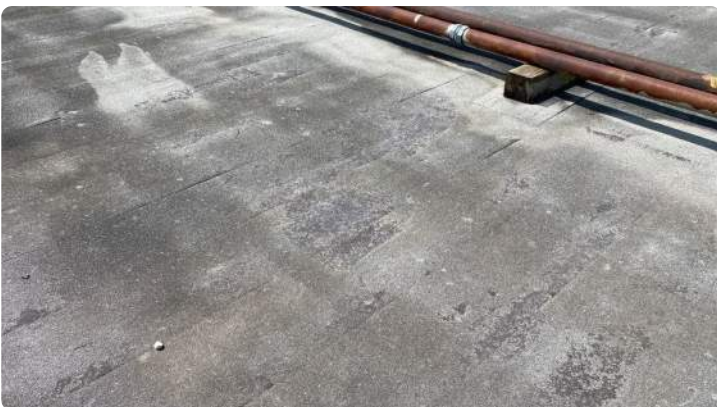
Photo showing skim showing through deteriorated roof.

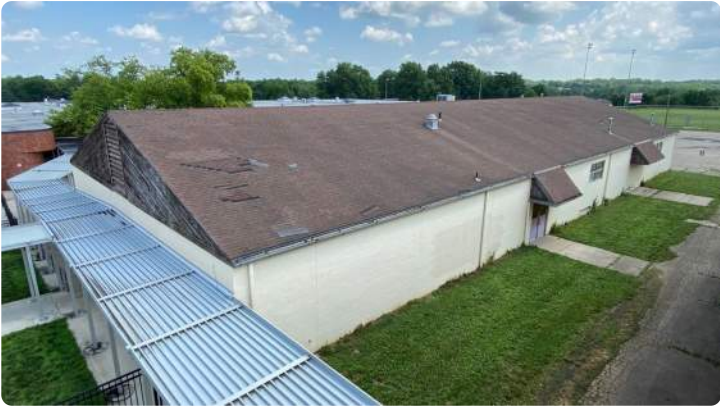
Poor condition

This roof does not appear to be performing well

Photo showing overview of Area 23 roof.

See Financial Summary for estimated replacement cost

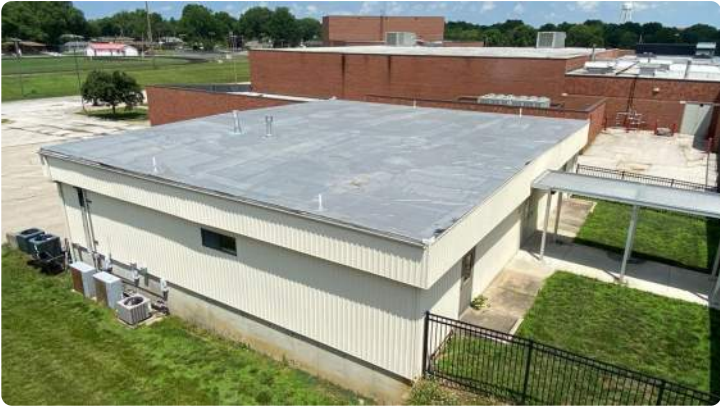
Poor condition

Aluminum coated Mod Bit

Photo showing overview of Area 24 roof.

See Financial Summary for estimated replacement cost

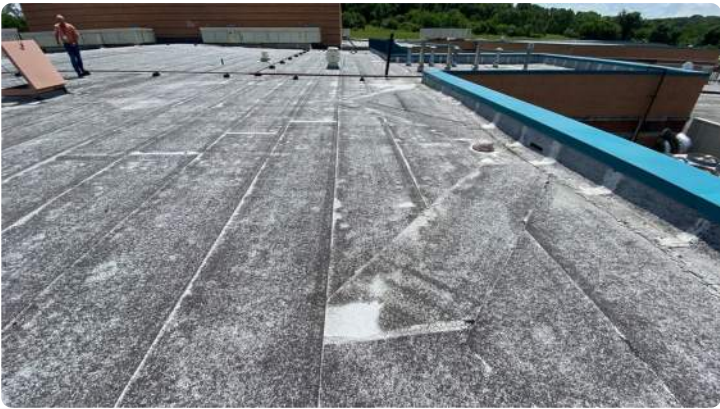
Poor condition

Soft areas, base sheet missing granules, rubber flashed interior perimeter

Photo showing overview of Area 01 roof.

See Financial Summary for estimated replacement cost
