## 2024 LANSING PUBLIC SCHOOL CONDITION MAP

## Lansing KS Financial Summary Overview

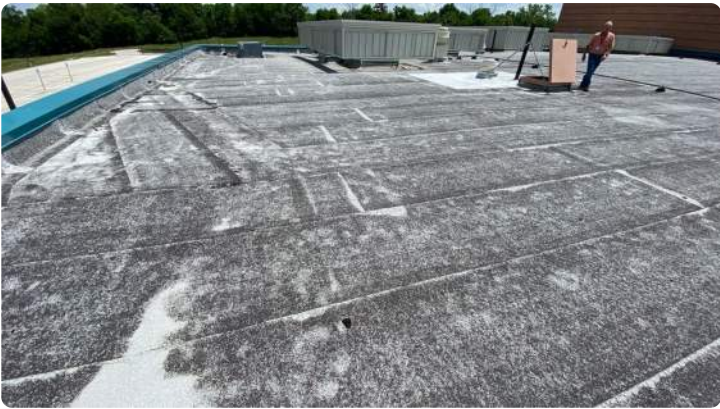
Photo showing additional overview of Area 01 roof.

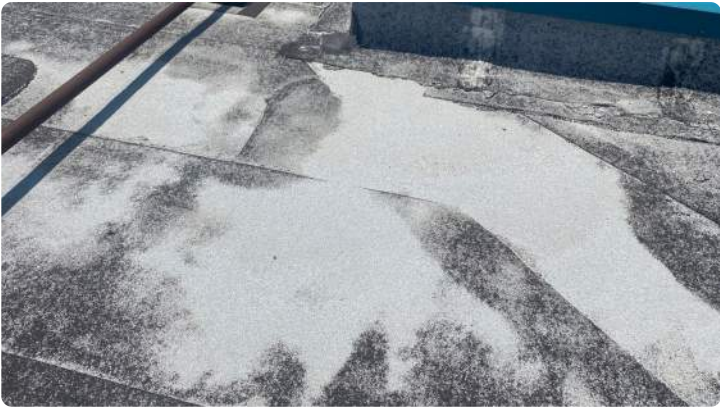
Photo showing granules piled up from deterioration.

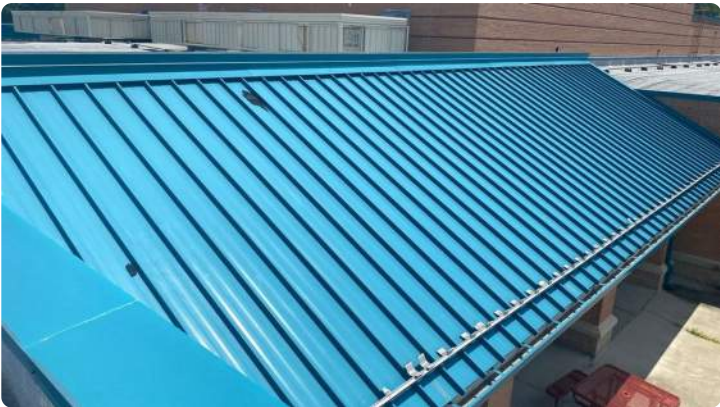
Photo showing condition of adjacent roof.

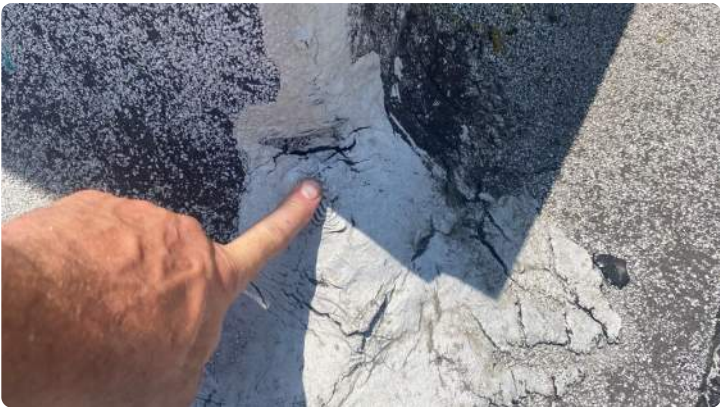
Photo showing crack in the projection flashings.

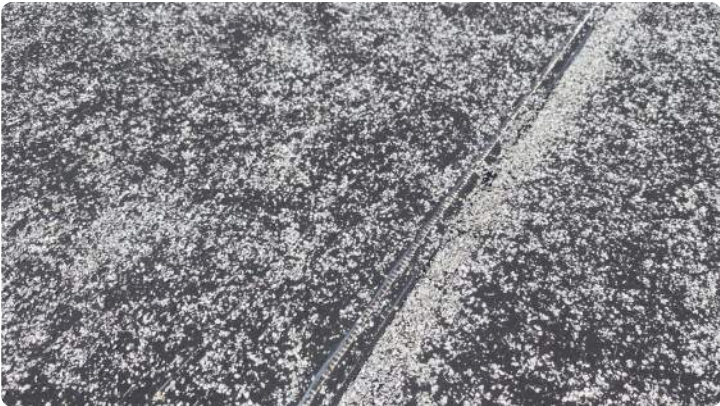
Photo showing scrim visible through deteriorating field.

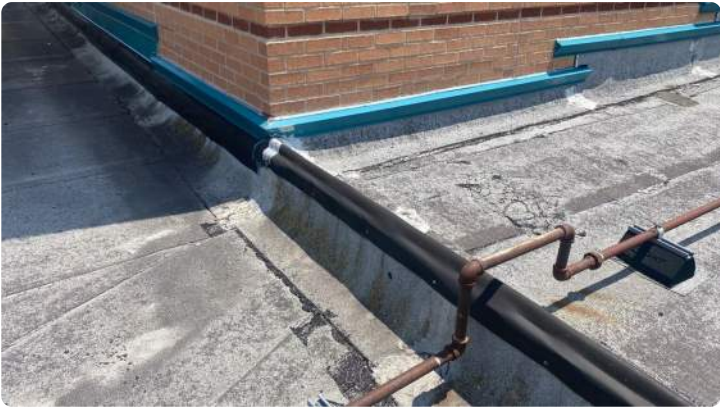
Photo showing condition of the expansion joint.

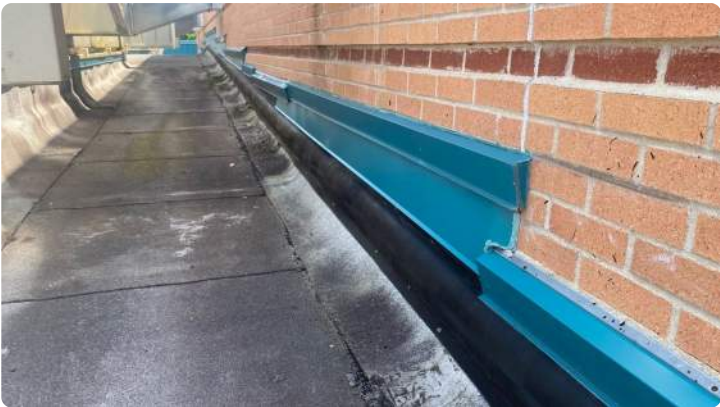
Photo showing condition of the perimeter flashings.

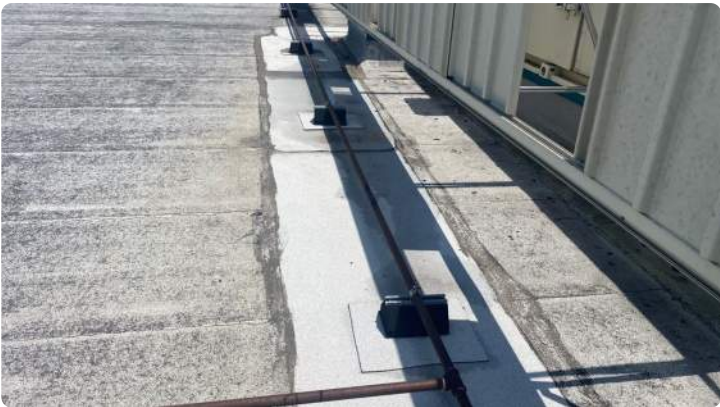
Photo showing area with new Mod Bit under sleepers.

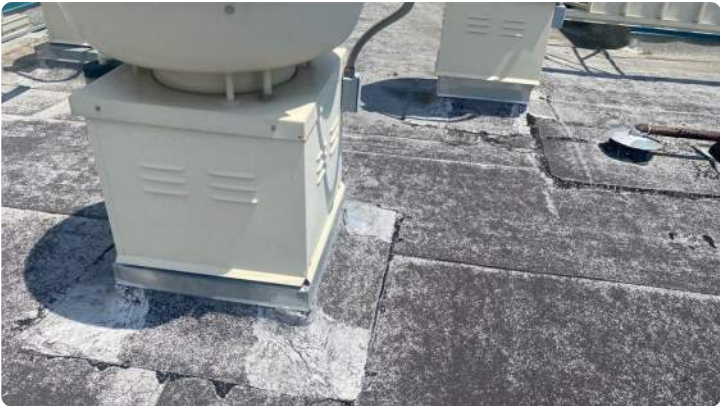
Photo showing condition of the projection flashings and deteriorating field.

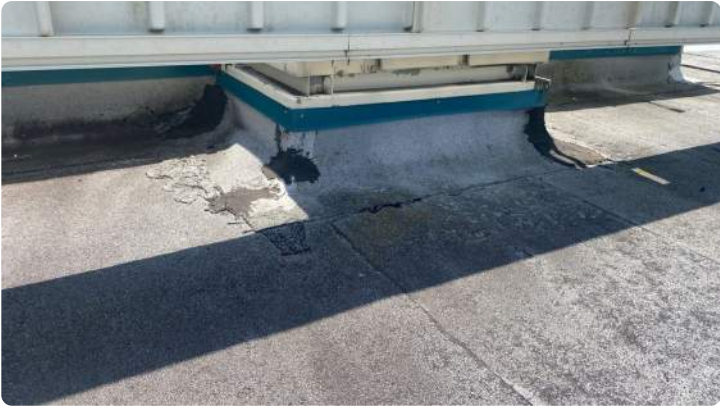
Photo showing condition of the projection flashings.

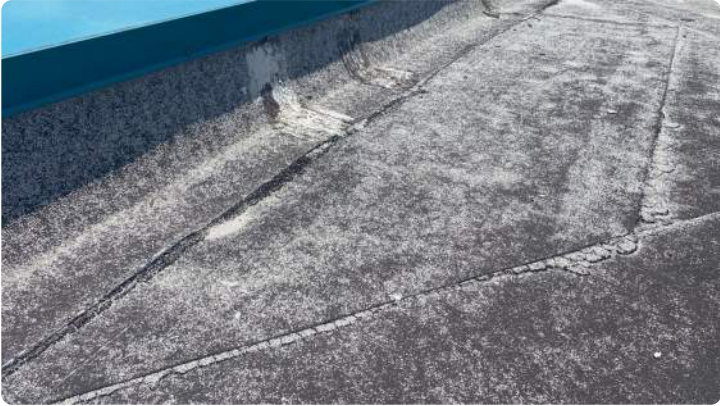
Photo showing deteriorated field.

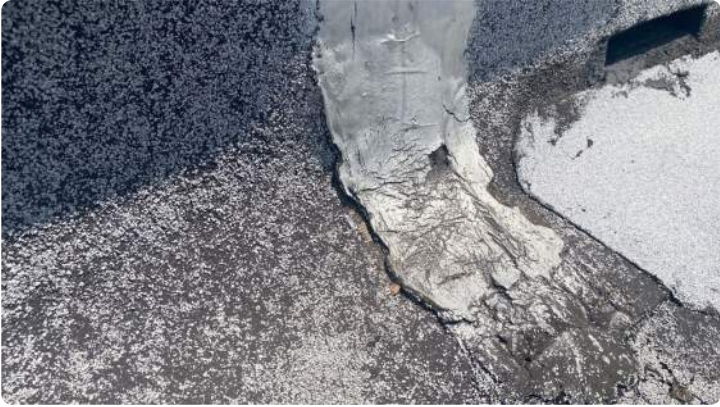
Photo showing deteriorating details.

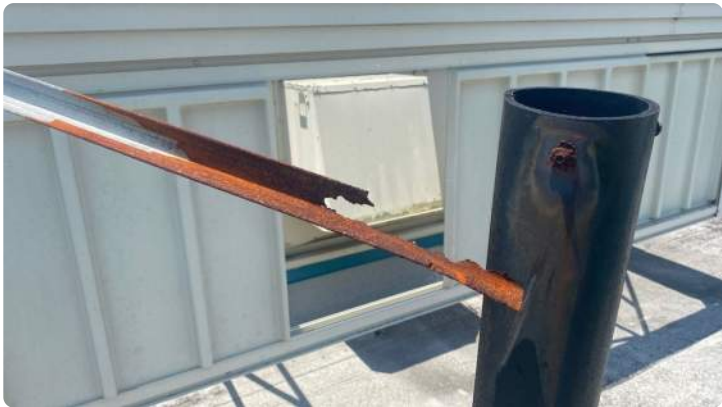
Photo showing rusted vent stack supports.

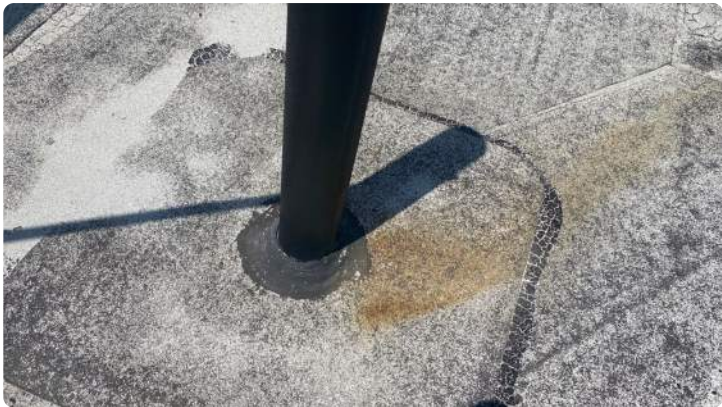
Photo showing vent flashings.

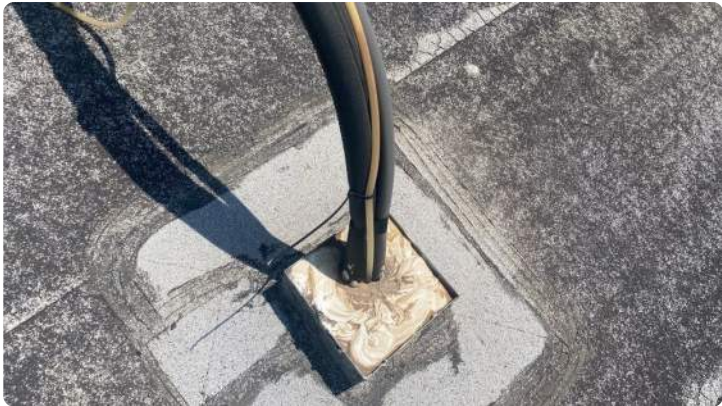
Photo showing condition of pitch pan.

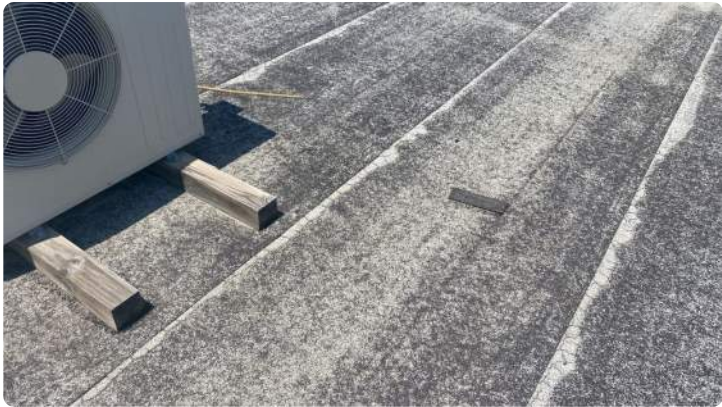
Photo showing area were insulation is soft under field.

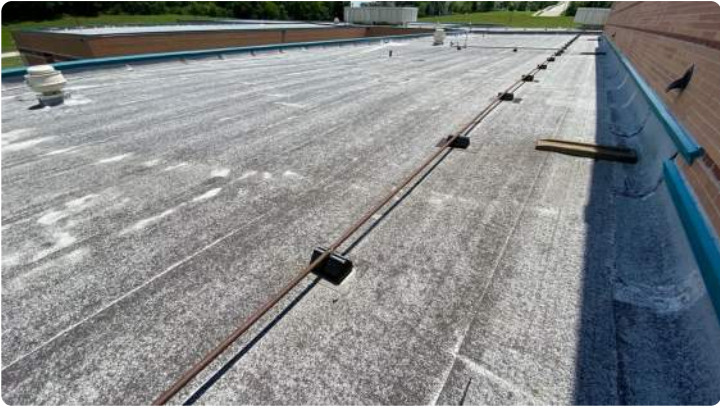
Poor condition

Base sheet missing granules, rubber flashed interior perimeter

Photo showing overview of Area 02 roof.

See Financial Summary for estimated replacement cost

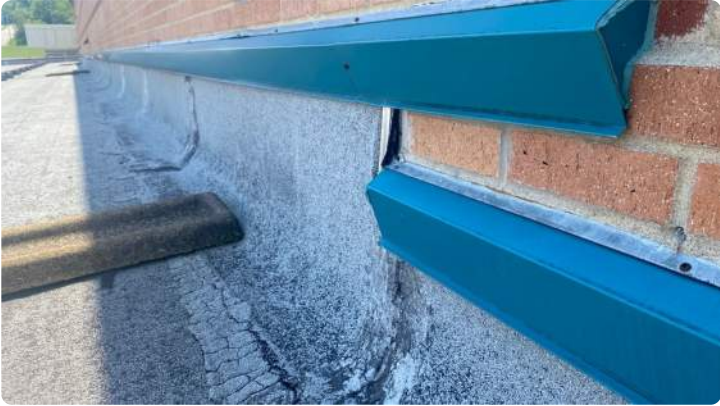
Photo showing condition of the perimeter flashings.

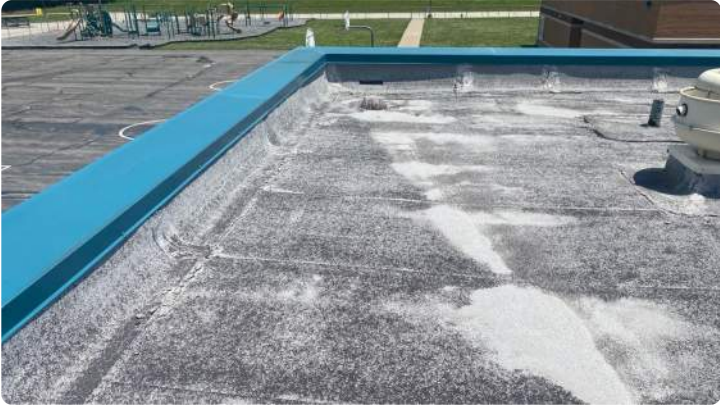
Photo showing granules piled up from deterioration.

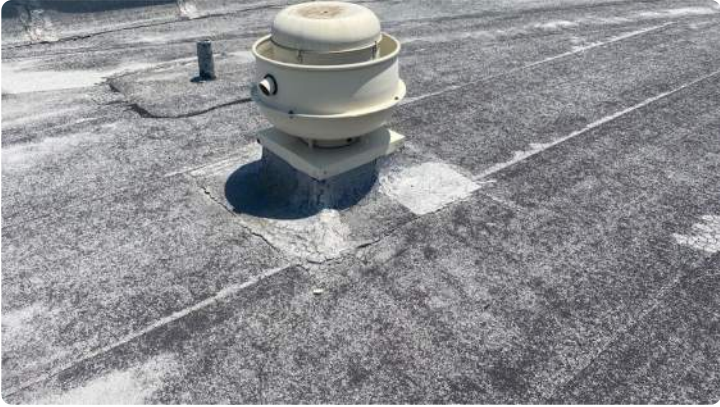
Photo showing condition of the projection flashings and deteriorated field.

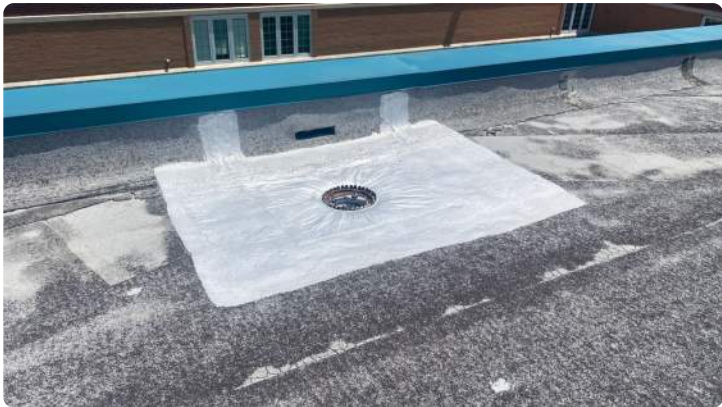
Photo showing drain area coated with aluminum.

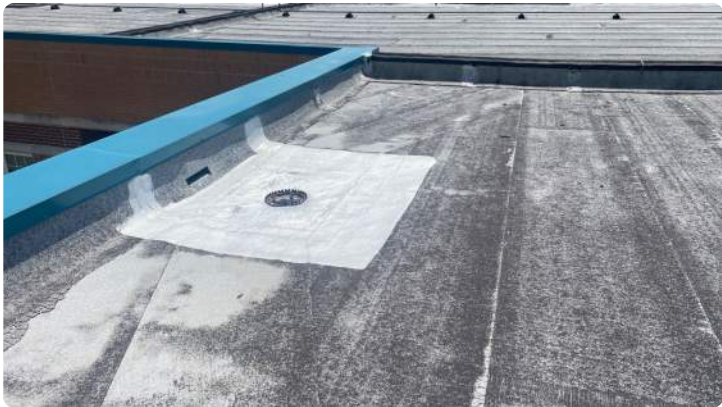
Photo showing additional area around drain coated with aluminum.

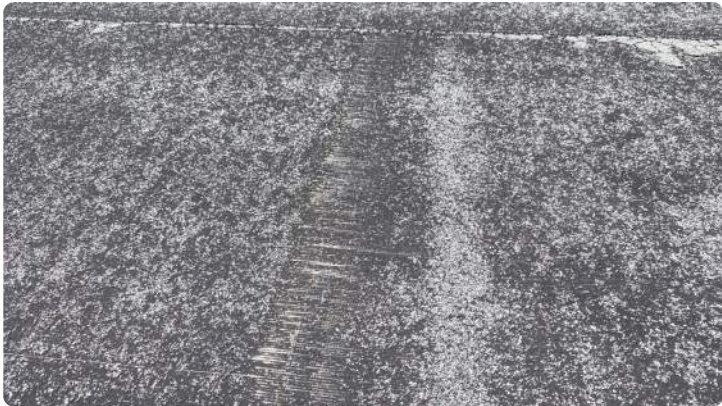
Photo showing skim visible through deteriorating field.

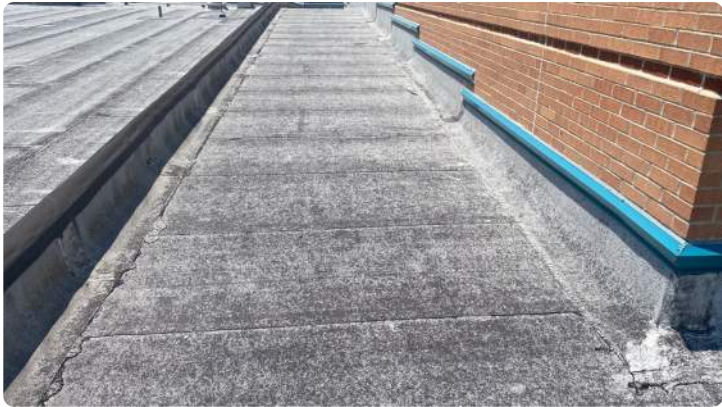
Photo showing condition of the perimeter flashings.

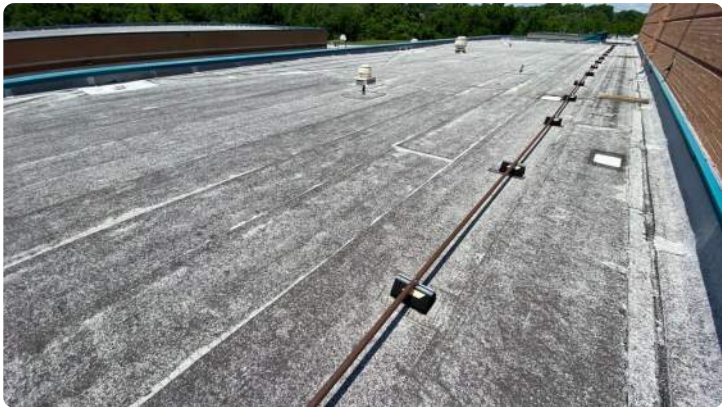
Photo showing deteriorating field.

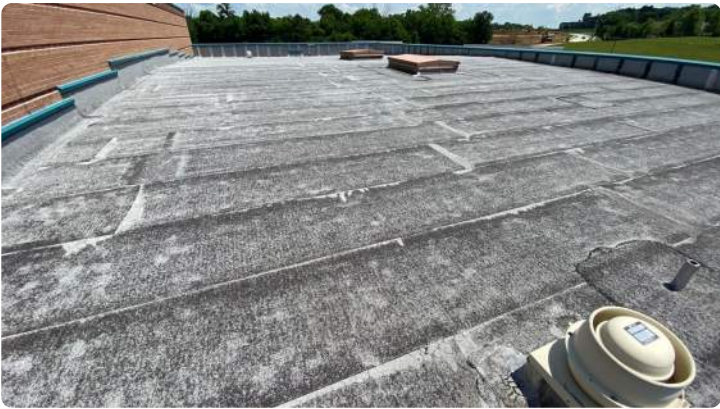
Poor condition

Base sheet missing granules, rubber flashed interior perimeter

Photo showing overview of Area 03 roof.

See Financial Summary for estimated replacement cost

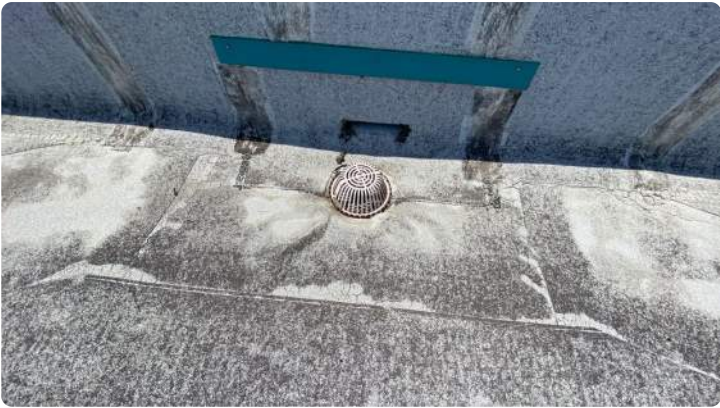
Photo showing granules and wrinkles around drain.

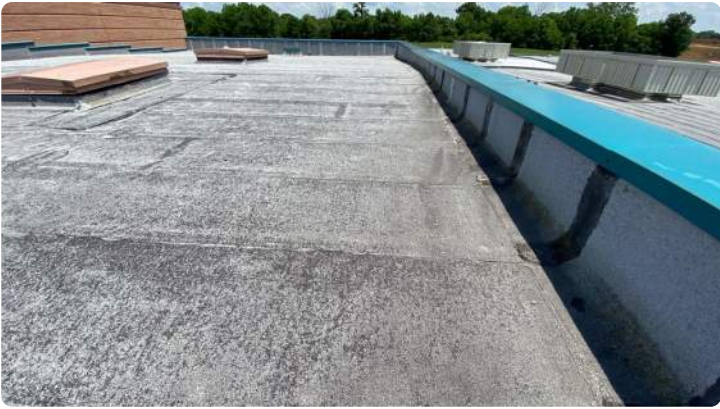
Photo showing condition of the perimeter flashings.

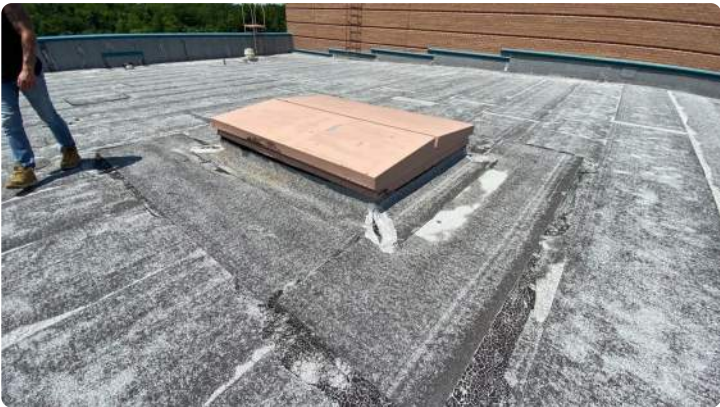
Photo showing condition of the projection flashings.

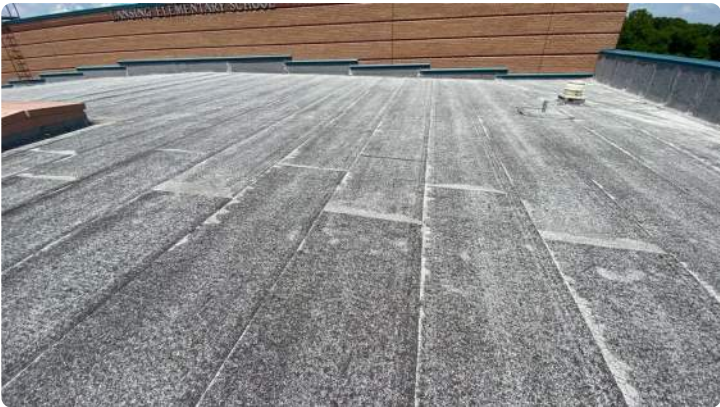
Photo showing deteriorated field.

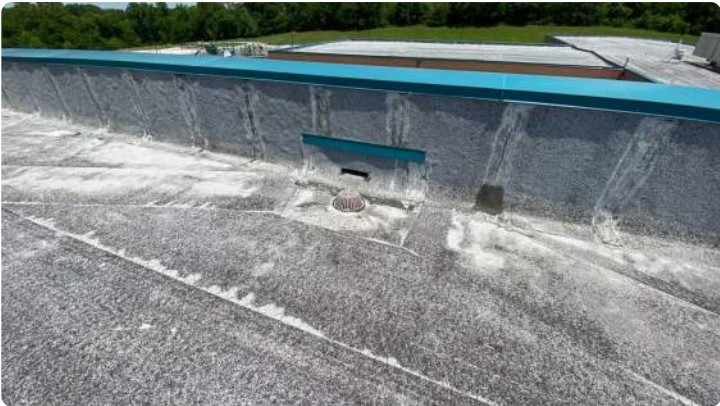
Photo showing condition of the drain.

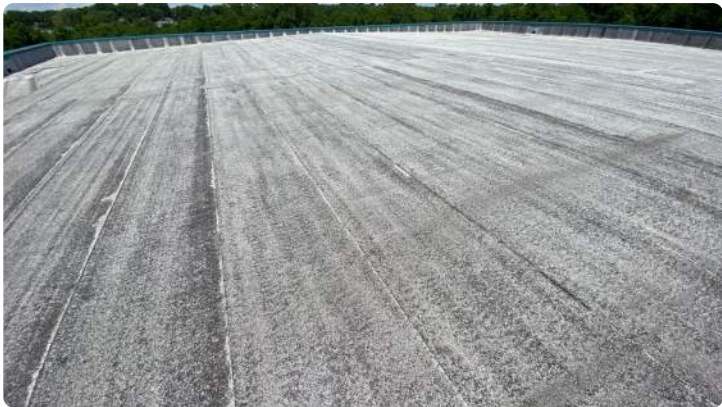
# Area 04

Poor condition

Blisters, Skrim showing through seams

Photo showing overview of Area 04 roof.

See Financial Summary for estimated replacement cost

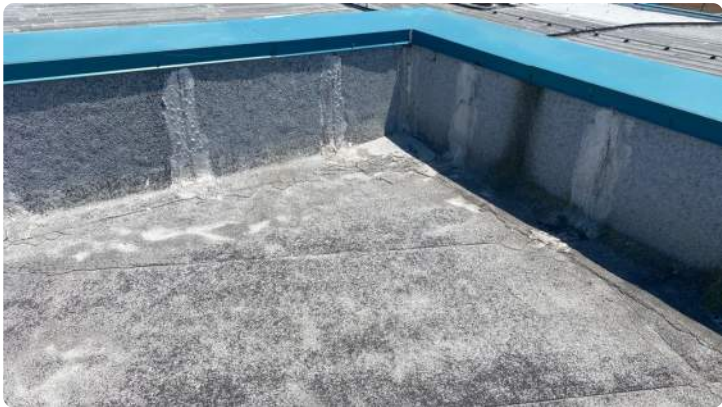
Photo showing condition of the perimeter flashings.

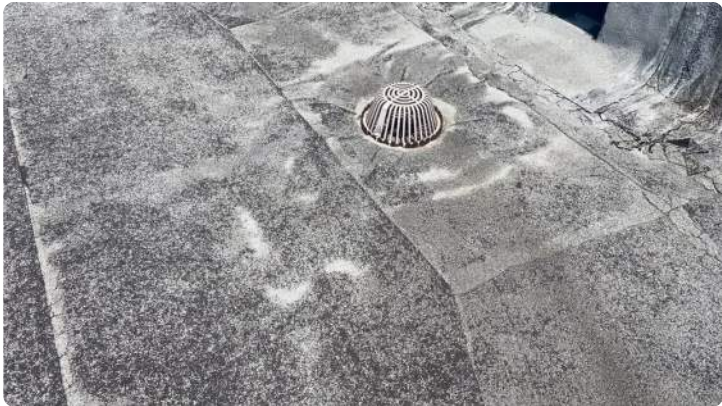
Photo showing deterioration around drain.

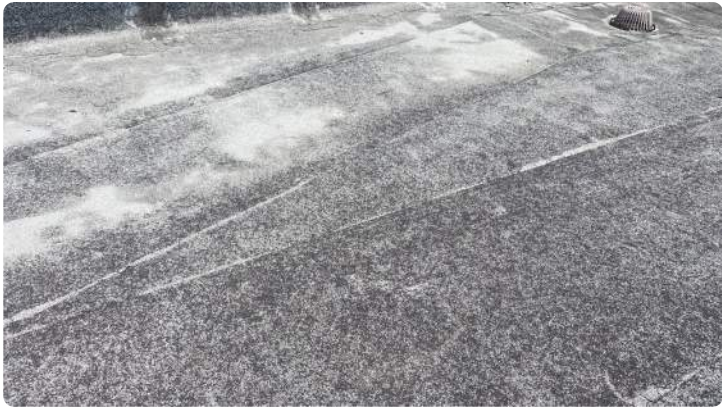
Photo showing loose granules and deterioration of field.

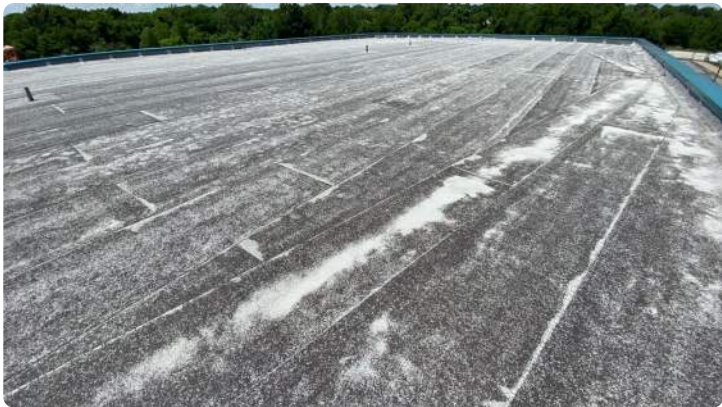
Poor condition

Base sheet missing granules, rubber flashed interior perimeter

Photo showing overview of Area 05 roof.

See Financial Summary for estimated replacement cost

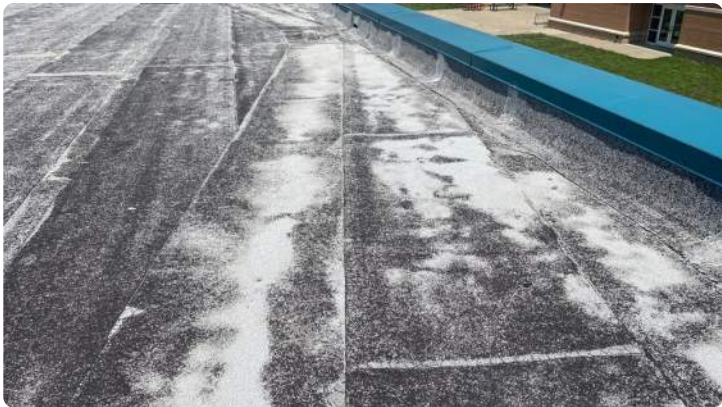
Photo showing granules piled up from deterioration.

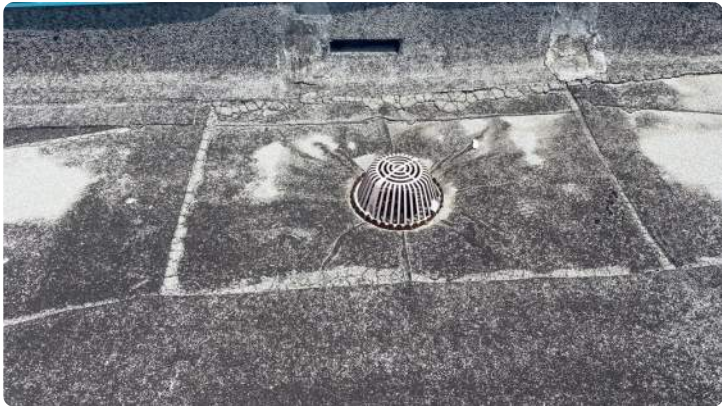
Photo showing deterioration around drain.

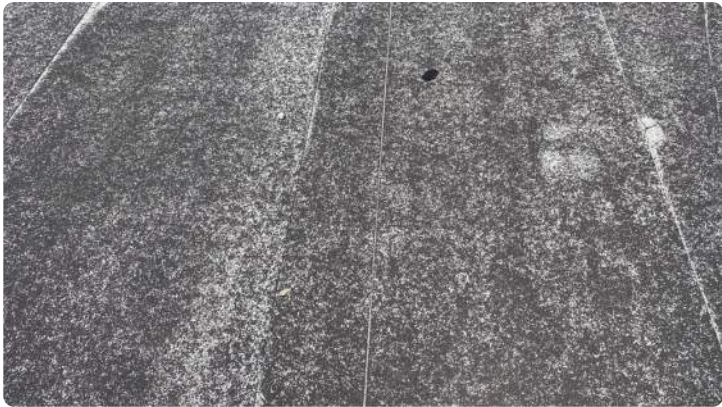
Photo showing scrim visible through deteriorating field.

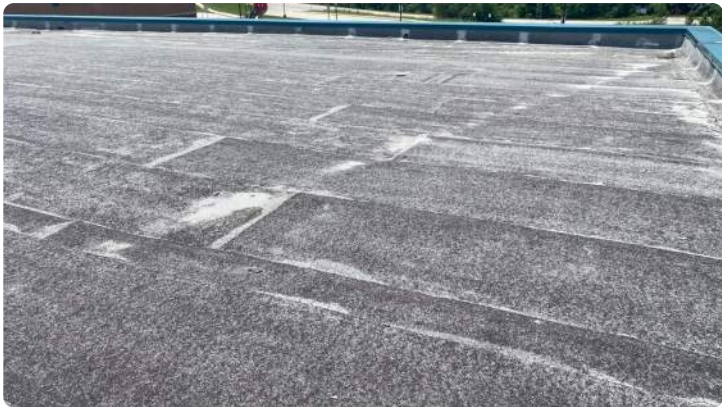
Photo showing deterioration of the field.

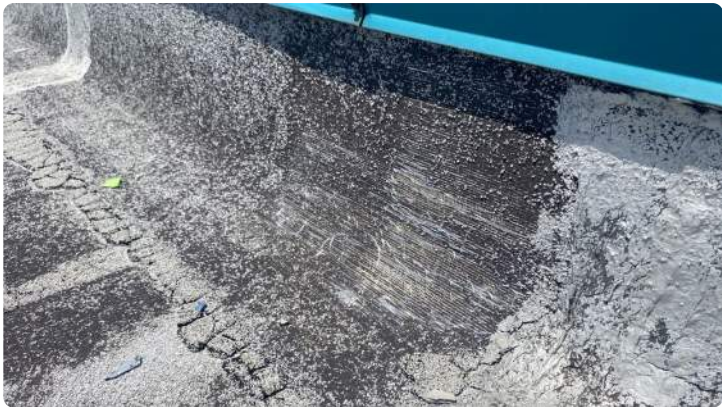
Photo showing skim visible through deteriorating perimeter.

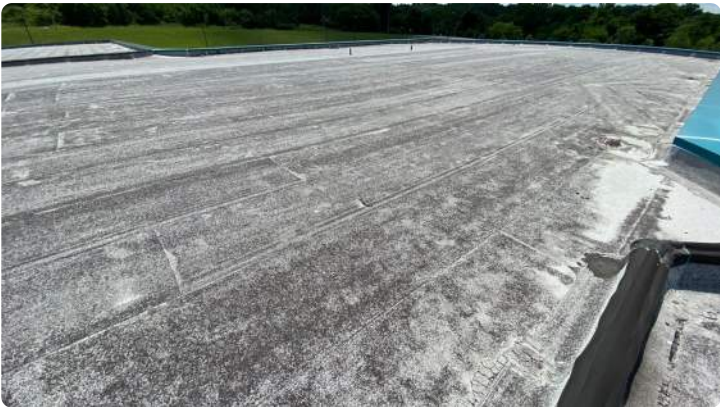
# Area 06

Poor condition

Soft areas, base sheet missing granules, rubber flashed interior perimeter

Photo showing overview of Area 06 roof.

See Financial Summary for estimated replacement cost

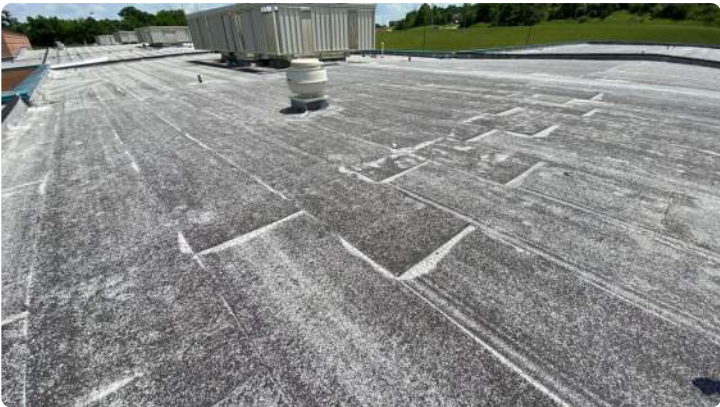
Additional overview of Area 06 roof.

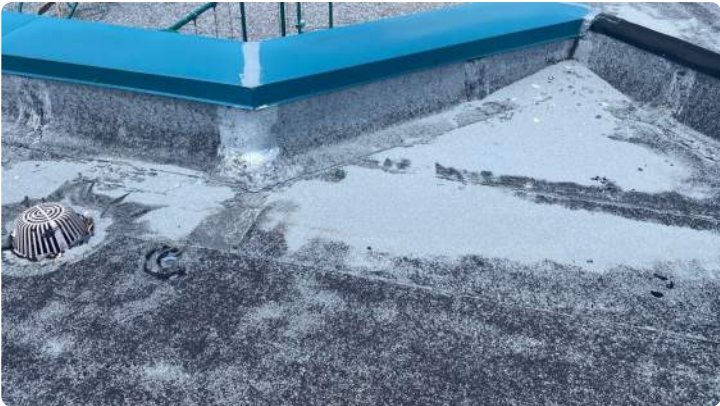
Photo showing granules piled up from deterioration.

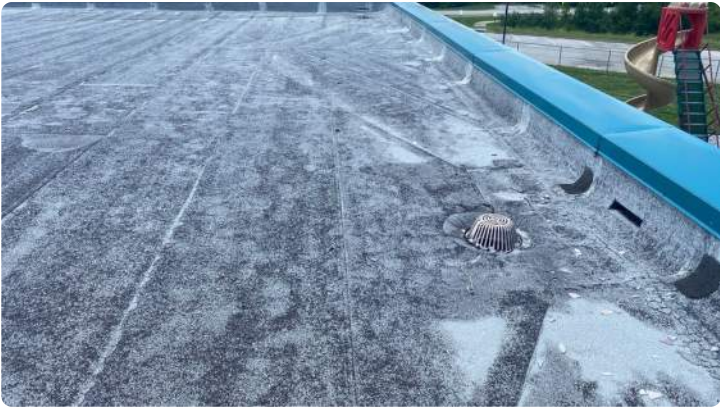
Photo showing condition of the perimeter flashings.

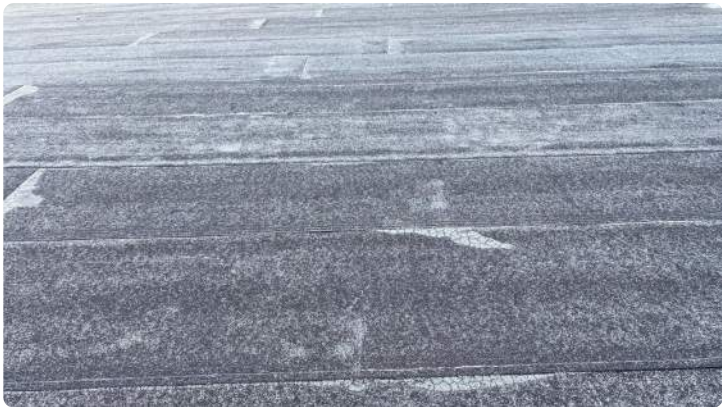
Photo showing deterioration in field.

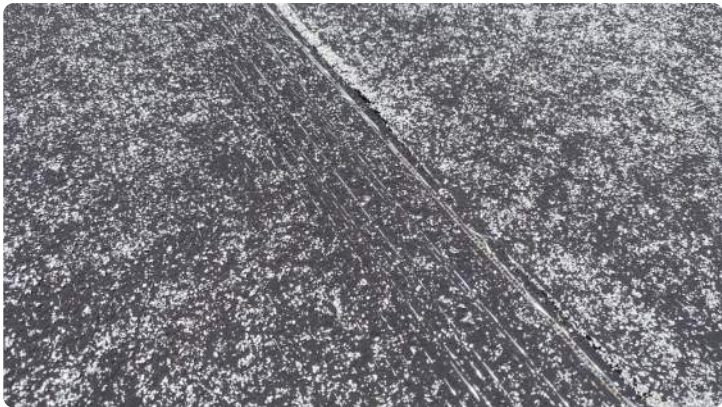
Photo showing skim showing through field at seam.

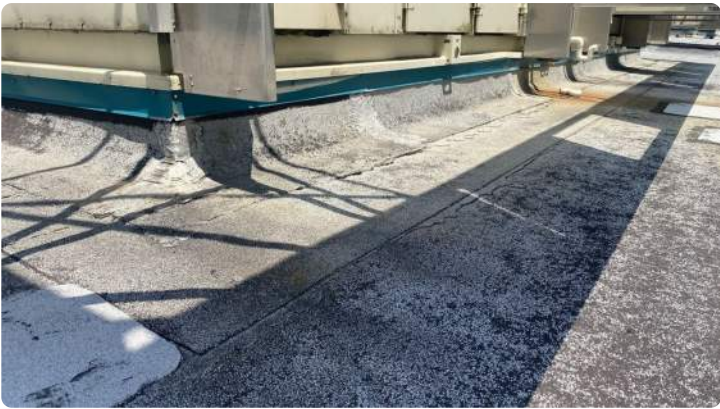
Photo showing condition of the projection flashings.

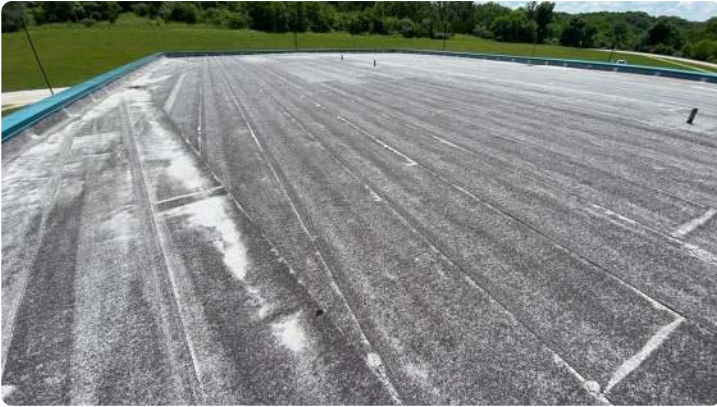
# Area 07

Poor condition

Soft areas, base sheet missing granules, rubber flashed interior perimeter

Photo showing overview of Area 07 roof.

See Financial Summary for estimated replacement cost

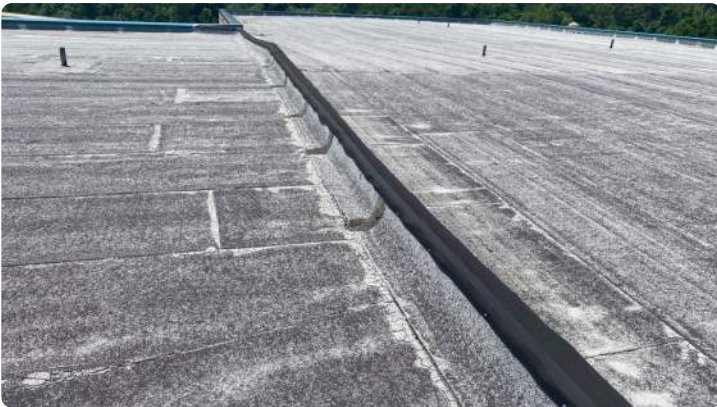
Photo showing condition of the expansion joint.

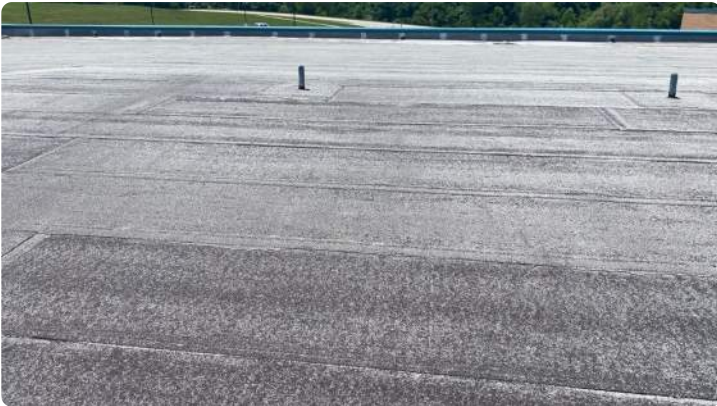
Photo showing additional overview of Area 07 roof.

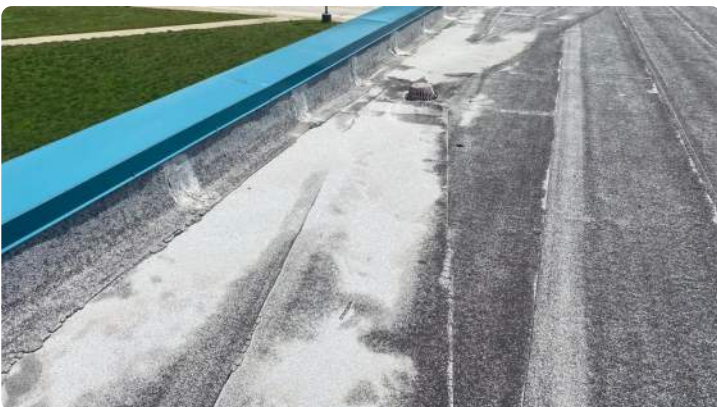
Photo showing granules piled up from deterioration.

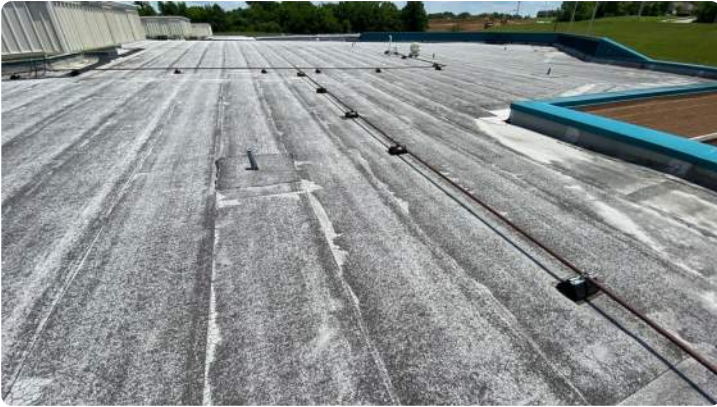
# Area 08

Poor condition

Soft areas, base sheet missing granules, rubber flashed interior perimeter

Photo showing overview of Area 08 roof.

See financial Summary for estimated replacement cost

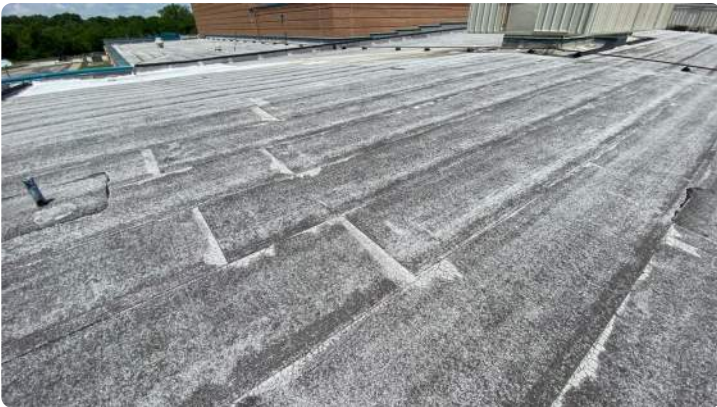
Additional overview of Area 08 roof.

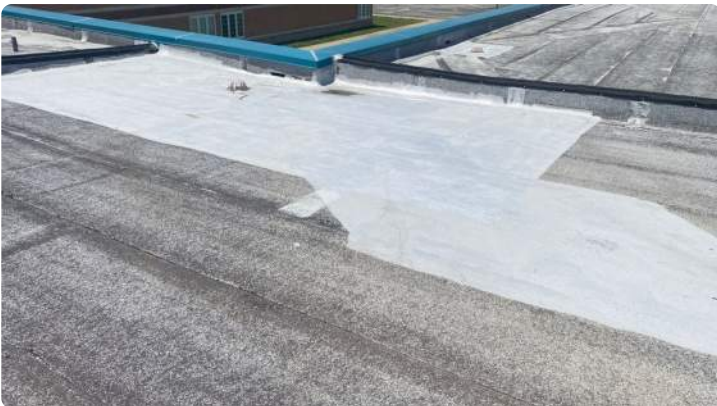
Photo showing section of roof previously coated.

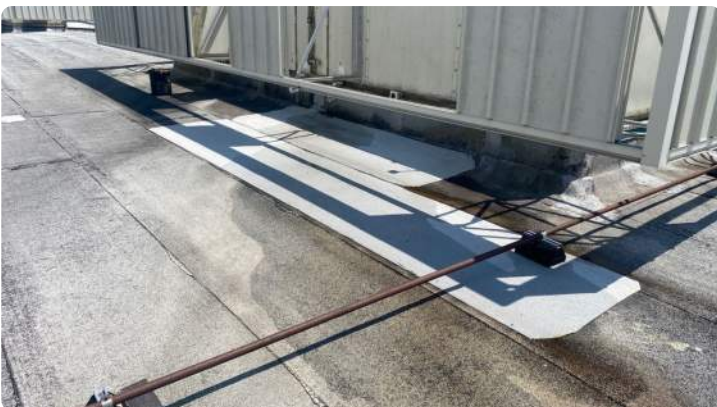
Photo showing patch previously made next to unit where condensation is ponding.

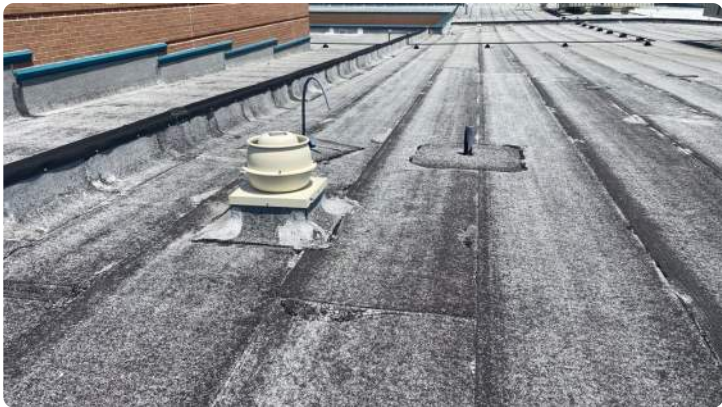
Photo showing roof with granules deteriorated from field.

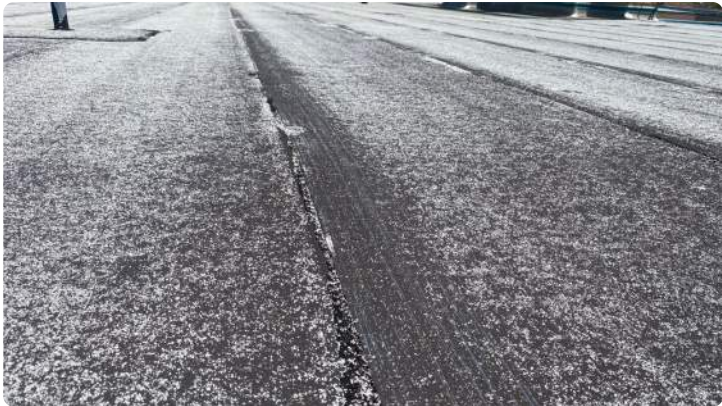
Photo showing addition deterioration in field.

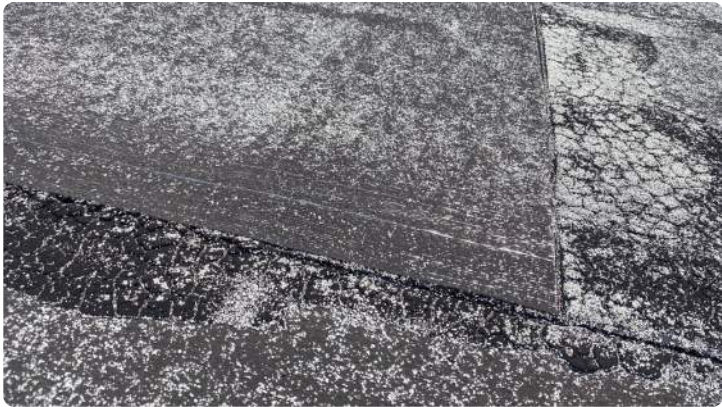
Photo showing deterioration in field.

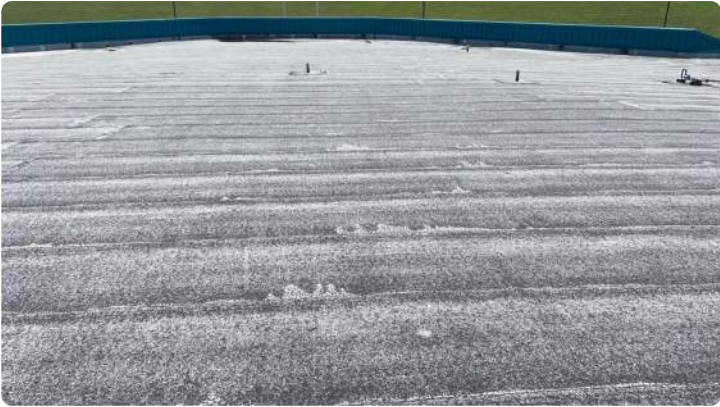
Photo showing field deterioration.

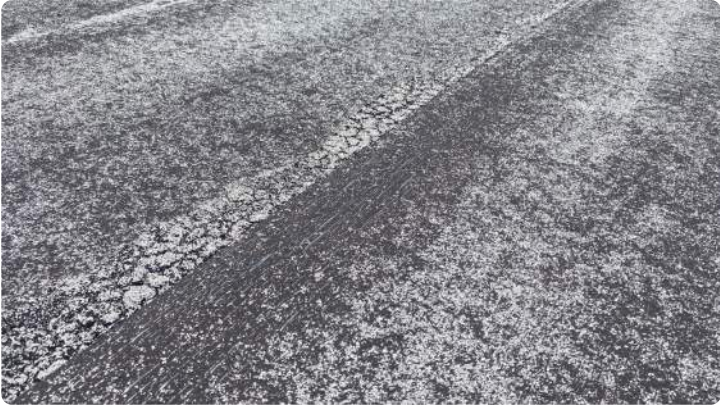
Photo showing deterioration of field.

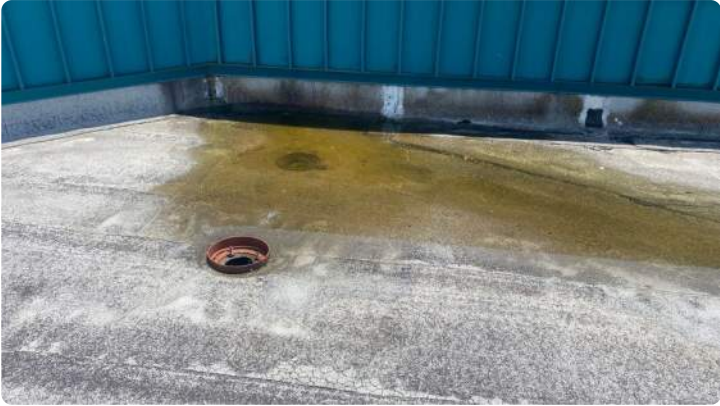
Photo showing drain clogged with trash. Cleared as part of the maintenance agreement.

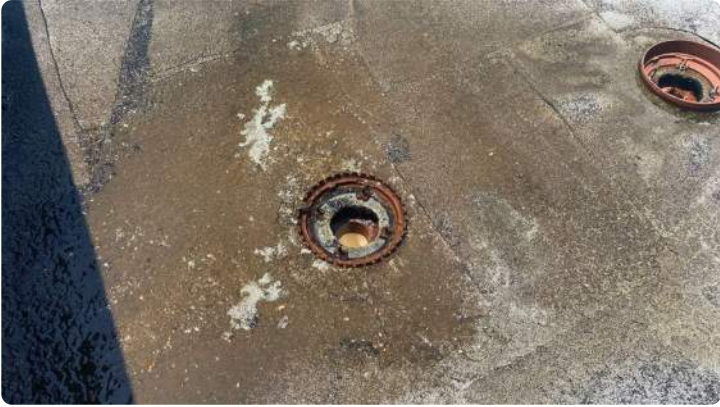
photo showing cleared drain.

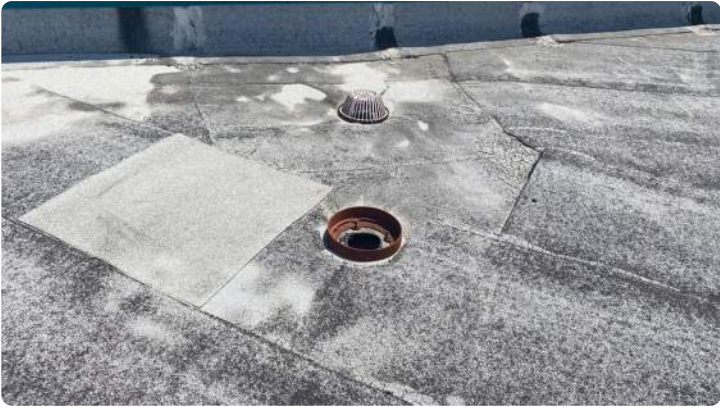
Photo showing blisters around drains.

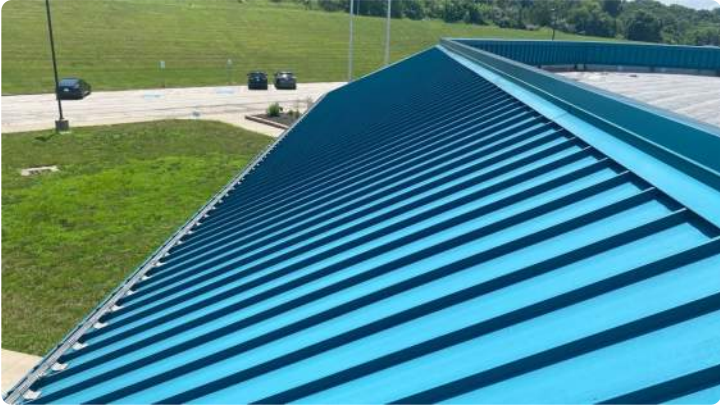
Photo showing overview of adjacent metal roof.

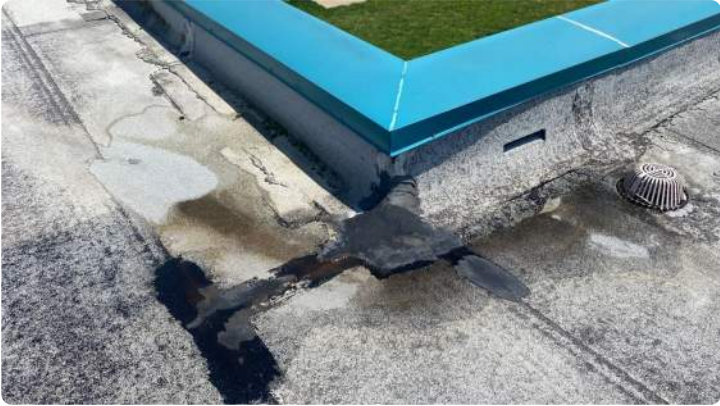
Photo showing corner with multiple openings that was repaired.

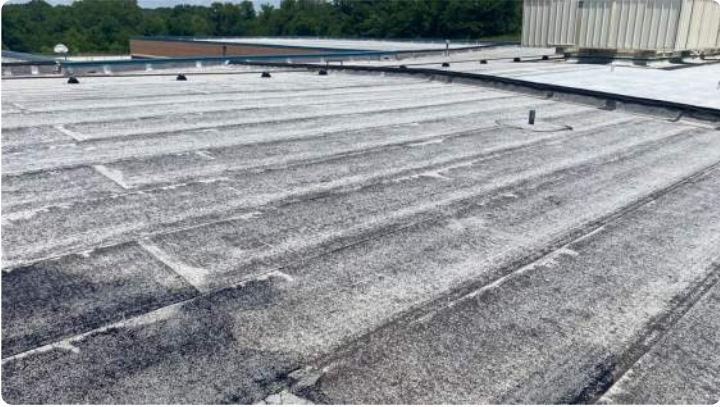
Photo showing deterioration in field.

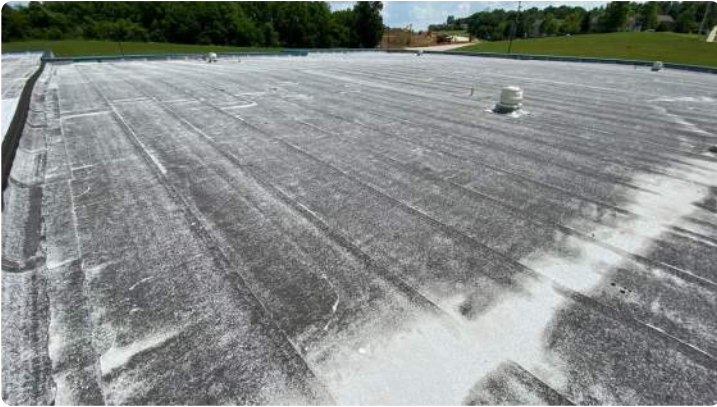
Poor condition

Soft areas, base sheet missing granules, rubber flashed interior perimeter

Photo showing overview of Area 09 roof.

See Financial Summary for estimated replacement cost

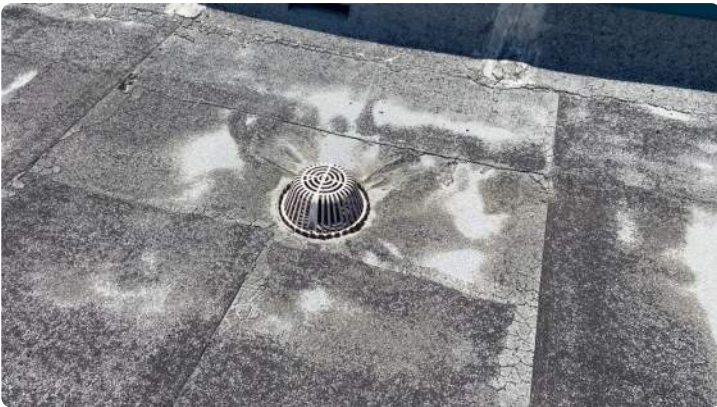
Photo showing blistering and granules piled up around drain.

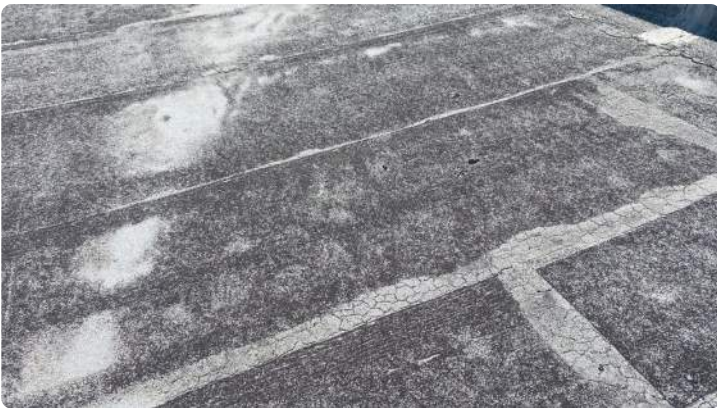
Photo showing deterioration of the field.

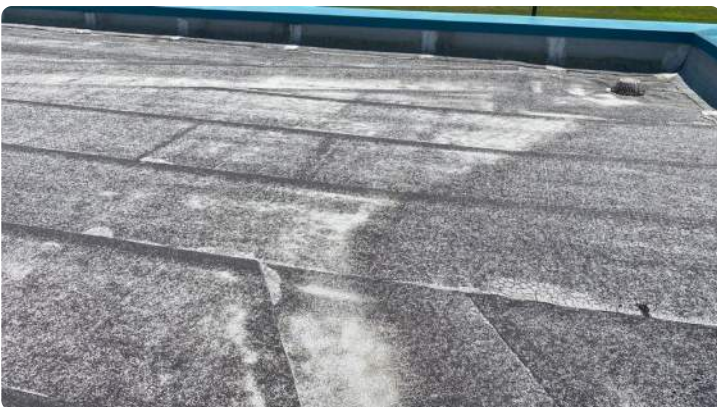
Photo showing loose granules and field deterioration.

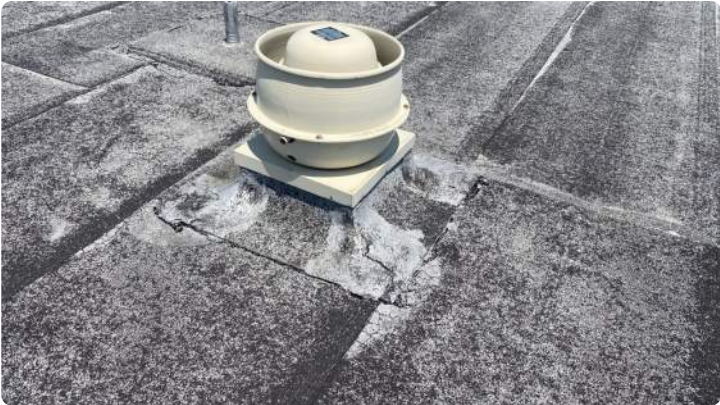
Photo showing condition of projection flashing.

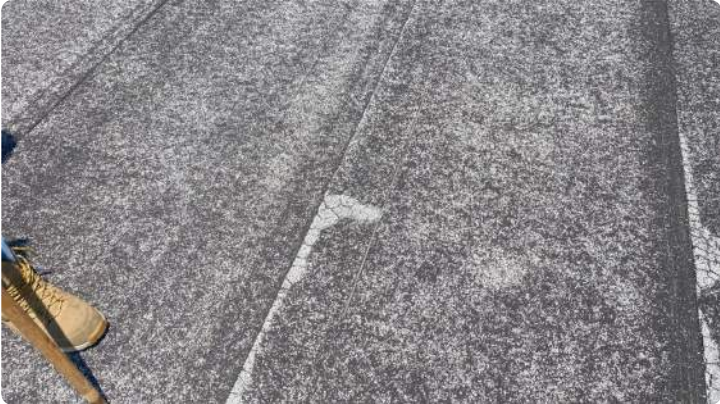
Photo showing deterioration of the field.

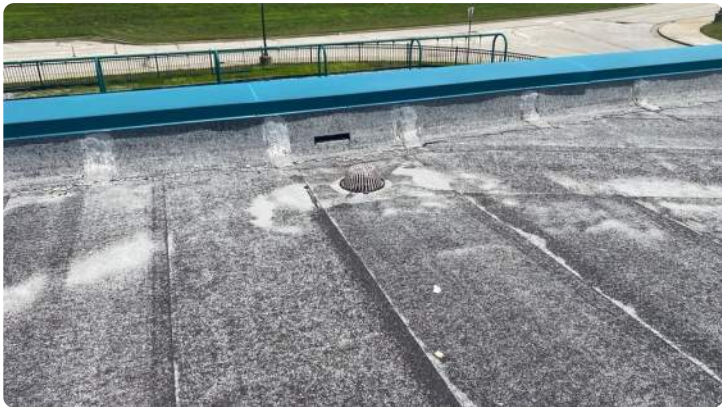
Photo showing condition of the perimeter flashings.

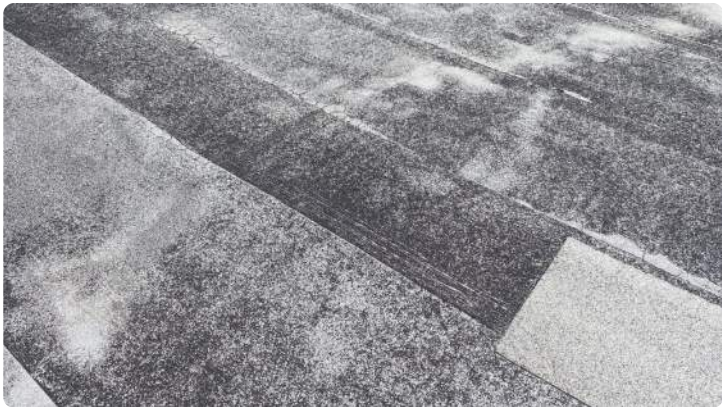
Photo showing additional skim exposed in deteriorated field.
