## 2024 LANSING PUBLIC SCHOOL CONDITION MAP

## Lansing KS Financial Summary Overview

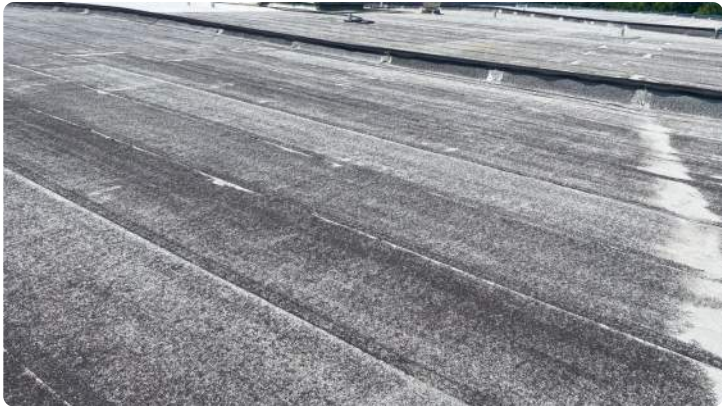
Photo showing additional skim exposed and deterioration in field.

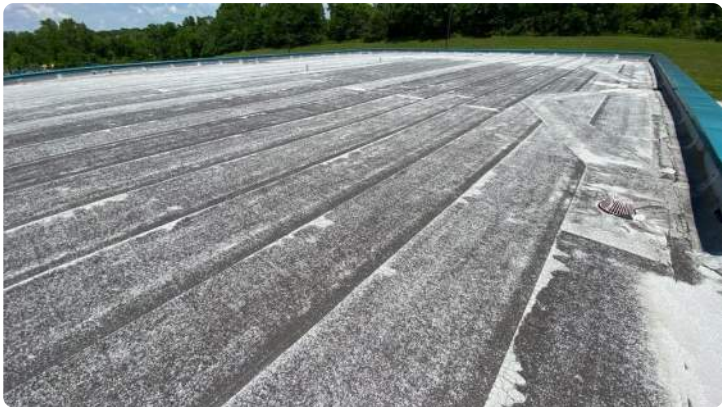
Poor condition

Base sheet missing granules, rubber flashed interior perimeter

Photo showing overview of Area 10 roof.

See Financial Summary for estimated replacement cost

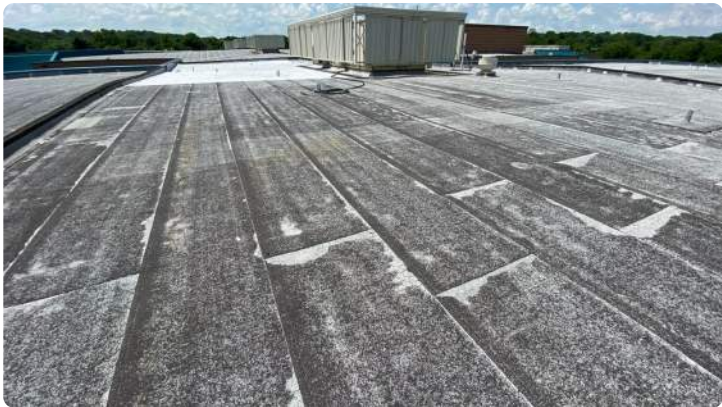
Photo showing deteriorated field.

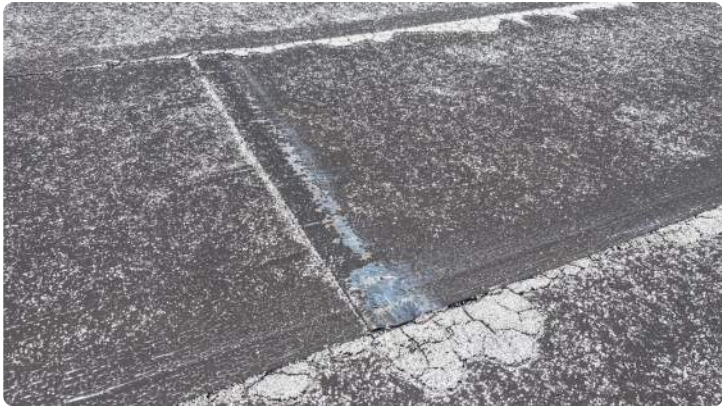
Photo showing skim exposed at seams.

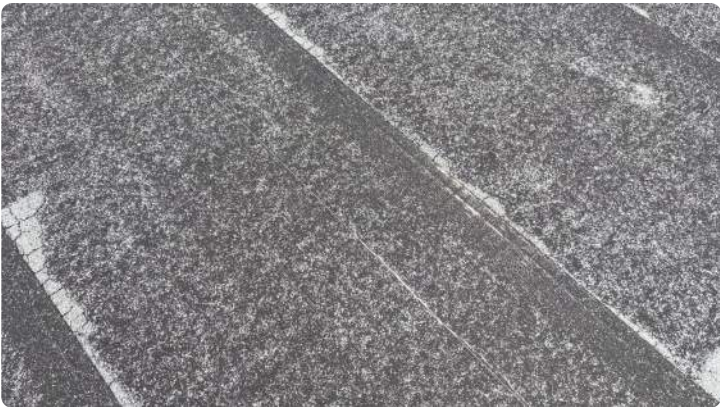
Photo showing additional skim exposed at seams.

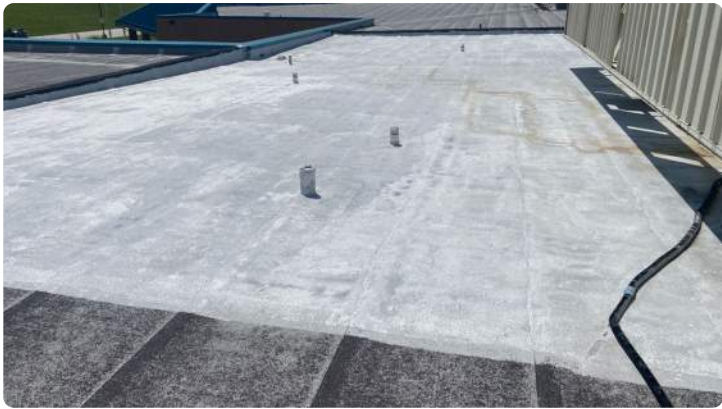
Photo showing section of roof that was previously coated.

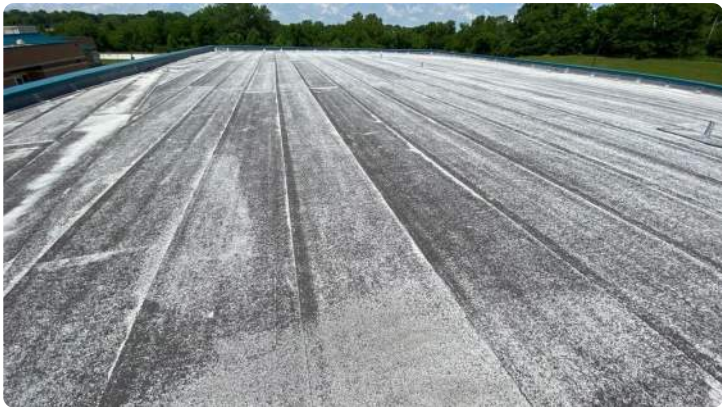
Poor condition

Base sheet missing granules, rubber flashed interior perimeter

Photo showing overview of Area 11 roof.

See Financial Summary for estimated replacement cost

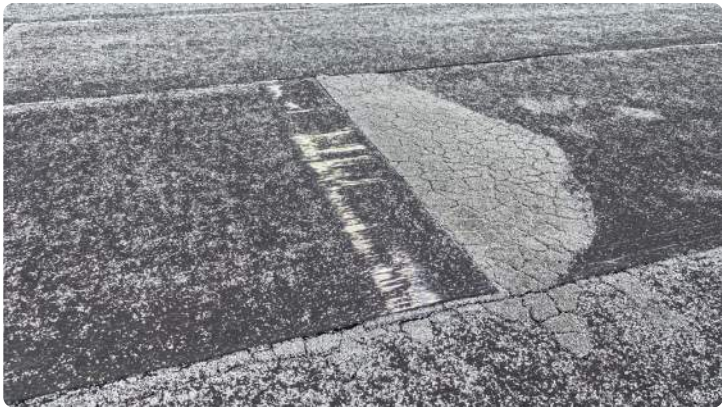
Photo showing exposed scrim at seam.

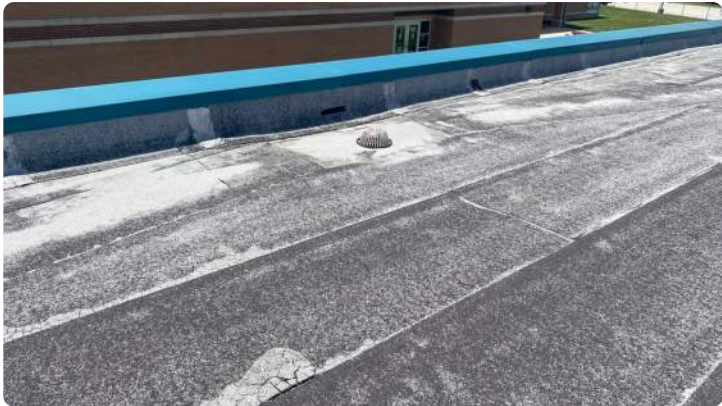
Photo showing granules piled up along drain valley and in drain.

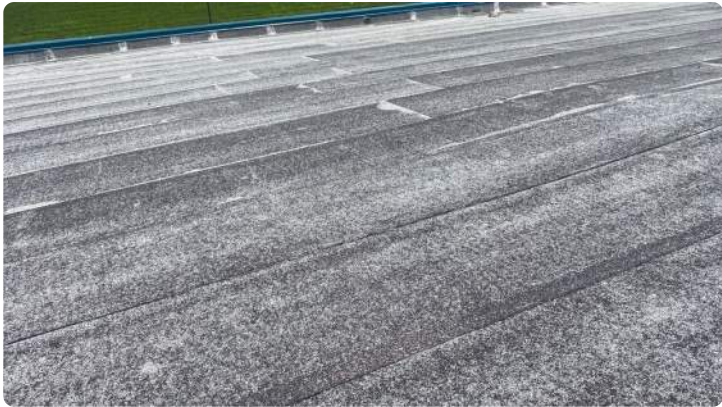
Photo showing deteriorated field with exposed scrim.

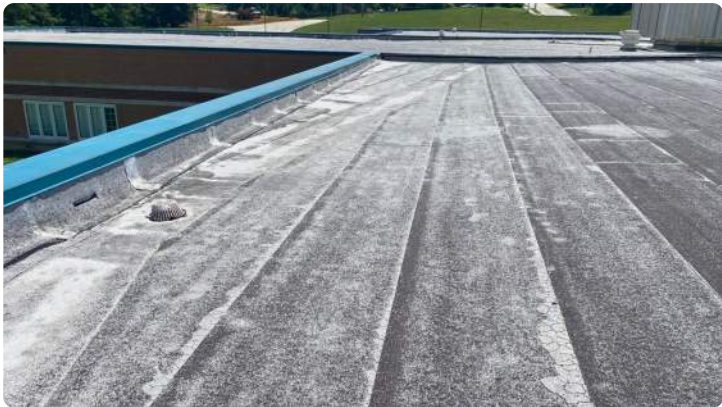
Photo showing additional deterioration.

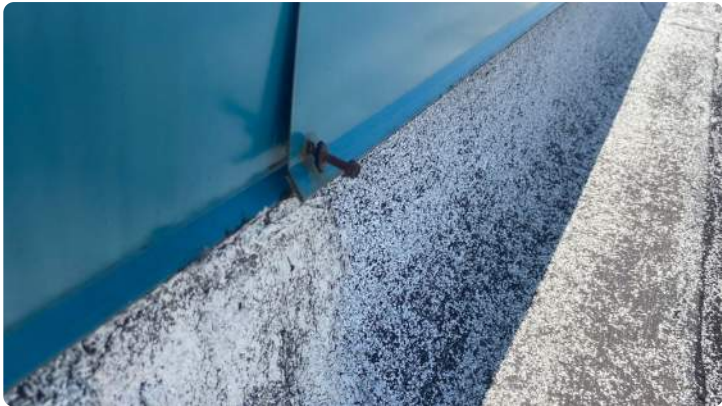
Photo showing screw backing out of the metal perimeter cap.

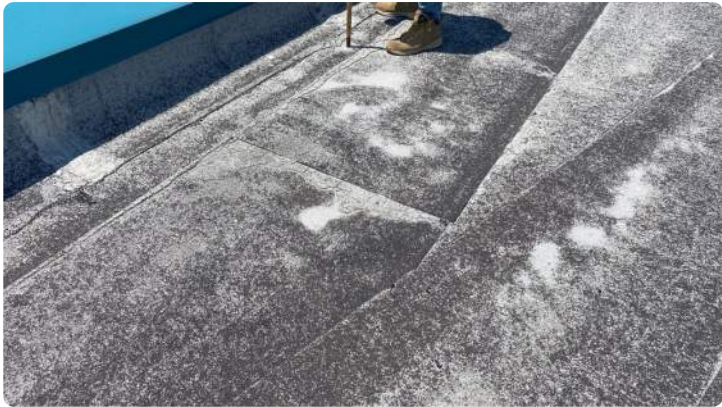
Photo showing deterioration of the field.

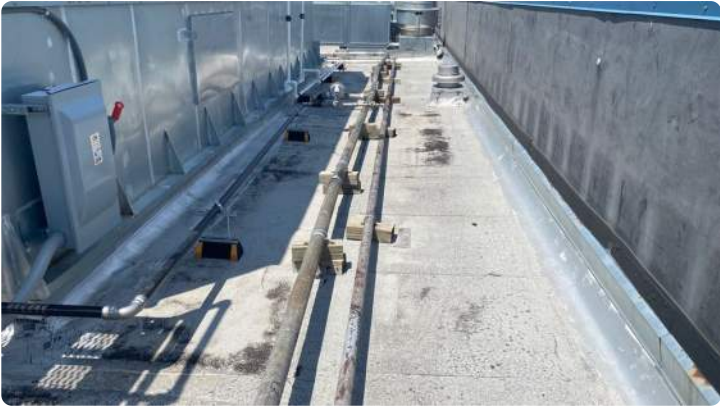
Poor condition

Cracking base sheet, soft areas, skim exposed, Hypalon flashings

Photo showing overview of Area 01 roof.

See Financial Summary for estimated replacement cost

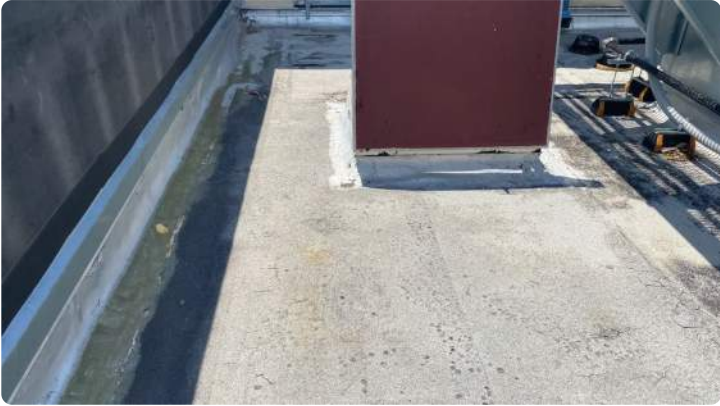
Photo showing condition of area surrounding hatch.

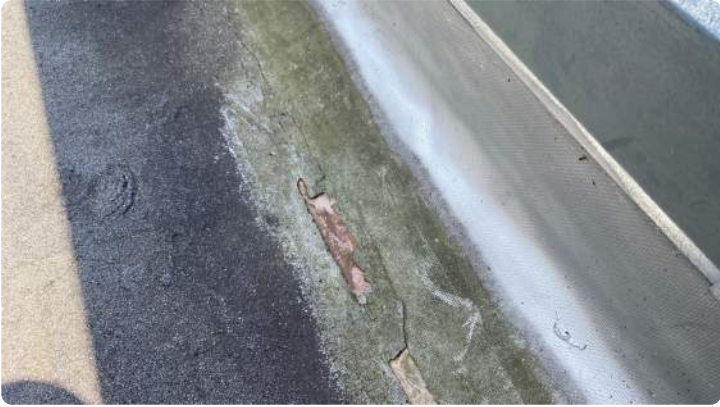
Photo showing coating cracking.

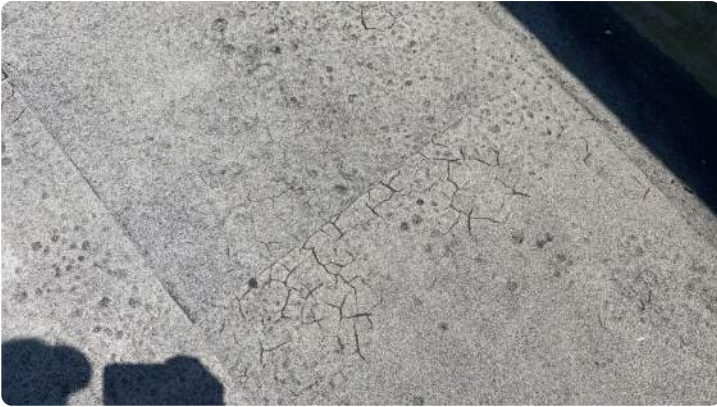
Photo showing additional cracking in field.

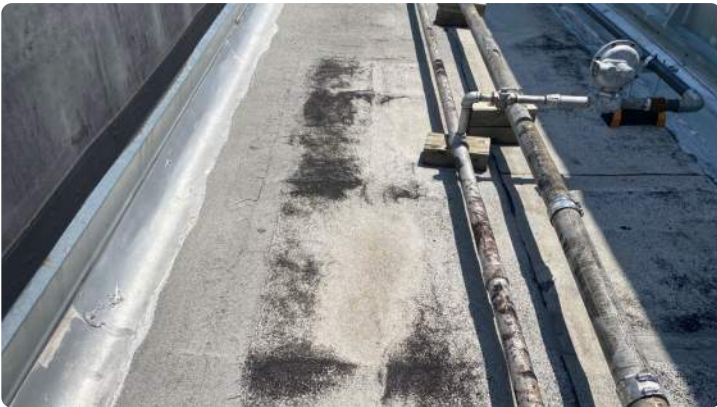
Photo showing more field deterioration.

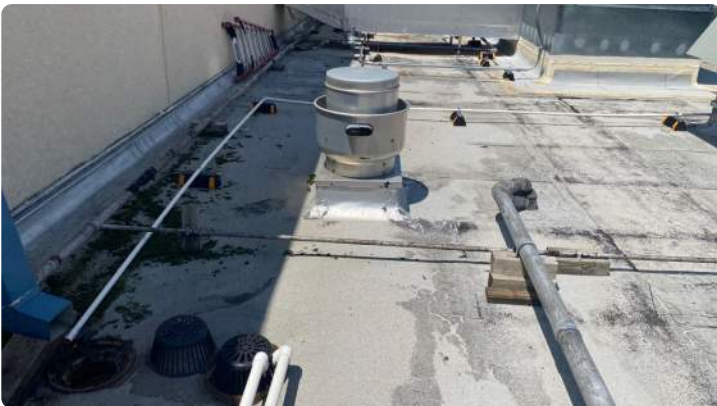
Photo showing additional overview of Area 01 roof.

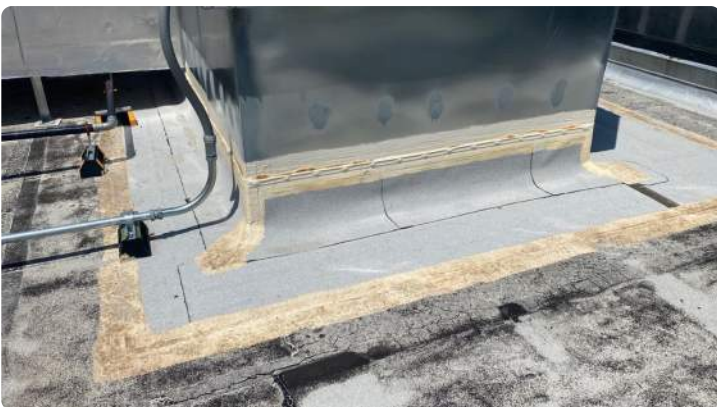
Photo showing condition of the projection flashings.

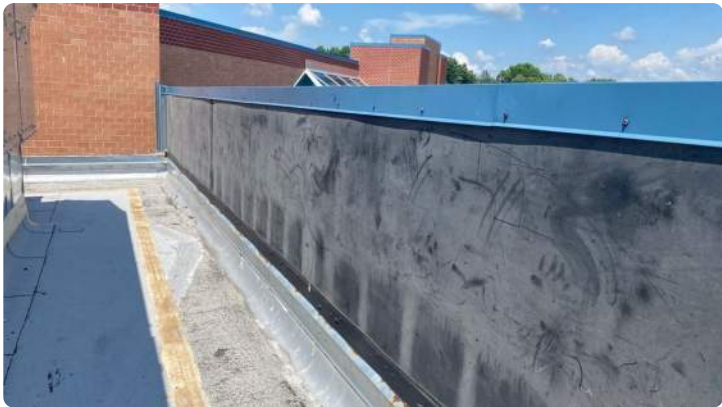
Photo showing condition of wall membrane.

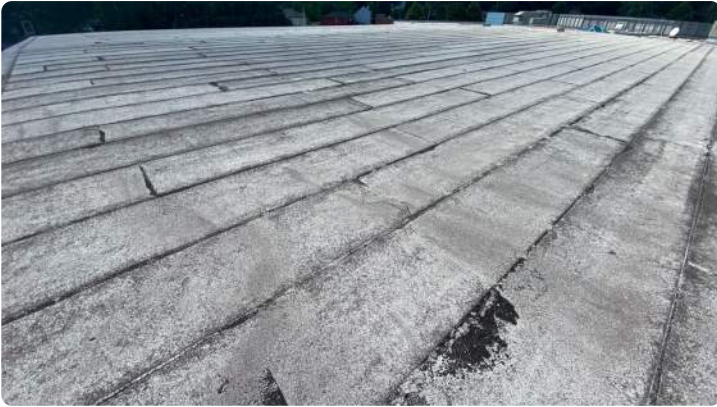
Poor condition

Skrim exposed, field deteriorating

Photo showing overview of Area 02 roof.

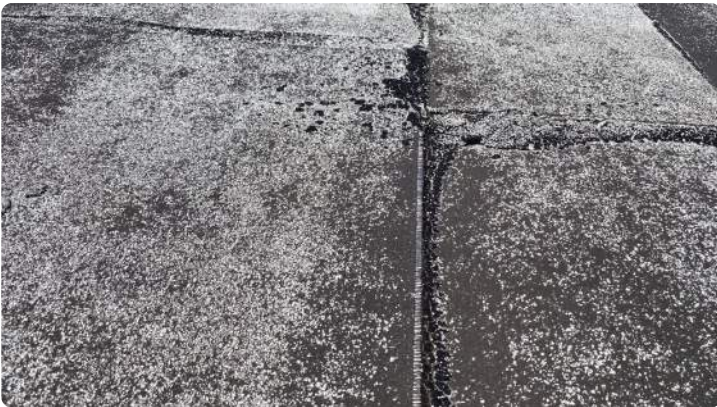
Photo showing skim coming through in the field due to deterioration.

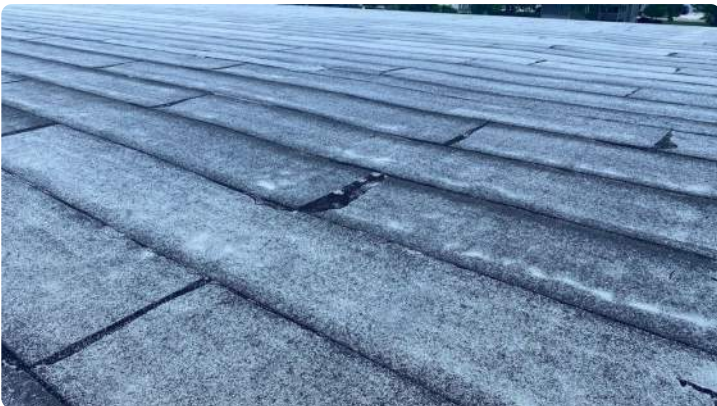
Photo showing deterioration of the field.

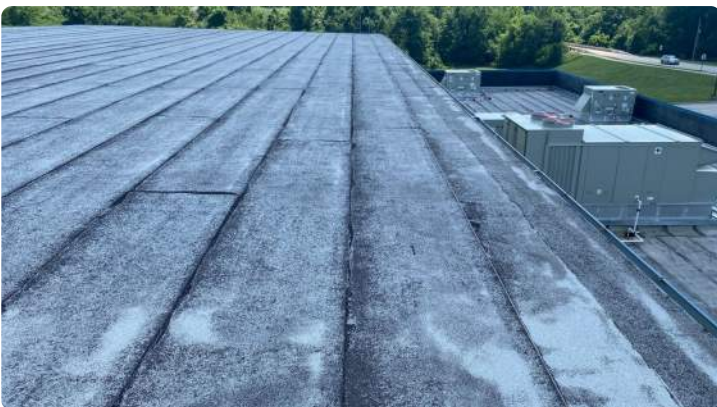
Photo showing additional deterioration of the field.

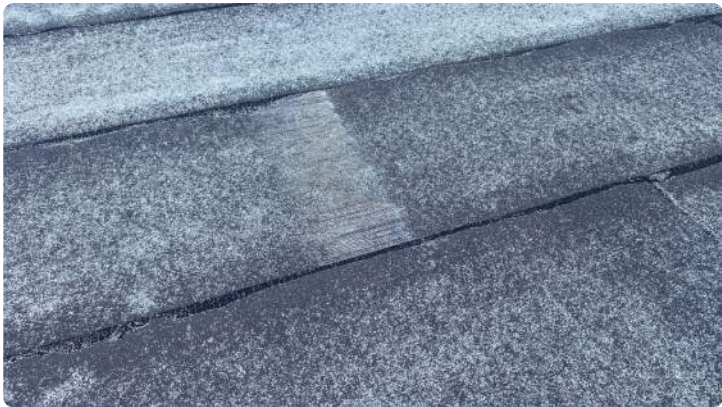
Photo showing scrim visible through the deteriorating field.

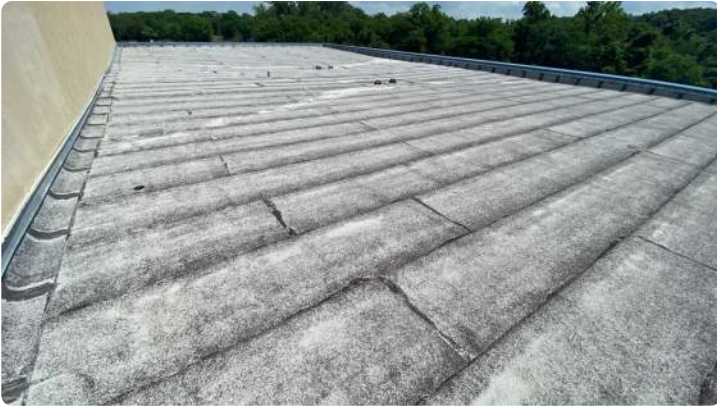
Poor condition

Skrim exposed, field deteriorating

Photo showing overview of Area 03 roof.

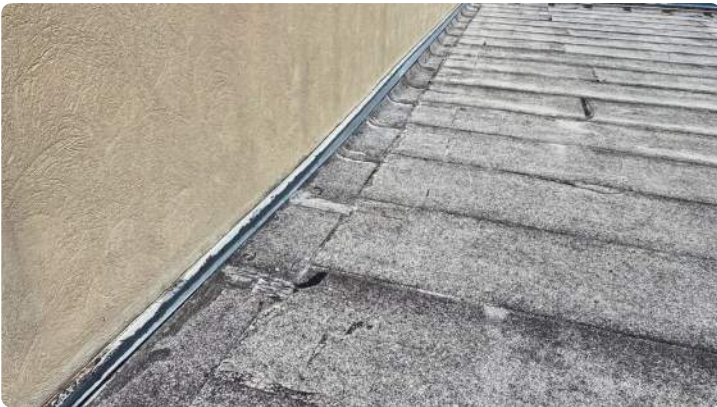
Photo showing condition of the perimeter flashings.

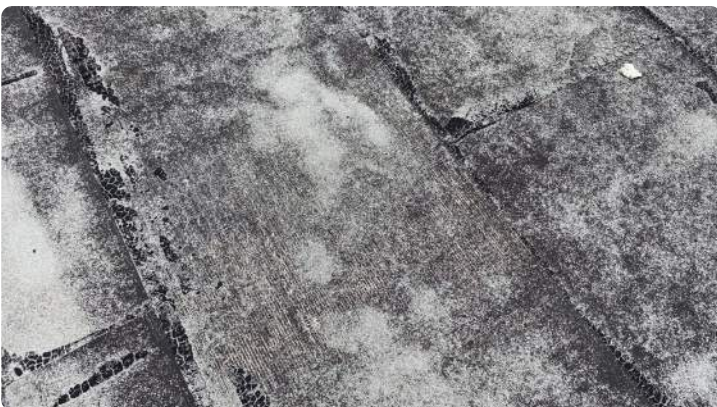
Photo showing skrim visible through the deteriorated field.

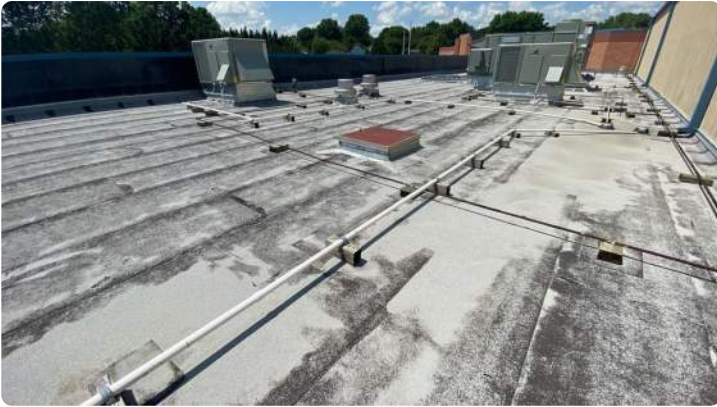
Poor condition

Skrim exposed, loose granules, field deteriorating

Photo showing overview of Area 04 roof.

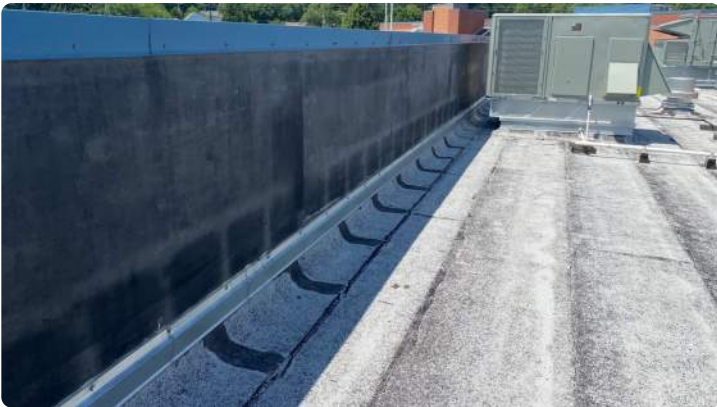
Photo showing condition of the perimeter flashings.

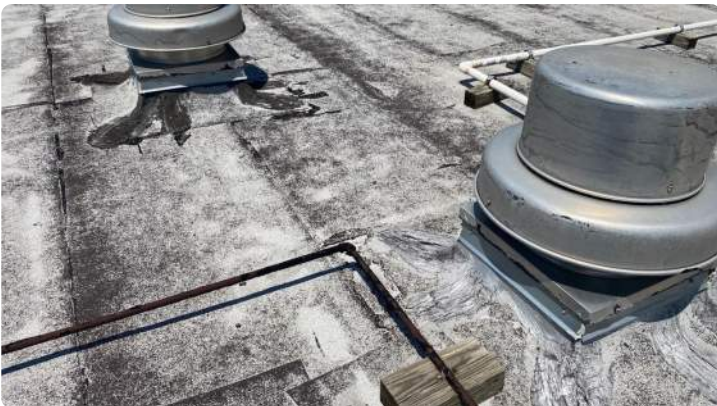
Photo showing condition of the projection flashings and deterioration of the field.

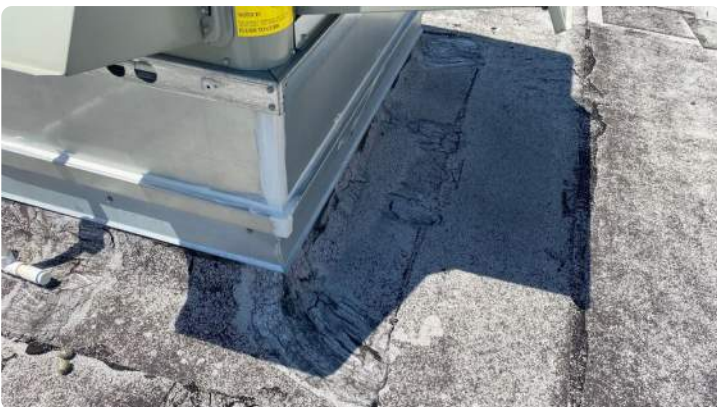
Photo showing cracking in projection flashings.

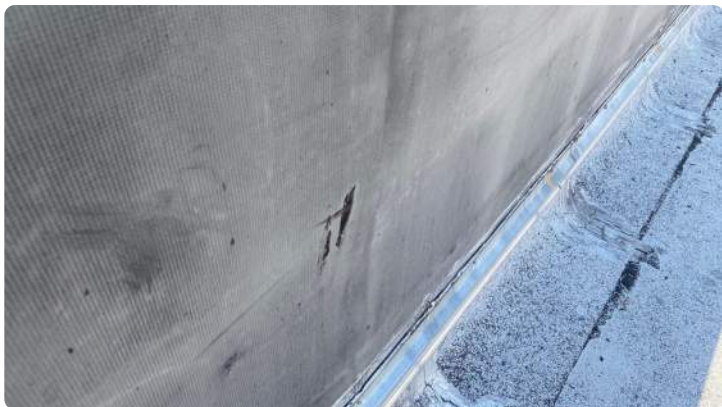
Photo showing deterioration in the perimeter flashings.

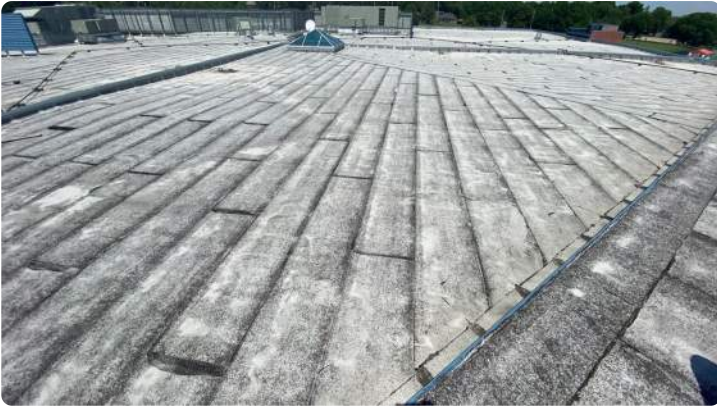
Poor condition

Skrim exposed, field deteriorating

Photo showing overview of Area 05 roof.

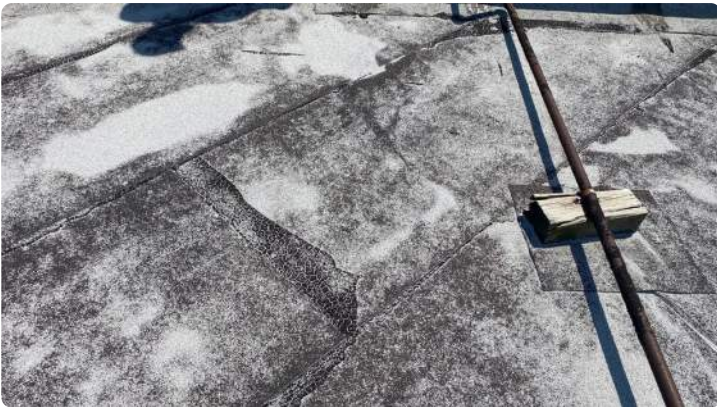
Photo showing granules piled up and deterioration of the field.

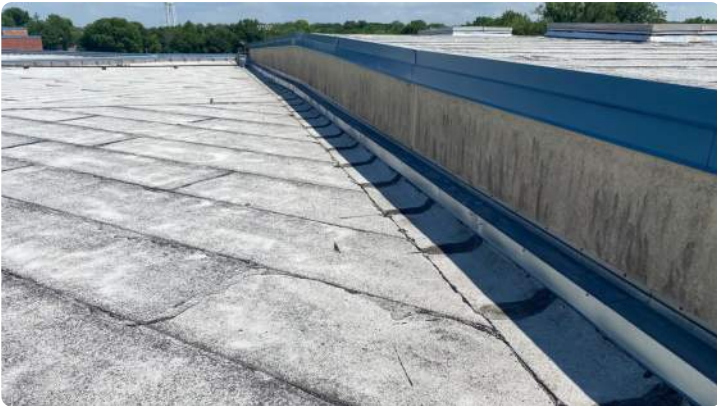
Photo showing condition of the perimeter flashings.

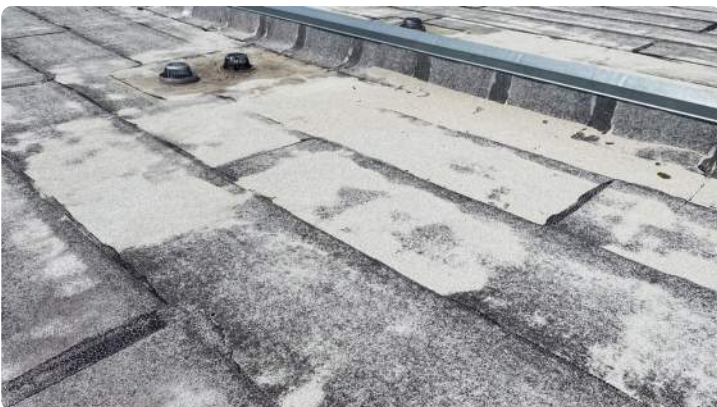
Photo showing granules piled up from field deterioration.

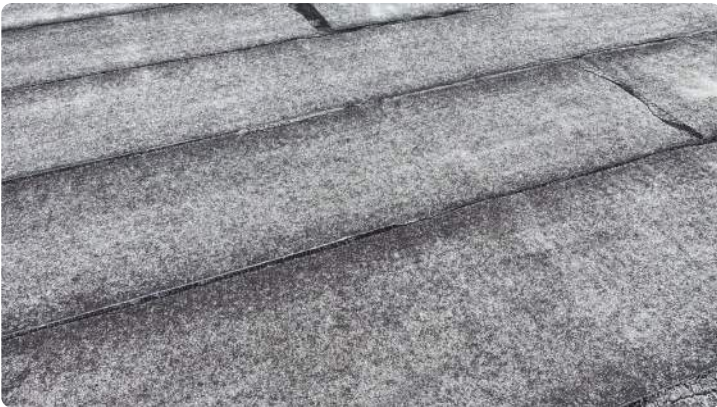
Photo showing scrim visble through deteriorated field.

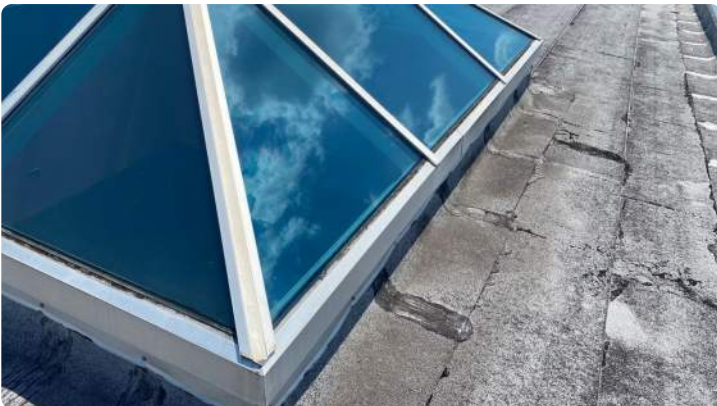
Photo showing condition of the skylight.

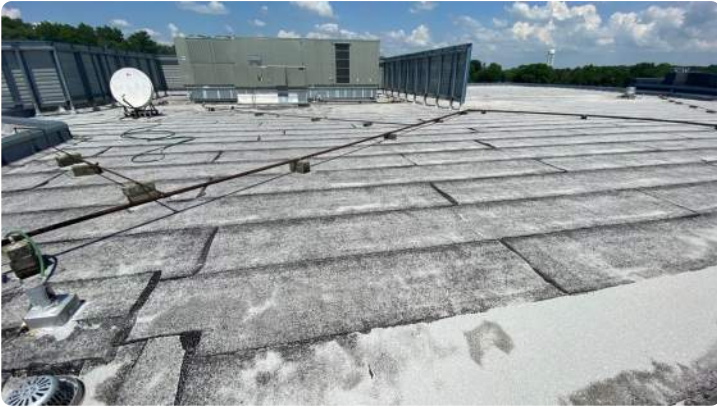
Poor condition

Skrim exposed, field deteriorating

Photo showing overview of Area 06 roof.

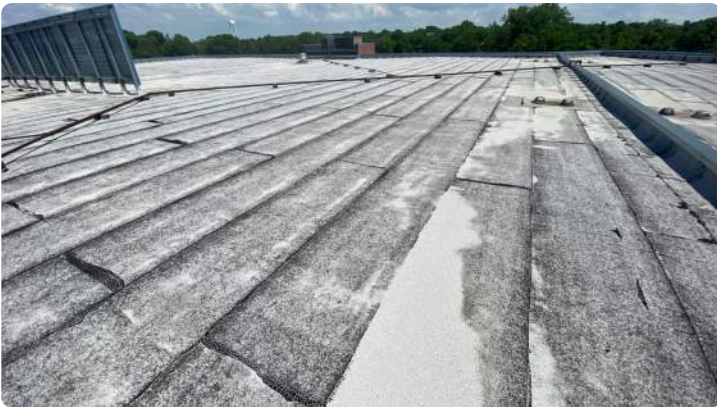
Photo showing additional overview of Area 06 roof.

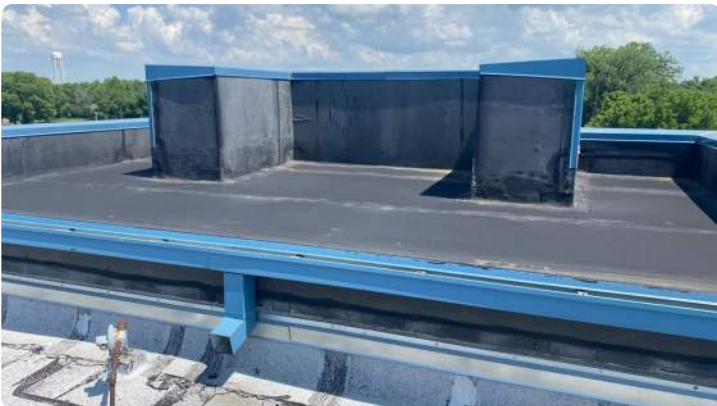
Photo showing condition of adjacent EPDM roof.

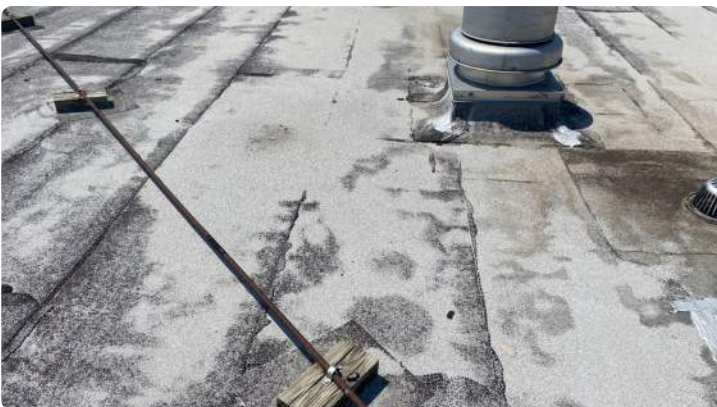
Photos showing granules piled up from deteriorating field.

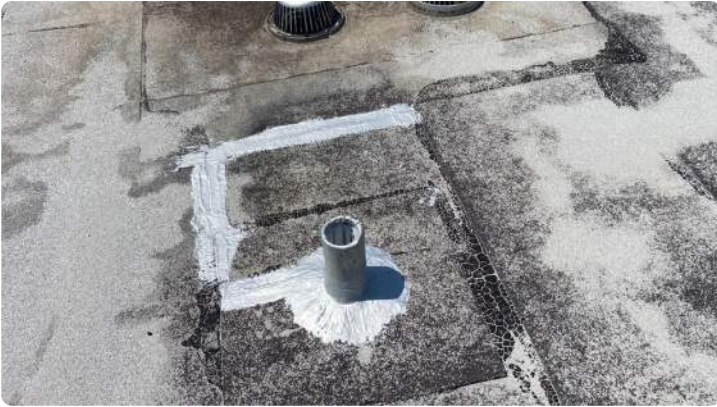
Photo showing aluminum coated seams on deteriorated field.

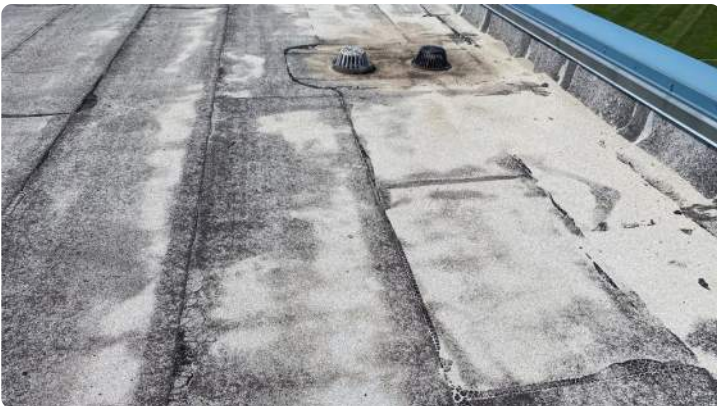
Photo showing granules piled up from deteriorated roof.

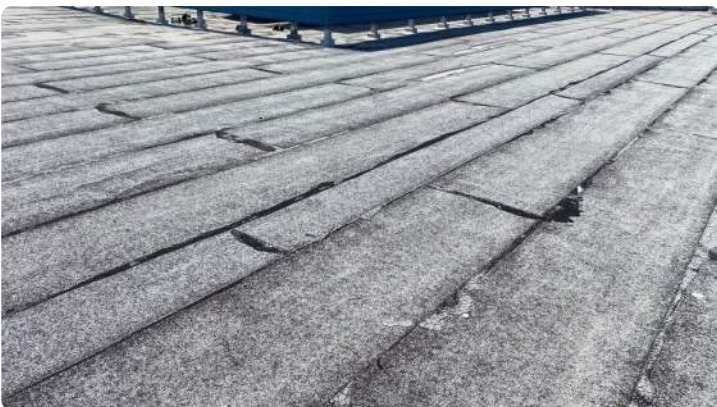
Photo showing deterioration of field.

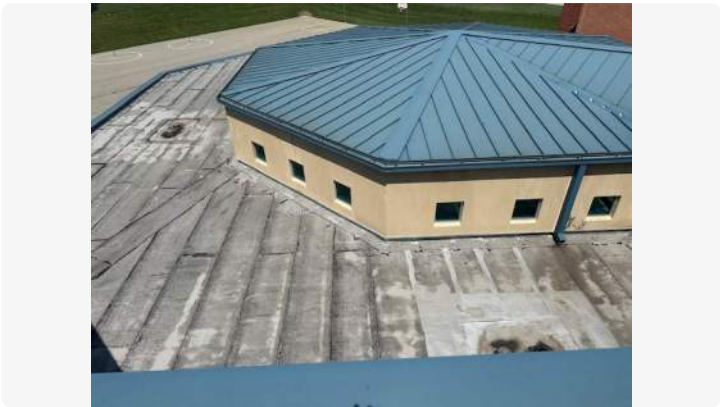
Poor condition

Skrim exposed, field deteriorating

Photo showing overview of Area 07 roof.

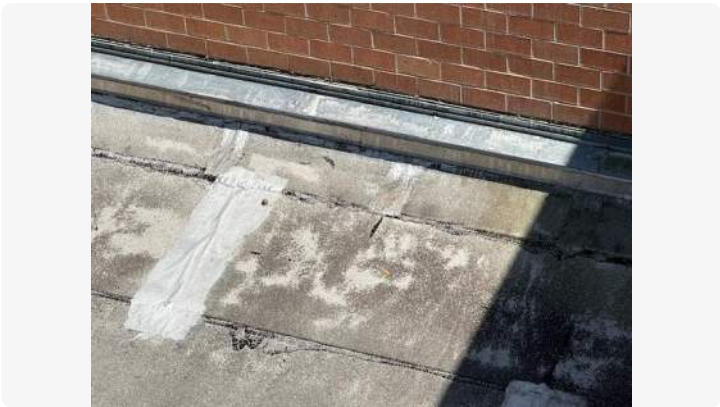
Photo showing condition of the perimeter flashings.

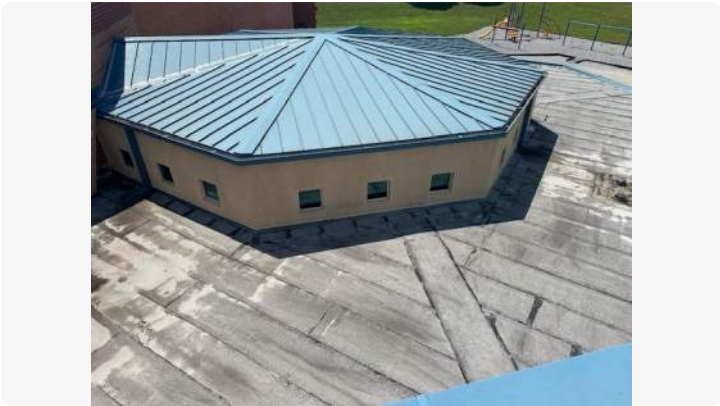
Photo showing additional overview of Area 07 roof.

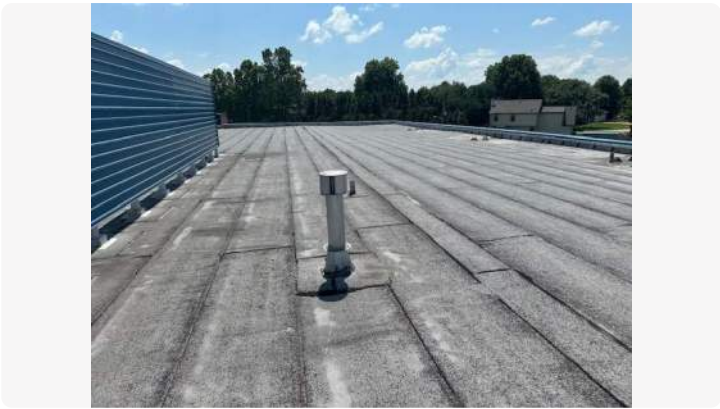
Poor condition

Skrim exposed, field deteriorating

Photo showing overview of Area 08 roof.

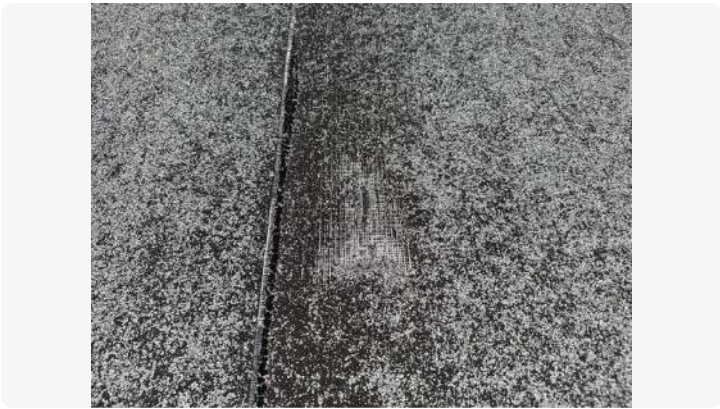
Photo showing exposed scrim in field.

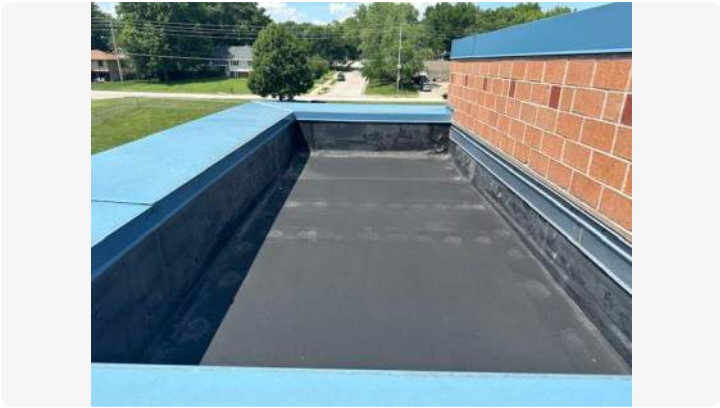
Photo showing adjacent EPDM section.

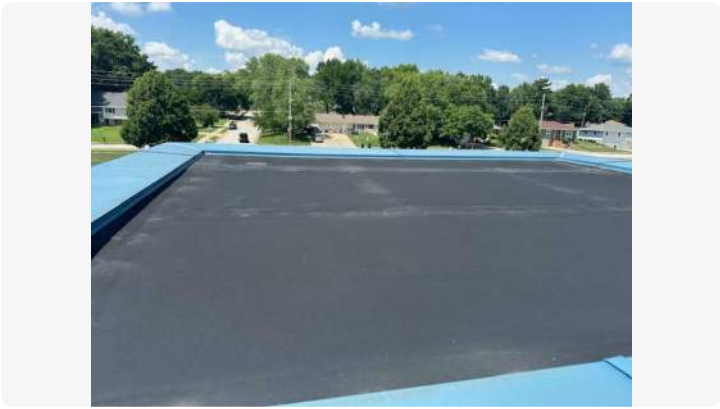
Photo showing additional EPDM section.

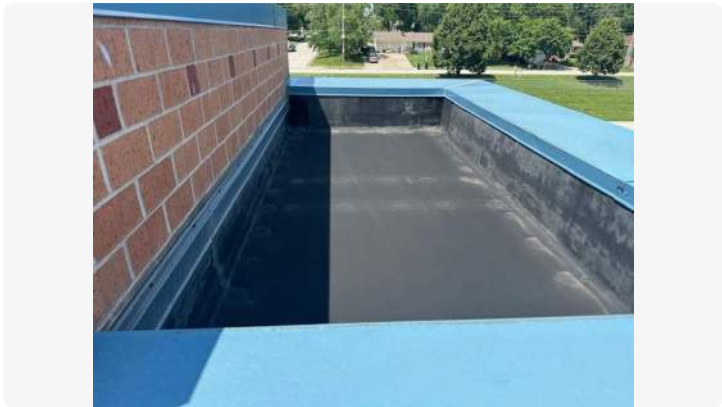
Photo showing additional EPDM section.

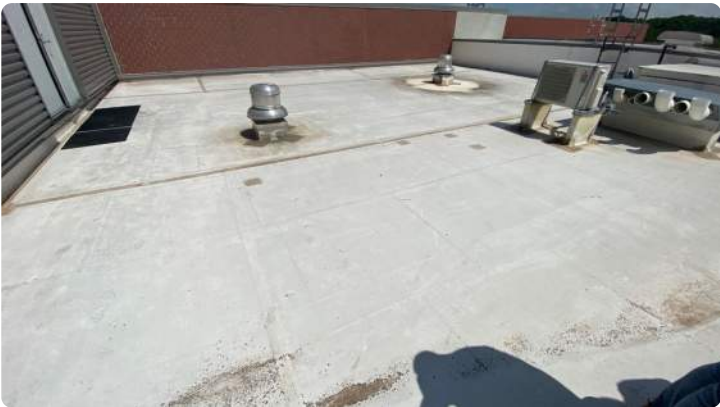
Photo showing overview of Area 01 roof.

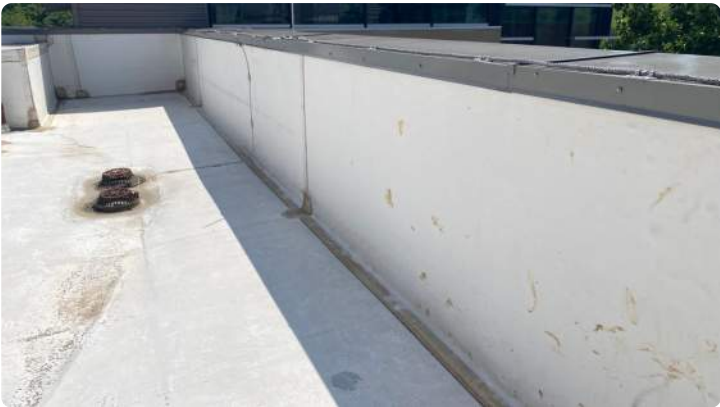
Photo showing condition of the perimeter flashings.

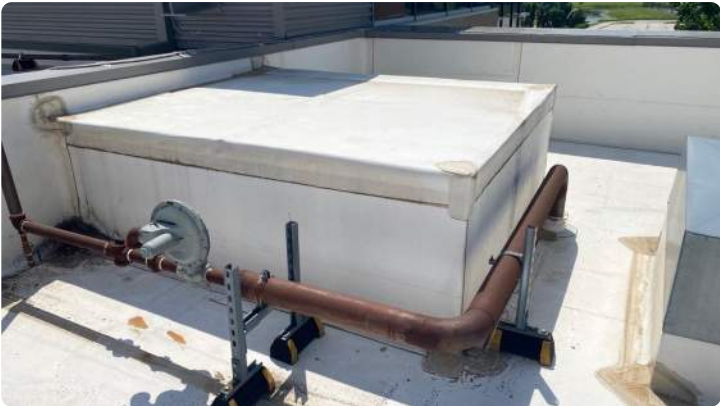
Photo showing condition of the projection flashings.

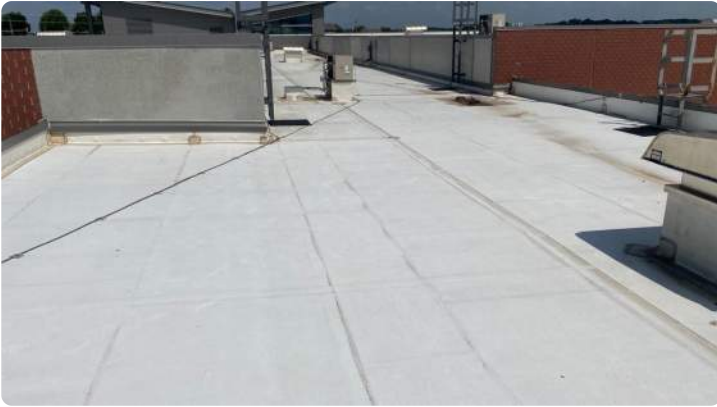
Photo showing overview of Area 02 roof.

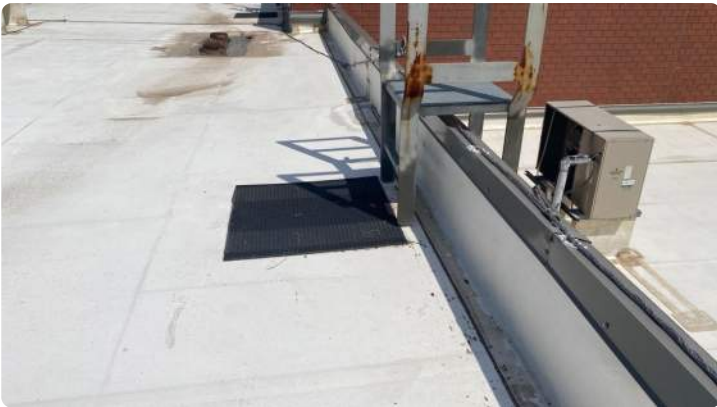
Photo showing condition of the perimeter flashings.

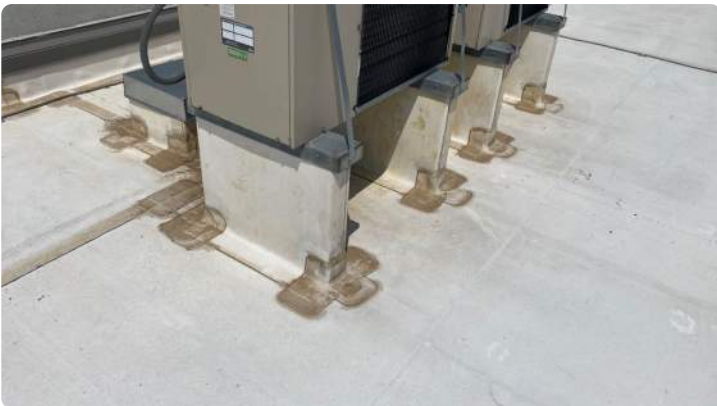
Photo showing condition of the projection flashings.

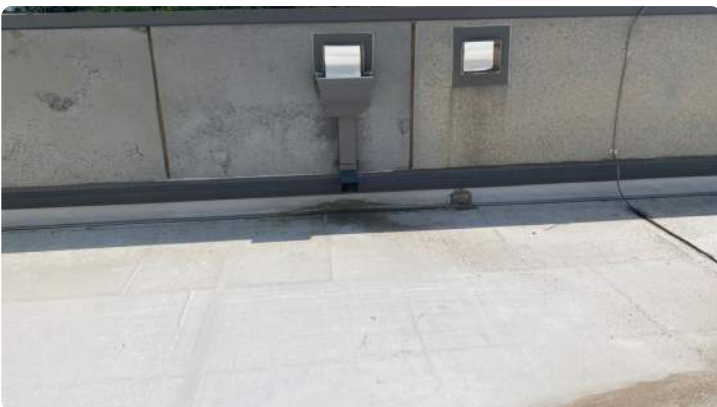
Photo showing additional photo of the perimeter flashings.

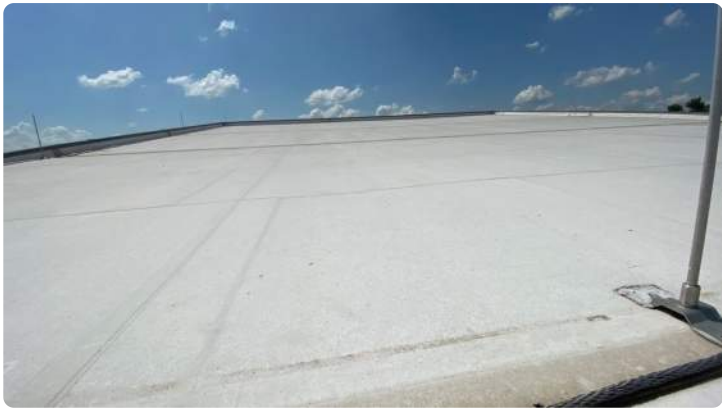
Photo showing overview of Area 03 roof.

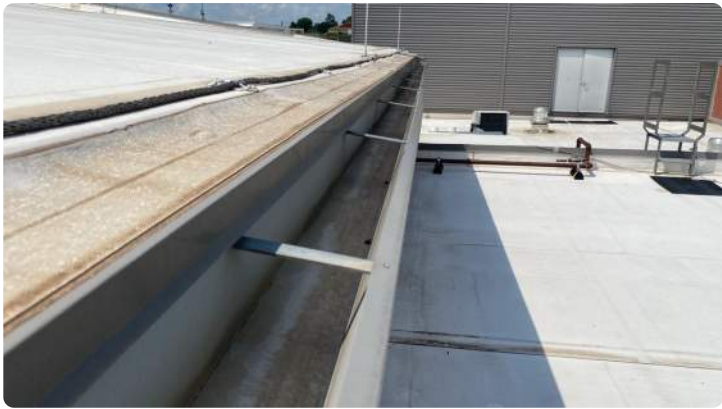
Photo showing condition of the gutter edge.

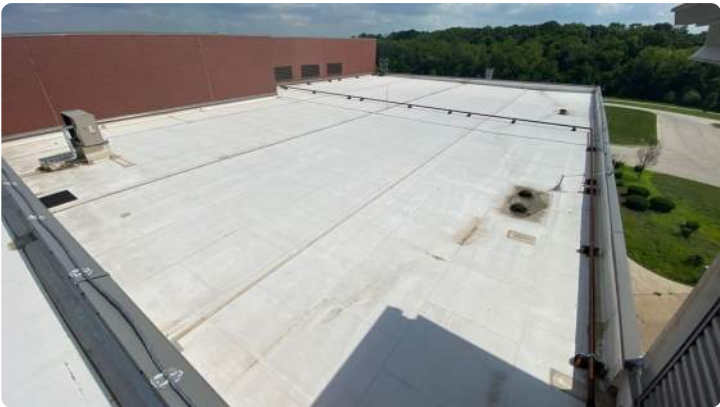
Photo showing overview of the Area 04 roof.

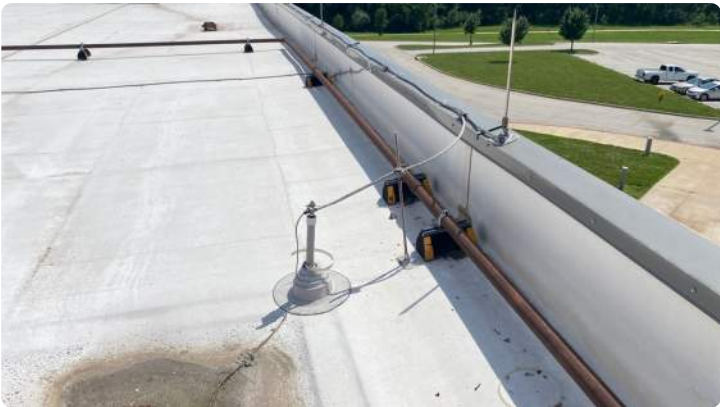
Photo showing condition of the perimeter flashings.

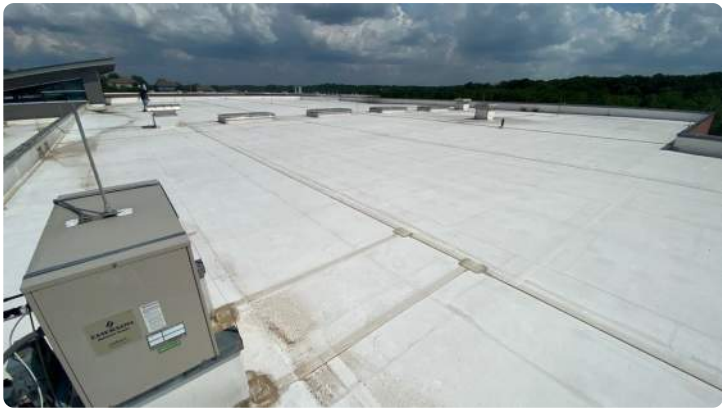
Photo showing overview of Area 05 roof.

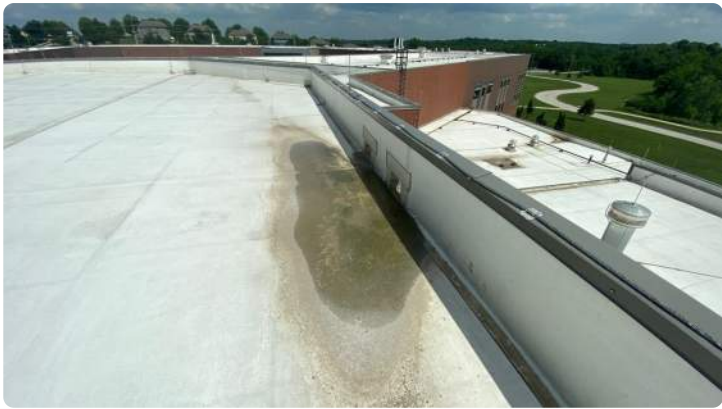
Photo showing condition of perimeter flashings.

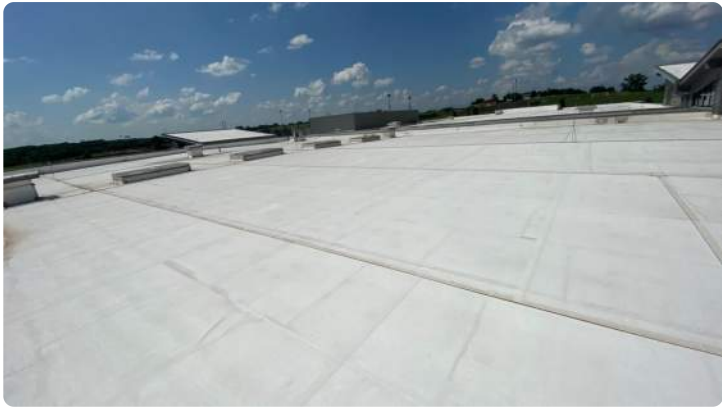
Photo showing additional overview of Area 05 roof.

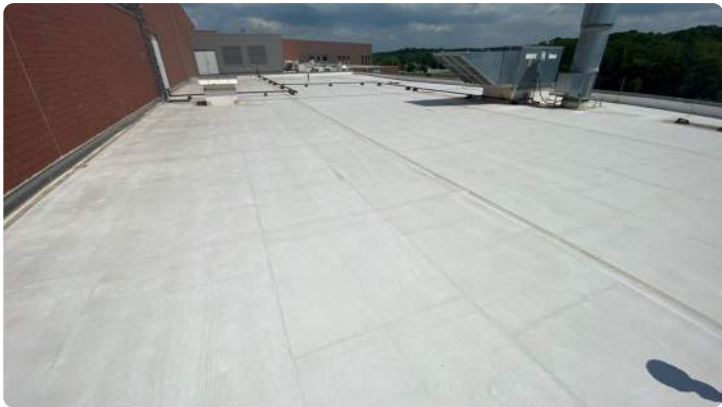
Photo showing overview of Area 06 roof.

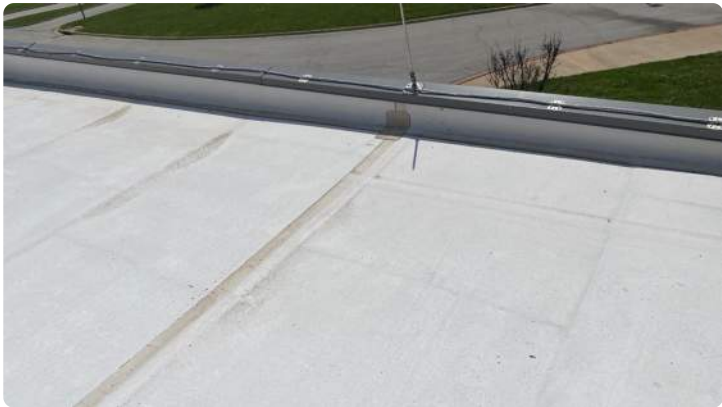
Photo showing condition of perimeter flashings.

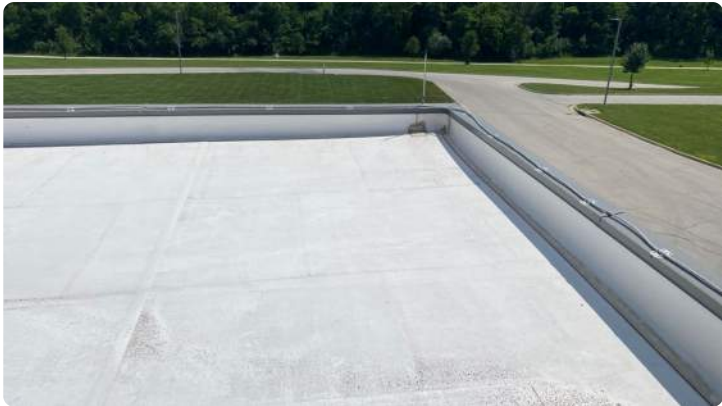
Photo showing condition of perimeter flashings.

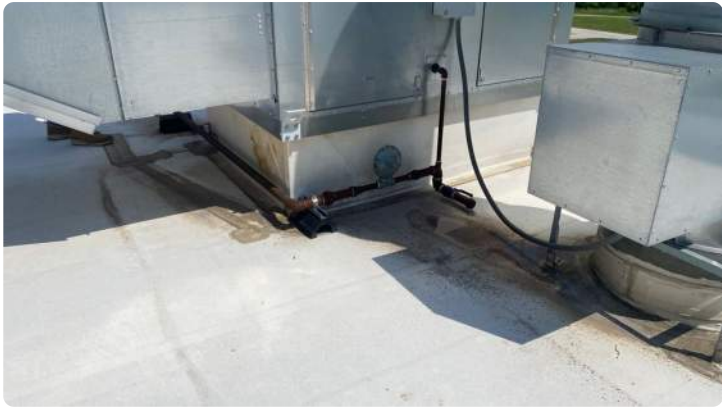
Photo showing condition if the projection flashings.

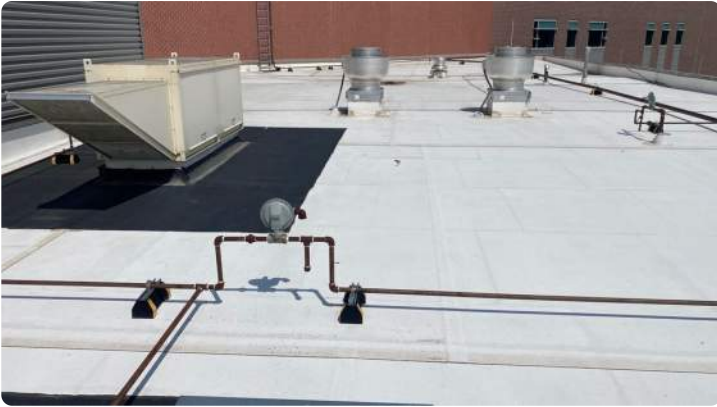
Photo showing overview of Area 07 roof.

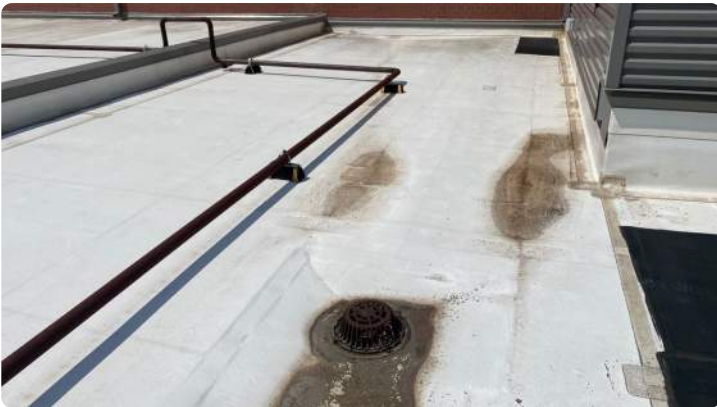
Photo showing additional overview of Area 07 roof.
