## 2024 LANSING PUBLIC SCHOOL CONDITION MAP

## Lansing KS Financial Summary Overview

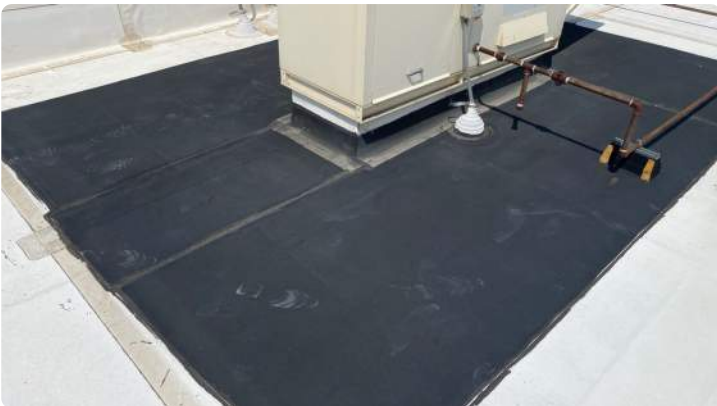
Photo showing condition if the projection flashings with layer of EPDM around unit.

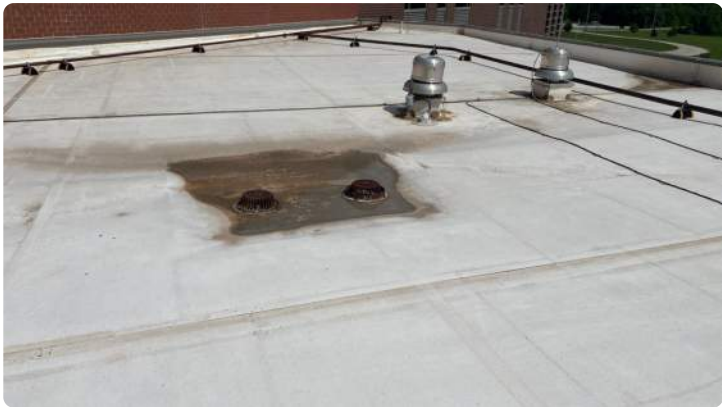
Photo showing additional overview of Area 07 roof.

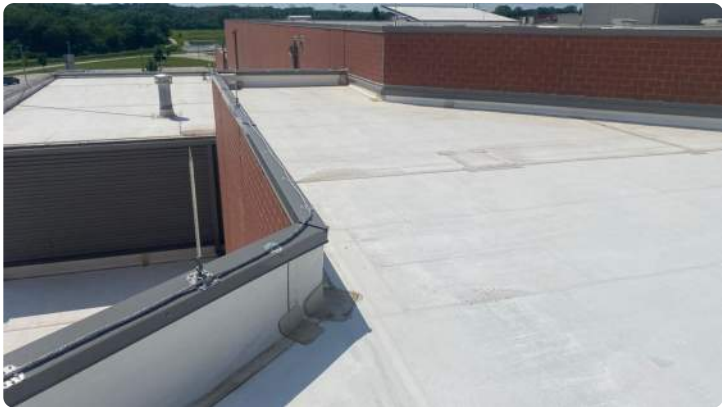
Photo showing overview of Area 08 roof.

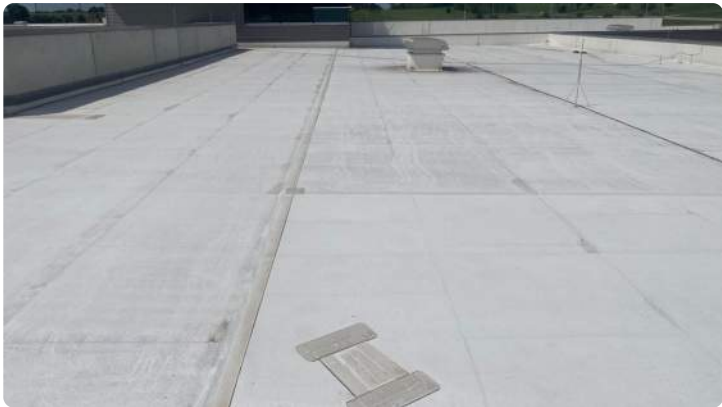
Photo showing additional overview of Area 08 roof.

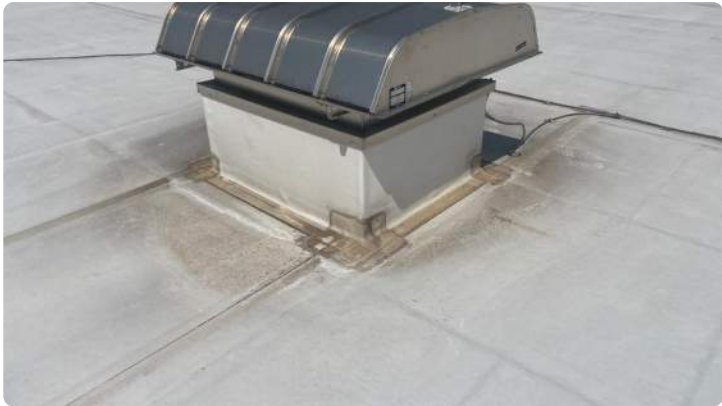
Photo showing condition of the projection flashings.

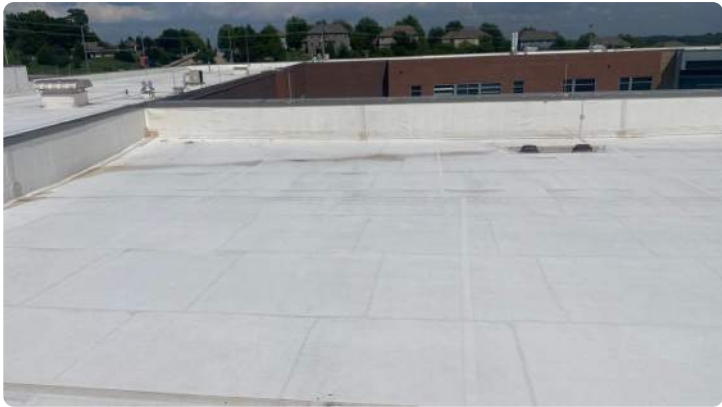
Photo showing condition of perimeter flashings.

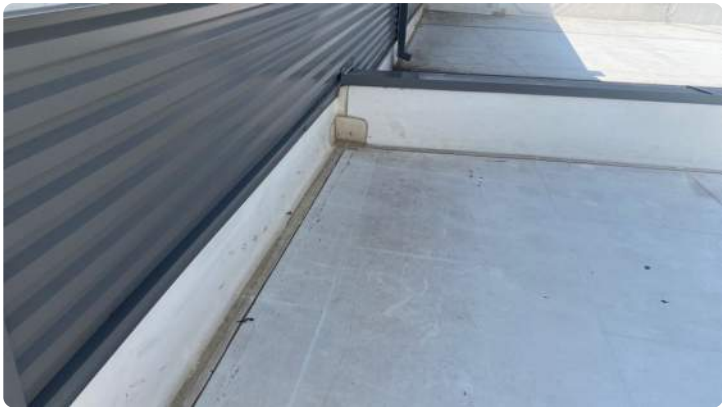
Photo showing condition of perimeter flashings.

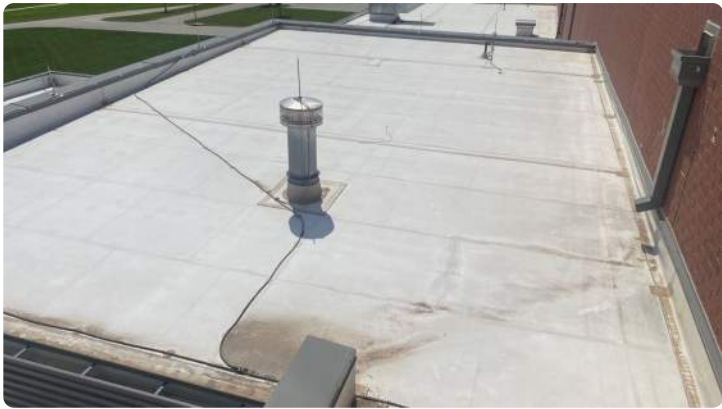
Photo showing overview of Area 09 roof.

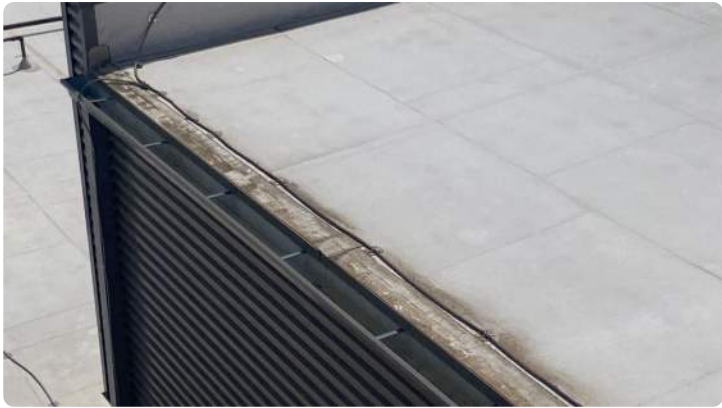
Photo showing condition of the gutter edge.

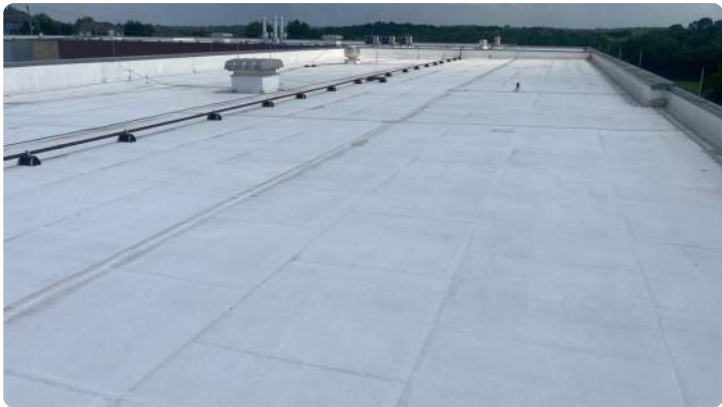
Photo showing overview of Area 10 roof.

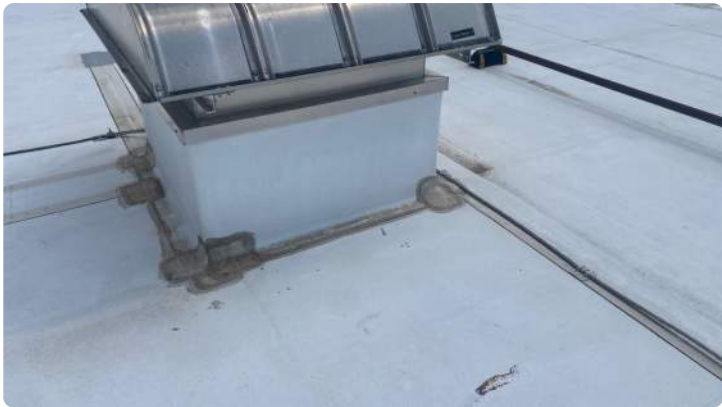
Photo showing condition of the projection flashings.

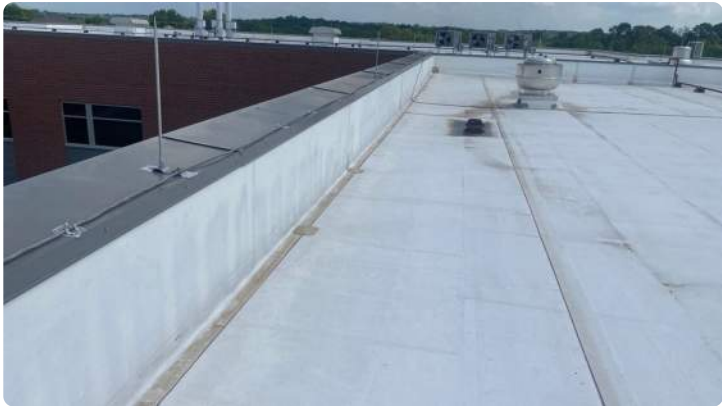
Photo showing condition of perimeter flashings.

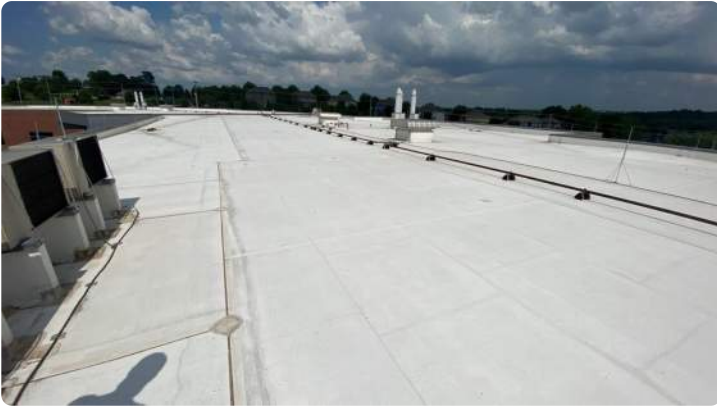
Fair condition

Photo showing overview of Area 11 roof.

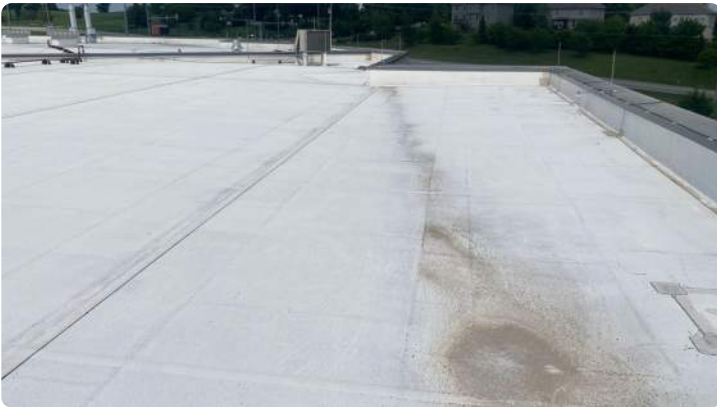
Photo showing additional overview of Area 11 roof.

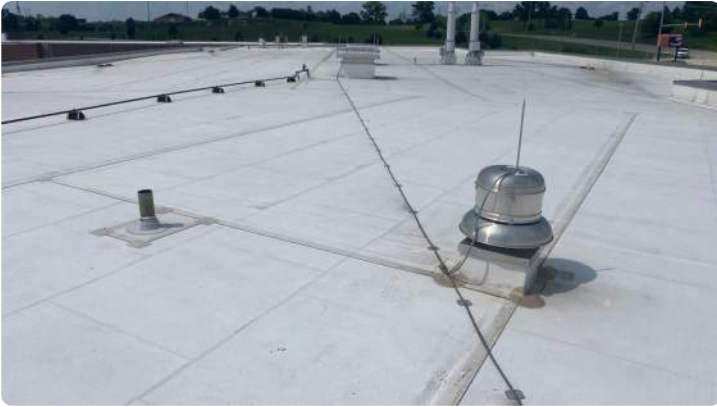
Fair condition

Photo showing overview of Area 12 roof.

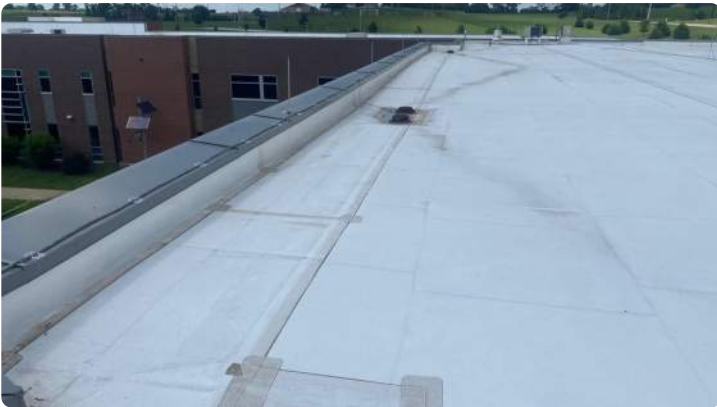
Photo showing condition of perimeter flashings.

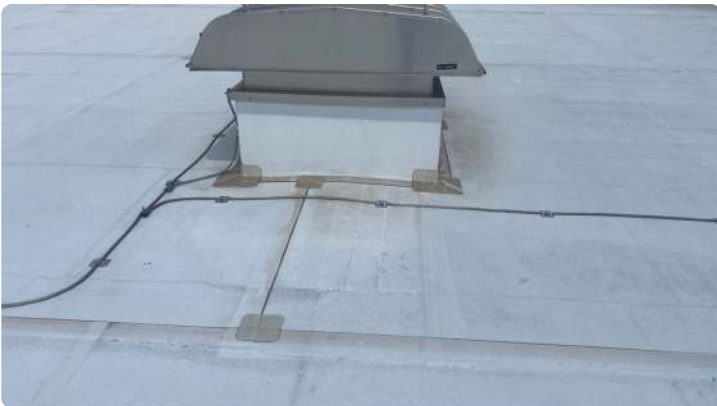
Photo showing condition of the projection flashings.

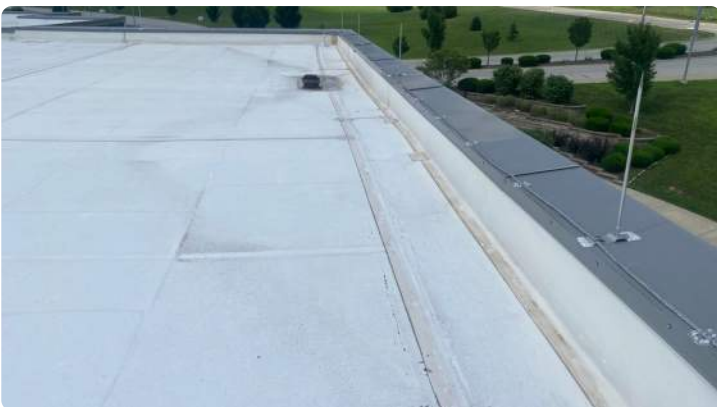
Additional photo showing condition of perimeter flashings.

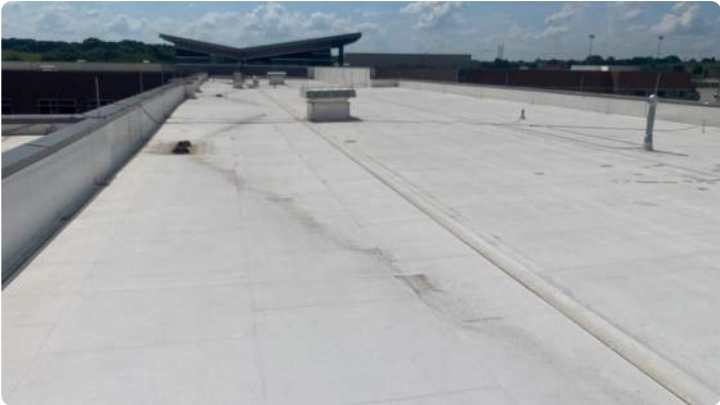
Fair condition

Photo showing overview of Area 13 roof.

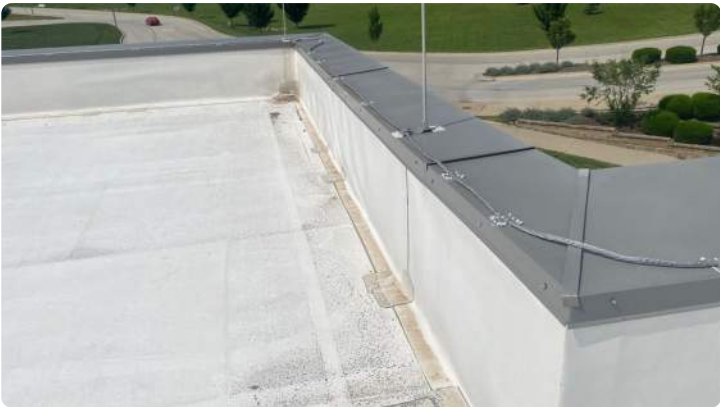
Photo showing condition of perimeter flashings.

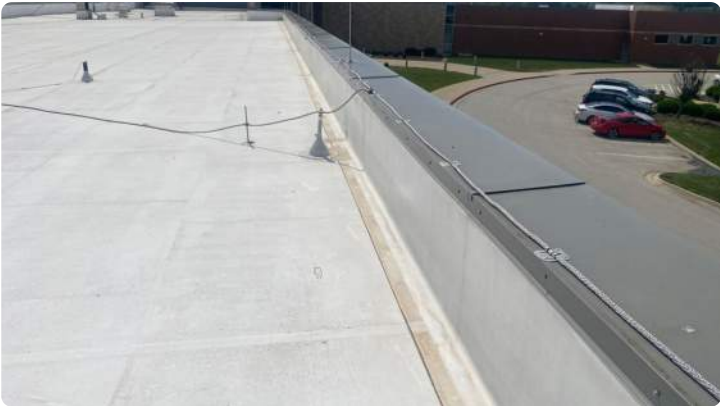
Photo showing condition of perimeter flashings.

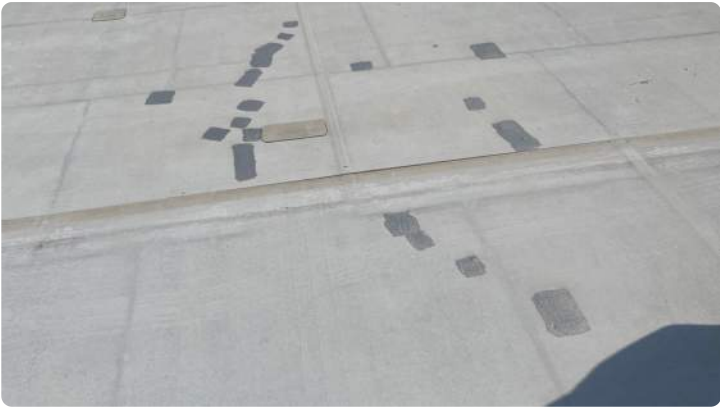
Photo showing multiple patches from previous damage.

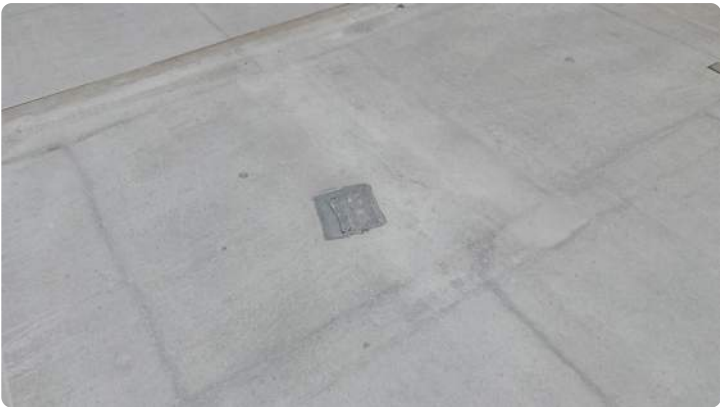
Photo showing additional patch to previous damage.

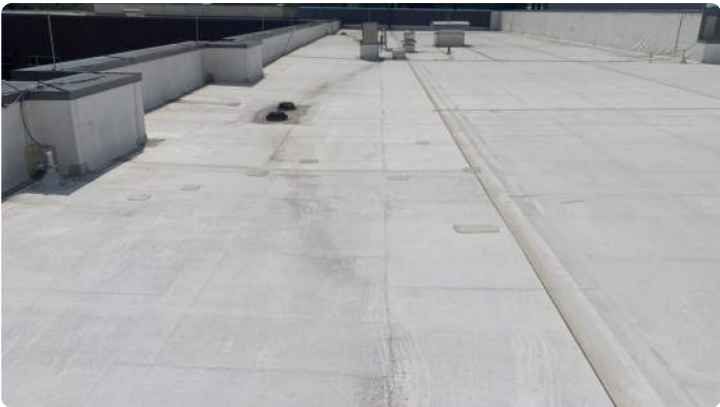
Photo showing additional overview of Area 13 roof.

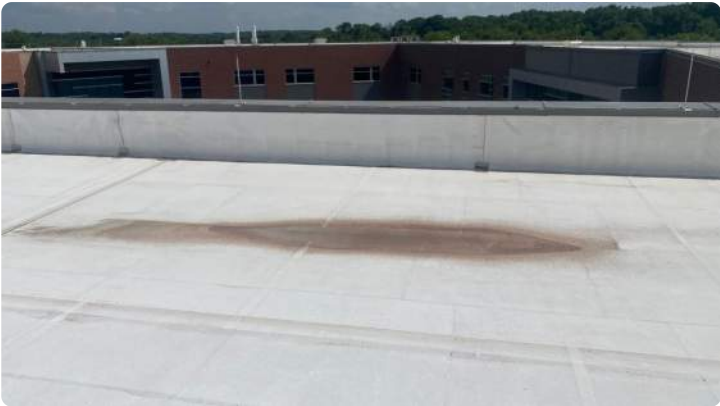
Photo showing minor ponding water.

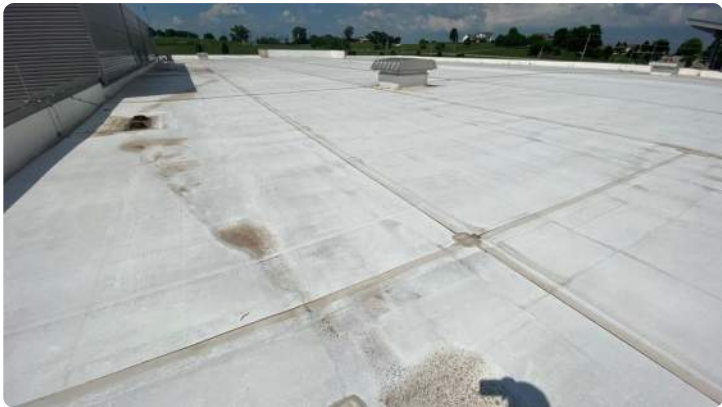
Fair condition

Photo showing overview of Area 14 roof.

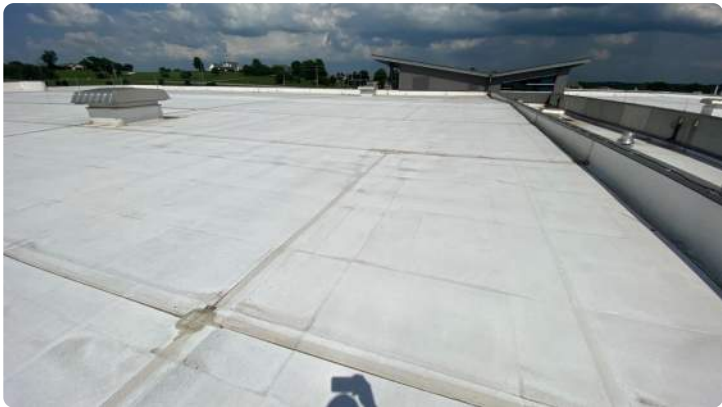
Photo showing additional overview of Area 14 roof.

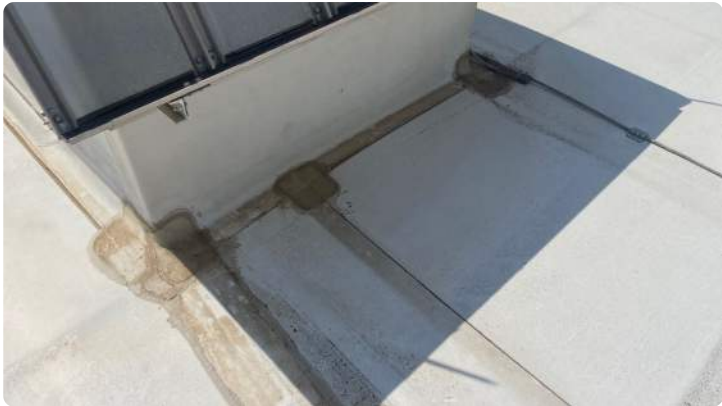
Photo showing condition of perimeter flashings.

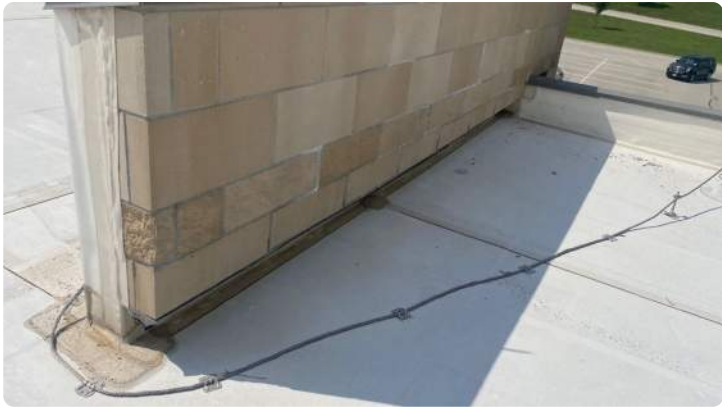
Photo showing condition of perimeter flashings.

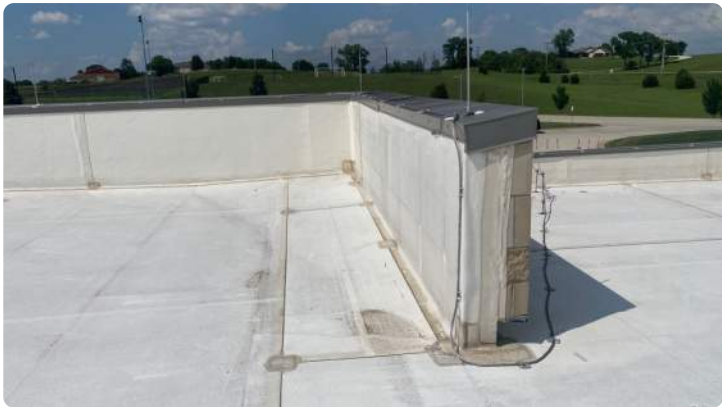
Photo showing condition of perimeter flashings.

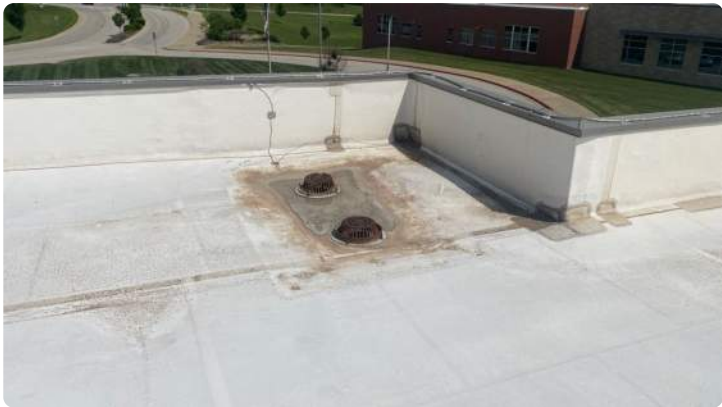
Photo showing condition of perimeter flashings.

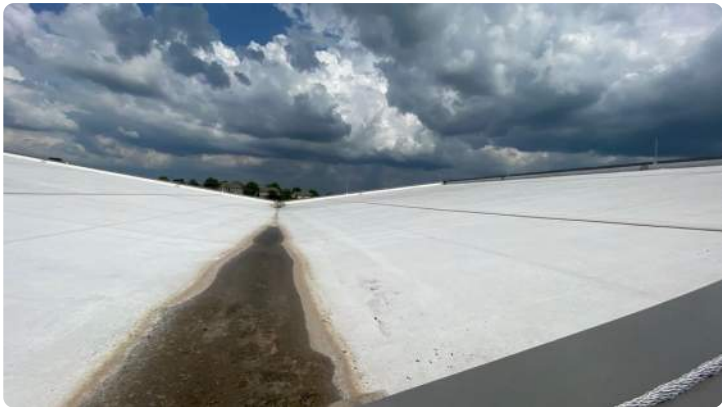
Fair condition

Photo showing overview of Area 15 roof.

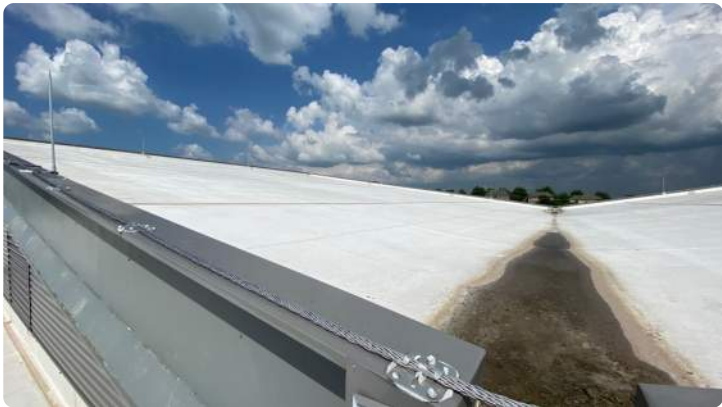
Photo showing additional overview of Area 15 roof.

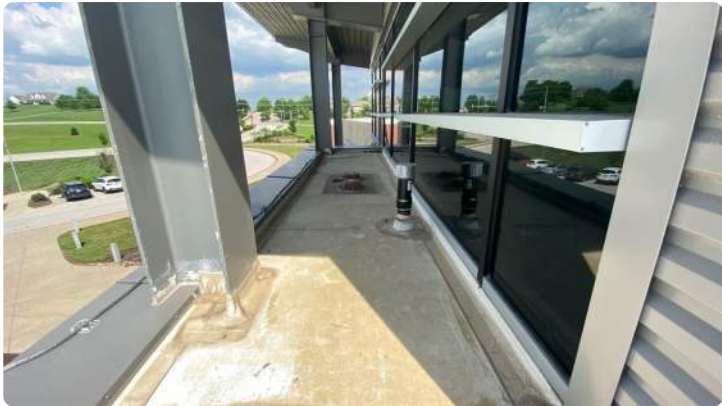
Photo showing condition of perimeter flashings.

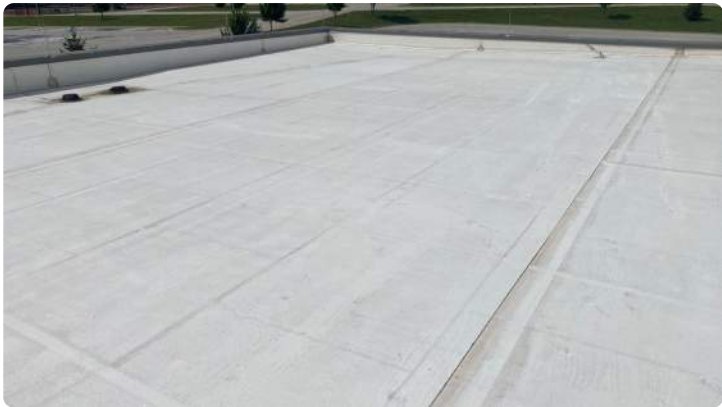
Fair condition

Photo showing overview of Area 16 roof.

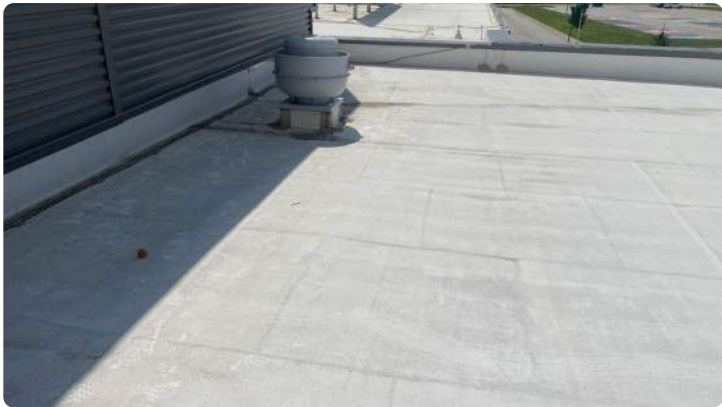
Photo showing condition of perimeter flashings.

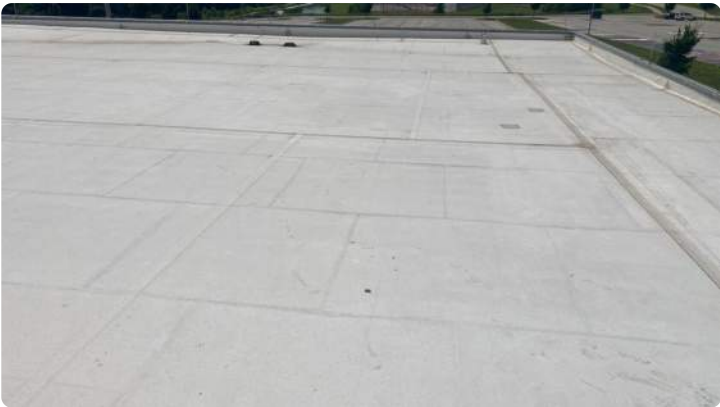
Fair condition

Photo showing overview of Area 17 roof.

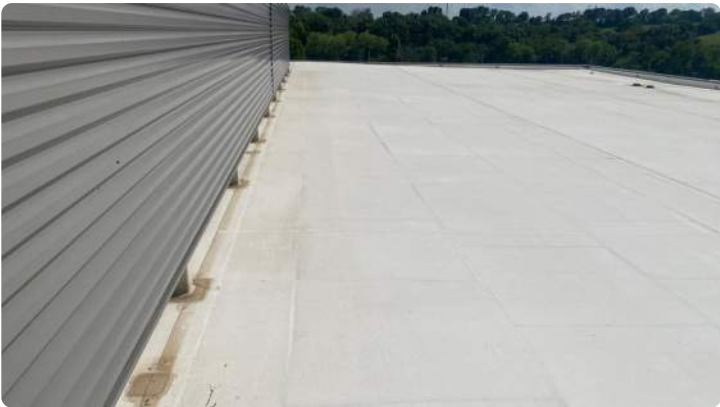
Photo showing additional overview of Area 17 roof.

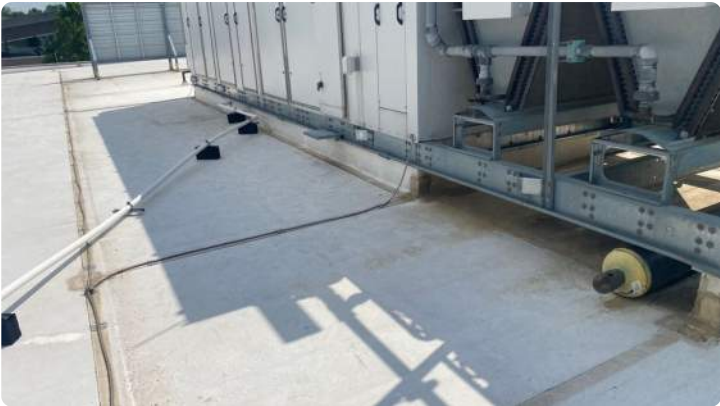
Photo showing condition if the projection flashings.

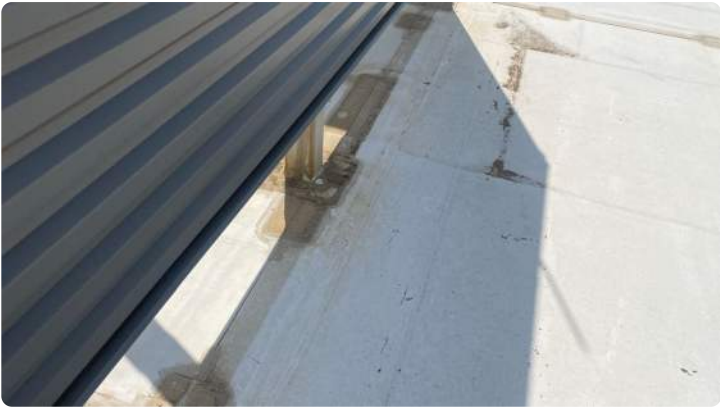
Photo showing condition if the projection flashings.

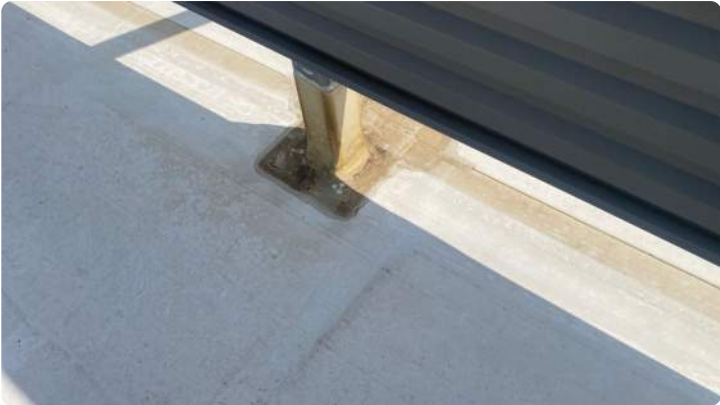
Photo showing condition if the projection flashings.

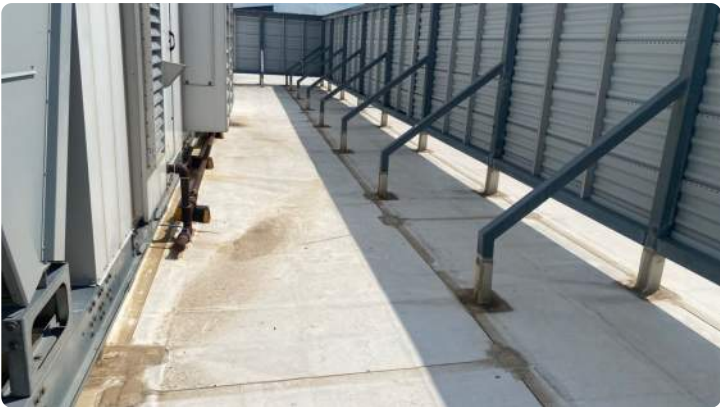
Photo showing condition if the projection flashings.

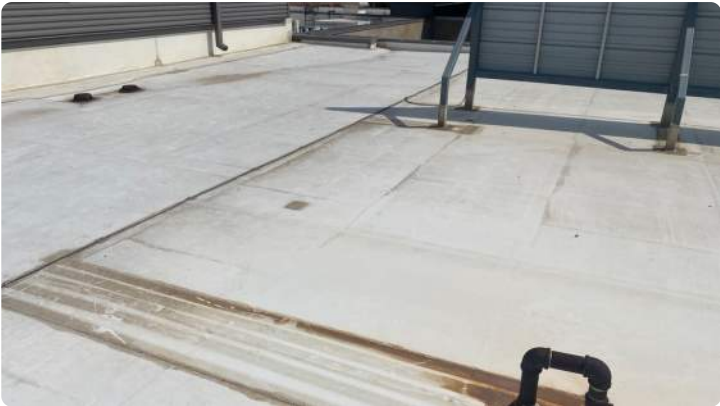
Photo showing additional overview of Area 17 roof.
