USD 469

Lansing

Facility Assessments

Summer 2023

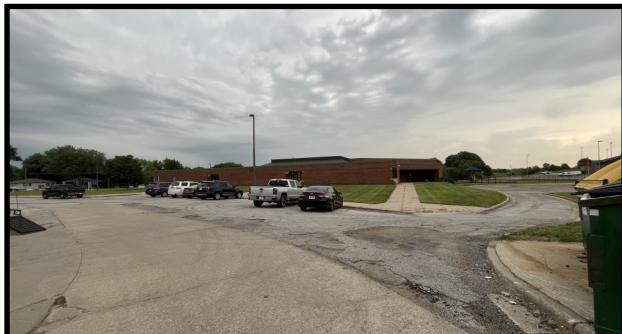
Drives and Sidewalk Access

Site Component	Comments
Parking	1 Drives and sidewalk accesses are worn and damaged.
Parking	2 There is no handicap parking striping and ramp access is non-compliant.
Parking	2 There is no sidewalk protection at drop off area. Bollards or curbs would help protect the sidewalk.
Parking	2 No sidewalk protection at drop off area. Concrete drive is in need of repair.
Parking	2 Handicap parking, stalls, ramp, and signage is non-compliant.
Pavement-Sidewalks	2 Parking area, loading area, and sidewalks are deteriorated and overgrown with weeds.
Pavement-Sidewalks	2 Sidewalks and building joint at sidewalk is overgrown with weeds.
Pavement-Sidewalks	2 Expansion joint at sidewalk is overgrown with weeds.
Pavement-Sidewalks	1 Brick sidewalks are pulling away from the building. There is differential settlement at the sidewalk and minor brick cracking in the corner.
Pavement-Sidewalks	2 Concrete sidewalks are spalling.

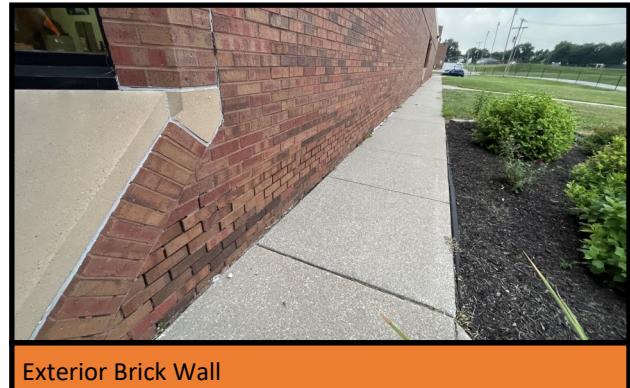
Exterior Brick Wall

Envelope Component		Comments
Walls-Soffits	2	Deteriorated masonry joints indicate water within the exterior wall. Sidewalk joint at building recommended to be sealed.
Walls-Soffits	2	There appears to be no weep holes within the brick cavity wall.
Walls-Soffits	2	There is brick cracking and movement at the underside of the corner soffit. Paint and rust touch up at the underside of the soffit is necessary.
Walls-Soffits	2	Brick joints have deteriorated and brick has moved at upper corner of wall.
Walls-Soffits	1	Precast concrete accent at the underside of the lintel has shifted, causing large gap at the wall.
Walls-Soffits	2	Steel lintel has rusted at underside of soffit. There appears to be no flashing or weep holes at the brick.
Walls-Soffits	2	Evidence of water damage with rust at the lintel, and effervescence at the brick.
Walls-Soffits	2	Effervescence at the brick wall, likely caused by water damage.

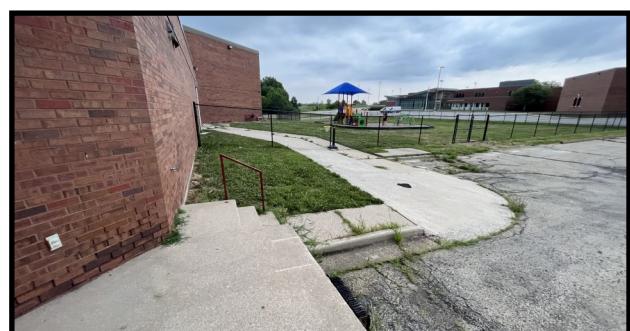
Damaged Brick at Lower Wall Section

Miscellaneous	1	Damaged brick at lower section of wall. Non-compliant railings at loading dock stair.
Miscellaneous	3	Playground equipment appears to be in good condition. There is yardwork and writing in the grass area that may need addressed.
Miscellaneous	2	There is erosion under the sidewalk adjacent to the stair. Railings are non-compliant.
Miscellaneous	1	The railroad tie retaining wall is shifting and may be unsafe.
Miscellaneous	1	Playground retaining wall is deteriorated and appears unsafe.
Miscellaneous	2	There is no protective railing at retaining wall in excess of 3 feet tall.
Miscellaneous	2	Sidewalks and lower portion of concrete wall are deteriorated.

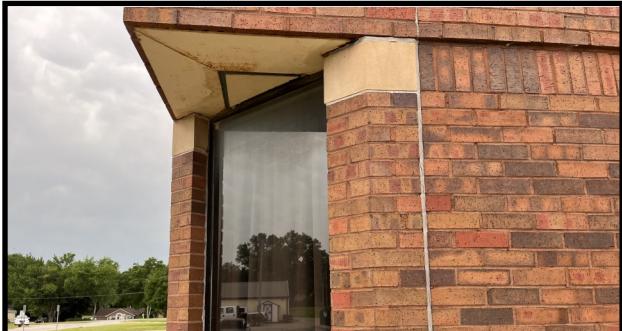
Lintels, Window Sills

Envelope Component	Comments
Miscellaneous	Lintel and soffit finish are rusted and damaged. No lens at light fixture.
Windows-Doors	Lintel wall and window sills are deteriorated and need repair.
Windows-Doors	There is a large gap between the soffit and the door frame. General door damage as well.
Windows-Doors	Window frame and glazing is in poor condition.
Roof	Roof finish is damaged. Thorough and detailed roof inspection is recommended.
Roof	Roof finish is peeling. Dark areas of roof indicate significant ponding may be an issue.
Roof	Significant peeling and blistering of roof finish.
Roof	Metal roof appears to be damaged.
Roof	Roof flashing sealant has been heavily applied. Roof transition cants appear worn.
Roof	Corner of roof appears to experience significant ponding. Roofing granules have collected in large areas. Roof membrane appears deteriorated.
Roof	Roof granules have collected in large areas.

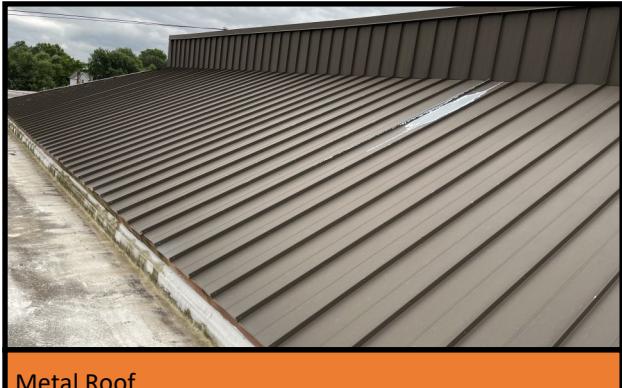
Metal Roof

Roof	Wood expansion joint covering is damaged with exposed nails.
Roof	Roof at screened equipment area is blistered, and traffic mats are deteriorated.
Roof	Metal wall panel at equipment room has significant gap.
Roof	Roof penetrations appear to be at areas of ponding water. There appears to be minimal flashing at penetrations.

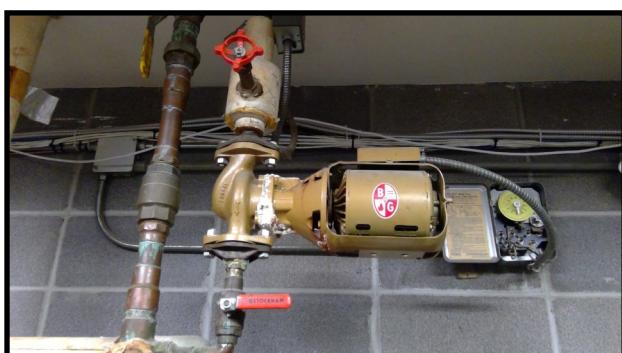
Plumbing Component	Comments
Water Closets	3 Floor mount manual flush valve.
Urinals	3 Wall mount manual flush valve.
Lavatories	3 Wall hung lavatories with two handle manual faucets.
Drinking Fountains/ Water Coolers	3 ADA height units with bottle fillers.
Janitor Sinks	3 2x2 floor mount sink with wall mount faucet; ensure faucet is provided with vacuum breaker.
Roof Drains/Overflow Drains	3 Roof drains and overflow drains with cast iron dome strainers in good condition.
Water Heaters	3 2014 electric water heater.
Circulation Pumps	3 Inline circulator showing signs of corrosion.

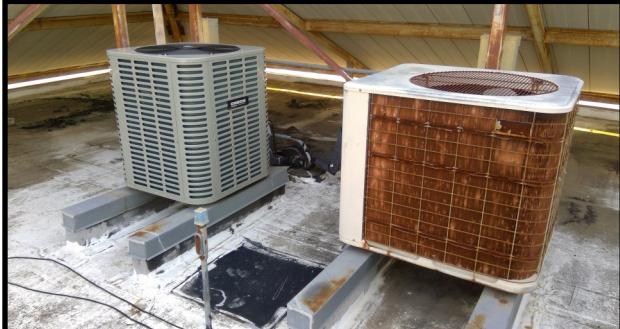
HVAC Component	Comments
Building Automation System	3 Automated Logic controls for all buildings in district. Some units on standalone thermostats. Recommend integrating all equipment into BAS control system.
1985 Addition Condensing Units	2 Residential style condensing units. One unit is new and in good condition. Second unit is 40+ years old and well beyond expected life.
1985 Addition Air Handling Units	2 Trane horizontal air handlers 40+ years old are well beyond expected life.
Original Building Condensing Unit	2 2003 Condensing unit is approaching end of expected life.
Original Building Air Handling Unit	1 1970s air handler located in rooftop penthouse is beyond expected life.
VAV Boxes	1 VAV boxes were not visible on walk through; if original to building, equipment is beyond expected life.
Baseboard Heaters	2 Electric baseboard heaters; recommend improved controls for thermostatic operation of heaters.

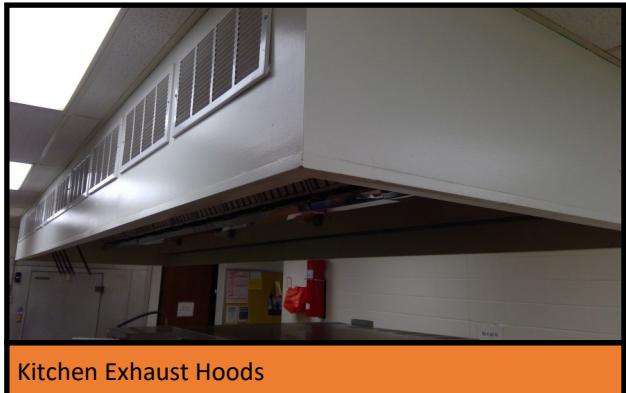
HVAC Component	Comments
Heating and Ventilating Unit	1 Heating and ventilation unit with electric heater for kitchen hood make up air is beyond expected life.
Kitchen Exhaust Hoods	2 Kitchen exhaust hood with ansul system appeared to be in good condition. Recommend test and balance to ensure proper airflow; exhaust fan is beyond expected life. Dishwasher exhaust ducted to outdoors.
Ventilation Air	3 Via Air handler. Configuration of outside air intake does not allow for accurate balancing of outside air to individual spaces.
Air Distribution Ductwork	3 Sheetmetal rectangular.
Unit Heaters	3 Electric wall heaters; some superficial damage to grates.
Exhaust Fans	2 Rooftop exhaust fans beyond expected life.
HVAC Piping Insulation	2 Exterior refrigerant piping insulation is damaged/missing where visible.

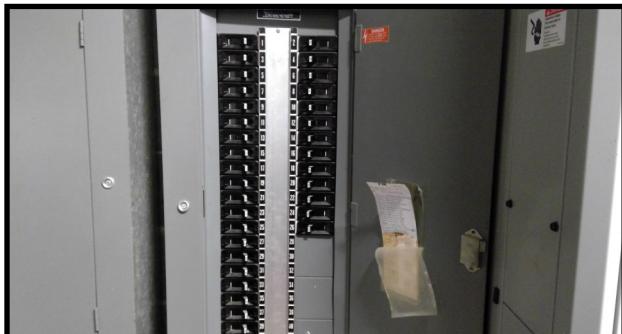
Electrical Component	Comments
Switchboards	4 1600A 480V-3ph Siemens SB3 switch-board.
Branch Circuit Panelboards	2 Obsolete Federal Pacific panels. Recommend replacement with new. Some new GE A-Series panels in good condition.
Enclosed Disconnect Switches	3 Heavy duty square D disconnects in NEMA 3R enclosure.
Feeders	3 Rigid EMT where visible. Some MC cabling utilized.
Wiring Devices	3 Devices appear to be commercial specification grade with stainless steel or nylon cover plates. Snap switches are rated for 20 amps, and receptacles rated for 15 amps.
Ambient Lighting	2 Surface mounted and recessed T8 Linear Fluorescent is in serviceable condition. Consider replacement with LED for improved efficacy and energy savings.
Gymnasium Lighting	2 Recessed T8 Linear Fluorescent is in serviceable condition. Consider replacement with LED for improved efficacy and energy savings.
Emergency Lighting	3 Twin head unitary emergency lights with integral battery backup.

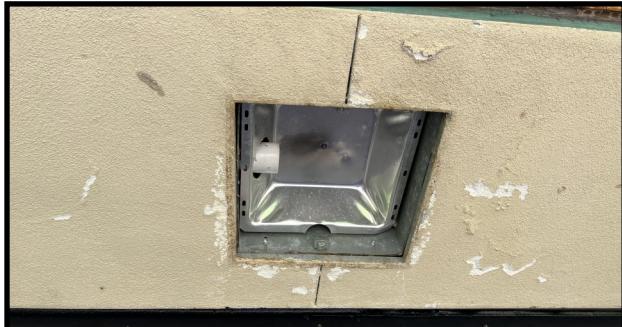
Exit Signage	3 Thermoplastic exit signs with red LED letters and integral battery backup.
Exterior Building Mounted Lighting	2 Compact fluorescent and HID wall packs and surface canopy lights. Consider replacement with LED.
Parking Lot Lighting	2 Pole mounted fixtures with LED replacement lamps; source of power unknown. Recommend investigation to determine how to safely disconnect power for servicing fixtures.

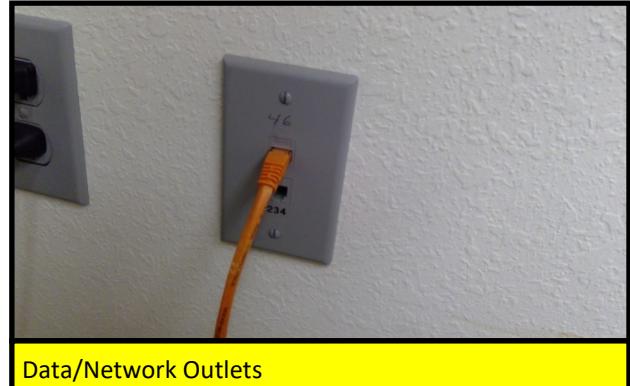
Communications Component		Comments
Communications Raceway Systems	3	Cabling installed loose overhead and concealed inside walls. Some surface raceway is present.
Data/Network System Equipment	3	Category 5/5e patch panels wall mounted I.T. racks.
Data/Network Horizontal Cabling	3	Category 5e/6 UTP copper cabling from patch panels to wall outlets.
Data/Network Outlets	3	Category 5e/6 RJ45 jacks in nylon wall outlets.

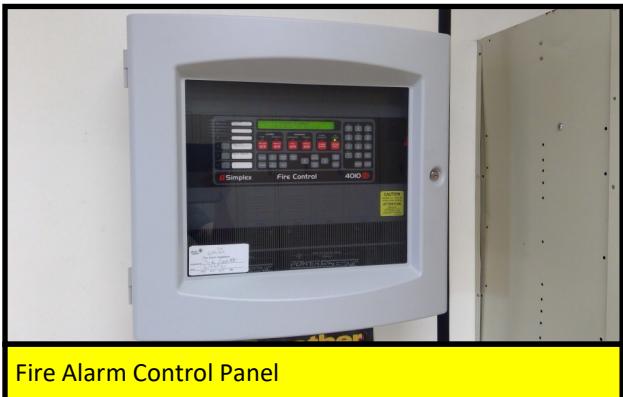
Fire Alarm Component	Comments
Fire Alarm Control Panel	3 Simplex 4010 control panel.
Smoke Detectors	3 Ceiling mounted spot type area detectors.
Manual Pull Stations	3 Single action stations at exits.
Notification Appliances	3 Ceiling and wall mounted strobes/horns.

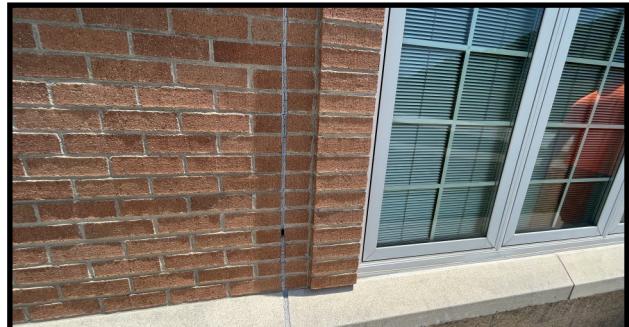
Brick Control Joints

Envelope Component		Comments
Walls-Soffits	2	Brick control joints should be resealed.
Walls-Soffits	3	Brick and masonry sills in generally good condition. Resealing is needed at many control joints.
Miscellaneous	3	No rust at lintels. Some paint scraping and touch up is necessary.
Miscellaneous	2	Gate gets stuck on asphalt.
Miscellaneous	3	Blacktop surface in good condition. Ramp access to playground is provided.
Miscellaneous	2	Playground curbing system does not contain the cushion material within the curbed area.
Windows-Doors	2	Brick tuckpointing and paint touchup at lintel is necessary.
Windows-Doors	3	Exterior windows appear in generally good condition.
Roof	2	Modified Bitumen roof, appears aged and worn.
Roof	3	Gas pipe support appears secure.
Roof	2	There is debris on roof. Roof is worn with large areas of aggregate collected.
Roof	2	There appears to be water damage at brick wall at duct penetration.

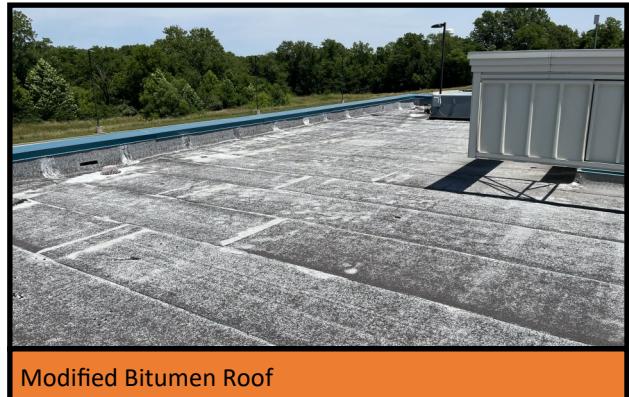
Modified Bitumen Roof

Roof	3	Roof to wall transition is well flashed. Roof is worn and dated.
Roof	2	Roof is worn and dated with cracking and blistering at some joints.
Roof	2	Appropriate roof curb not provided at condenser. Wood is deteriorated.

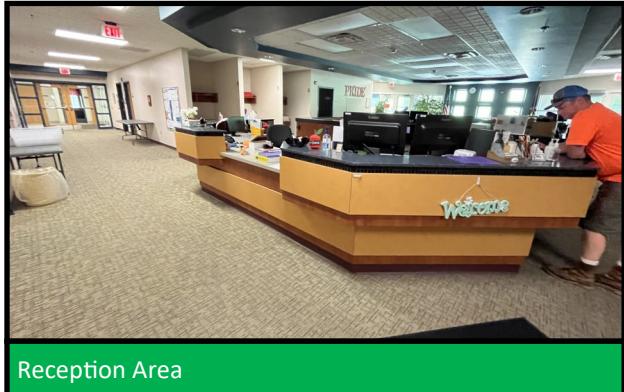
Reception Area

Interior Component	Comments
Accessibility	4 Handicap accessible space at reception area.
Accessibility	4 Handicap restroom stall is compliant with ADA.
Accessibility	4 Library reception and check out desk is handicap accessible.
Accessibility	4 Platform area at gym has accessible railings at the side stair entrance. Ramp access from the other side.
Accessibility	4 Access to food service line is accessible.
Accessibility	3 Restroom lavatories are ADA accessible. Paper towel dispensers exceed 4 inch projection limit for ADA compliance.
Aesthetics	2 Some sagging and stained ceiling tiles. Building finishes are generally in good condition.
Floors	3 Ceramic tile floors at entries are in good condition. Loose mats are used at the floor, which may be a tripping hazard.
Floors	3 VCT floors at corridors are in generally good condition.
Floors	3 Ceramic tile floors at handwashing stations are in good condition.

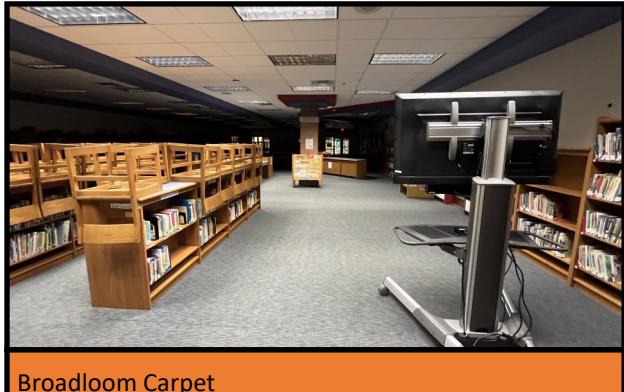
Broadloom Carpet

Floors	2 Broadloom carpet at media center and other areas is in fair condition. It is older and there is some fraying at carpet seams.
Floors	3 The wood gym floor is in good condition, needing only routine maintenance.

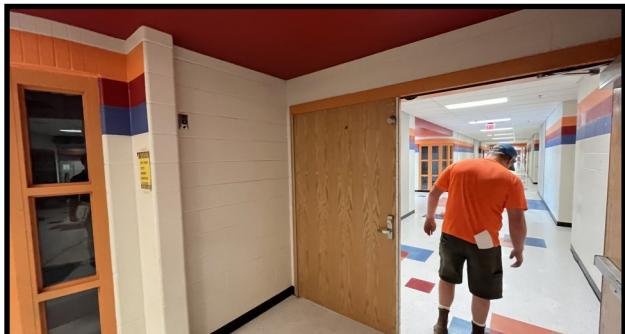
Sprinkled Building Compartments

Interior Component	Comments
Life Safety	4 Building is sprinkled and building compartments appear to be separated by rated construction.
Life Safety	4 Fire rated doors are provided at areas required by code.
Life Safety	4 Kitchen hood appears adequately sized to properly cover cooking equipment.
Life Safety	4 Rated doors with hold open devices, integrated with fire alarm are provided building compartments.
Miscellaneous	2 There appear to be some staining at top of wall and roof transition. Verify and repair source of leaks.
Miscellaneous	1 There are leaks at the yellow soffit and exterior wall causing blistering and peeling paint. Leaks should be corrected immediately.
Miscellaneous	1 Blistering at soffit and peeling paint appears to be caused by leaks above soffit.
Miscellaneous	2 Kiln does not appear to be properly installed with venting hood.
Miscellaneous	1 There are leaks at ceiling tiles and lights.

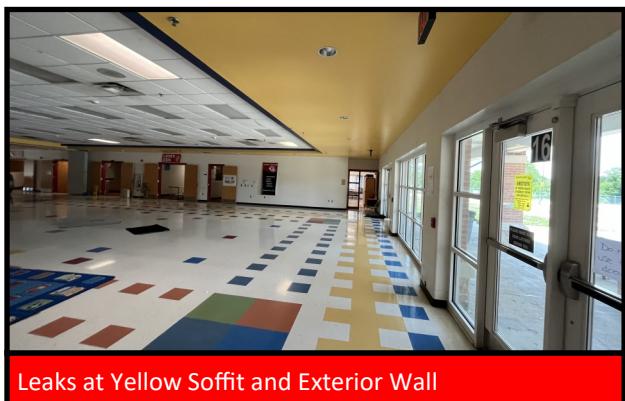
Leaks at Yellow Soffit and Exterior Wall

Interior Component	Comments
Floors	1 There is missing ceramic tile base at restroom floor. Discoloration, dirt, or possibly mold at the joint line in the wall.
Floors	2 There is some cracking and settlement at VCT floor outside of classroom door. This is likely at a building control or expansion joint.
Floors	3 Hallway VCT and ceramic tile is in good condition. Loose mats at doorways may be a trip hazard.
Floors	3 There is VCT floor settlement and cracking at doorway. This is likely at a building joint. This could be addressed by a floor expansion joint cover.
Windows-Doors	3 Exterior windows in classroom and office in generally good condition.
Windows-Doors	4 Hallway windows, extending to floor, are in good condition. No evidence of rusting at base of hollow metal frames.
Windows-Doors	4 Building compartment doors are fire rated.
Windows-Doors	1 There are leaks at the exterior wall and soffit at the large common area entry.

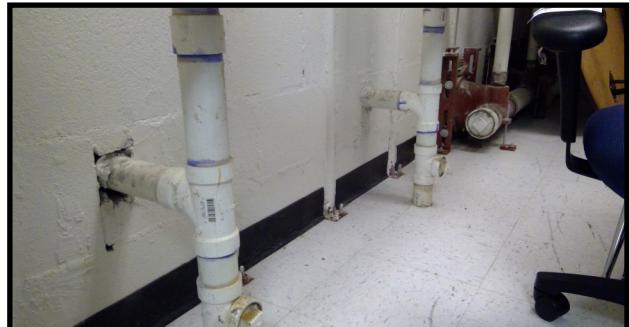
Plumbing Component	Comments
Drainage Piping	3 Cast iron and PVC piping; no known issues.
Water Piping	3 Copper piping where visible.
Gas Piping	3 Schedule 40 black steel piping. Rooftop supports in good condition.
Classroom Sinks	3 Stainless steel drop in sinks with manual faucets.
Water Softener	3 Whole building water softener system in main mechanical room.
Kitchen Sinks	3 Commercial type stainless steel sinks.
Grease Interceptor	3 2500 gallon precast concrete exterior interceptor. Ensure regular maintenance for proper operation.
Emergency Eye Wash	3 Eye wash station located in kitchen.
Fire Protection System	3 Fire protection system provides complete coverage.

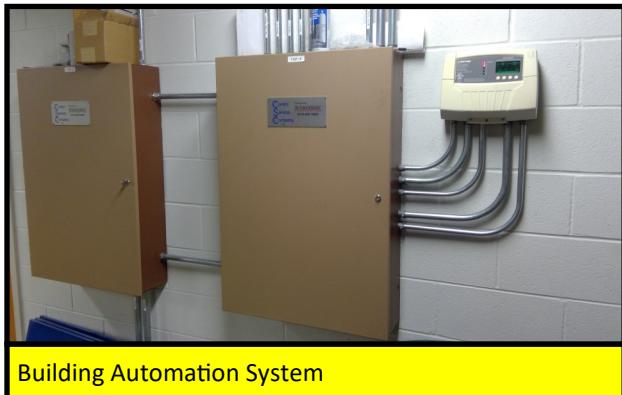
HVAC Component	Comments
Building Automation System	3 Automated Logic controls for all buildings in district.
Chillers	2 2007 (2) 250 ton air cooled chillers at end of expected life.
Boilers	2 2007 Raypack boilers with primary and secondary pumping at end of expected life.
HVAC Pumps	2 Hot and chilled water pumps will be at end of expected life if original to building.
HVAC Piping	3 Heating and chilled water piping in good condition.
VAV Boxes	2 2007 VAV and fan powered VAV boxes with hot water reheat coils at end of expected life.
Blower Coils	2 4-pipe blower coils with outside air intake are at end of expected life.
Computer Room Unit	2 Liebert CRAC unit at end of expected life. (note: computer room no longer used as such).

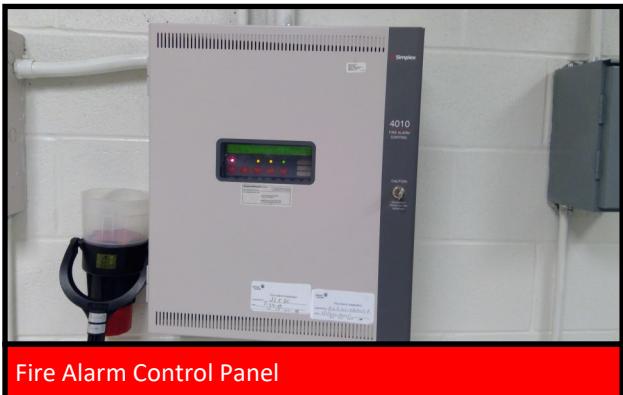
Fire Alarm Component	Comments
Fire Alarm Control Panel	1 Simplex 4010 panel in need of replacement due to faults and programming requirements.
Smoke Detectors	3 Ceiling mounted spot type area detectors.
Manual Pull Stations	3 Single action stations at exits with keyed reset.
Notification Appliances	3 Ceiling and wall mounted strobes/horns.
Electromagnetic Door Holds	3 Holds located at all fire doors.

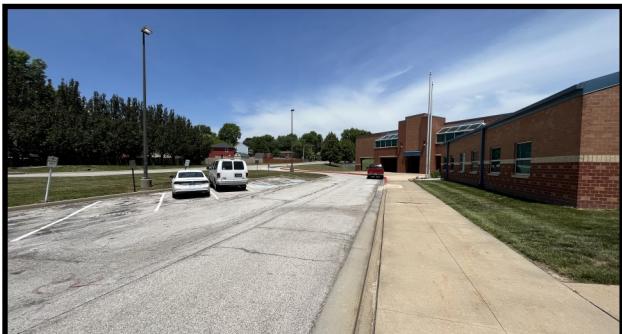
Site Component	Comments
Parking	2 Driveway and parking, notably handicap parking areas are damaged. No crosswalk identified across driveway from parking to sidewalk.
Parking	2 Pavement is worn and deteriorated at east parking lot.
Parking	2 Parking area, pavement, and sidewalk pavement is damaged. Appropriate ADA parking signs not provided.
Pavement-Sidewalks	2 There is a step at the exterior door. Foot scraper potentially interferes at sidewalk.
Pavement-Sidewalks	2 Stoop at exterior door is small without required side clearance. Settlement at sidewalk transition to stoop.
Pavement-Sidewalks	2 Stairs are deteriorated and spalled off at handrail penetrations.
Pavement-Sidewalks	3 Ramp access to playground is provided. Curb system does not contain the cushioning mulch material.
Pavement-Sidewalks	2 Sidewalk sections are damaged. Expansion joints not sealed to prevent weed growth.

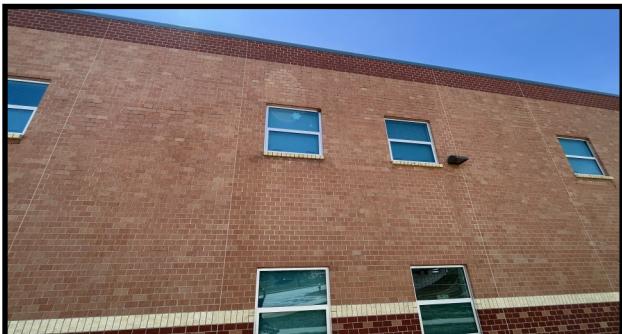
Water Damage Under Windowsills

Envelope Component	Comments
Windows-Doors	2 There is brick damage underneath windowsills, likely from water infiltration. This is typical around the building.
Roof	2 No cant strip at roof to EIFS wall transition. No control joints at a EIFS wall.
Roof	2 No downspouts at roof downspout locations.
Roof	2 Roof material is worn and cracking. Large quantity of roof aggregate has collected. Loose debris, including razor blades are laying on the roof.
Roof	2 Roof material is aged and very worn.
Roof	2 Roof is very worn and cracking. Condensate pipe lays directly on roof.
Roof	1 Condensate piping is not properly connected. Roof is worn and cracking.
Roof	1 There are no drainage weeps at the EIFS wall finish where it transitions to roof flashing.
Roof	1 Roof is bubbled and blistered.
Roof	2 EIFS wall finish is dirty and stained. Unclear if this is related to moisture issues and lack of drainage. Control joints are cracked.

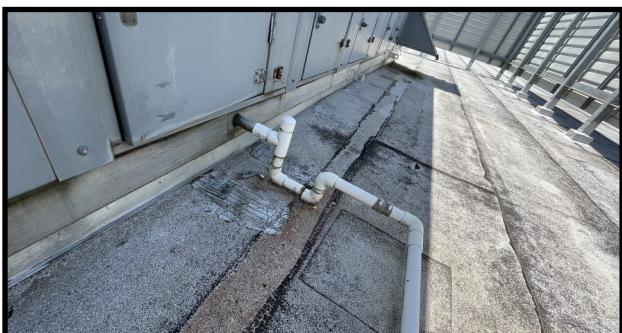
Condensate Piping

Roof	2 Roof is aged and cracking. There appears to be condensate piping, not connected or extended to drains. Piping not properly supported. Appears to be large areas of ponding.
Roof	1 Roof is worn. Condensate piping is not connected. Appears to have large areas of ponding.

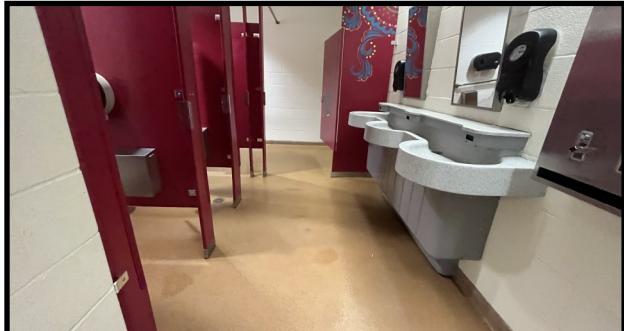
Restroom Access

Interior Component	Comments
Accessibility	ADA restroom is not entirely accessible by new standards, however, it is accessible per original ADA requirements at time of construction.
Accessibility	Accessible stall is ADA compliant.
Accessibility	Restroom has accessible fixtures, but limited floor clearance.
Aesthetics	Wall behind toilet stall is blistered. Seal around toilet.
Aesthetics	Floor, wall, and ceiling finishes in generally good condition. Some drywall touchup is necessary at various areas.
Aesthetics	Toilet partitions have been sanded to cover scratches or vandalism.
Aesthetics	Hallway finishes in good condition.
Aesthetics	Hallway finishes in good condition. Stained ceiling tiles need repair or replacement.
Floors	VCT floors and entry rug in fair condition. Roll up rug is difficult to maintain. Walk off carpet may be preferred.
Floors	Floor devices are loose at office carpet.
Floors	Epoxy floors at restroom are in generally good condition. There is some staining, however.

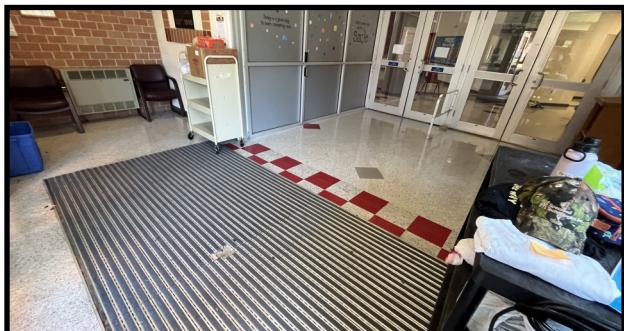
VCT Flooring

Floors	Hallway finishes in good condition. Rolled style carpet is aging.
Floors	Wood gym floor in good condition. Routine maintenance is necessary.
Floors	VCT floors at hallway in good condition.

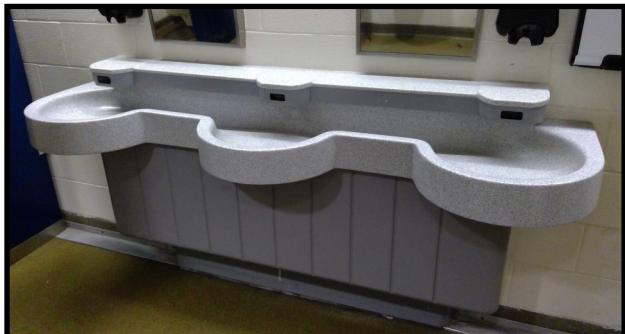
Plumbing Component	Comments
Water Closets	3 Wall mount manual flush valve.
Urinals	3 Wall mount manual flush valve.
Lavatories	3 Wall hung and self rimming lavatories with sensor operated faucets.
Wash Fountains	2 Wall hung sensor operated wash fountains with poor water pressure.
Drinking Fountains/ Water Coolers	3 ADA height units; some with bottle fillers.
Janitor Sinks	3 2x2 floor mount sink with wall mount faucet; ensure faucet is provided with vacuum breaker.
Roof Drains/ Overflow Drains	3 Roof drains and overflow drains with cast iron dome strainers in good condition.
Water Heaters	3 2014 tankless gas fired boilers (one unit for school and one unit for kitchen).
Circulation Pumps	3 Inline circulators at all water heaters.
Drainage Piping	3 Cast iron and PVC piping; no known issues.
Water Piping	3 Copper piping where visible. Some portions of piping missing insulation.

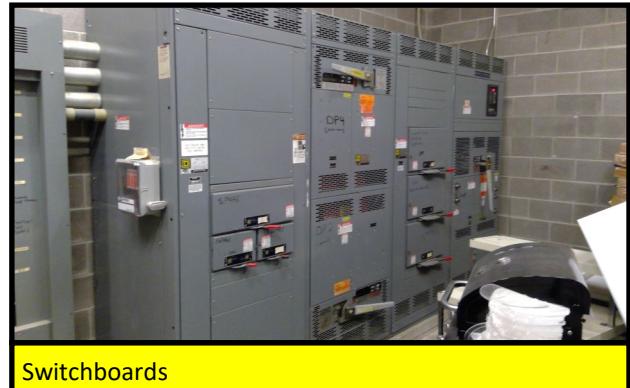
Electrical Component	Comments
Switchboards	3 2500A 480V-3ph Square D QED switchboard (1995).
Distribution Panelboards	3 Square D I-Line panel.
Branch Circuit Panelboards	3 Square D NQOD panelboards. Square D NHEB panels may be nearing obsolescence.
Dry Type Transformers	3 Square D transformers.
Enclosed Disconnect Switches	3 Heavy duty disconnects in NEMA 3R enclosure.
Feeders	3 Rigid EMT where visible.
Wiring Devices	3 Devices appear to be specification grade with stainless steel or nylon cover plates.
Ambient Lighting	2 Surface mounted and recessed T8 Linear Fluorescent is in serviceable condition. Consider replacement with LED for improved efficacy and energy savings.

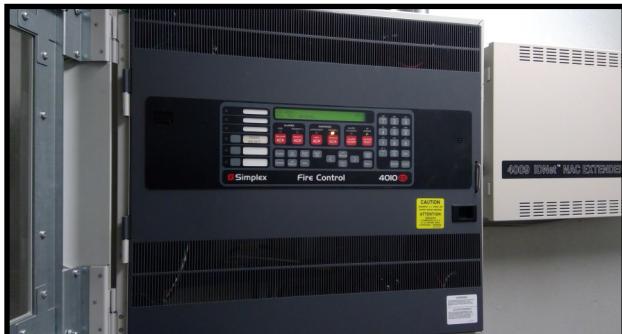
Fire Alarm Component	Comments
Fire Alarm Control Panel	3 Simplex 4010 panel.
Fire Alarm Remote Annunciator Panel	3 Simplex remote annunciator panel in vestibule.
Smoke Detectors	3 Ceiling mounted spot type area detectors.
Manual Pull Stations	3 Single action stations at exits with keyed reset.
Notification Appliances	3 Ceiling and wall mounted strobes/horns.

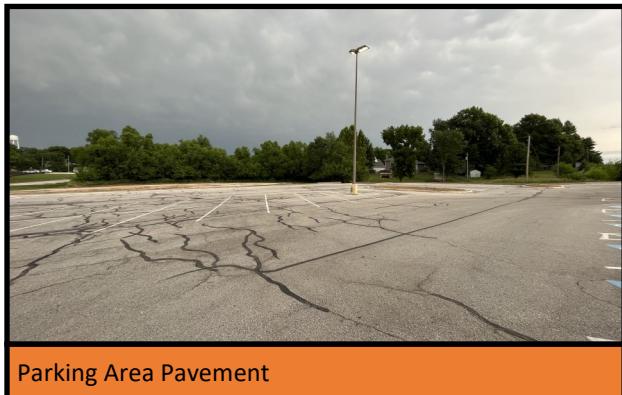
Parking Area Pavement

Site Component	Comments
Parking	3 Van accessible stalls not identified. Some damage at parking bumpers.
Parking	2 Parking area pavement requires maintenance and future replacement.
Parking	2 Parking area and drive is deteriorating.
Pavement-Sidewalks	1 Permeable pavement has no vegetation growth. Surface is uneven and potentially hazardous due to unstable footing.
Pavement-Sidewalks	3 Drainage trench has collected some debris.
Pavement-Sidewalks	1 Concrete paving at outdoor seating area is deteriorated.
Pavement-Sidewalks	2 Concrete footing tops are damaged at some of the canopy columns.
Pavement-Sidewalks	2 Concrete around canopy column is deteriorated.
Pavement-Sidewalks	1 Concrete sidewalk around screen wall is deteriorated.
Pavement-Sidewalks	1 Concrete sidewalk is deteriorated.
Pavement-Sidewalks	1 Stair has crumbled and deteriorated.

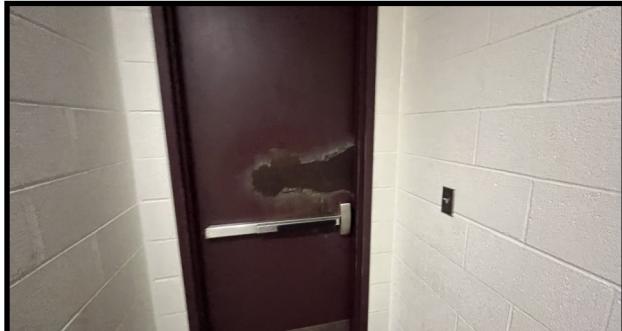
Locker Room Door

Interior Component	Comments
Windows-Doors	Hallway door is propped open, rather than hold-open device, and integrated with fire alarm.
Windows-Doors	Locker room door is damaged.
Windows-Doors	Interior panels of skylights have been broken.
Windows-Doors	Gymnasium doors are damaged, and propped open rather than using hold-open devices integrated with fire alarm.
Windows-Doors	Exterior doors appear in good condition, note there is signage to ensure doors latch, indicating a potential problem with doors closing properly.
Windows-Doors	Music room doors are damaged. Edge protection may be preferred where transporting musical instruments through doorway.
Windows-Doors	Windows at outbuilding classrooms appear in generally good condition. Accent screens have been provided to reduce light at teaching wall.
Life Safety	Rated doors are provided at transition between building compartments.
Life Safety	Kitchen equipment fits adequately under hood system.

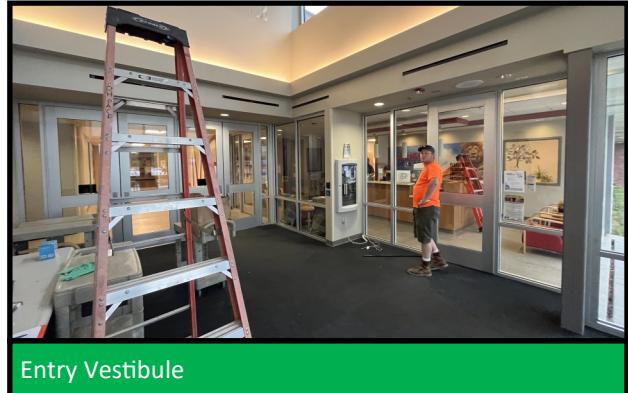
Entry Vestibule

Interior Component	Comments
Miscellaneous	Entry vestibule has access control entry requiring office staff to allow visitors in.
Miscellaneous	Wall damage at windowsill in newer office area.
Miscellaneous	Stained ceiling tiles in new office area from water leaks.
Miscellaneous	Minor damage at ceramic wall tile at restroom. Missing ceiling tiles at restroom.
Miscellaneous	Lavatory appears loose at wall, secure, and reseal.
Miscellaneous	Concession area cabinets have some damage with de-lamination. Cabinet doors have been removed.
Miscellaneous	Older bleacher system appears to not have handrails or handicap seating cut outs.
Miscellaneous	Locker room, floors, benches, and lockers in generally good condition. Some damage at ceilings and lights.
Miscellaneous	Locker floors in generally good condition.
Miscellaneous	Water pipes at shower tower are exposed with no escutcheon at ceiling penetration.
Miscellaneous	Minor trim damage at music storage lockers.

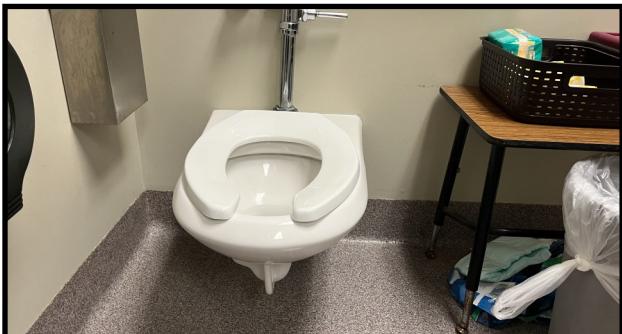
Plumbing Component	Comments
Water Closets	3 Wall mount manual flush valve.
Urinals	3 Wall mount manual flush valve.
Lavatories	3 Wall hung lavatories with lever and two handle manual faucets.
Drinking Fountains/ Water Coolers	3 ADA height units with bottle fillers.
Janitor Sinks	3 2x2 floor mount sink with wall mount faucet; ensure faucet is provided with vacuum breaker.
Roof Drains/ Overflow Drains	3 Roof drains and overflow drains with cast iron dome strainers in good condition. Some roof drains have debris built up resulting in standing water. Recommend cleaning area around all drains.
Water Heaters	2 2022 electric water heater (Kitchen) Tankless gas fired boiler nearing end of expected life (School). 2017 gas fired natural draft water heater (Detached Building). 2022 electric water heater (Auditorium).
Circulation Pumps	3 Inline circulators at all water heaters. Unit in kitchen showing signs of wear.

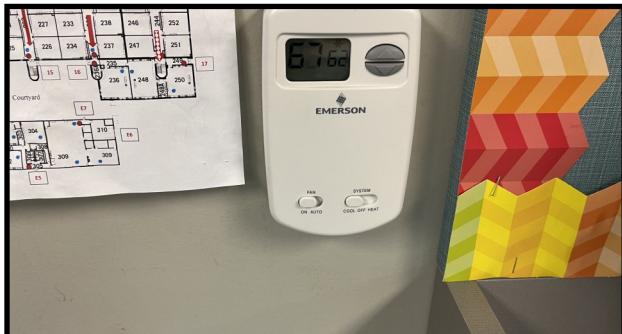
Building Controls

HVAC Component	Comments
Building Automation System	Automated Logic controls for all buildings in district. Some units on standalone thermostats. Recommend integrating all equipment into BAS control system. 3
Air Cooled Condensing Units	2015 roof mounted equipment. 3
Air Handling Units	2015 Trane air handlers. 3
HVAC Pumps	Heating water pumps in good condition. 3
Hydronic Piping	Heating water piping in good condition. 3
VAV Boxes	2015 VAV and Fan Powered VAV boxes with hot water reheat coils. 3
Packaged RTUs	2007 Trane Gas fired RTUs at end of expected life. 2015 Trane gas fired RTUs serving Admin, Media, Gym and Annex in good condition. 2
Heating and Ventilating Unit	H&V unit for locker rooms nearing end of expected life. 2
Mini-Split Systems (IT Closets)	Ceiling suspended indoor units serving IT closets not operating properly. 2
Kitchen Exhaust Hoods	Kitchen exhaust hood with ansul system appeared to be in good condition. Heated makeup air unit on roof. Dishwasher exhaust ducted to outdoors. 3

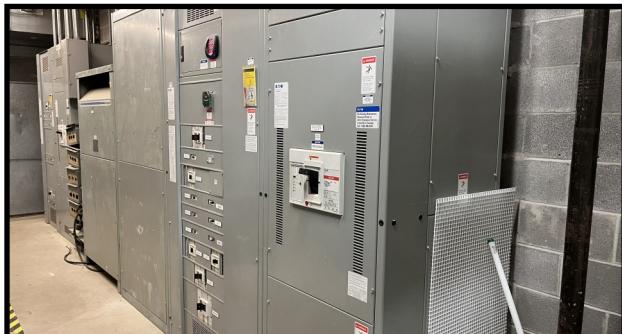
Electrical Component	Comments
Switchboards	2000A 480V-3ph Eaton Pow-R-Line Switchboards (2015). Investigate issue with main breaker tripping. Problem could be due to faulty breaker. 1600A 208V-3ph Eaton Pow-R-Line switchboards (2015).
Distribution Panelboards	3 Siemens Type S4 (1992).
Branch Circuit Panelboards	3 Eaton PRL1A panelboards.
Detached Buildings	1 Obsolete Federal Pacific panels. Recommend replacement with new.
Dry Type Transformers	3 Eaton, Westinghouse, and Siemens transformers.
Enclosed Disconnect Switches	3 Heavy duty Eaton disconnects in NEMA 3R enclosure.
Feeders	3 Rigid EMT where visible.
Wiring Devices	3 Devices appear to be specification grade with stainless steel or nylon cover plates.

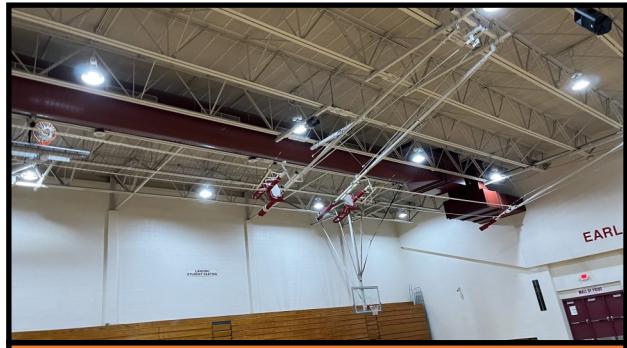
Electrical Component	Comments
Ambient Lighting	3 Surface mounted and recessed T8 Linear Fluorescent is in serviceable condition. Consider replacement with LED for improved efficacy and energy savings.
Gymnasium Lighting	2 High Bay HID fixtures in serviceable condition. Consider replacement with LED for improved efficacy and energy savings.
Emergency Lighting	3 Twin head unitary emergency lights with integral battery backup.
Exit Signage	3 Thermoplastic exit signs with red LED letters and integral battery backup.
Exterior Building Mounted Lighting	3 Compact fluorescent and HID wall packs and surface canopy lights. Consider replacement with LED.
Parking Lot Lighting	3 Pole mounted fixtures with LED replacement lamps; source of power unknown. Recommend investigation to determine how to safely disconnect power for servicing fixtures.
Occupancy Sensors	4 Wall switch and ceiling mounted occupancy sensors.

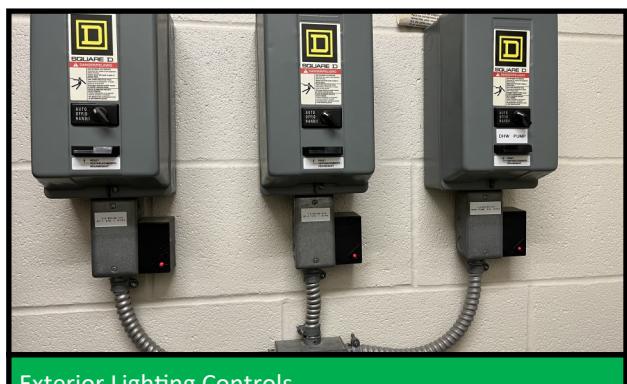
Exterior Lighting Controls	4 Distributed lighting controls with photocell and override control.
Electric Service Detached Buildings	1 Pad mount transformer feeds wireway with 7 disconnect switches. Number of disconnects exceeds code allowed quantity of 6. Disconnect switches nearing obsolescence. Recommend replacement with distribution panel with main circuit breaker.

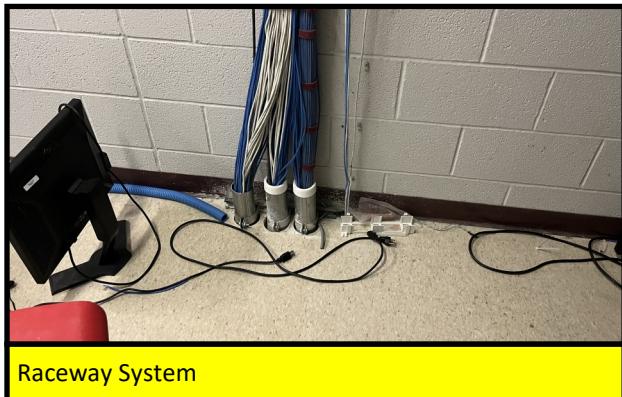
Raceway System

Communications Component	Comments
Communications Raceway Systems	3 Cabling installed in cable tray, conduit and surface ladder hooks.
Data/Network System Equipment	3 Category 5/5e patch panels wall mounted I.T. racks.
Data/Network Horizontal Cabling	3 Category 5e/6 UTP copper cabling from patch panels to wall outlets.
Data/Network Outlets	3 Category 5e/6 RJ45 jacks in nylon wall outlets.
Intercom	3 Intercom through ceiling speakers via VOIP phones.

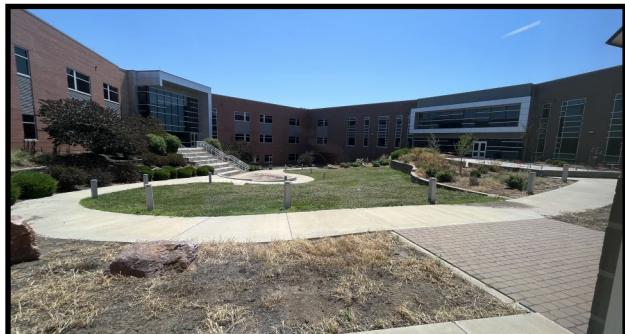
Courtyard Sidewalks

Site Component	Comments
Pavement-Sidewalks	4 Courtyard sidewalks and pavers in good condition.
Pavement-Sidewalks	2 Exit door and stoop does not lead to sidewalk.
Pavement-Sidewalks	1 Sidewalk trench drain is deteriorated. Decorative retaining wall contains some loose blocks.

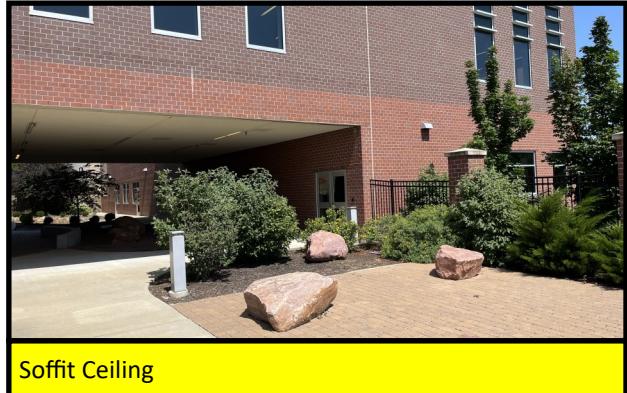
Soffit Ceiling

Envelope Component		Comments
Walls-Soffits	3	Soffit ceiling at tunnel area appears to be sagging. Minor effervescence at corner and at single weep hole above.
Miscellaneous	2	Some effervescence at building control joints and stone accent band.
Miscellaneous	4	Attractive building appearance in generally good condition.
Miscellaneous	3	Soffits and overhand in good condition. Some wall staining at roof drain outlet.
Miscellaneous	3	Flashing and expansion provided at pavers.
Miscellaneous	4	Building finishes and sidewalk and drives attractive and in good condition.
Miscellaneous	3	Some staining at roof drain. Verify if this is an overflow roof drain that is functioning properly.
Miscellaneous	2	Areas of courtyard irrigation system may not be functioning properly.

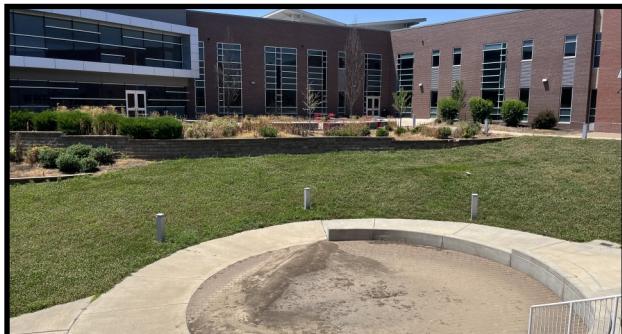
Courtyard Erosion

Envelope Component	Comments
Miscellaneous 2	There appears to be some dirt erosion into the courtyard lower plaza area.
Miscellaneous 2	There is some erosion at courtyard. Irrigation system may not be functioning properly.
Miscellaneous 3	Sidewalk transition with warning pads provided.
Windows-Doors 4	Window systems appear in good condition. There appears to be some water drainage at weep holes.
Windows-Doors 2	There appears to be some settlement at sidewalks and building steps.
Windows-Doors 2	Exterior door stoop does not lead to sidewalk or right of way. Unsure if this is an issue of concern.
Windows-Doors 2	There appears to be some moisture issue with effervescence around exterior door.

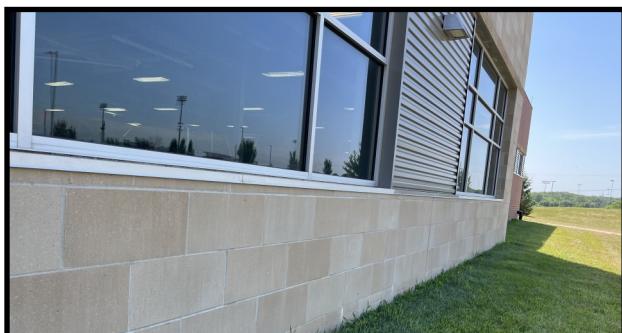
Window System

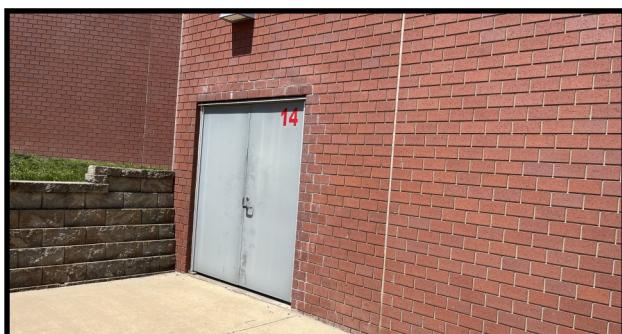
Brick Around Door-Effervescence

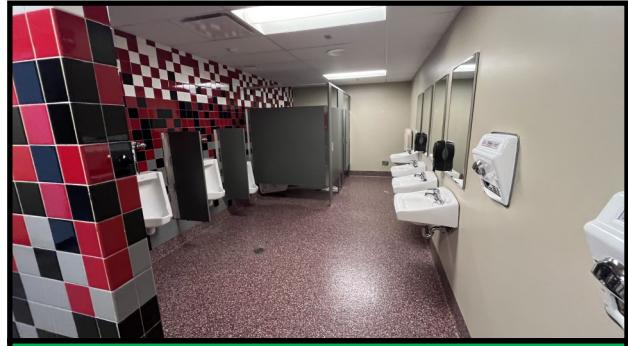
Restroom Accessibility

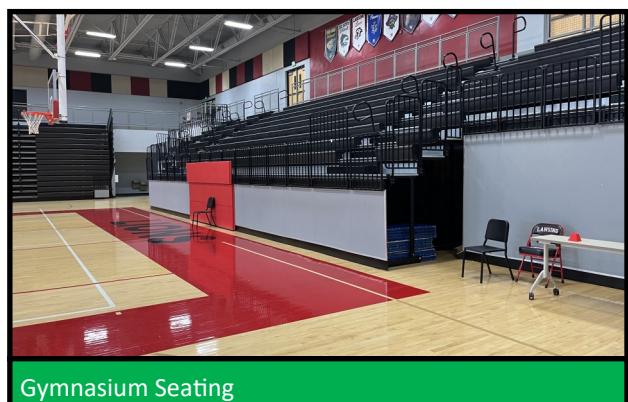
Gymnasium Seating

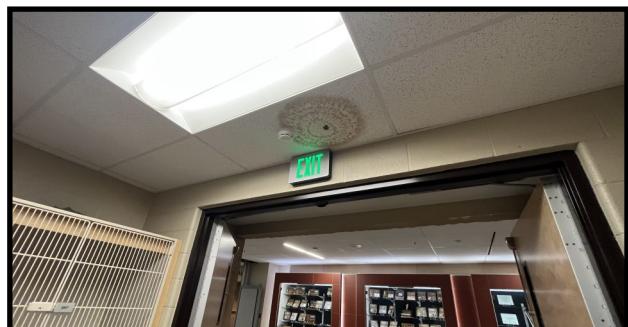
Ceiling Tile

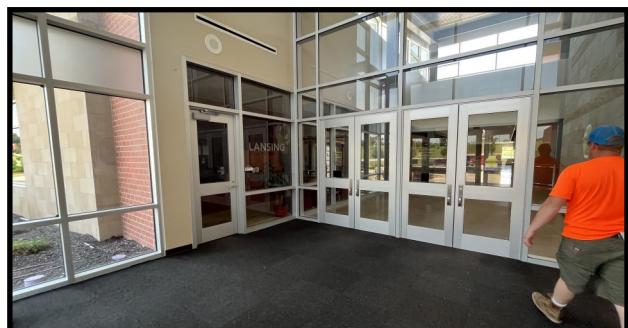
Entry Walk Off Carpet

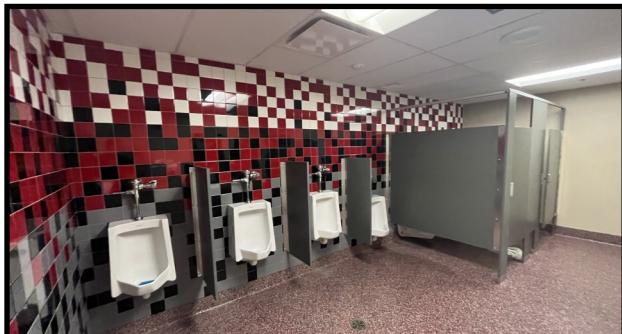
Restroom Epoxy Resin Flooring

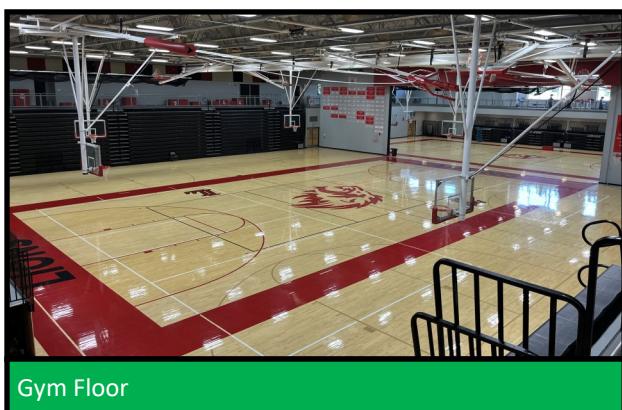
Gym Floor

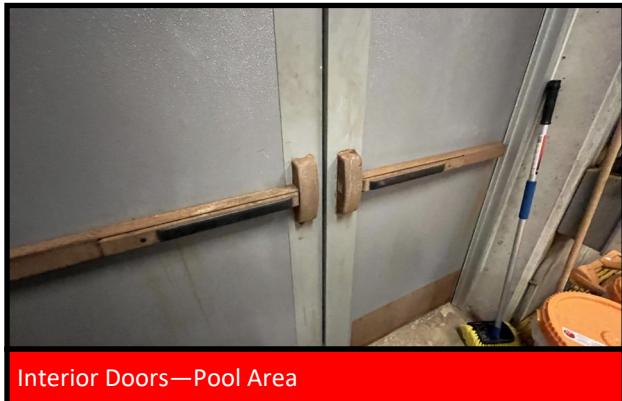
Interior Doors—Pool Area

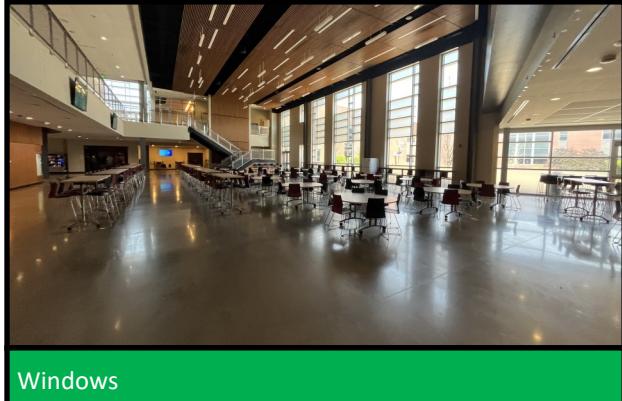
Windows

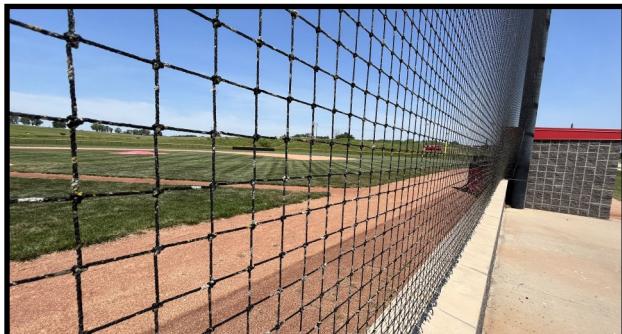
Baseball Field

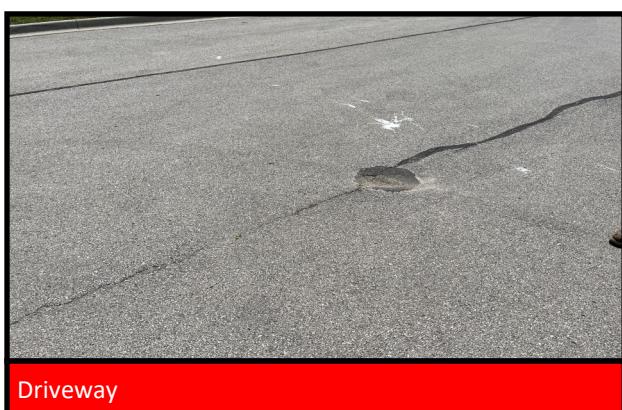
Driveway

Athletic Component		Comments
Miscellaneous	3	Baseball field in good condition. No field lighting exists.
Miscellaneous	1	There is odd settlement at driveway area. Cracking at pavement and previous filled void in pavement is settling.
Miscellaneous	2	Area drain inlet may not be fully handling draining from the soccer field and surround area.
Miscellaneous	1	Fence post is loose south of soccer field.
Concessions	1	Effervescence at walls of concession building and there appears to be significant settlement of 2+ inches adjacent to concession windows.
Concessions	2	Sidewalk expansion joint at building should be sealed.
Concessions	2	Sidewalk appears to have settled and cracked along edge of building.
Concessions	1	Appears to be a leak at the wall hydrant box.
Concessions	2	Field level storage area shows signs of water infiltration throughout several walls.
Concessions	1	Source of water infiltration should be investigated by an expert.

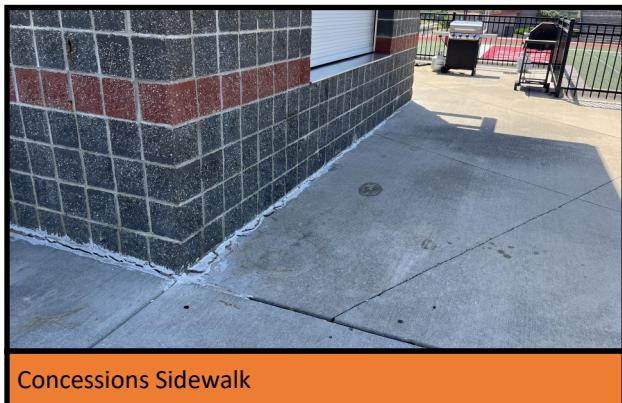
Concessions Sidewalk

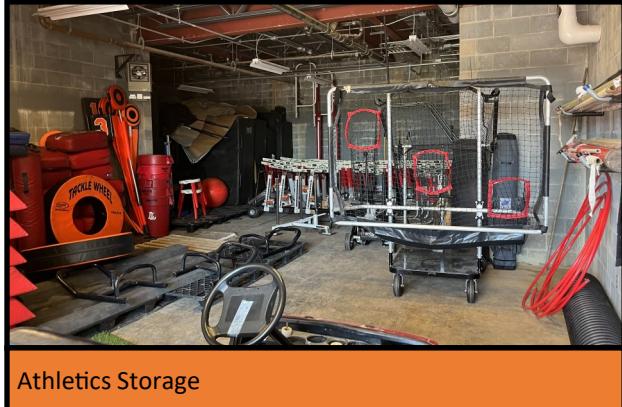
Athletics Storage

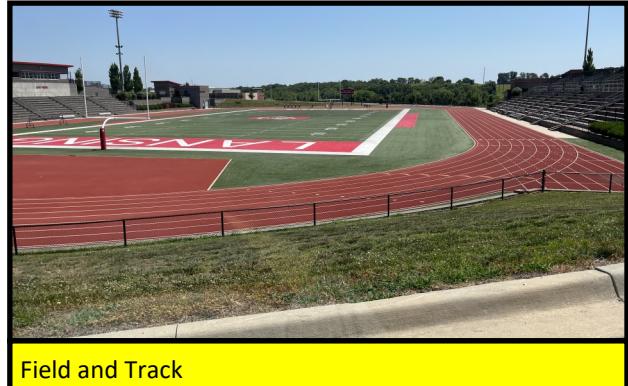
Field and Track

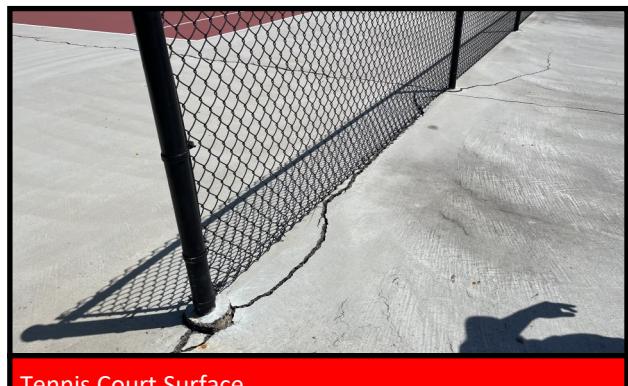
Tennis Court Surface

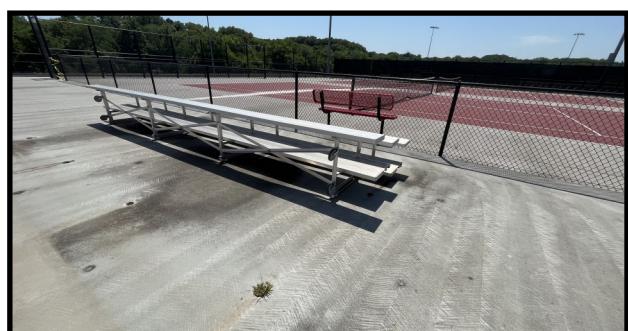
Tennis Court

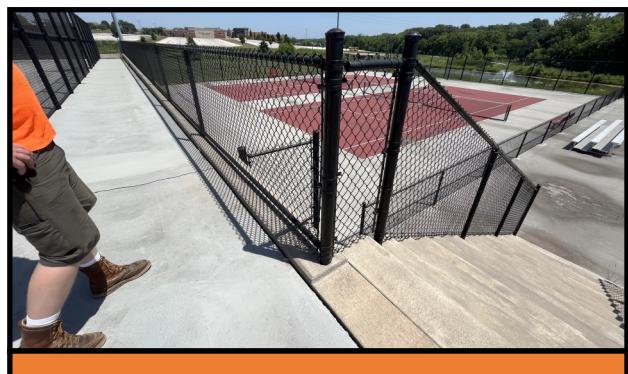
Athletic Component	Comments
Athletics Concessions	2 Effervescence coming through wall.
Athletics Football Track	3 Field and track appear in good condition although maintenance and infill of rubber may be required.
Athletics Tennis	2 Handrail extensions do not return to post as required by code.
Athletics Tennis	1 Tennis court surfacing is cracked and settling throughout.
Athletics Tennis	1 Indentations at court surface caused by weight of bleacher.
Athletics Tennis	1 Court surfacing is cracked throughout. Appears to be settling.
Athletics Tennis	2 Expansion joint at wall between court levels is not sealed. Court finish is peeling below.

Tennis Court Expansion Joint

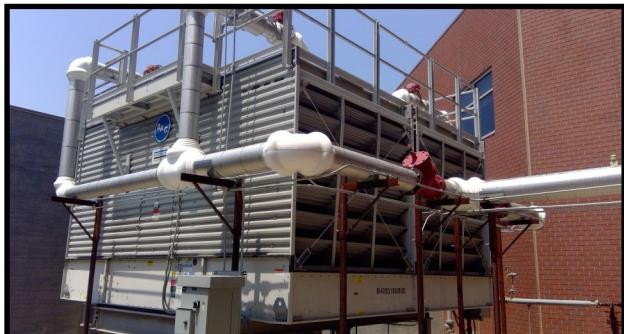
Cooling Towers

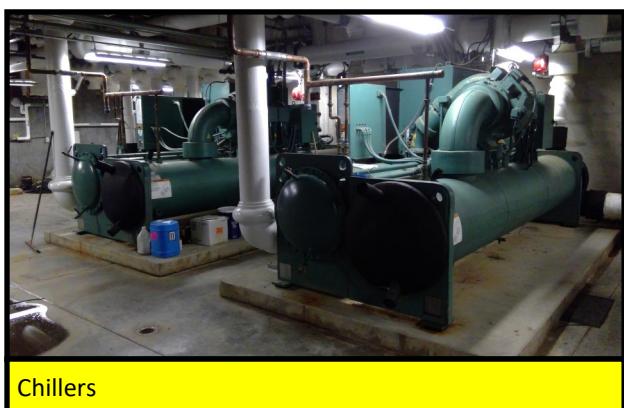
Chillers
