USD 469

Lansing

Facility Assessments

Summer 2023

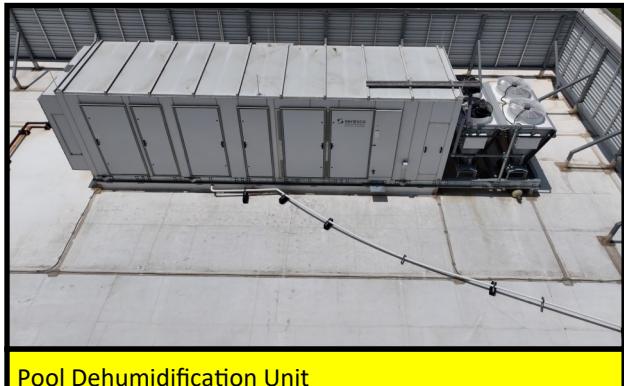
Pool Dehumidification Unit

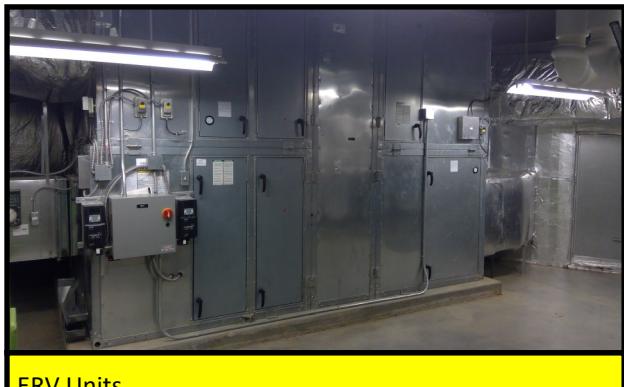
ERV Units

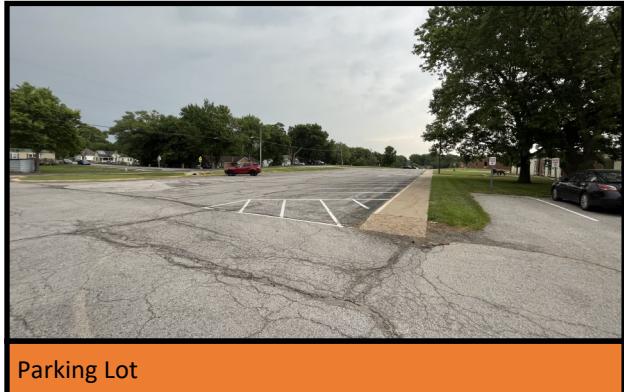
Parking Lot

Site Component	Comments
Parking	2 Parking lot needs repair and resurfacing. No handicap parking near main entrance.
Pavement-Sidewalks	2 Concrete walk is deteriorating with asphalt road topping aggregate accumulating at curb line.
Pavement-Sidewalks	1 Concrete stoop outside exterior door is deteriorated.
Pavement-Sidewalks	2 Concrete walks at west staff entrance in fair condition, adjacent parking is deteriorated and in need of repair.
Pavement-Sidewalks	1 Asphalt paving outside southside of west staff entrance is deteriorated, in need of replacement.
Pavement-Sidewalks	1 South back door, concrete stoop, and asphalt is deteriorated. Hole in paving adjacent to stairwell is large enough for animals to live.

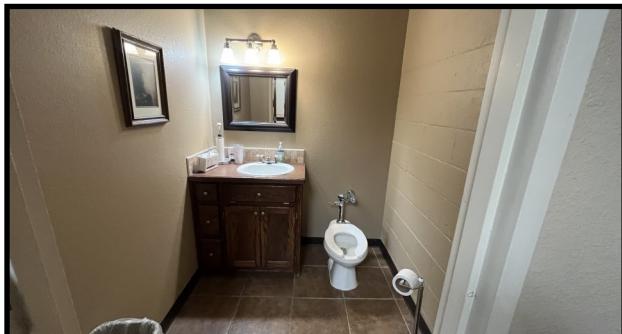
Office Staff Restroom

Interior Component	Comments
Accessibility	Entry and office access doors are accessible. Proper door clearance not provided at office side with cabinet under the window encroaching on clear area requirements.
Accessibility	Office staff restroom is not accessible. Accessible restrooms located elsewhere within the building. Room and finishes are in good condition.
Accessibility	Lavatory area and urinals are accessible, limited access to water closets.
Accessibility	Good open area and access at lavatory area to doors.
Accessibility	Accessible water closet, meets size and grab bar requirements.
Accessibility	Accessible drinking fountains provided.
Accessibility	Staff restroom and shower is accessible, except interference from cabinetry.
Aesthetics	Entry area finishes are in good condition, tile may be considered dated, but good condition.
Aesthetics	Carpet floors are aged and dated, wall, ceiling, and light finishes are good.

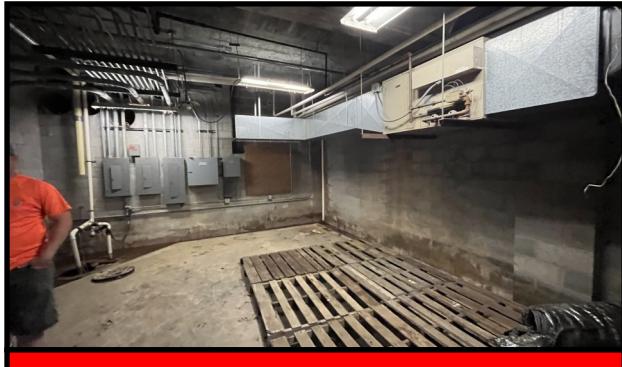
Basement Boiler Room Floor

Interior Component	Comments
Life Safety	1 Standing water at electrical equipment is hazardous.
Life Safety	1 Boiler room entry door and railing system is unsafe due to difficult access.
Life Safety	2 Fire alarm system should be evaluated to confirm modernization requirements.
Life Safety	3 Good exiting provided. Exit doors to exit path are non-rated, however.
Miscellaneous	1 Boiler room walls and floors have water damage and standing water. Overall access is limited by areaway debris.
Miscellaneous	1 Water damage and standing water at perimeter of room around electrical panels.
Miscellaneous	3 Minor repair needed at hallway ceilings. Floors and walls in generally good condition.
Miscellaneous	3 Some ceiling repair needed at meeting room.
Miscellaneous	2 Exit blocked by stored materials. Some ceiling finish and lighting repair required.
Miscellaneous	1 Wall and base damage, may be the result of water infiltration.

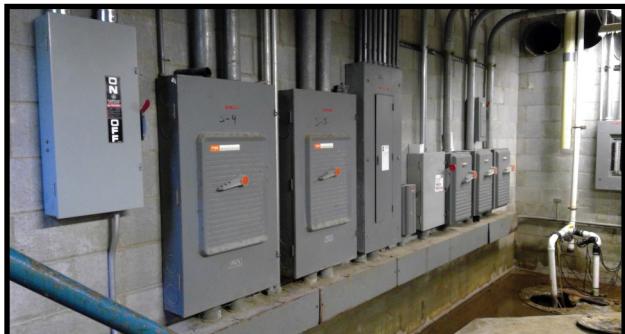
Electrical Component	Comments
Electric Service Entrance Equipment	Overhead service to basement electrical room. Main disconnect switches located above standing water. Devices are beyond expected life. Recommend replacement of disconnects and wireway with new service entrance rated panelboard to feed downstream panels.
Branch Circuit Panelboards	Obsolete Federal Pacific panels. Equipment in basement located above standing water. Recommend replacement with new.
Enclosed Disconnect Switches	Obsolete Federal Pacific disconnect switches. Equipment in basement located above standing water. Recommend replacement with new or modify per 26.01.
Feeders	Rigid EMT where visible. Some MC cabling utilized.
Wiring Devices	Devices appear to be commercial specification grade with stainless steel or nylon cover plates. Snap switches are rated for 20 amps, and receptacles rated for 15 amps.
Ambient Lighting	Surface mounted and recessed T8 Linear Fluorescent is in serviceable condition. Consider replacement with LED for improved efficacy and energy savings.

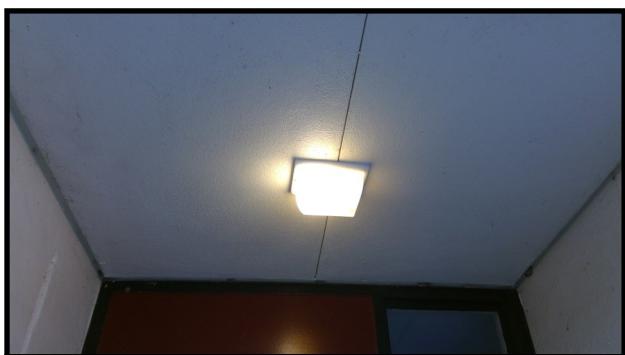
Emergency Lighting	Twin head unitary emergency lights with integral battery backup.
Exit Signage	Thermoplastic exit signs with red LED letters and integral battery backup.
Exterior Building Mounted Lighting	Compact fluorescent and LED wall packs and surface canopy lights.
Parking Lot Lighting	Pole mounted fixtures; source of power unknown. Recommend investigation to determine how to safely disconnect power for servicing fixtures.

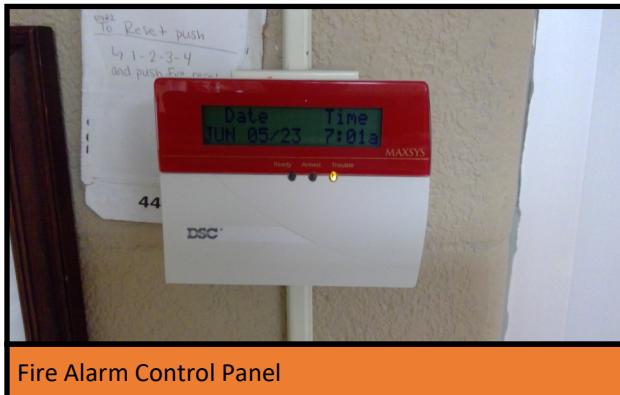
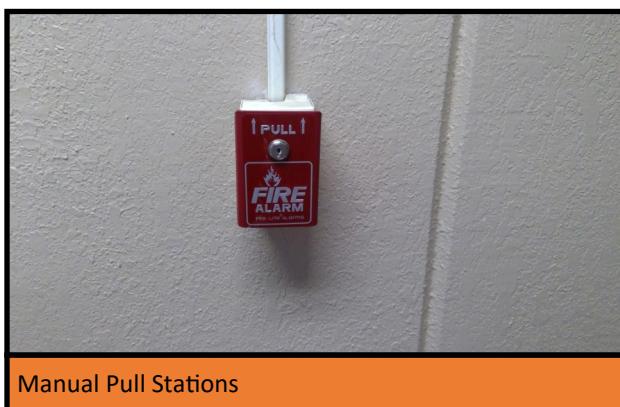
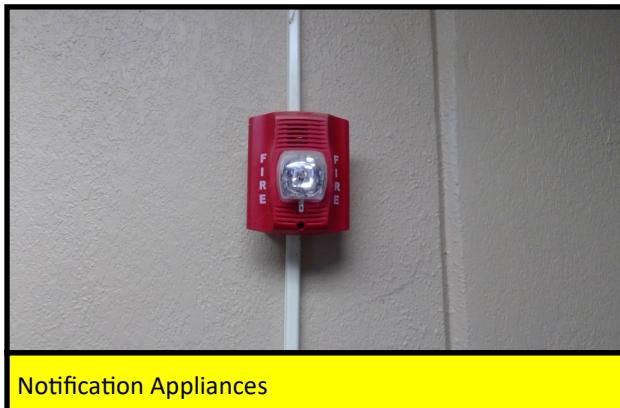
Fire Alarm Component	Comments
Fire Alarm Control Panel	2 DSC MAXSYS fire alarm control panel. System is not fully operational and produces regular trouble codes. Recommend replacing with new fire alarm control panel.
Smoke Detectors	3 Ceiling mounted spot type area detectors.
Manual Pull Stations	2 Single action station with keyed reset; recommend replacement with new devices compatible with replacement control panel.
Notification Appliances	3 Wall mounted strobes/horns.

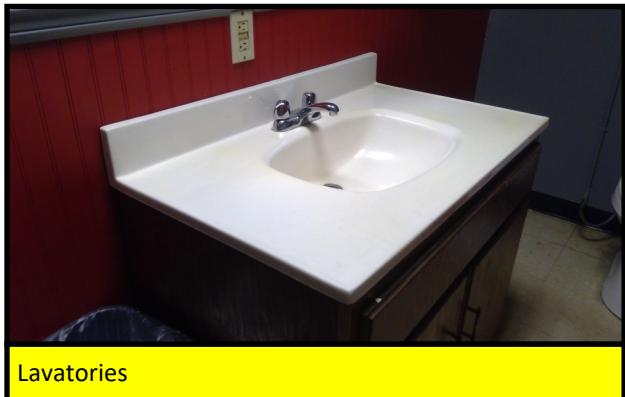
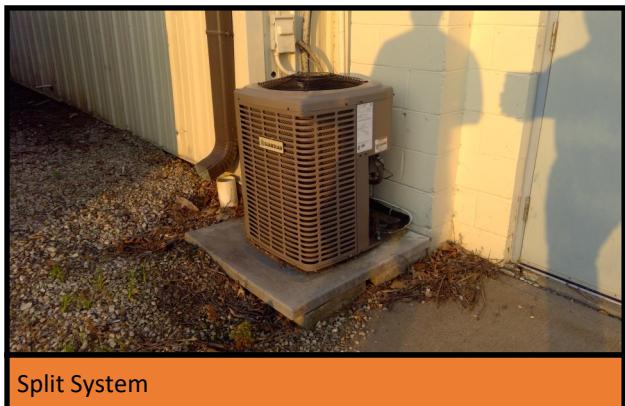
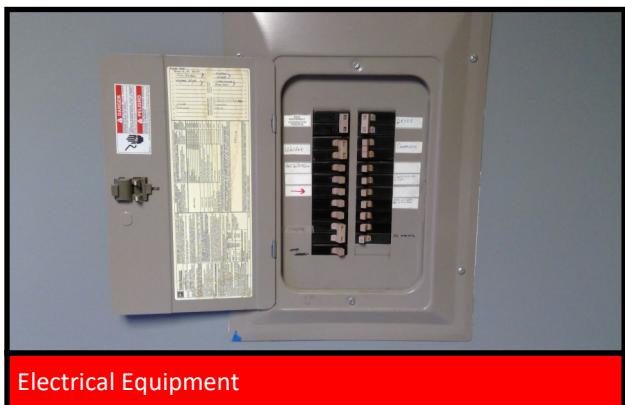
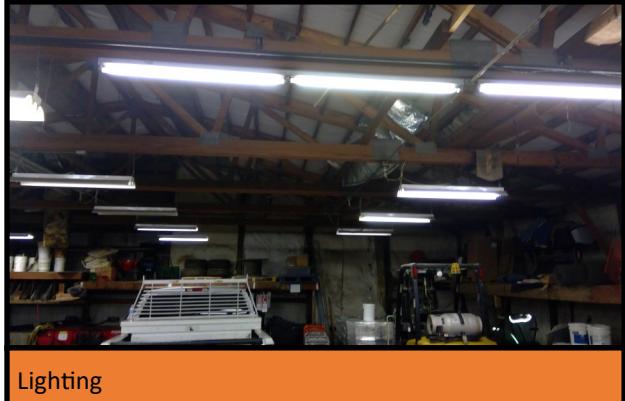
Building Component	Comments
Plumbing	<p>3</p> <p>Floor mount flush tank water closet Self rimming lavatory with two handle faucet. Wall hung laundry tub sink in shop area. Schedule 40 black steel gas pipe.</p>
Mechanical	<p>2</p> <p>2014 Guardian condensing unit and gas fired furnace in good condition. Insulated ductwork where visible. Standalone thermostats. Gas fired unit heaters (only 2 of 3 in operational condition). No exhaust or hood above break room range.</p>
Electrical Power	<p>1</p> <p>Electric service via adjacent district office building; provide clear indication labeling location of service disconnect. Electrical panel in shop area needs replacement for safe operation. Industrial receptacles and switches.</p>
Lighting	<p>2</p> <p>T8 strips and surface mount fixtures; consider fixtures rated for use in shop environment. Wall mounted exit signs with battery backup. No emergency lighting visible.</p>

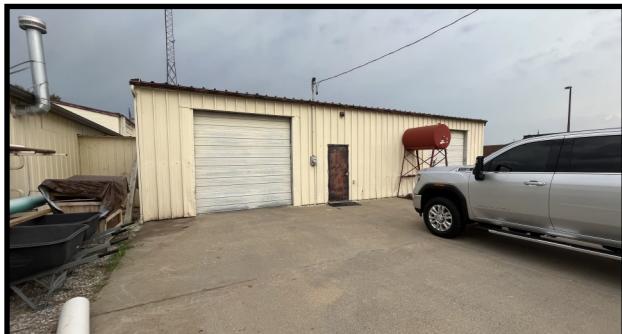
Building Exterior Components

Site and Envelope Component	Comments
Exterior	2 Building components are worn and damaged. There is no containment area at fuel dispensing.
Exterior	2 Building components are damaged and material storage is not secured .
Exterior	1 There is minimal drainage from building. Area way is full of gravel and leaves. This window and similar conditions result in leaks at the interior of the building.
Exterior	2 Paving around containment areas is deteriorated. Building transition at containment area is deteriorated.
Exterior	1 Wall panels are sealed at concrete retaining wall/ containment area in lieu of being properly flashed and sealed .
Exterior	1 Stored materials are not contained, including gas cans.
Exterior	1 Exterior door and threshold is deteriorated. There is no gas containment at dispensing area.

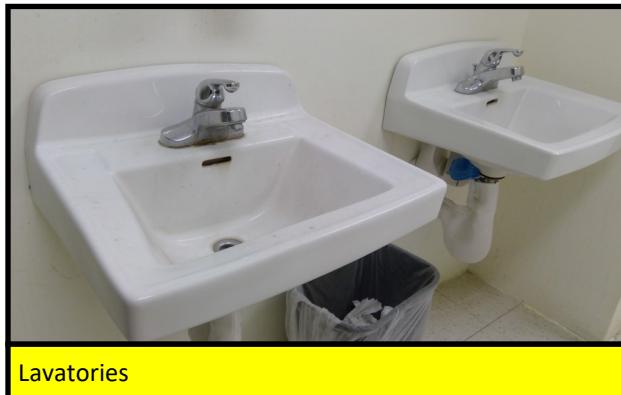
Building Component	Comments
Water Closets	3 Floor mount flush tank water closets in good condition.
Urinals	3 Wall hung urinals with manual flush valves.
Lavatories	3 Wall hung lavatories with lever-handle faucets.
Janitor Sinks	3 2x2 floor mounted sinks with wall mounted faucets.
Water Heaters	4 2022 electric water heater .
Circulation Pumps	1 No circulation pumps present.
Waste and Vent Piping	3 No observable or known issues with waste and vent piping.
Domestic Water Piping	3 Copper piping in good condition.
Gas Piping	3 Schedule 40 black steel in good condition. Wood block roof supports are starting to degrade.

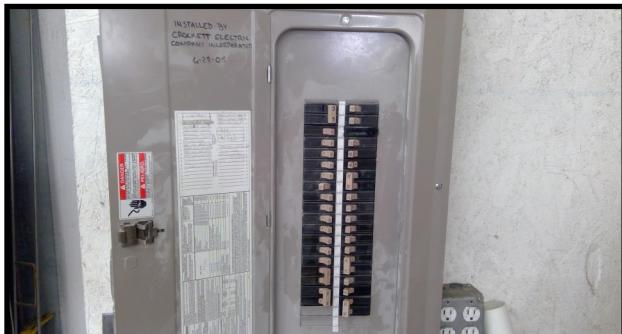
Electrical Component	Comments
Interior Branch Circuit Panelboards	3 Cutler Hammer panelboards.
Wiring Devices (Shop)	3 Industrial and commercial grade devices with stainless steel and nylon cover plates.
Enclosed Disconnect Switches	3 Heavy and medium duty switches serving large equipment and A/C in serviceable condition.
Feeders (Exposed to view)	3 Enclosed in rigid conduit system.
Wiring Devices (Offices, Common Spaces)	3 Industrial and commercial grade devices with stainless steel and nylon cover plates.
Ambient Lighting in Office/Common Spaces	2 T8 linear fluorescent lensed troffers, strips, wraparounds in serviceable condition. Consider replacement with LED.
Shop Lighting	2 Suspended T8 linear fluorescent strips in serviceable condition. Consider replacement with LED.
Exit Signage	3 LED exit signs with red letters and integral battery backup.
Emergency Lighting	3 Twin head emergency lights with battery backup.

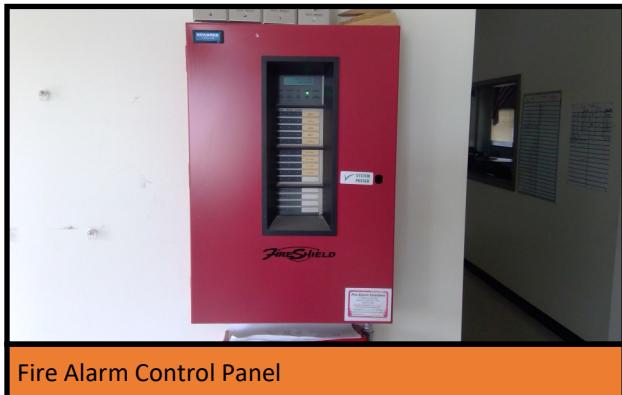
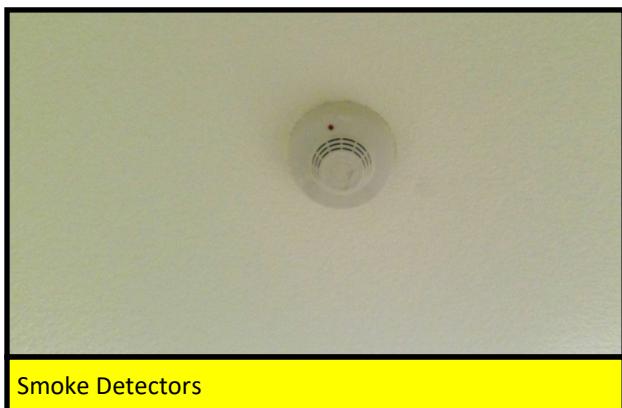
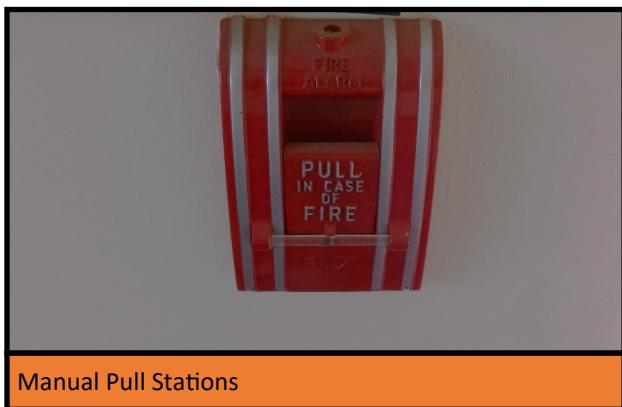
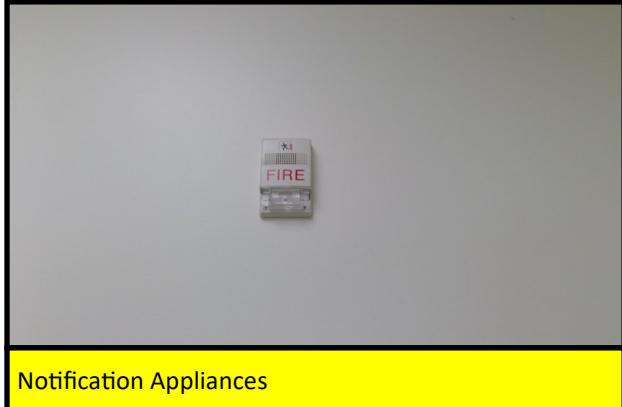
Fire Alarm Component	Comments
Fire Alarm Control Panel	2 Edwards Fire Shield panel; recommend replacement with addressable fire alarm control panel.
Smoke Detectors	3 Ceiling mount spot type area detectors.
Manual Pull Stations	2 Single action stations at exits; some devices are aging, recommend updating with devices compatible with new panel.
Notification Appliances	3 Ceiling and wall mounted strobes/horns.

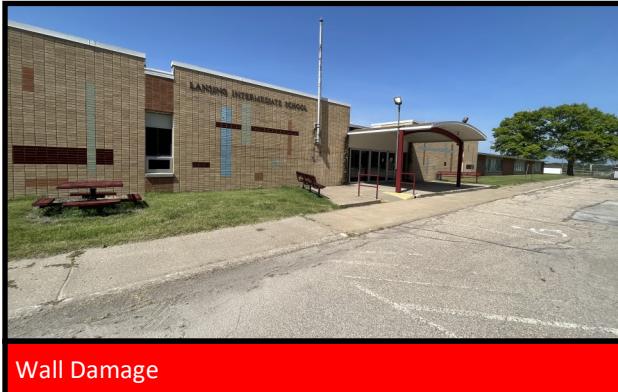
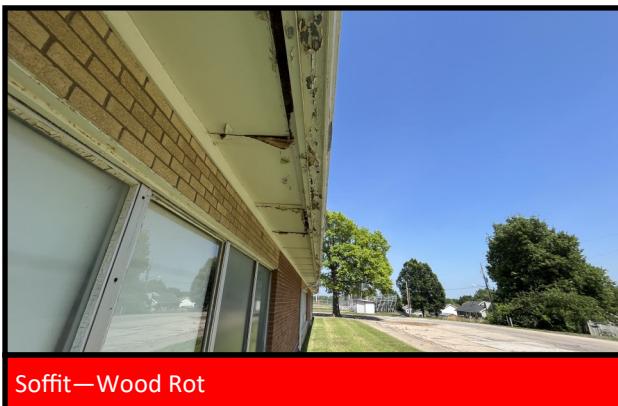
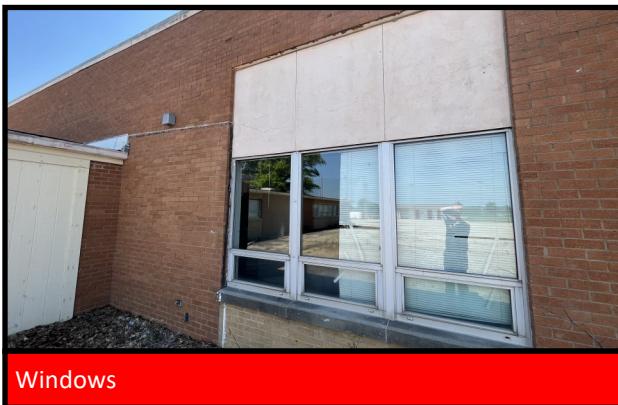
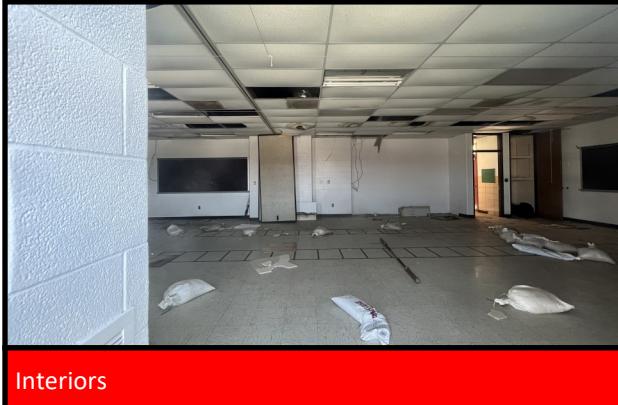
Building Component		Comments
Site-Envelope-Interior	1	Significant wall damage at building entry, caused by water infiltration. Parking and drive in poor condition.
Site-Envelope-Interior	1	Soffit and brick wall damaged due to water infiltration issues.
Site-Envelope-Interior	2	Exterior window glazing is cracking and damaged. Likely additional leaks at windows throughout.
Site-Envelope-Interior	1	Wood rot at soffit and damage windows, common throughout building.
Site-Envelope-Interior	1	Water damage and damaged building components common through building exterior.
Site-Envelope-Interior	1	Windows and building components in poor condition. Typical throughout.
Site-Envelope-Interior	1	Exterior door damaged and brick cracked. Settlement at north side of building.
Site-Envelope-Interior	1	Abandoned building interiors, the source of moisture and mold. Appears prevalent.
Site-Envelope-Interior	1	Exterior windows damaged, in poor condition throughout.
