## BERLIN AREA SCHOOL DISTRICT

Facilities Assessment and  
Comprehensive Master Plan - Report Part 1  
August 24, 2022

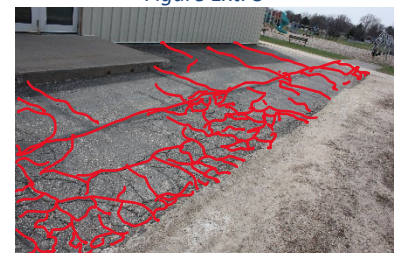
Figure Ext. 4

- **Asphalt Paving:** The asphalt paving is in poor to fair condition. The heavily traveled portions of the paving have significant cracking (Figures Ext.4 – Ext.7).

The main drive aisle in front of the building has some locations that are cracked beyond filling and sealing the cracks. When the cracking in asphalt reaches the point where the cracks form pavement sections with small pieces resembling spiderwebs (Figures Ext.4 & Ext.5), the pieces will eventually dislodge and create potholes.

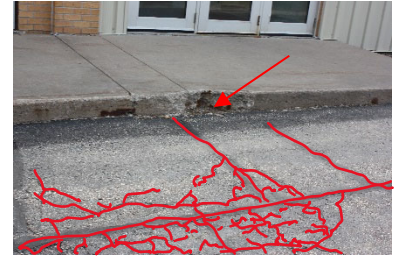
Figure Ext. 5

The Service drive on the north side of the building is in poor condition in several locations (Figure Ext.5 & Ext. 6). The cracks allow water to infiltrate the substrate. In this climate, the water freezes and heaves the asphalt making more cracks. The cold seams between section installations usually are the first cracks to form. One of the concerns with the extent of the north drive isle condition is that the asphalt will begin to dislodge, and the students running out to the playground surfaces will trip on potholes or loose pieces of asphalt.

Sealing the cracks after they first form can slow the deterioration. Eventually, the sections of paving move through freeze-thaw cycles, and the crack gets wider making it more difficult to fill and maintain (Figure Ext.7).

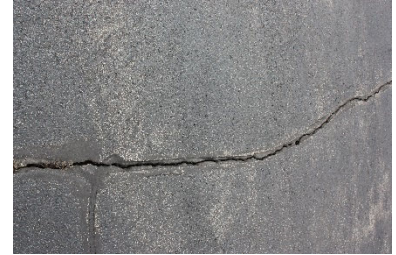
Figure Ext. 6

Note the curb deterioration at the north exit stoop in Figure Ext.6 is an additional concern contributing to the deterioration of the asphalt.

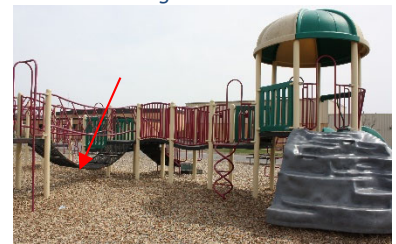
Figure Ext. 8

- **Play Areas and Structures:** The play structures are in fair condition but are showing significant wear (Figure Ext.8 – Ext.10). These structures are dated, and many of the features are not particularly utilized by most of the students.

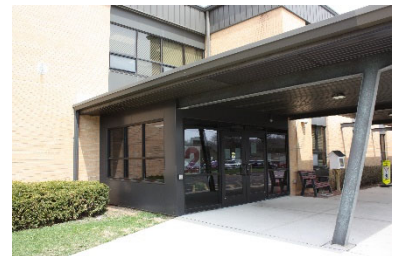
Figure Ext. 18

A little rust is forming at the base of the metal frame at the door's hinges (Figure Ext.18). The rust will need to be mitigated before it progresses to keep the rust from spreading and to increase the lifespan of the door assembly.

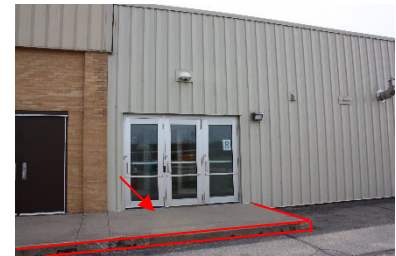
Figure Ext. 27

The steel plate above the opening is sagging (Figure Ext.27). This is a structural steel lintel that may appear to be sagging, but it could be due to rust jacking. When steel is compromised and exposed to water, it rusts. Advanced rusting will cause the steel to separate into stratified layers, becoming thicker and weaker at the same time. If this is what is causing the issue, this will need to be investigated to verify the cause soon. The sealant applied here may be causing the condition to worsen.

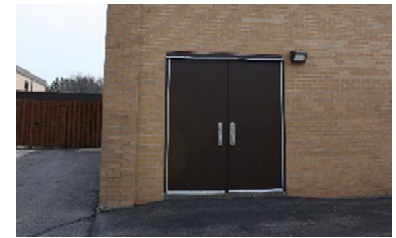
Figure Ext. 31

- Gym Exits: As exit access from the multipurpose room in the first-grade wing, these three openings are all double leaf doors with center mullions. These are exit-only doors; thus, there is no hardware on one of the sets of doors (Figure Ext.31). the sealants, seals, and sweeps are all in good condition as well.

The concrete and asphalt at the door sill of all three openings are not flush. This is problematic as they likely can't qualify as an ADA exit from the multipurpose room. Making sure at least one, if not all, of these exits have accessible transitions to safety should be a priority.

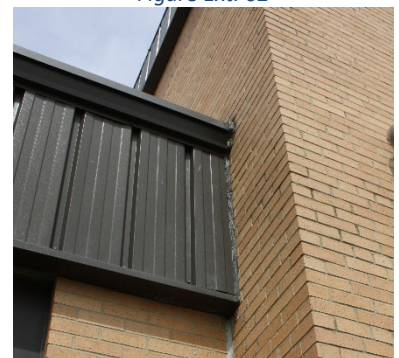
Figure Ext. 63

- Metal Wall Panels: The ribbed metal wall panel at the first-grade wing addition (Figure Ext.63). The metal panel is in good condition despite the slight fading of the finish.

- Metal Panel Assemblies:** No immediate actions are expected currently. The metal panel wall assemblies could also be on the same inspection cycle as the adjacent masonry walls. The sealant at the fastener heads could be replaced by removing the fastener and replacing the washers with neoprene washers that remain soft for a better seal.

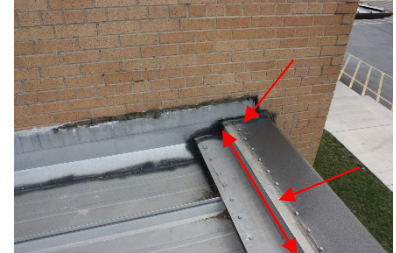
Figure Ext. 78

- **Parapet Copings:** the largest concern with the coping installations on the metal roof conditions is the exposed fasteners on the top of the copings (Figures Ext. 78, Ext. 79, & Ext. 80). Several different preventative measures have been installed to combat leaking at these coping caps.

- **Roofing:** The installed sealants on the standing seam metal roofs need to be fully inspected to verify their integrity. The exposed fasteners also should be inspected to verify the gasket or washers are still actively sealing around the fasteners. A future capital improvement project could be the replacement of the roof system to include a sheathing to provide more stability to the roof system.

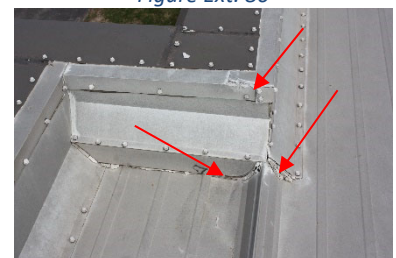
Figure Ext. 81

The vertical end flashings at the high ends of the sloped are coped over the seams and ribs (Figure Ext.81). Some of the sealant at these locations is a blind condition behind the flashing. It appears some of these are drying out. The sealant in other similar locations that have been applied after the original installation is also drying out and cracking (Figure ext. 82). This sealant is brittle. It will eventually fall out or off, creating an open gap. The high point portions of the roof have a smaller likelihood of leaking than the low points; however, wind-driven rain can penetrate these conditions.

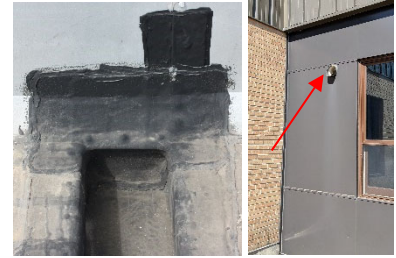
Figure Ext. 84

- **Roof Drainage Components:** As mentioned before, the lower roof on the original elementary building has an inverted slope that drains everything to a central building in a gutter (Figures Ext. 83, Ext.84, & Ext.85). This gutter system was connected to the vertical conductors at the original roof drains or overflow system.

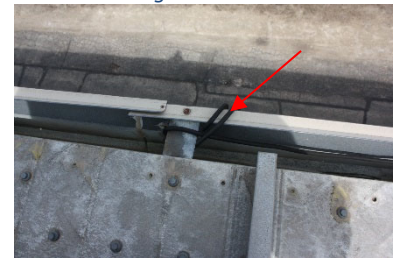
Figure Ext. 86

At the lamb's tongue outlet (Figure Ext.86), located at the southwest corner of the original building, A steady volume of water is discharged

here during rain events. This indicates the integrated gutter is connected to this outlet, and the attributing area for this discharge is the first-floor section of the original building. As mentioned before in the site drainage portion of this report (Figure Ext.16), the force at which the stormwater exits this discharge point hits the river rock in the landscaping bed at a velocity great enough to displace the stones.

Gutters are deployed at the metal roofing installations (Figures Ext. 86 & Ext.87). Most of the conductor's discharge via downspouts is discussed later in this report.

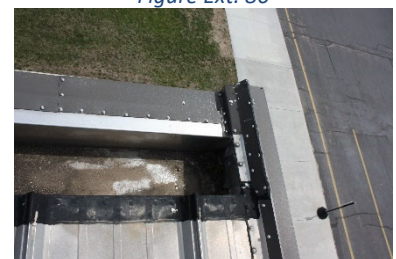
Figure Ext. 87

Heat trace elements are installed in several of the gutters (Figure Ext.87). This indicates an issue with ice forming at the gutters. These are installed to melt any ice that forms in the gutter to prevent ice dams and dangerous snow and ice buildup from sliding off the roof.

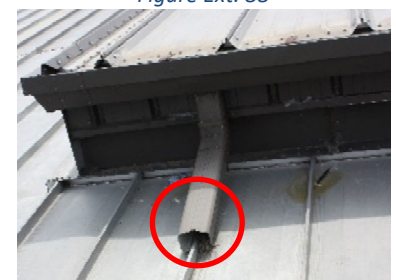
Figure Ext. 89

There are a few locations where downspouts discharge onto the metal roof below (Figures Ext.89 & Ext.90). There are no logistical concerns with these discharge points as long as the final gutters and conductors can adequately handle the stormwater volumes. Further analysis may be recommended if verification is desirable.

- Drainage Components:** The external gutters and downspouts do not need immediate maintenance. Consider altering the downspout on the roof where the outfall is split around a roofing seam. The built-in gutter systems have a more critical concern. If this leaks, it can cause more issues and be harder to detect as they are in the attic spaces. These need to be inspected more often. If these reroofing systems are ever replaced, it is recommended to reconfigure these to not be built in.

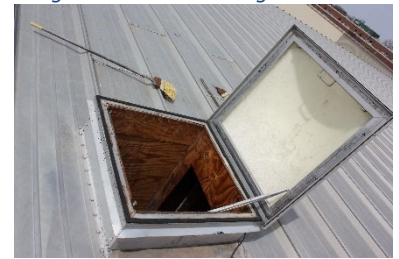
Figure Ext. 92

- Roof Access Components:** The original building has a roof hatch both at the single-story and the two-story portions of the building. The hatches have been installed, penetrating the attic spaces created when the over-framed roof was installed (Figure Ext. 91 & Ext. 92). The attic spaces are directly accessible as navigation to the roof occurs.

The roof hatches are located in Figure Ext. 94 by the circled areas. The hatches do not have safety navigation assistance integrated with the hatch making it difficult to transfer from the hatch to the roof surface (Figure Ext. 92).

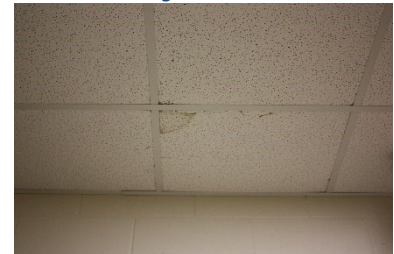
Figure Int. 2

There are some locations observed to have staining on the ceiling tile surface, indicating it had been wet at some point in time (Figures Int. 2 & Int. 4). This could be from a roof leak or a leak in a piece of mechanical equipment. It does not necessarily mean there is an active leak, only that a leak had occurred and may have already been rectified. These conditions should be investigated to verify that there are no active leaks.

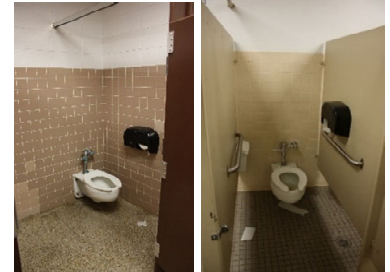
Figure Int. 40

There are some Full ADA-compliant toilet stalls (Figure Int.40), but most of the facilities only have ambulatory stalls available (Figure Int.41). This is quite typical of older buildings.

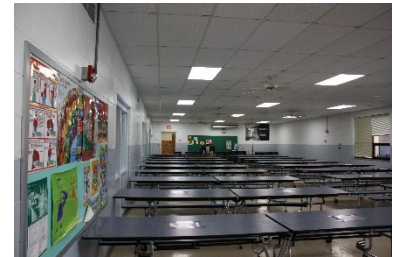
Figure Int. 48

- Cafeteria: The dining area of the cafeteria is tight (Figure Int.48 & Int.49). This requires six lunch periods to get all the students through the lunch program.

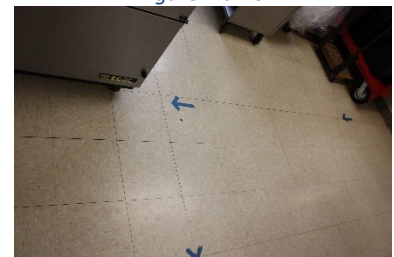
Figure Int. 50

Tape arrows are placed on the VCT flooring for traffic direction (Figure Int.50). This could potentially be a permanent strip added before refinishing.

The VCT (Vinyl Composite Tile) flooring itself is beginning to shrink and separate at the joints. In nonfood spaces, this is less of a concern except for aesthetics. In areas where food is served, you would want to have minimal opportunity for dirt and food particles to get ground into the gaps on the floor.

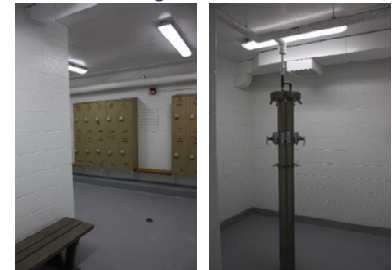
Figure Int. 66

In the changing/locker rooms of the pool, there are two-tier units and much fewer of them (Figure Int.66). The floor covering in the pool changing area and the rinse-off station is an epoxy coating (Figure Int.67). The wood benched also need to be refinished.

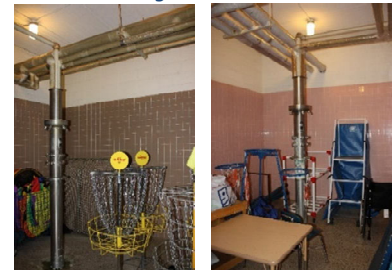
Figure Int. 67

The gang showers in the locker room are not utilized as they have gym equipment stored in them (Figure Int.67). It is becoming common that students do not shower after the gym class is concluded, even if they change clothing for class. This typically comes down to a privacy issue.

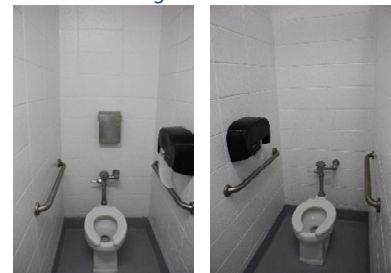
Figure Int. 75

The restrooms in the pool changing area are only equipped with ambulatory toilet stalls (Figure Int.75).

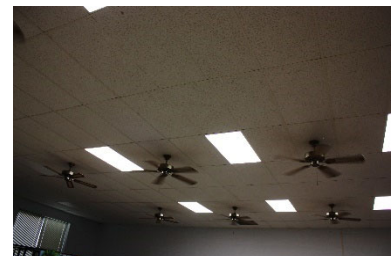
Figure Int. 76

- Music Room:** The music room is a large, uncooled space. There are nine ceiling fans installed to help provide comfort in the classroom (Figure Int.76). The ceiling is a 2x4 acoustical ceiling tile, and the walls are hard CMU. There are no significant acoustical treatments on the walls to assist with acoustical control. There is casework used for storage; however, there is loose storage at the back of the room. There is a horizontal crack at the lintel line of the windows (Figure Int.77). There may not be a structural concern; however, evaluation is recommended.

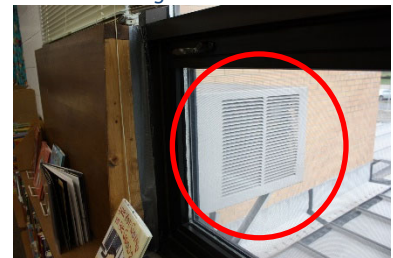
Figure Int. 86

There is no cooling integrated into the building in this area. Small window air conditioning units are installed in the media center (Figure Int.86). These units likely struggle to keep the space comfortable. This is not a viable long-term solution to the need for cooling.

- Media Center: Consider replacing the carpet with a carpet tile for a more resilient and lower maintenance installation. Refer to the mechanical analysis portion of this report for recommendations on cooling.

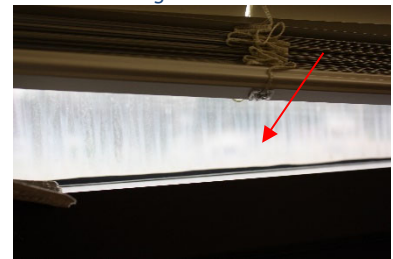
Figure Int. 87

There is discoloration between the glazing panes on some of the windows (Figure Int. 87). This indicates the gaskets and seals for the double pane glazing units have failed and are no longer preventing heat transfer as condensation is occurring between the glass.

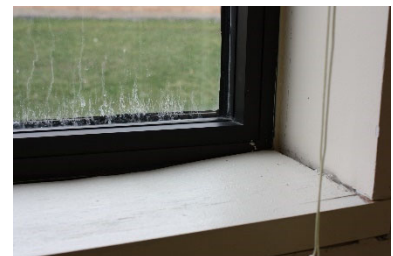
- **STEM Lab:** the new STEM lab location also has failed glazing and evidence of leaking at the window frame (Figure Int.88). the plastic laminate sill in Figure Int. 88 is severely damaged and delaminating. The cause of the water intrusion may have been rectified with the recent envelope repairs, but the damage to the interior will need to be addressed next.

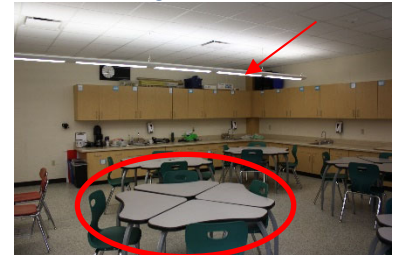
Figure Int. 90

The casework is newer and in good condition (Figure Int.90). The flexible seating style is great for adjusting from collaborative to individual instruction and is also in good condition.

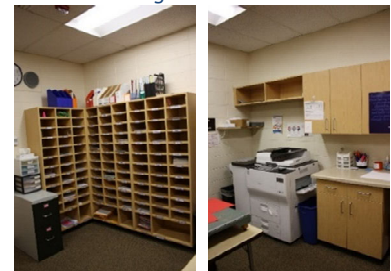
Figure Int. 96

The workroom for the main office is located at the east end of the suite. It has newer casework installed during a renovation (Figure Int.96). The workroom has an adjacent restroom and an additional storage room.

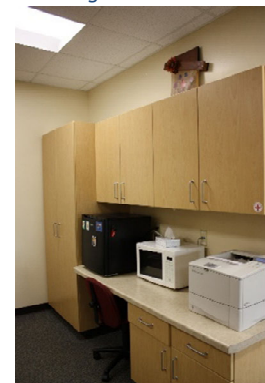
Speech

- **Resources:** The speech suite was part of the administration renovation. The casework is in good condition. No major deficiencies were observed during the survey visit.

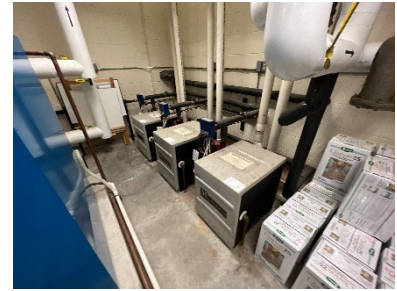
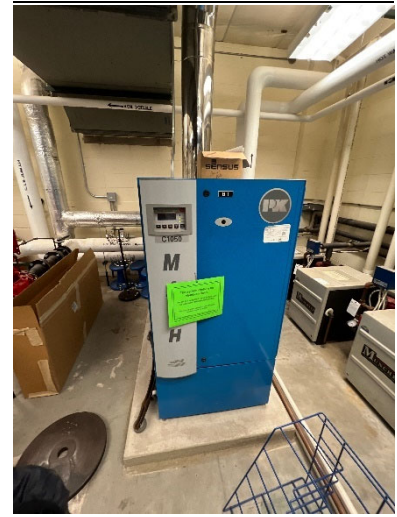
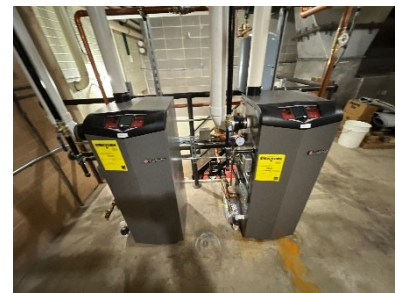
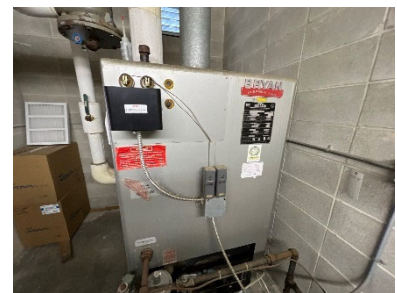
- The NE equipment room boiler plant serving the building consists of two (3) HW boilers from HTP. The boilers are 500 MBH input each and up to 94% efficient. The boilers were installed in 2003 and are in fair condition.

- The north equipment room boiler plant serving the building consists of one (1) HW boiler from Bryan. The boiler is 750 MBH input each and up to 80% efficient. The boilers were installed in 1991 and are in fair condition.

- The pool equipment room boiler plant serving the building consists of two (2) HW boilers from Lochinvar. The boiler is 750 MBH input each and up to 80% efficient. The boilers were installed in 1991 and are in fair condition.

- Review boiler supply water reset curve to determine if additional energy savings can be achieved.
- Replace the Bryan Flextube boiler with new condensing boiler technology capable of increased efficiency during shoulder heating months. Replace the HW pumps and provide new pumps with VFDs to vary system flow.

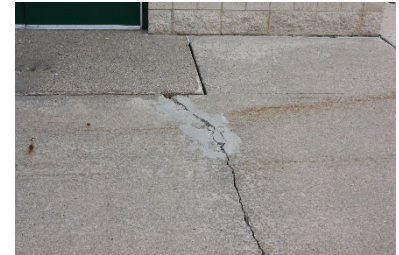
Figure Ext. 1

Concrete walks: An observed condition is the patches installed as corrective action, where concrete has spalled near the edges of a control or construction joint (Figure Ext.1). These repairs, although unsightly, are to ensure that pedestrian traffic does not trip on the pothole created at the spalling.

- Exit Doors: No recommendations currently.
- Windows General Conditions: No recommendations currently.
- Stone and masonry sills: No recommendations currently.
- Roofing: No recommendations currently.
- Roofing Accessories: No recommendations currently.
- Control Joints: No recommendations currently.
- Walls: No recommendations currently.
- Paving and lots: Consider concrete replacement at the severely rust-stained stoops. Using a concrete additive and coated reinforcement can prevent rust staining. Consider replacing the concrete walks and curbs that are deteriorated and patched. Include the sections of concrete that are uneven and ones that need to be ground down.

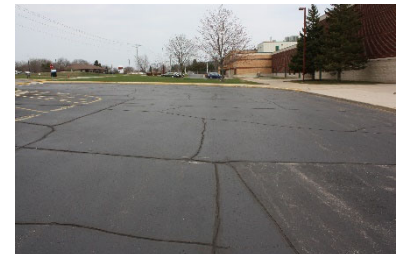
Figure Ext. 3

- Asphalt Paving: The asphalt paving is in generally fair condition. The cracks have been filled to prevent water from getting into the substrate. Some areas have tighter knit cracks that need to be monitored.

Continue filling the cracks in the asphalt to keep water from infiltrating the subgrade. Monitor the cracking after every winter to verify the asphalt doesn't crack into small pieces or create potholes.

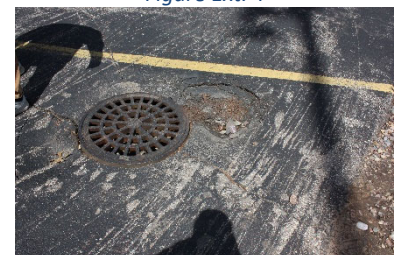
Figure Ext. 5

Maintenance may be deferred in most areas; however, one location is reported to have a potential issue. Figure Ext.4 shows the approximate location where a catch basin may be compromised, and the underground erosion is occurring. This could mean a storm pipe may be compromised and the catch basin leaking into the soil, washing soil into the storm system. This is causing the asphalt to sink around the immediate area of the catch basin (Figure Ext.5).

- Stormwater catch basin: Investigate the potential undermining at the two indicated catch basin locations. Repair these conditions to prevent dangerous sinkhole conditions.

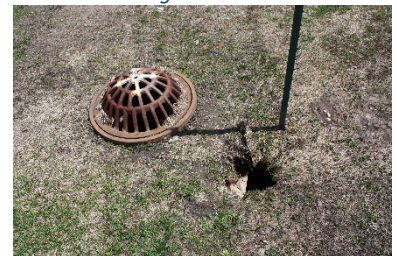
Figure Ext. 10

South of the building near the maintenance access drive is another catch basin in the grass that may have a compromised basin and pipe connection. The soil here is also getting undermined, and a sinkhole is beginning to form. This is causing a dangerous condition at the edge of the catch basin/yard drain (Figure Ext.10).

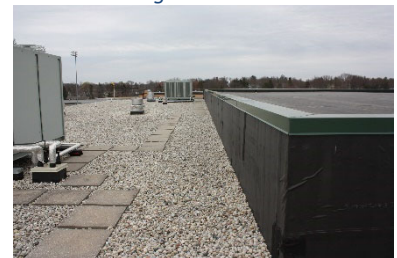
Figure Ext. 40

There is another high roof that has a fully adhered vertical flashing up to the high roof (Figure Ext.40).

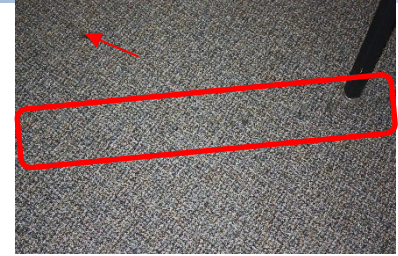
Figure Int. 12

- Classroom Floors:** There is sheet carpeting in some locations. In-room MA204, the sheet carpet has both stains, and the seam is fraying in one spot (Figure Int.12). There was also cracking in the concrete slab beneath the carpet that was detected during the survey by visible and tactile buckling.

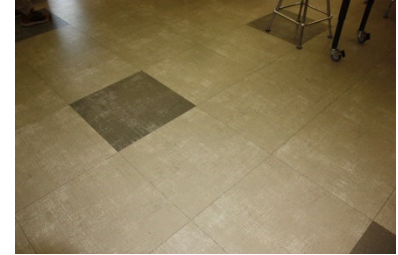
Figure Int. 13

There is Luxury vinyl tile in many of the lab classrooms (Figure Int.13). This tile is usually resilient and requires less maintenance than traditional vinyl composite tile (VCT). There were a few locations where a tile corner was chipped. The damage was small and can be deferred, but it may be desirable to eventually replace individual damaged tiles with attic stock.

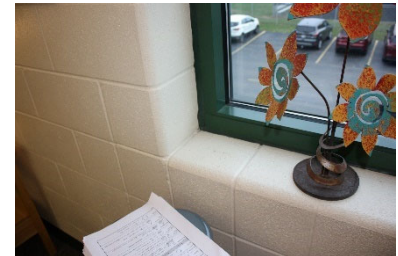
Figure Int. 14

- Classroom Walls:** The exterior and corridor walls are CMU (Concrete Masonry Units) which are painted and very durable (Figure Int.14).

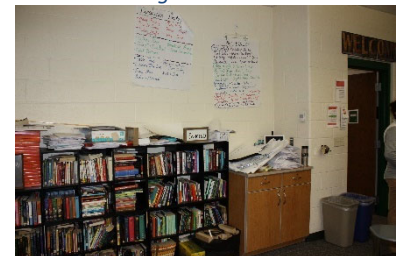
Figure Int. 15

The balance of the walls are framed, painted gypsum board, and are in good condition (Figure Int.15). These walls are in good condition but will need additional maintenance as they can be more easily damaged than the CMU walls.

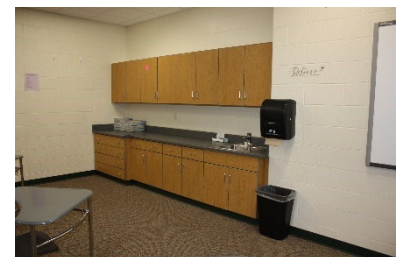
Figure Int. 16

- Casework:** The wood look plastic laminate casework is in good condition (Figure Int.16). There are select cabinets with lockable cylinders, which are important for securing classroom supplies and teachers' items.

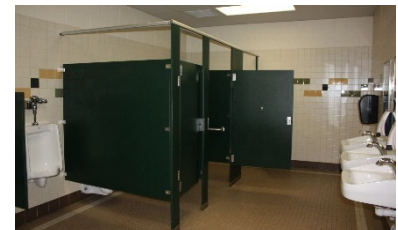
Figure Int. 21

- **Restrooms:** The restrooms are clad in ceramic tiles on the floor and the ceilings. The partitions are still in good condition (Figure Int.21), and the urinals have privacy screens (Figure Int.22).

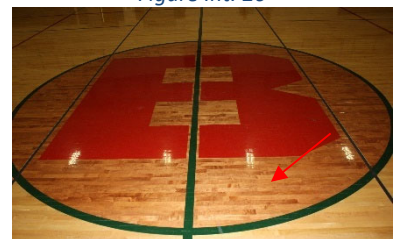
Figure Int. 27

The flooring is in good condition and has light scratches and scuffs (Figure In.27). No immediate concerns for the floor finish were observed during the survey visit.

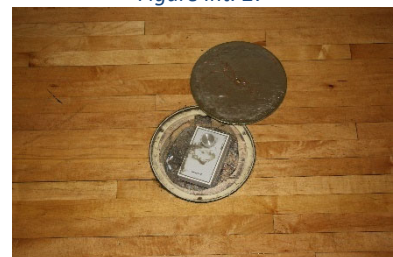
Figure Int. 28

The wood athletic floor has a ventilation system installed (Figure Int.28). This is designed to pull air under the flooring sleeper supports to ensure that the flooring stays dry and that humidity does not have adverse effects on the wood flooring.

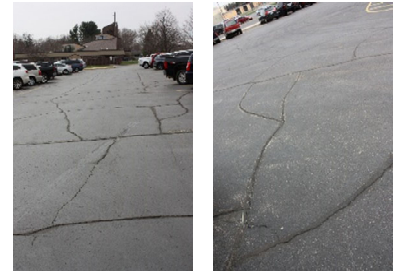
Figure Ext. 8

- Asphalt Paving: Asphalt paving on the high school lot is in good condition despite the number of cracks that have been filled (Figure Ext.8 & Ext.9). Not all the surface area was observed; however, when the asphalt cracks and the sections remain large, the serviceability remains better. When smaller sections are formed, and more of a tight-knit spider web type of condition occurs, the asphalt shifts easily under traffic, dislodges, and creates potholes.

Continue filling the cracks in the asphalt to keep water from infiltrating the subgrade. Monitor the cracking after every winter to verify the asphalt doesn't crack into small pieces or create potholes.

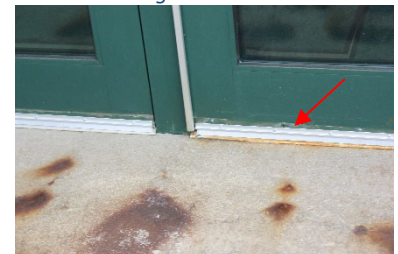
Figure Ext. 12

The door and frame are aluminum and in good condition. The perimeter sealant is intact, not drying out, and should be functioning well. The sweeps at the bottom of the doors have been replaced (Figure Ext.12). The scar from the previous sweep installation could be cleaned up and painted to match, but not necessary for the door to function.

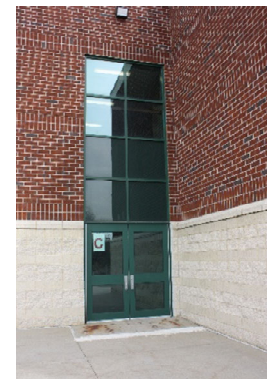
Figure Ext. 13

The stoop has iron oxide staining as described in the exterior concrete assessment. There is also patching around the stoop here to accommodate where the sidewalk has settled (Figure Ext.13).

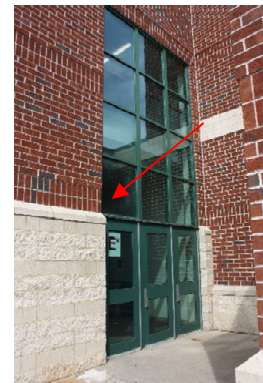
Figure Ext. 15

The door and frame are aluminum and in good condition. The perimeter sealant is intact, not drying out, and should be functioning well. The insulated glazing unit above the western door leaf appears to be failing (Figure Ext.15). There are deposits on the interior surface of the glazing due to the glazing seal being compromised, allowing condensation between the glass.

The compromised glazing unit may need to be replaced. However, there is a security risk that should be addressed.

- **Windows General Conditions:** Consider replacing the failing glazing units that have compromised glazing seals. This will increase the thermal performance of that glazing unit to at least the original performance.

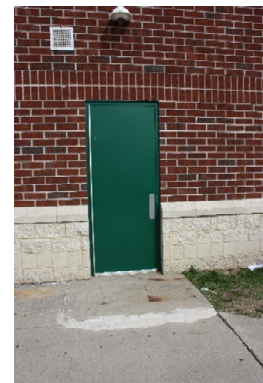
Figure Ext. 16

This hollow metal door is in good condition, including the perimeter seals, weather stripping, and sweep. There is some rust forming at the base of the frame jambs with bubbling paint (Figure Ext.16).

No immediate action is required, but addressing the rust at the bottom of the jambs will eventually need mitigation.

- **Exit Doors:** Rust at the bottom of the hollow metal doors need to be mechanically removed, primed, and painted. The exit door at receiving needs to be repaired where a hole has rusted through. The hole might be unable to repair and potentially will need to have the frame replaced. These repairs will increase the longevity of the doors and frames.

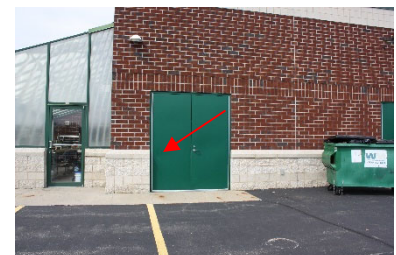
Figure Ext. 17

This is a hollow metal pair of doors in good condition, including the perimeter seals, weather stripping, and sweep. There is a small dent on the western (Figure Ext.17).

No immediate action is required, but addressing the rust at the bottom of the jambs will eventually need mitigation.

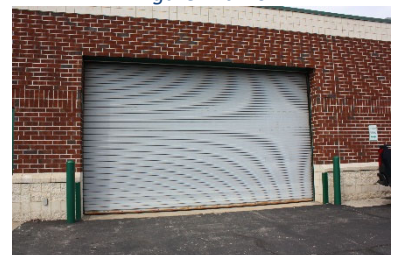
Figure Ext. 21

- Overhead Door @ Small Engines Shop: This is an insulated roll-up door that allows access to the small engines shop area. The door is in overall good condition. There is rust along the bottom stiffener connected to the door bottom seal. The rust hasn't reached an alarming condition, but repainting the metal will prevent further deterioration.

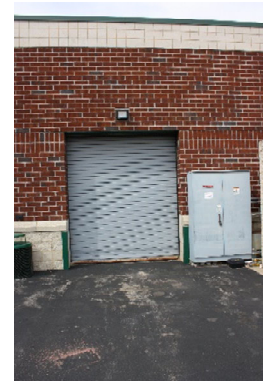
Figure Ext. 24

- Overhead Door @ Mechanical Room: This is an insulated roll-up door that allows access to the mechanical room. The door is in overall good condition. There is rust along the bottom stiffener connected to the door bottom seal. The rust hasn't reached an alarming condition, but repainting the metal will prevent further deterioration.

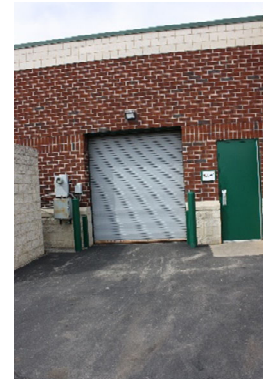
Figure Ext. 25

- Overhead Door @ Receiving: This is an insulated roll-up door that allows access to the receiving area. The door is in overall good condition. There is rust along the bottom stiffener connected to the door bottom seal. The rust hasn't reached an alarming condition, but repainting the metal will prevent further deterioration.

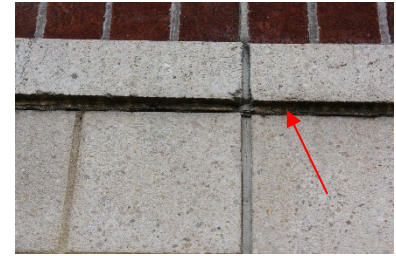
Figure Ext. 44

The horizontal mortar joint below the cast stone accent band is discolored and separated horizontally (Figure Ext.43 & Est.44). This discoloration appears to be mildew or mold. The condition may be caused by water escaping from the wall cavity at these locations.

- **Stone and masonry sills:** Replace the cracked and mildew-stained mortar joint just below the stone cap above the decorative CMU base. Where there are cracks located in the vertical mortar joints at this stone band and similar sills, consider installing soft calk joints

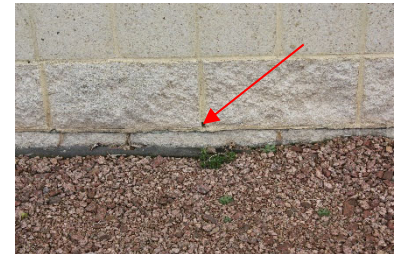
Figure Ext. 45

- Wall accessories:
- Masonry Weeps & Vents: Weeps appear to be installed at the bottom of the decorative concrete block (Figure Ext.45). However, the frequency of the installation is not apparent. The mortar joint at the bottom of the wall is mostly open and may be acting as a naturally formed weep location.

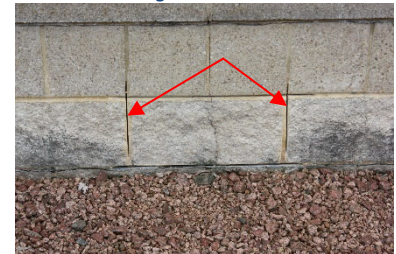
Figure Ext. 46

In at least one location, the head joints at the bottom block have been saw cut (FigureExt.46). This may have been done to relieve water head pressure if water had been trapped in the cavity.

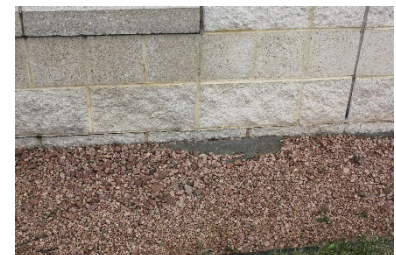
Figure Ext. 47

- Flashing: A flexible through wall flashing that terminates behind the face plane of the masonry. This type of installation is usually acceptable, but without the benefit of a drip edge, there is a chance of capillary action that could pull water in under the flashing. It is not known to be the case with this wall.

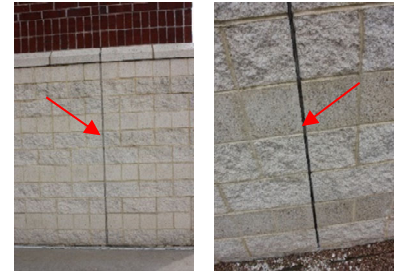
Figure Ext. 48

- **Building Expansion Assemblies:** The control joints installed were correctly spaced and installed. Some of the joints appear newer and may have been replaced. Some of the joints appear original and under the stress of their age (Figure Ext.48).

- **Control Joints:** Replace old joints that are cracking and beginning to separate from the substrate.
- **Walls:** inspect the walls for cracks in the masonry units and the mortar joints. Remove mortar and tuckpoint joints for cracks greater than 1/16" in with and greater than 8" long vertically and 16" long horizontally.
- **Paving and lots:** Consider concrete replacement at the severely rust-stained stoops. Using a concrete additive and coated reinforcement can prevent rust staining. Consider replacing the concrete walks and curbs that are deteriorated and patched. Include the sections of concrete that are uneven and ones that need to be ground down.

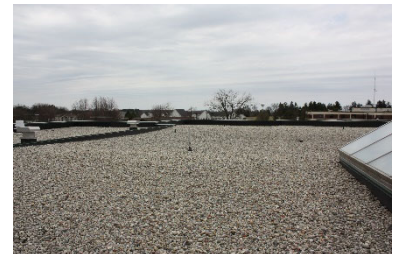
Figure Ext. 51

- **Roofing:**
- **General Roofing condition:** The high school roof is in good condition and was replaced in 2018. This is a ballasted EDPM roofing installation. There should be no immediate concerns with the roofing currently.

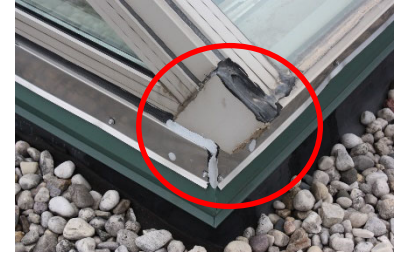
- **Flashings:** Some flashing conditions have needed additional sealant that likely was to mitigate a leak. Figure Ext. 54 is at one of the skylights shared between two classrooms.

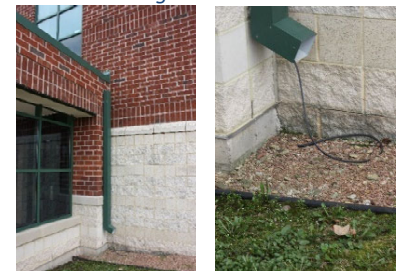
Figure Ext. 58

The lower canopies have a scupper opening and downspout for stormwater control (Figure Ext.58).

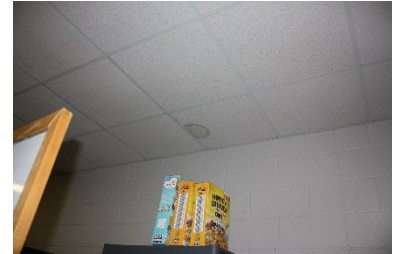
*Figure Int. 1*

- **Ceilings General:** The 2x2 acoustical tile ceiling installed will stand up to humidity longer than the typical 2x4 ceiling tiles usually installed. Some tiles have stains indicating a previous leak (Figure Int.1). It is recommended to verify there are no active leaks in the roof or mechanical equipment above ceilings when replacing the ceiling tile.

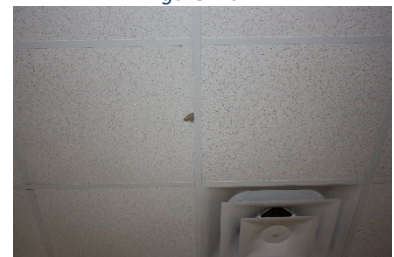
*Figure Int. 2*

Some damaged tiles might be desirable to be replaced. (Figure Int.2)

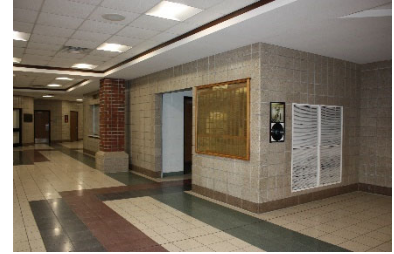
Figure Int. 6

The main commons space has ceramic tile flooring (Figure Int.6).

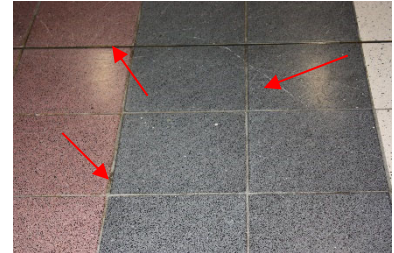
Figure Int. 7

The tile surface has many scratches, and the tile finish is compromised. The grout lines are also very stained and need a deep cleaning (Figure Int.7). The grout would need to be sealed frequently to prevent additional staining.

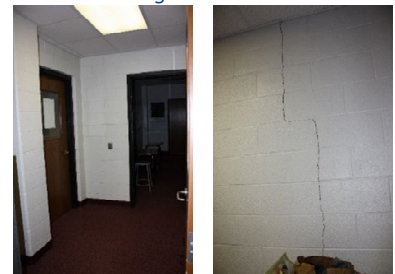
Figure Int. 15

Some locations have cracks in the masonry walls (Figures Int.15 & Int. 16). In these instances, the wall may need to be analyzed by a structural engineer to verify that a major structural issue has not occurred. The engineer would be able to recommend structural repairs or verify a standard tuck-pointing procedure would be adequate.

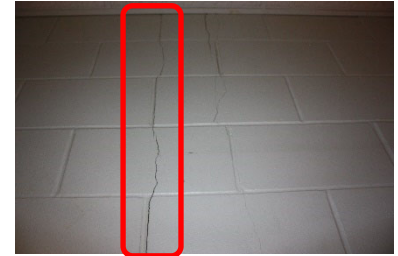
Figure Int. 25

- Classroom Walls:** Most walls of the gypsum board-covered walls in the classrooms are painted and in good condition. Some walls have vinyl wall coverings on them. In areas like these, unless the space is air-conditioned, the vinyl wall covering is susceptible to humidity and can peel. (Figure Int.25).

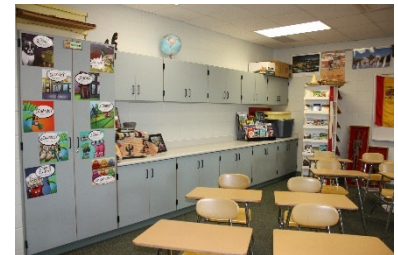
Figure Int. 26

Some locations have cracks in the masonry walls (Figures Int.26). In these instances, the wall may need to be analyzed by a structural engineer to verify that a major structural issue has not occurred. The engineer would be able to recommend structural repairs or verify a standard tuck-pointing procedure would be adequate.

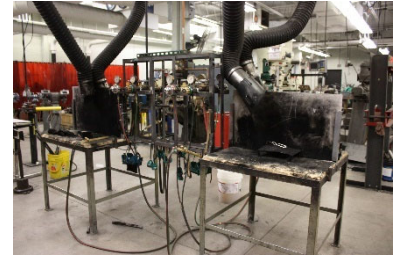
Figure Int. 54

There are additional welding stations that do not have the protection of welding curtains (Figure Int.54). It is recommended to have welding curtains around these stations. It may be desirable to reconfigure the welding stations to be more efficient, with hard walls on the welding booths. It is also recommended to add task lighting at the welding booths.

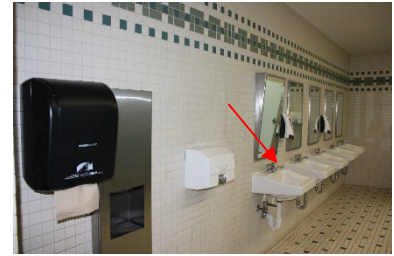
Figure Int. 60

- **Restrooms:** The restrooms typically have ceramic tile finishes on the walls (Figure Int.60) and mosaic tile flooring (Figure Int.61). The ceramic tile is in good condition, but the grout will need periodic deep cleaning and re-sealing. The installed grout does not likely contain epoxy additives that newer grout has.

The flush valve (Figures Int.63 & Int.64) and faucets (Figure Int.60) are manual controls. We recommend installing touchless controls for the water delivery controls for water savings and to reduce the number of surfaces occupants would touch. This will reduce the spread of bacteria and viruses. The faucets are the push-down spring controls. At the survey site visit, a stuck open control was observed, causing water to run continuously. This is where water savings could be improved upon.

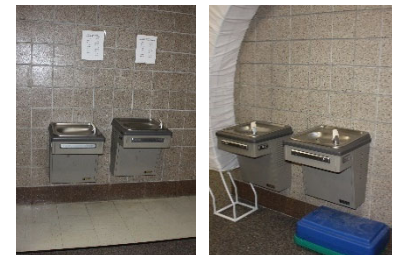
Figure Int. 75

- Drinking Fountains:** The drinking fountains located in the high school are original to the building (Figures Int. 75 & Int. 76). None of these have bottle filling stations. It is recommended that at least one drinking fountain at each location is replaced with a bottle filling station, or, in some cases, a bottle filling station is added to at least one of the drinking fountains. The recessed drinking fountains in the gymnasium should be upgraded to bottle filling stations.

- **Drinking Fountains:** We recommend adding bottle filling stations where existing equipment allows and/or replacing drinking fountains with bottle filling stations. This will allow touchless stations to reduce bacteria and virus spreading.

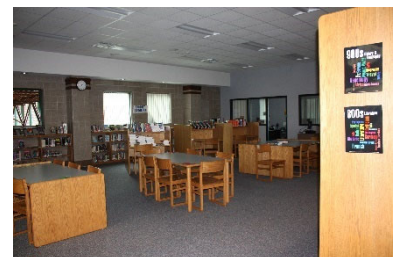
Figure Int. 77

- The Media Center:** The media center is carpeted with sheet carpeting, and the seating is typical older style library furniture (Figure Int. 77). Updating the carpet to a carpet tile is recommended, and it may be desirable to update to modern collaborative style seating.

- **Furnishings:** There is no immediate concern for the general furnishings in the school. Consider modern collaborative furnishings for replacement in some areas, including the Media Center.

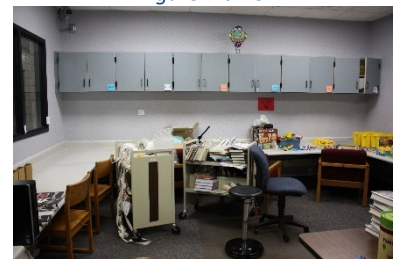
Figure Int. 80

The computer lab located in the media center is currently underutilized (Figure Int.80). This space is being used as a storage area and as a workroom. Since the school district operates as a one-to-one technology, computer labs are not needed as much as they had been in the past.

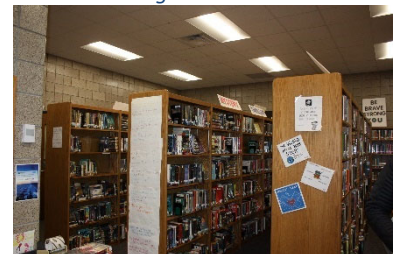
Figure Int. 81

There are more stacks with the collection than modern school libraries typically have (Figure Int.81). With online resources being available to students, the collection may be able to be reduced, opening the possibility for added collaborative spaces.

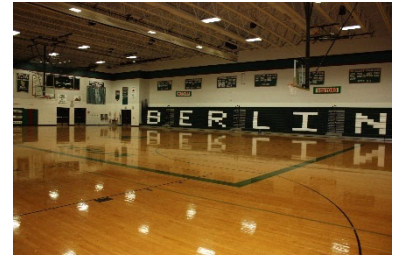
Figure Int. 85

- **Gymnasium:** The gymnasium is in good condition, and the wood floors have been well maintained. The bleachers are modern and have ADA spectator accommodations included (Figure Int.85).

- **Gymnasium:** No recommendations are currently required. Continue to maintain the flooring and refinishing as required. Consider staining the floor striping instead of painting when next doing a major refinishing of the gym floor.

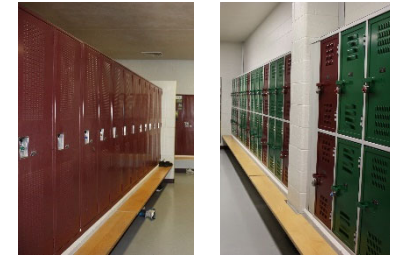
Figure Int. 87

- **Locker Rooms:** The locker rooms are in good condition, including the lockers and benches. The locker rooms were renovated when the middle school was added in 2015 (Figure Int.87).

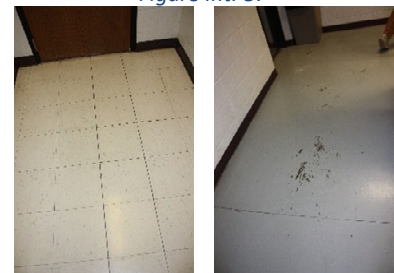
Figure Int. 88

The passage entry to the locker rooms is the original VCT. This floor covering is shrunken, and gaps are present between the tiles (Figure Int.88).

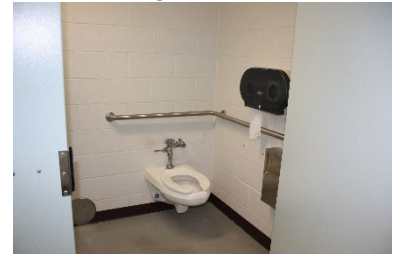
Figure Int. 92

The flush controls are manual and could use the same benefits of touchless controls as the main restrooms in the high school.

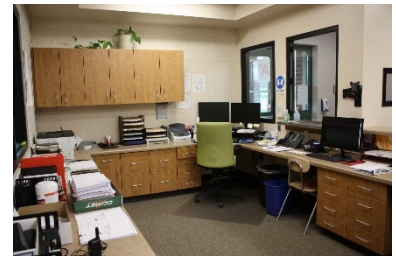
Figure Int. 93

- Administration:** The main reception is where visitors arrive at the school. The arrival sequence is reported to be awkward between the staff as operations ensue during a normal day. The layout may be better served to be renovated, and operations flipped between the reception desk and the workroom/conference room. This could allow better flow and more convenient control when checking in visitors or adjusting attendance while keeping the desk open to help other students.

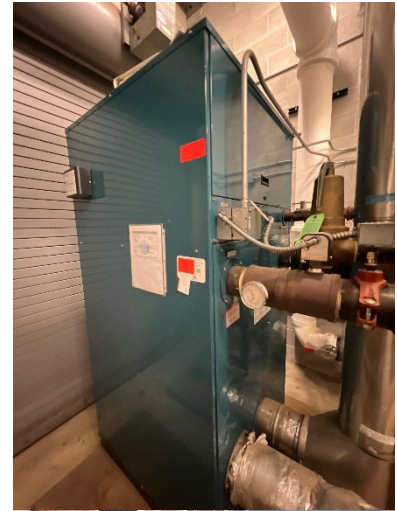
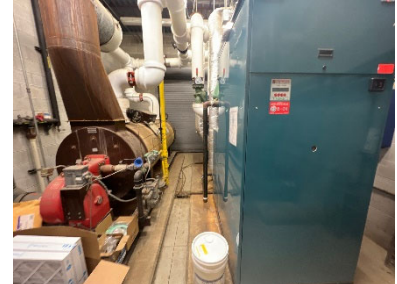
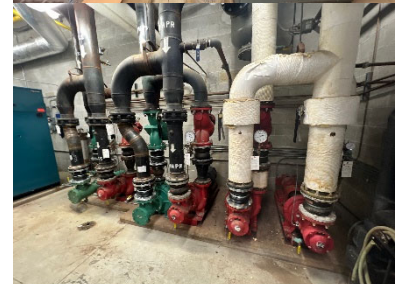
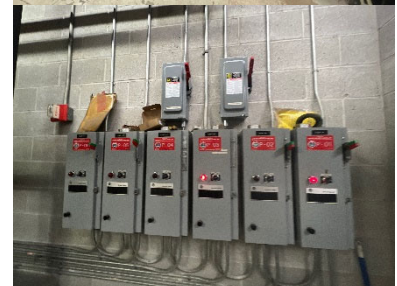
- The boiler plant serving the building consists of two (2) HW boilers from Thermal Solutions. The boilers are 3,000 MBH input each and up to 88% efficient. The boilers were installed in 2020 and are in good condition. There is also a decommissioned steam boiler that is not in use.

- The hot water plant distributes hot water to the building by two (2) inline primary pumps and two (2) base-mounted Taco distribution pumps. Both sets of pumps are at a constant speed and are in good condition. Another set of distribution pumps are base-mounted, constant speed, and should be targeted for replacement.

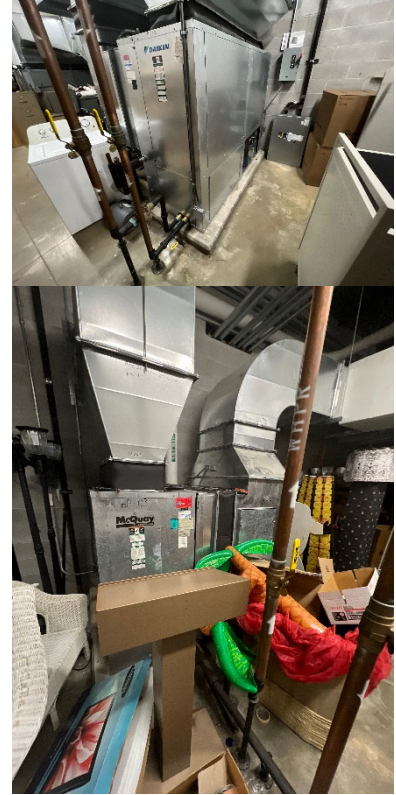
- All occupied spaces within the school are provided with air conditioning from (96) packaged DX water-source heat pumps that provide cooling and heating to the high school spaces. Though a handful of these units have been replaced due to failure, the majority of them are past their service life and should be targeted for replacement.
- The cooling tower is located on the roof and rejects heat to the outdoors from the loop while the system is in cooling mode. The cooling tower is in fair condition but has more recently been reconditioned and balanced to extend the operational life of the unit.

- Replace the water source heat pumps that have extended past their service life with either new units or evaluate a different system type if the facilities group has a different preference.

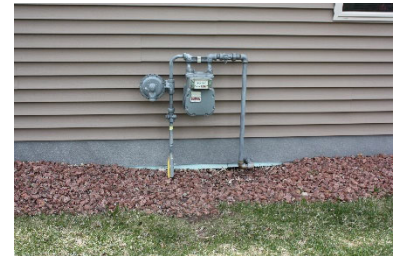
Figure Ext. 2

- Perimeter Foundation & Drainage conditions: There are no issues with most of the perimeter drainage and foundation. There is periodically exposed foundation insulation (Figure Ext.2) that should be covered to protect it from deterioration.

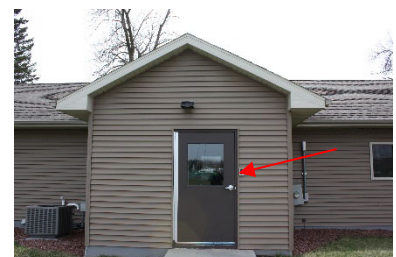
Figure Ext. 4

Exit/Entrance 2: This entrance, on the north side of the building, was added in 2000. Typically used for a staff entrance, as the main entrance is on the south side of the building, there is an Aiphone® video buzzer for secure access.

There is moisture infiltration around the foundation of this vestibule installation, as outlined later in this report.

- Exit Doors: No actions are required currently.
- Windows General Conditions: No actions are required currently.
- Masonry: No actions are required currently.
- Roofing & Roof Drainage: No actions are required currently.
- Exterior Walls: No actions are required currently.
- Paving and lots: No actions are required currently.
- Perimeter Foundations: Investigate the water infiltration into the added vestibule foundation to verify the grade waterproofing and drainage aren't' compromised.

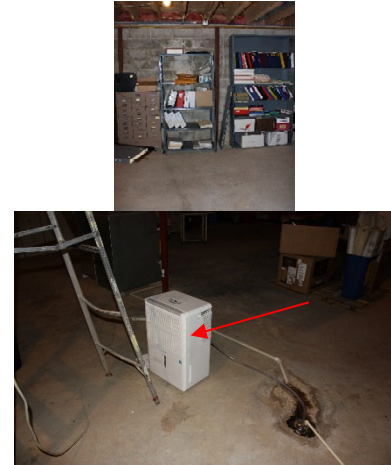
Figure Int. 11

Basements by nature are damp and not conducive to storing paper items unless environmental conditions are closely monitored and carefully controlled. The space currently has a dehumidifier that likely runs nearly constantly (Figure Int.11). This piece of equipment will likely fail and need replacing often as humidity is continually being added to the space. Not only is the dehumidifier draining in the floor drain, but also the condensate for the heating/cooling equipment and domestic water conditioning system.

- Basement Storage: The moisture infiltration needs to be mitigated to continue using for paper storage to not damage the records stored in this location. Excavating the foundation around the rear vestibule is required to locate the water infiltration points. After the repair is complete, the space will need dedicated dehumidification to keep it dry enough to store paper reports, records, and manuals.

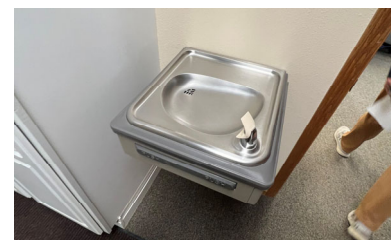
Figure Int. 13

- Drinking Fountains: The drinking fountain in the district office does not have a bottle filling station. It may not be as critical as in the education spaces, but a visitor may be wary of using the equipment after the conditions of the COVID – 19 pandemic.

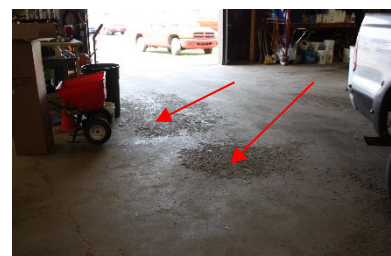
Figure 4

- **Floor Slab:** Some areas are severely pitted (Figure 4). The pitting will continue to happen as salt gets tracked in on the vehicles.

- This could potentially be repaired with concrete patching. Industrial grade floor coatings are recommended as an option to increase the life span of the slab.

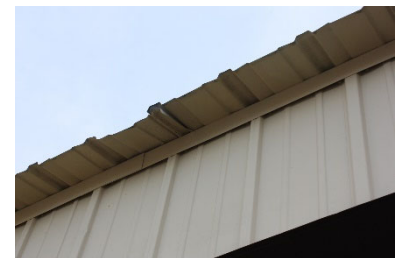
Figure 6

- **Enclosure:** This building is a basic metal panel on a pole shed frame. There is no structural overhang support (Figure 6) which eventually will cause an issue. The roof panel has already begun to sag some at the edge. Potential the ribs could reach a point of failure under the weight of snow and fold over. This may not cause catastrophic failure to the building but likely will cause leaks.

- Consider adding some kind of support to the roof overhang to prevent the roof panels from bending any further. Another option would be to cut the overhang back to only an inch or two from the top of the wall trim.

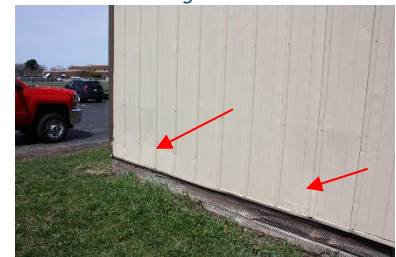
Figure 7

There are also dents in the metal siding (Figures 7 & 8). This building is not heated, so penetrations in the siding are not as much of a concern as for the heated maintenance building. It is important to protect the wood framing from getting wet to prevent conditions that would allow the wood to rot.

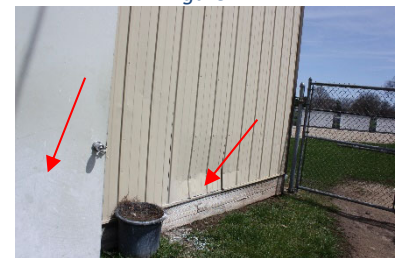
Figure 8

The doors are in relatively good condition; however, the service door has fading paint and could use refinishing (Figure 8).

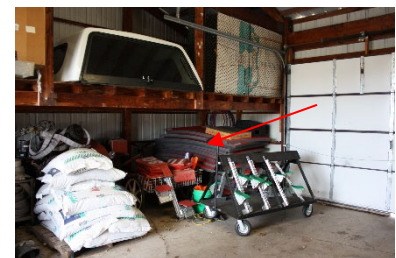
Figure 9

- **Interior Conditions:** This building is used for storing lawn care equipment. However, some athletic equipment and stock furnishings for the schools are also stored here (Figures 9 & 10).

It would be recommended if the non-lawn care items could be moved to a new location.

- One proposed suggestion is to construct an enclosure under the home bleachers that could utilize that space for athletic storage.

A potential additional solution could be to purchase a shipping container for athletic storage and place that under the edge of the bleachers. This is pre-built, securable, and could be painted with Berlin school colors.

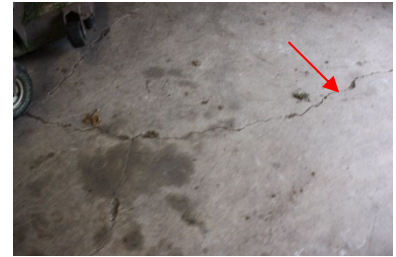
Figure 11

- **Floor Slab:** This floor slab is cracked in a few spots (Figure 11). There is no immediate concern currently, but the cracks could be repaired to prevent further deterioration.

- No recommendations currently. Consider patching the cracks in the slab.

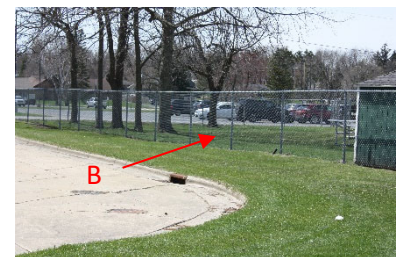
- **Grading Issues:** There are a couple of low spots in the grading that pools water during storm events. Location B above and in Figure 1 does not impede the track & field events, but the long jump pit is very close to this grading depression. Location A above is a more critical condition. This area does get flooded during a storm event and can render the discus stations unusable.
  - Location A needs to be regraded, so there is no ponding to impede the track and field events.

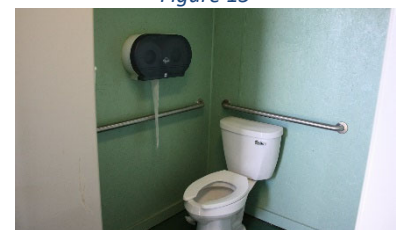
Figure 16

The painted floor is flaking and chipping. The interior walls are painted OSB sheathing, which isn't a good finish for a restroom (Figure 16). The fixtures are installed to be ADA compliant.

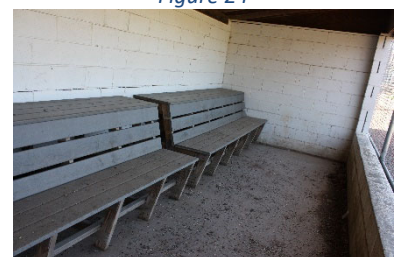
Figure 25

The structure is in good condition, but the benches in the home team dugout are very weathered, and the paint is peeling (Figure 24). The player's bench in the visiting team dugout is newer and in much better condition (Figure 25). Both dugouts have a set of loose wood steps that are in poor condition and quite rotted.

- The wood steps in both dugouts should be replaced. Consider a formed concrete installation in lieu of wood.
- Consider replacing the home team dugout players' bench with similar construction to what is in the visitor's dugout. It is recommended to construct the frame with treated lumber and to construct the seat and shelf surfaces with composite deck boards.

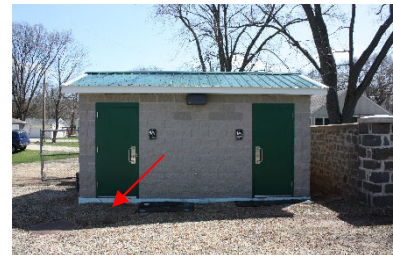
Figure 29

- Restrooms: The restroom facility is constructed from split-faced CMU and a metal roof (Figure 29). The restroom spaces are set up for ADA compliance (Figure 30) but are not accessible at the entries. Access to the restrooms requires a step up (Figure 29). The interiors are painted CMU and a bare concrete floor.

- It is recommended to add a transition ramp to the entries to make the restrooms fully accessible. Many premanufacture products could accommodate this condition.

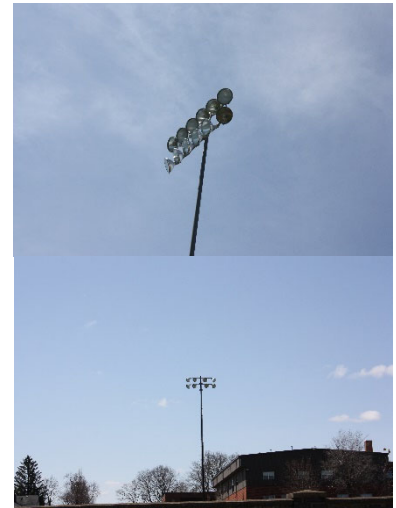
- The outdoor stadium lighting is an older technology that has a shorter life span and uses higher amounts of energy.

- We recommend replacing the stadium lighting at both the baseball field and the football field with LED lighting.
