## 2024 LANSING PUBLIC SCHOOL CONDITION MAP

## Lansing KS Financial Summary Overview

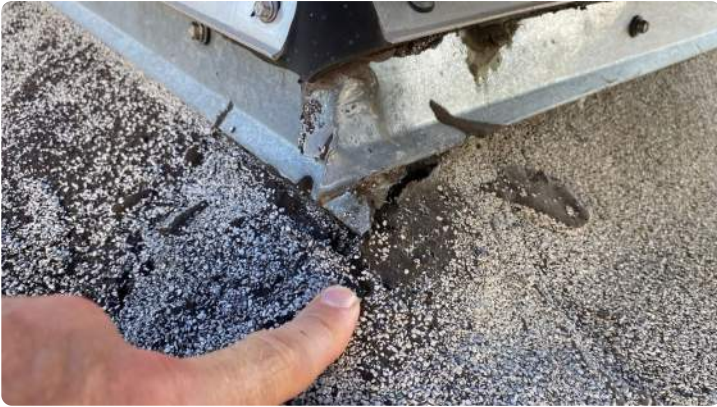
Photo showing a hole in the projection flashings. Repaired as part of the maintenance agreement.

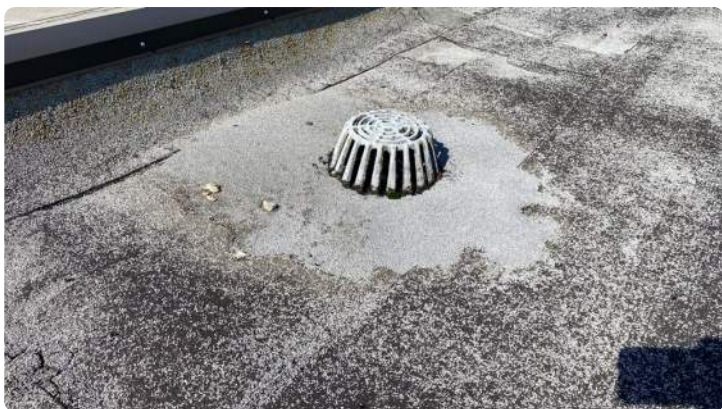
Photo showing granules piled up around drain.

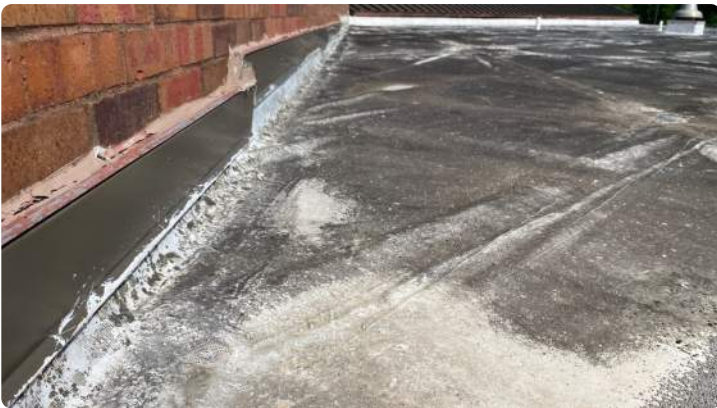
Photo showing condition of the perimeter flashings and loose membrane.

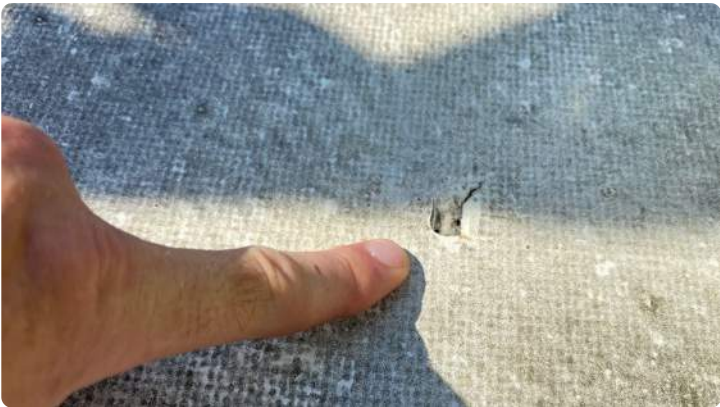
Photo showing a hole in the field membrane. Repaired as part of the maintenance agreement.

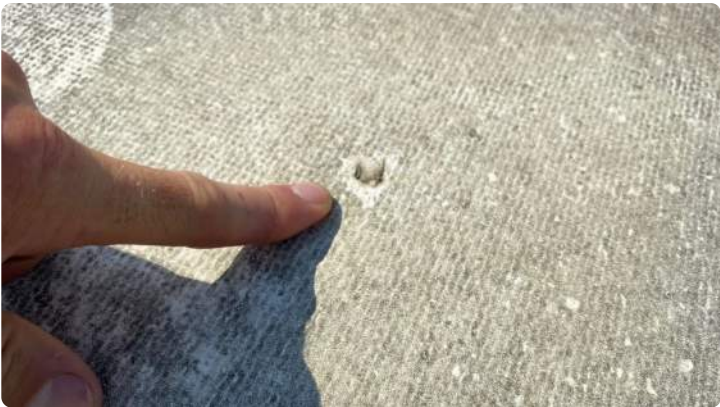
Photo showing a hole in the field membrane. Repaired as part of the maintenance agreement.

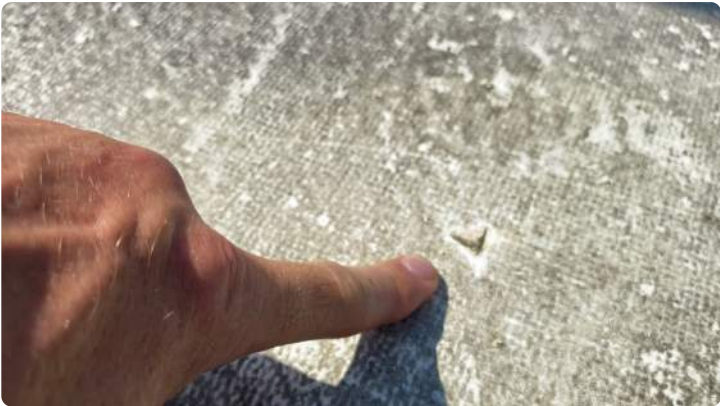
Photo showing a hole in the field membrane. Repaired as part of the maintenance agreement.

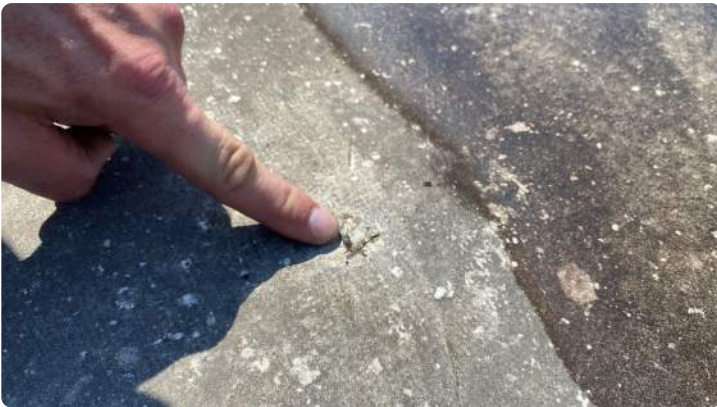
Photo showing a hole in the field membrane. Repaired as part of the maintenance agreement.

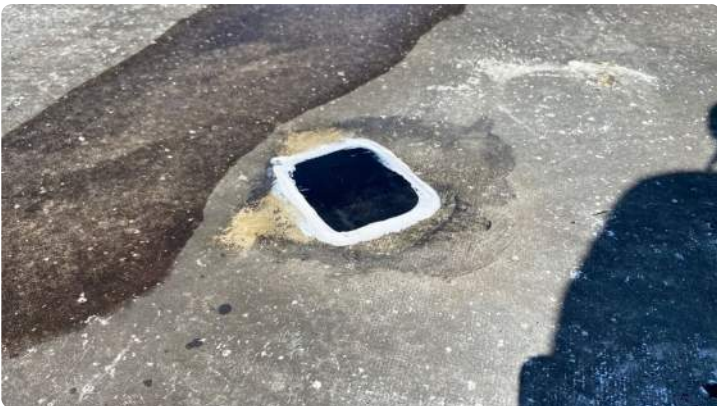
Photo showing repair made to the field membrane.

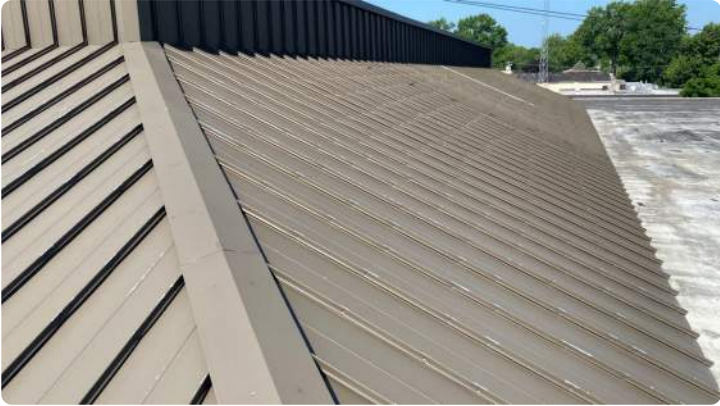
Photo showing additional condition of the metal awning.

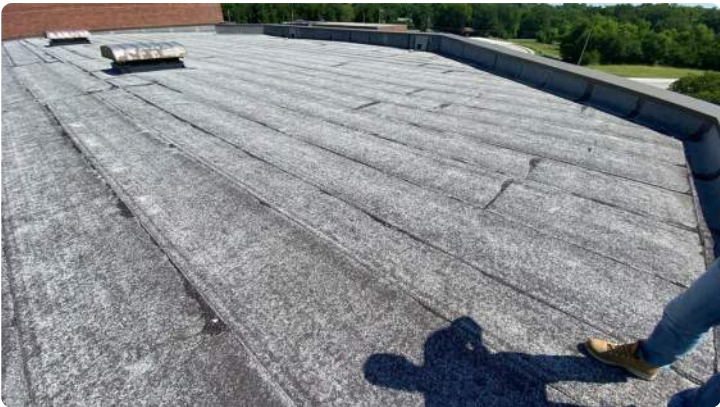
Photo showing skrim showing through deteriorated roof at seams.

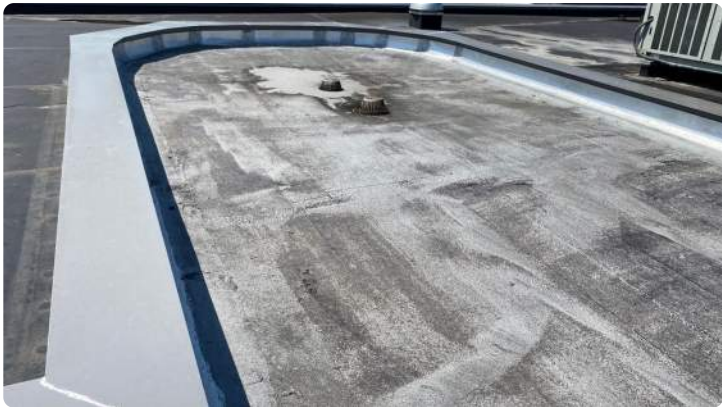
Photo showing overview of additional small section.

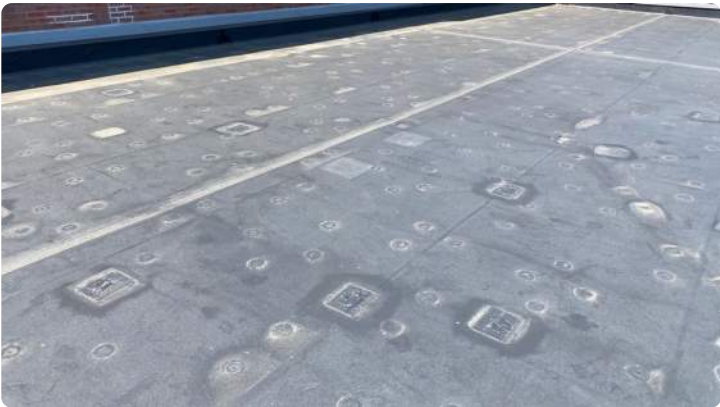
Photo showing more matches from previous holes.

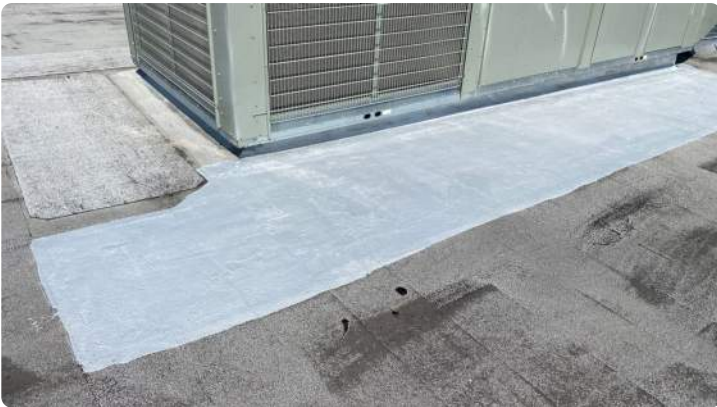
Photo showing aluminum coating around projection.

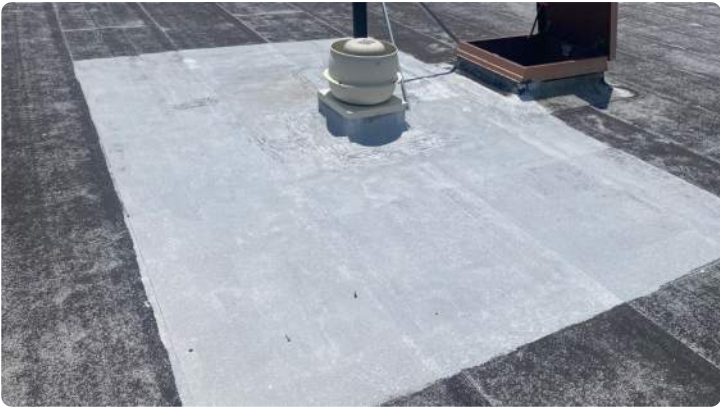
Photo showing area coated with aluminum.

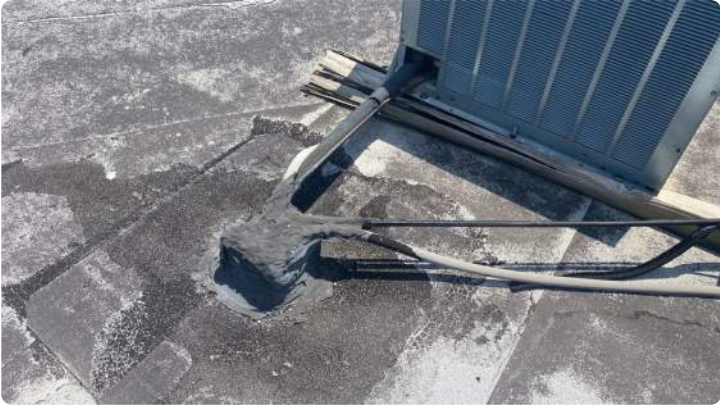
Photo showing condition of the pitch pan.

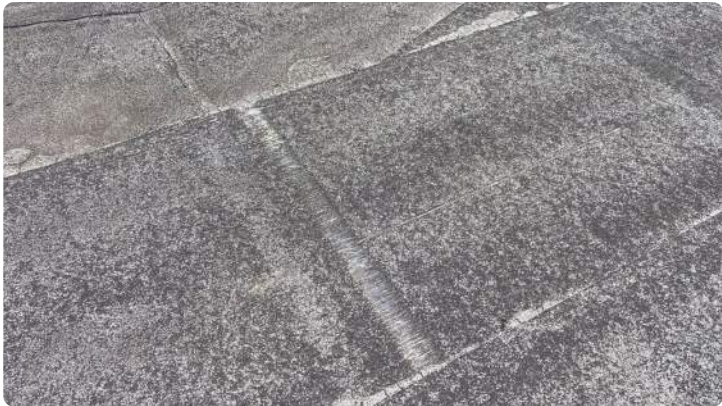
Photo showing skim showing through field.

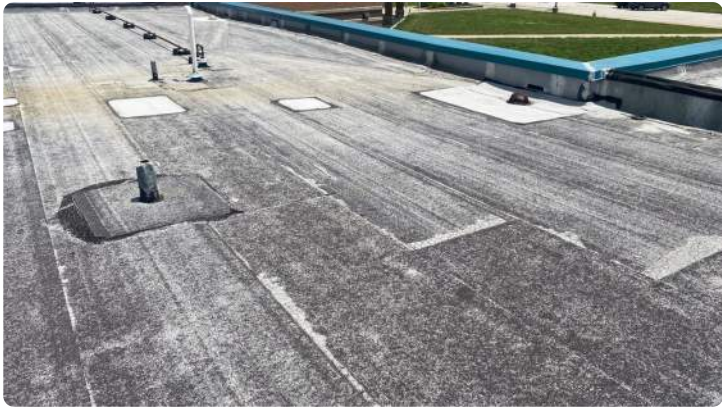
Photo showing areas previously coated in select areas.

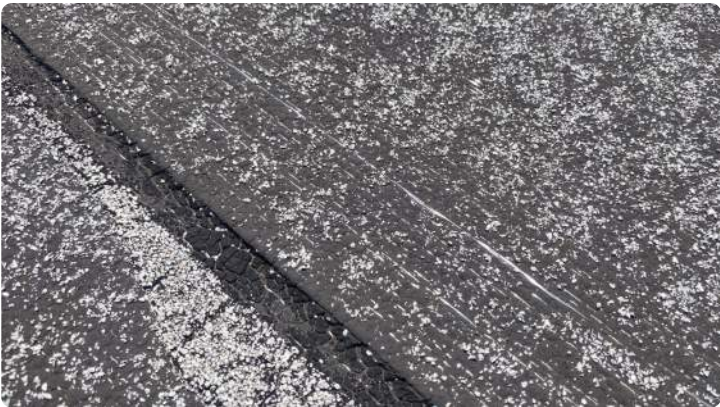
Photo showing skim showing through seams.

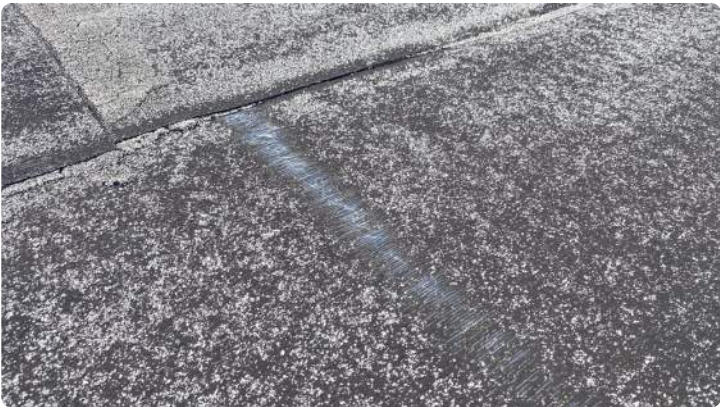
Photo showing skim showing through field.

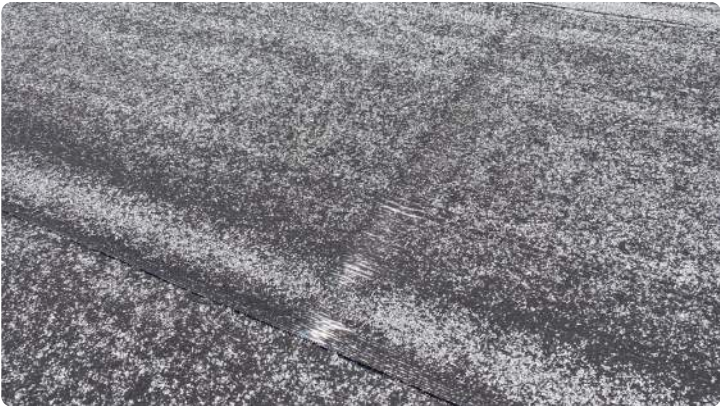
Photo showing skim exposed in field.

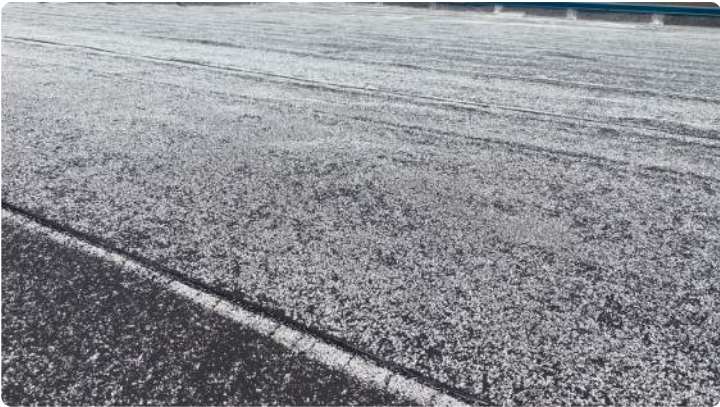
Additional photo of skim showing though field.

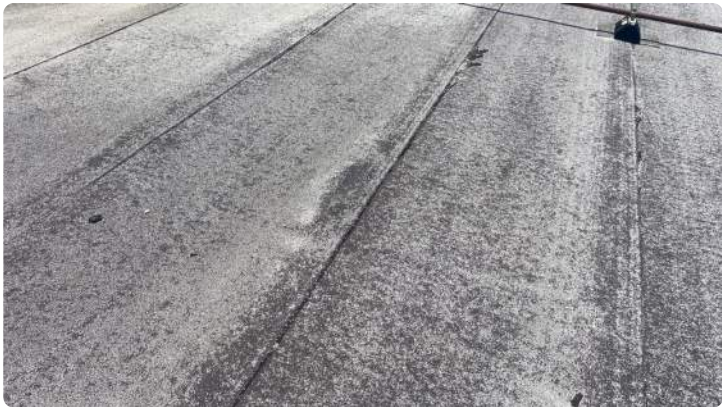
Photo showing skim exposed in the field.

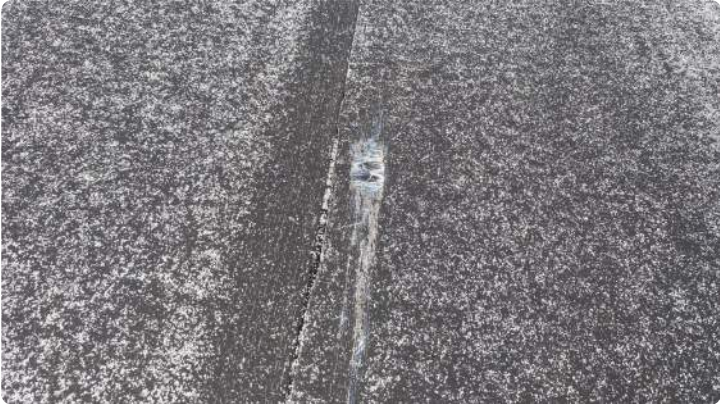
Photo showing skim showing through

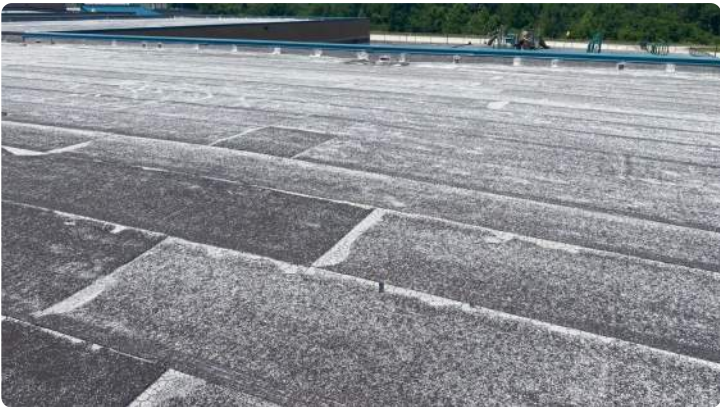
Photo showing exposed skim in deteriorated field.

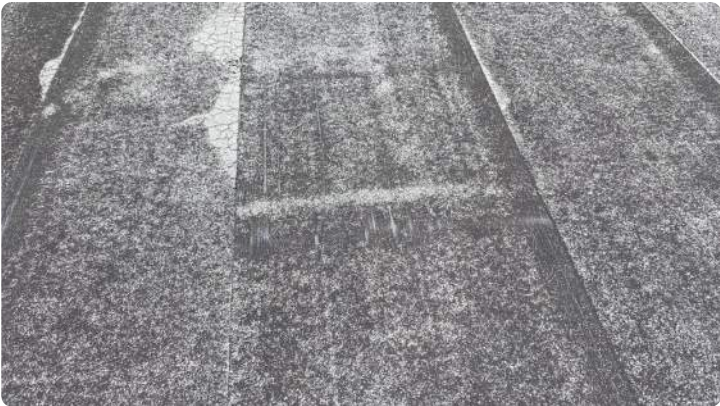
Photo showing skim exposed in field.

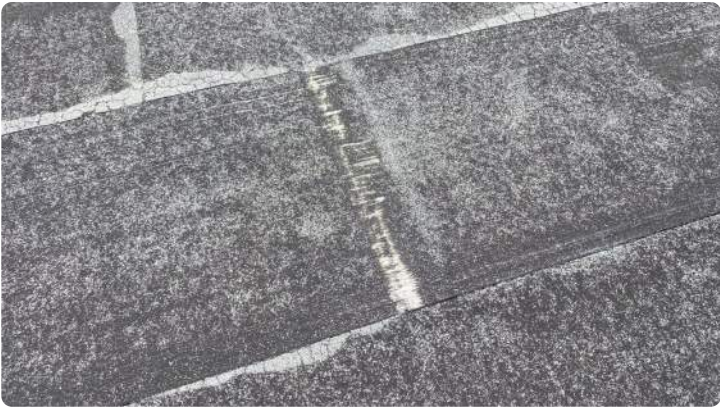
Photo showing skim exposed in field.

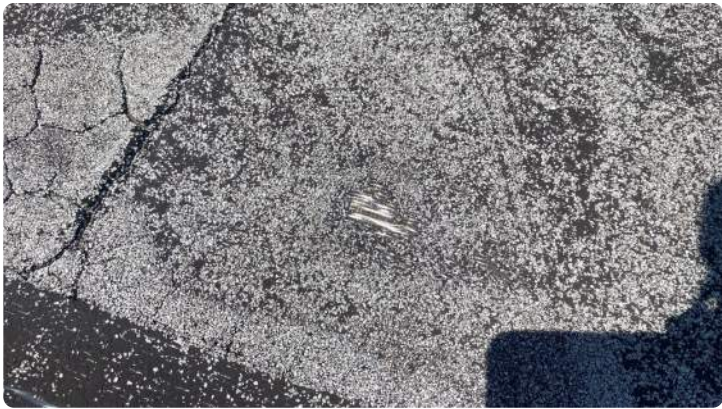
Photo showing gouge in field with exposed skim.

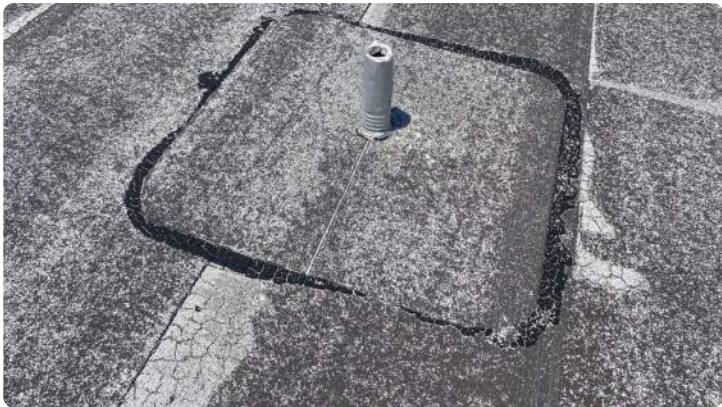
Photo showing skim exposed in target patch.

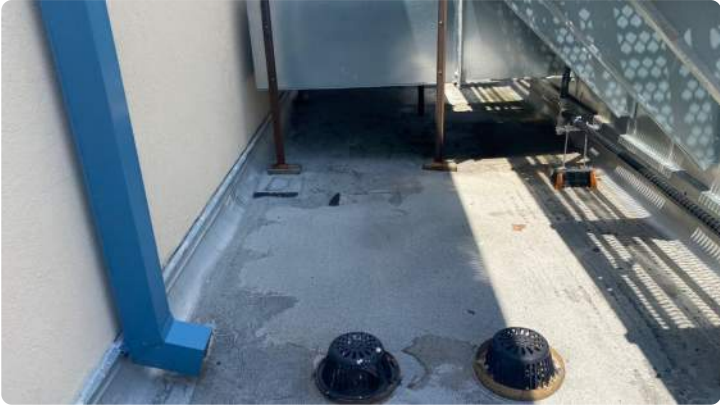
Photo showing loose granules piled up from field.

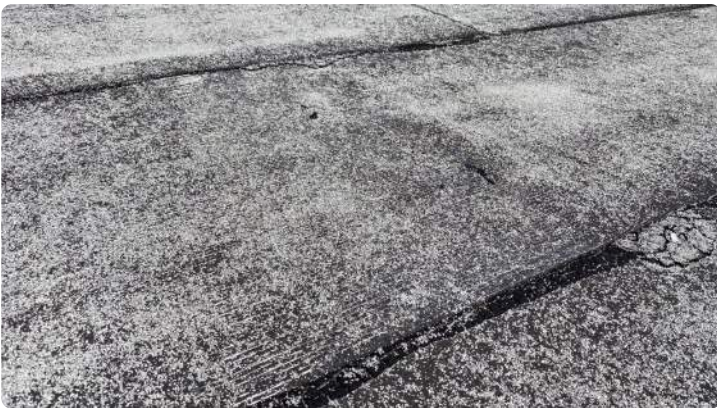
Photo showing skrim visible through the deteriorated field.

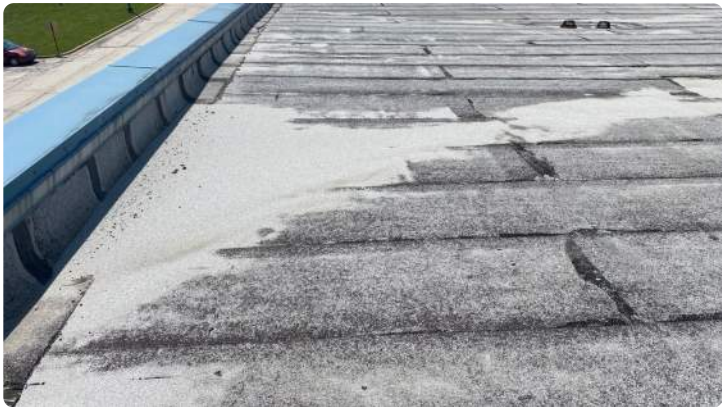
Photo showing granules piled up from deteriorated field.

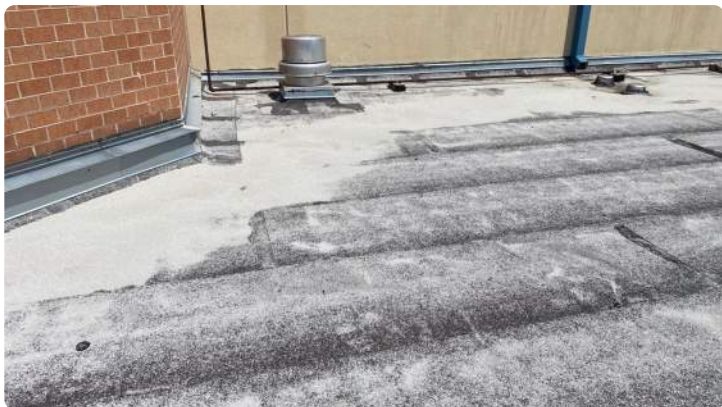
Photo showing granules piled up from deteriorated field.

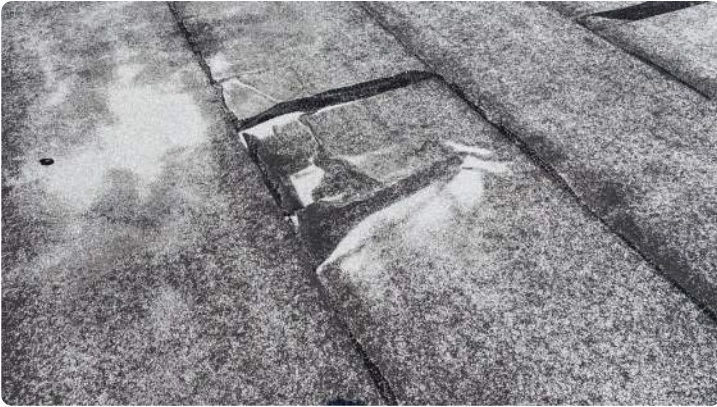
Photo showing area where field is wrinkled with fish-mouths.

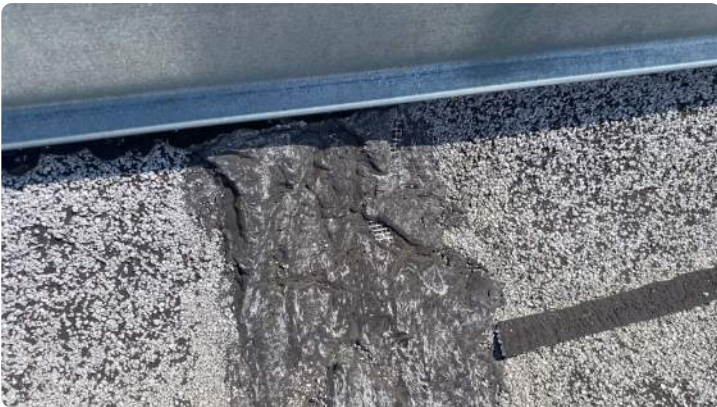
Photo showing skim visible through projection flashings.

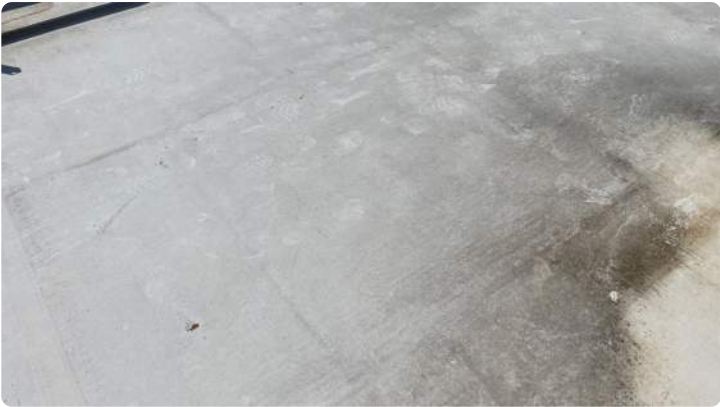
Soft area, one hole patched as part of the maintenance agreement

Photo showing a hole in the field membrane with soft insulation underneath. Repaired as part of the maintenance agreement.

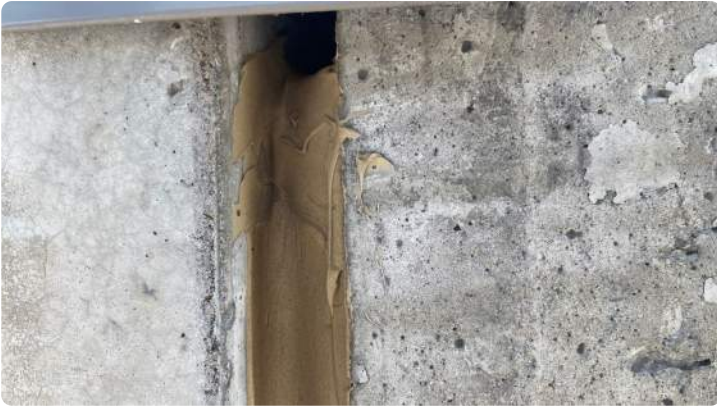
Wall joint is open and should be filled

Photo showing area in wall where it is open to elements. I recommend filling this gap with appropriate caulking.

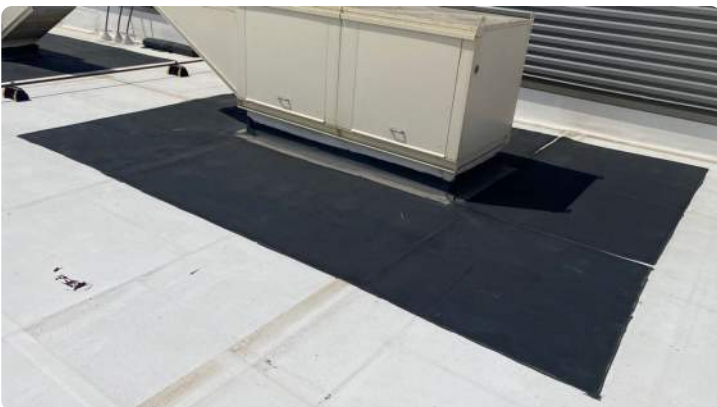
Additional photo showing unit surrounded by EPDM.
