# MASTER FACILITIES PLAN

MAY 2023

# CHAPTER 1: OVERVIEW

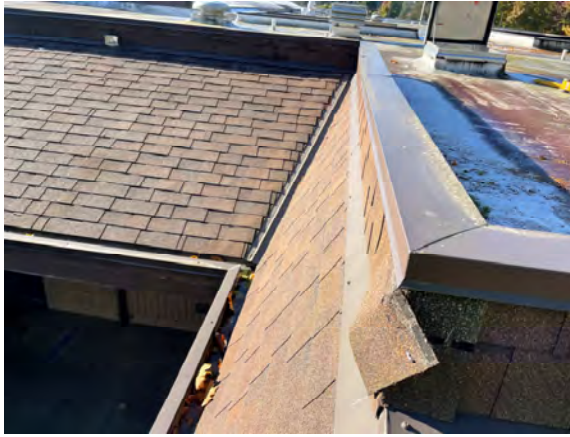
*Photo #1: Very Steep Slope Shingle Roof on Left*

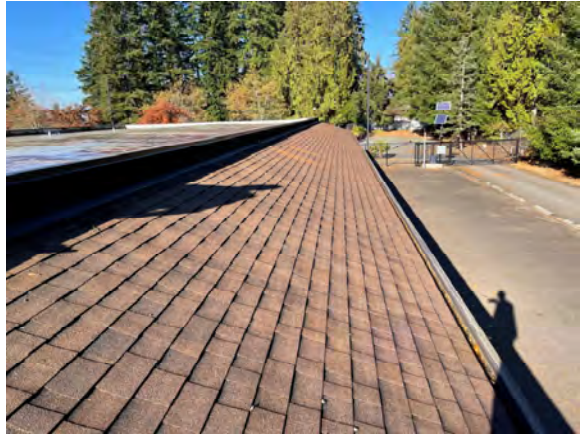
*Photo #2: Medium Shingle Roof*

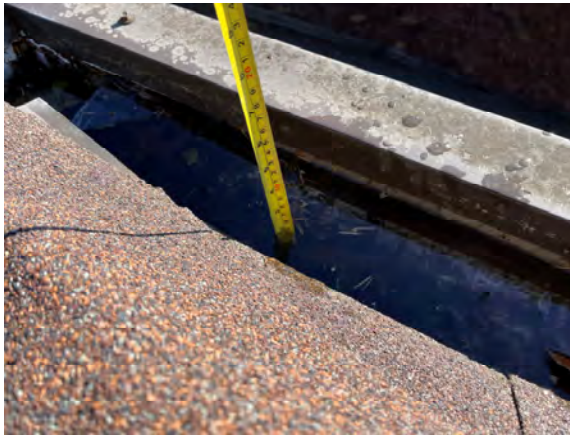
*Photo #3: Ponding Water in Gutter (Typical)*

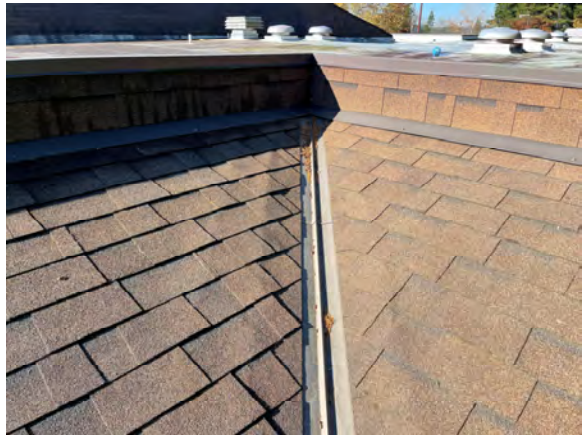
*Photo #4: Metal Valley at Shingle Roof*

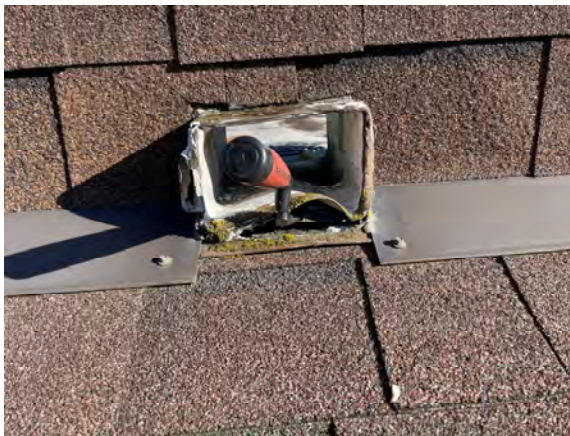
*Photo #5: Damaged Scupper Flashings*

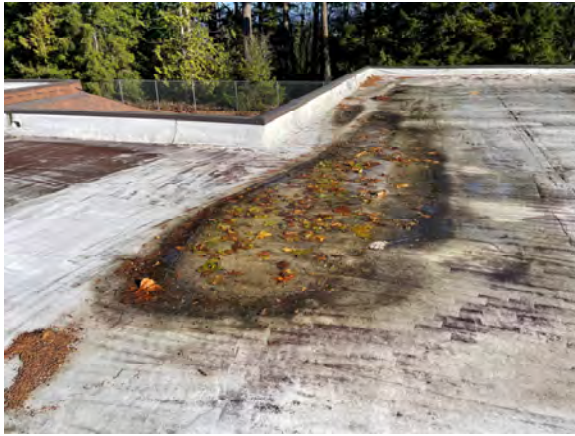
*Photo #7: Large Pond at Low Slope Roof (Typical many locations)*

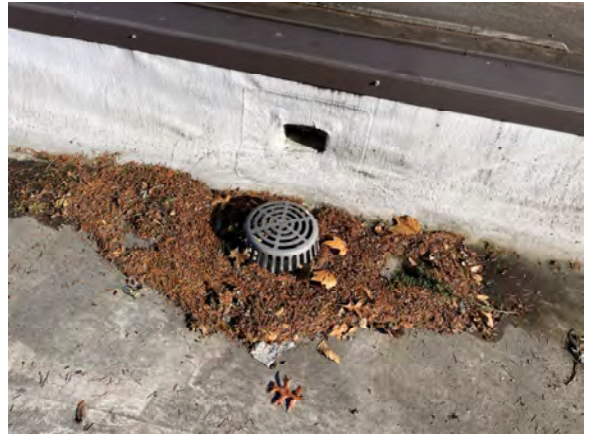
*Photo #8: Debris at Drain with Overflow Scupper*

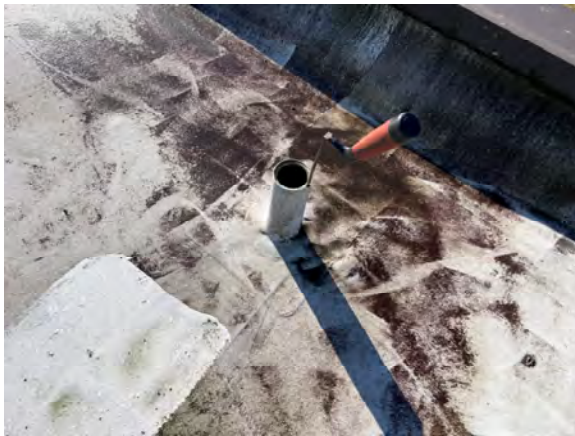
*Photo #9: Open Flashing*

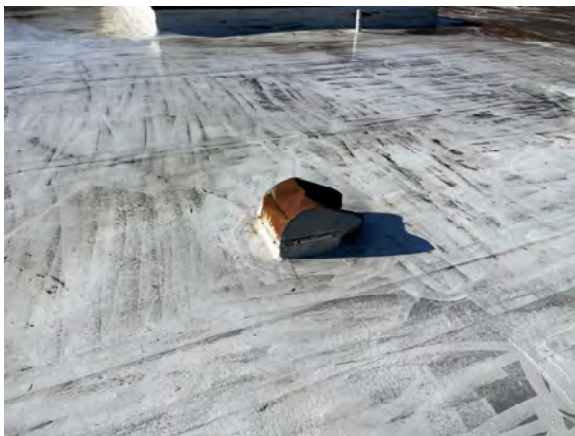
*Photo #11: Damaged Vent (Vandalism typical at vents) & Low Slope Roof (Typical)*

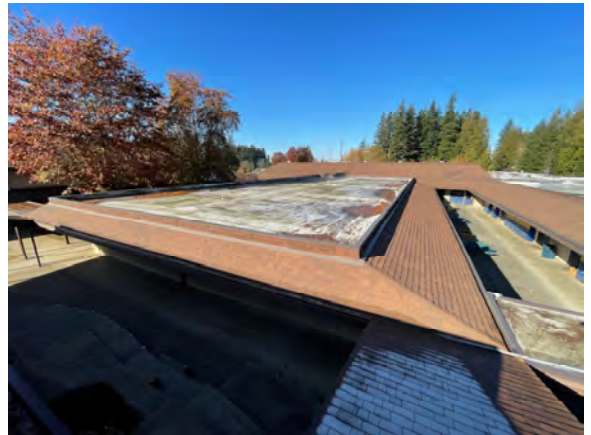
*Photo #18: Overview of Low Slope Roof (Typical)*

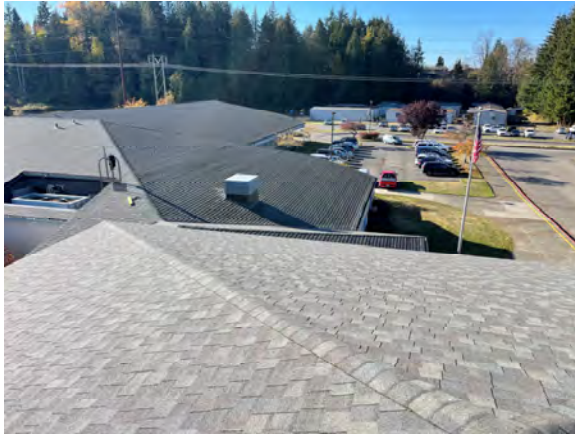
*Photo #1: Overall Roof Section*

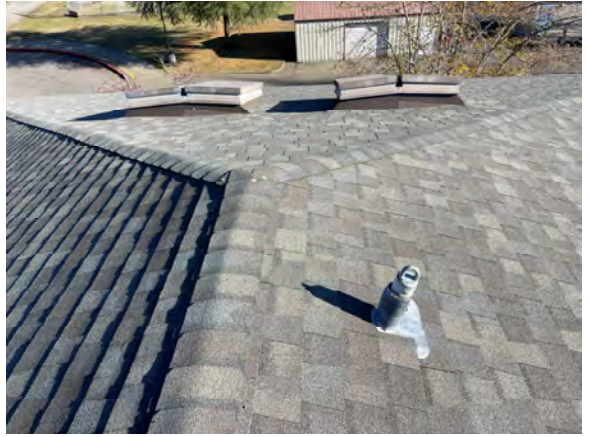
*Photo #2: Fall Protection Anchor & Smoke Hatches*

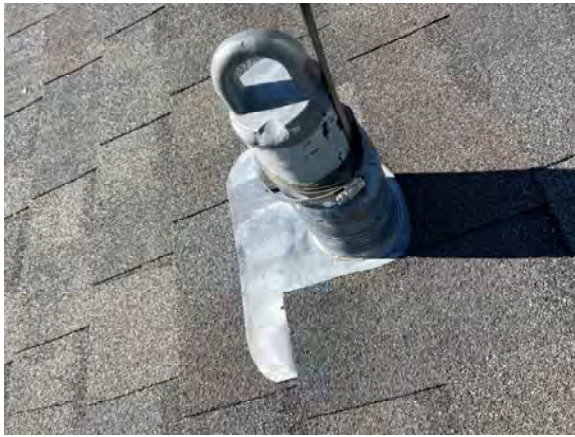
*Photo #3: Open Sealant at FP Anchor*

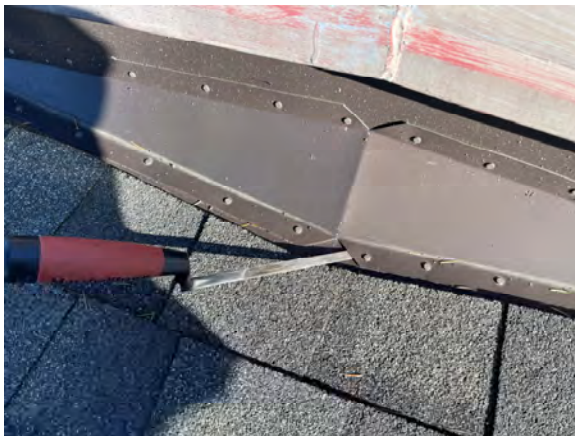
*Photo #5: Riveted Cricket w/ Open Seam*

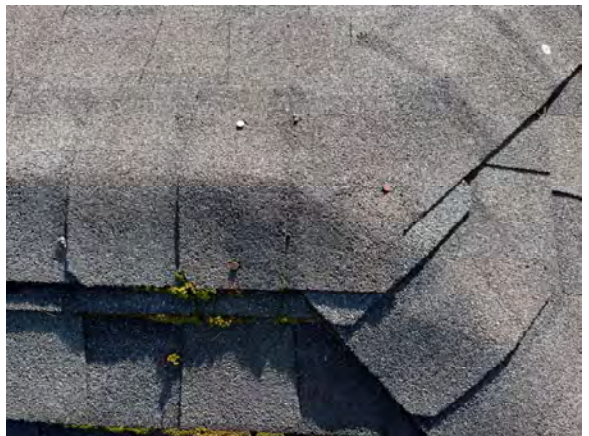
*Photo #6: Multiple Exposed Fasteners*

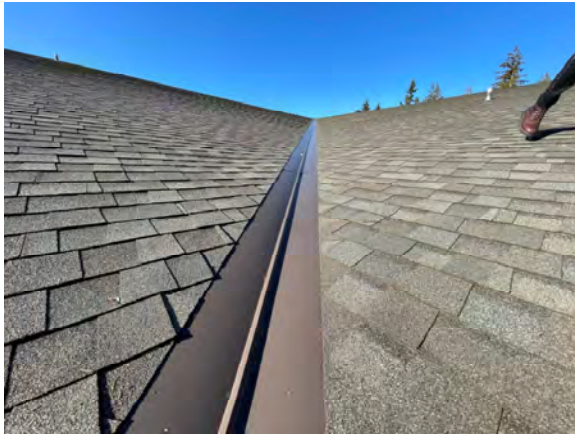
*Photo #7: "W" Metal Valley*

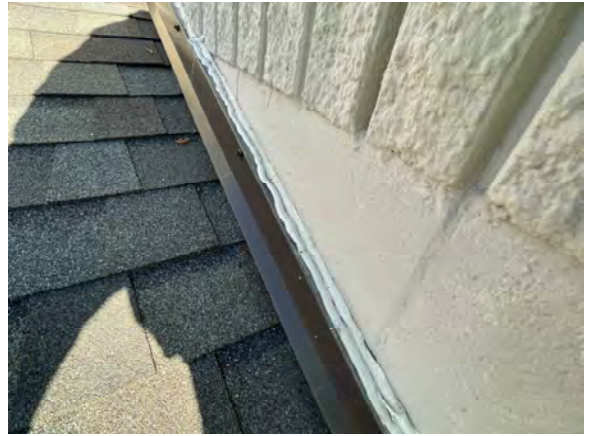
*Photo #8: Un-tooled Sealant*

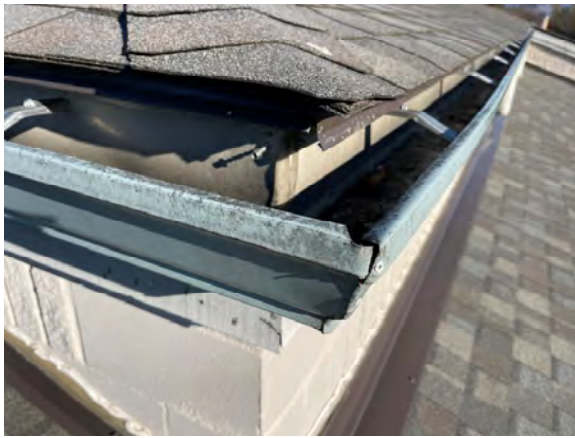
*Photo #9: Open Gutter Seam*

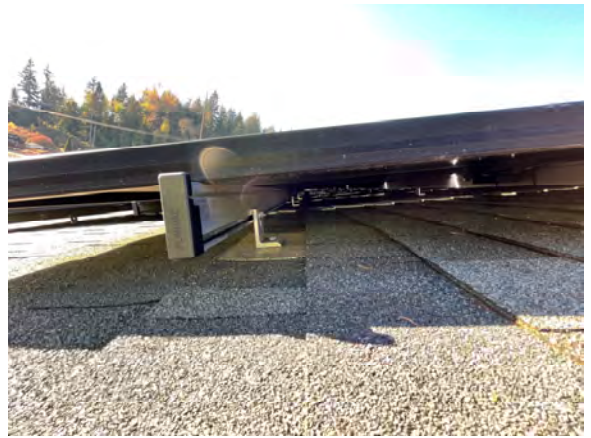
*Photo #10: Solar Panel Fastener Direct into Roof*

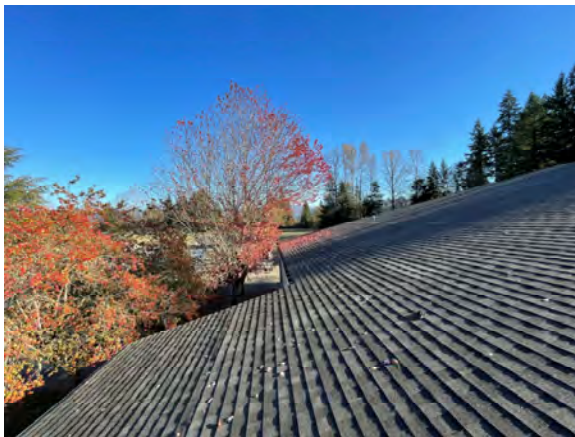
*Photo #11: Tree Hangs Over Roof*

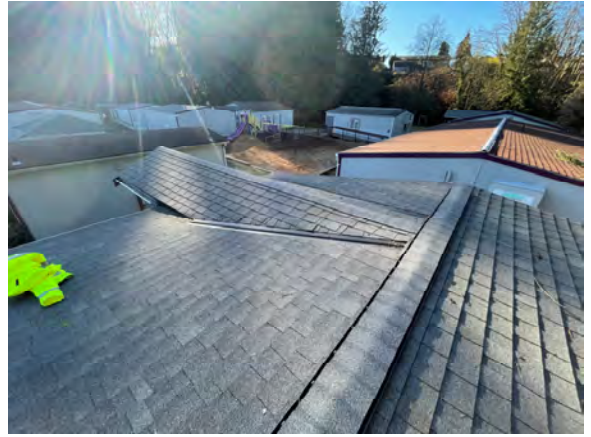
*Photo #2: Building 2 Roof – Metal Valley + Ridge*

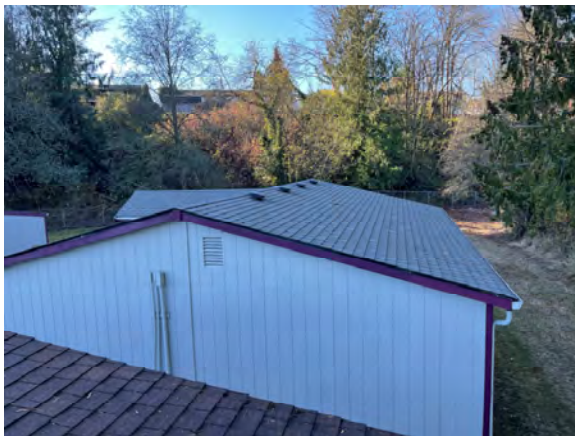
*Photo #5: Building 3 Roof [Good]*

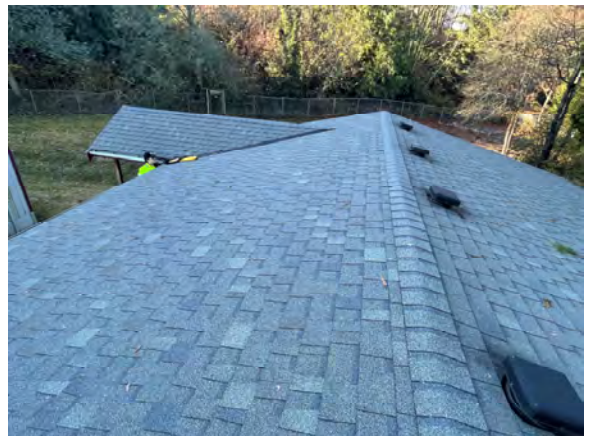
*Photo #6: Building 3 Roof*

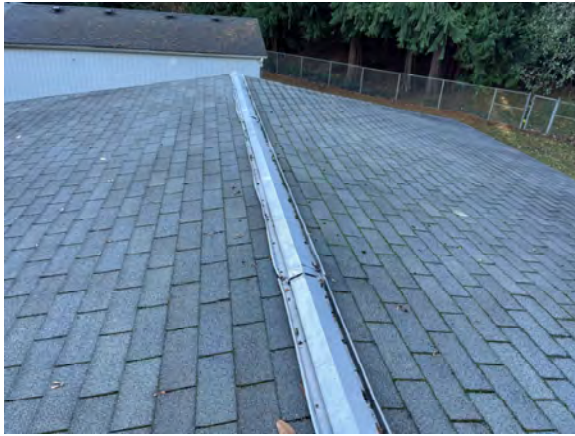
*Photo #7: Building 4 Roof [Failed] with Surface Fastened Ridge Vent*

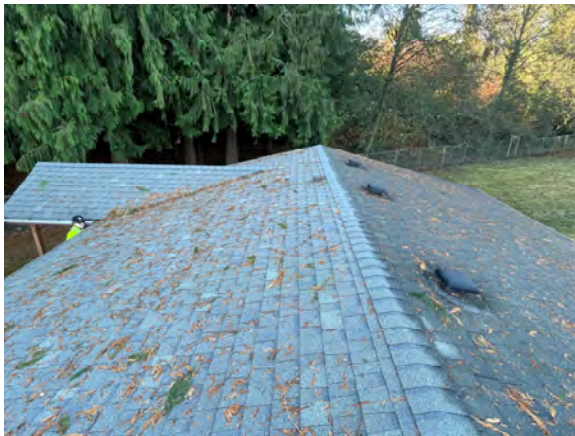
*Photo #9: Building 5 Roof [Good]*

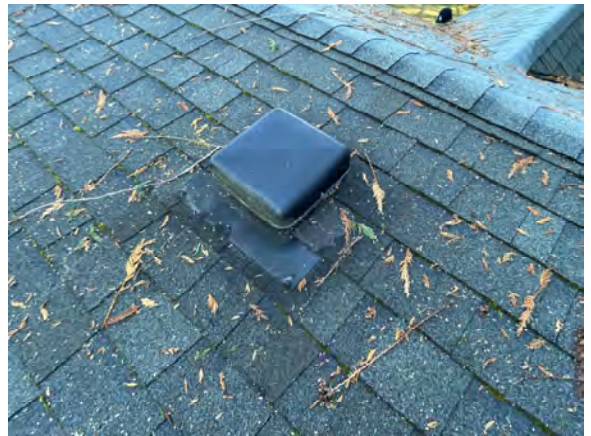
*Photo #10: Building 5 Roof Static Vent*

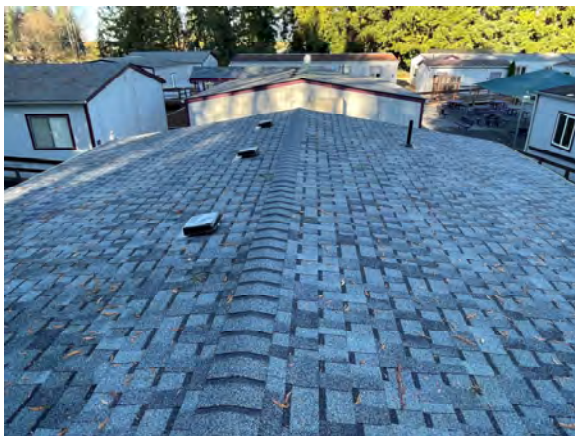
*Photo #11: Building 6 Roof [Good]*

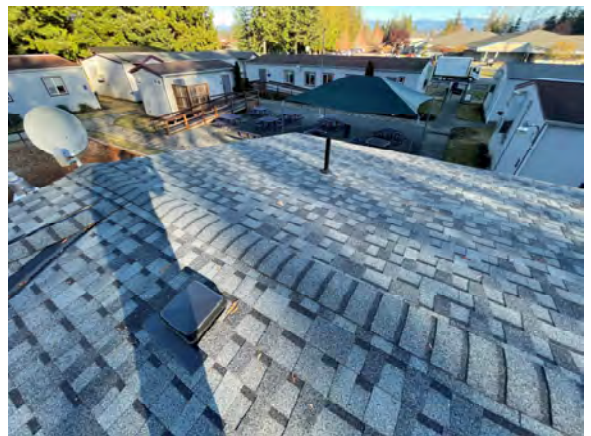
*Photo #12: Building 6 Roof Penetration + Static Vent*

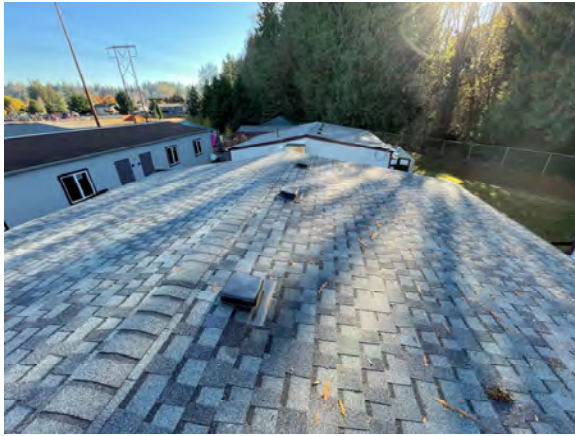
*Photo #7: Building 7 Roof [Good]  
(Building 6 in background)*

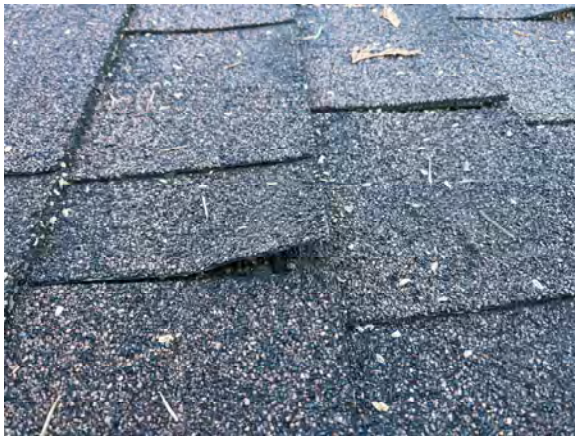
*Photo #9: Building 8 Shingle Curl*

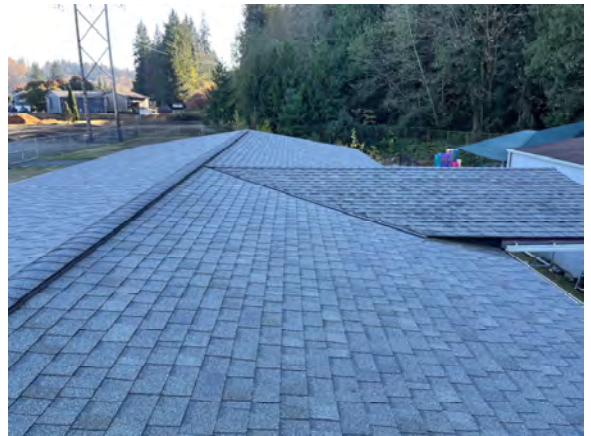
*Photo #10: Building 9 Roof [Good]*

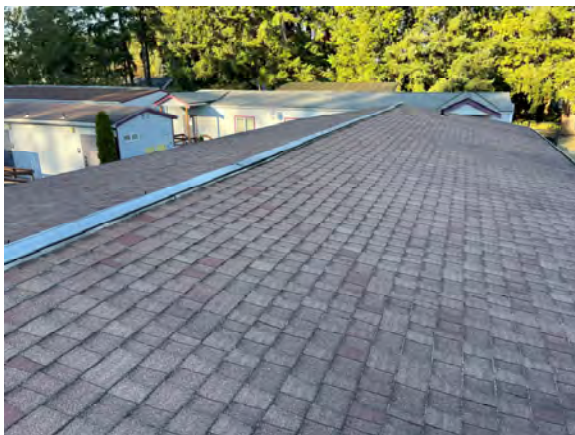
*Photo #11: Building 10 Roof [Failed]*

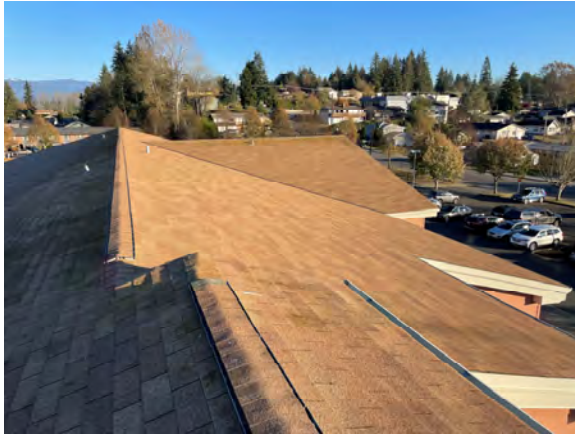
*Photo #1: Overall Roof Area (Looking East)*

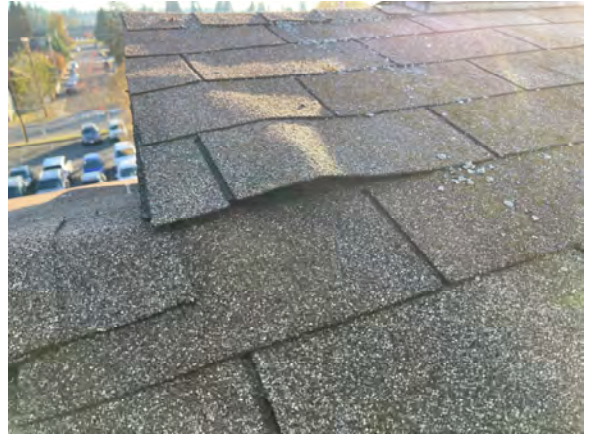
*Photo #2: Fastener Backout*

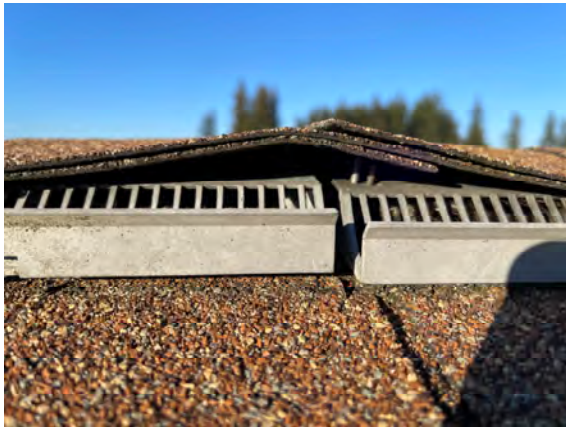
*Photo #3: Ridge Vent w/ Fastener Backout*

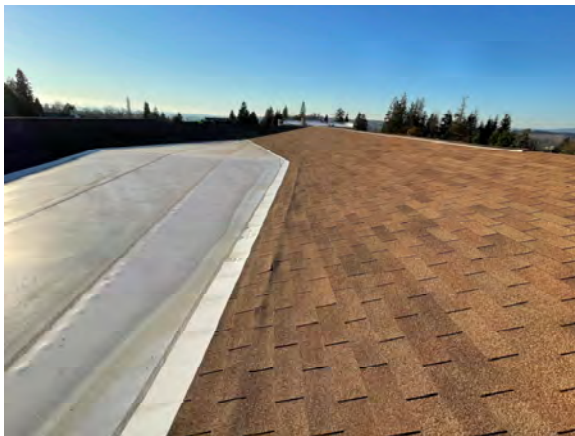
*Photo #5: Damage Shingles & Cricket Transition*

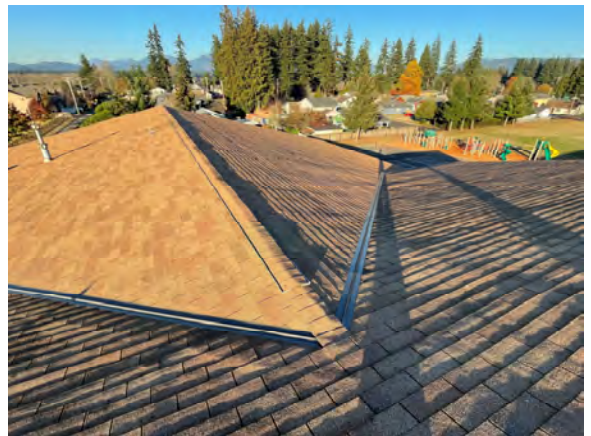
*Photo #6: "W" Sheet Metal Valleys*

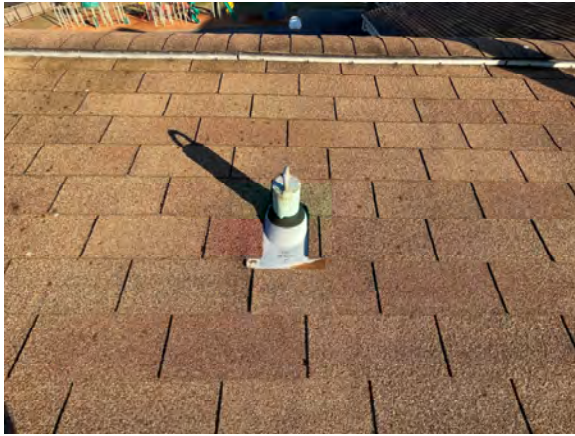
*Photo #7: Failed Penetration Flashing*

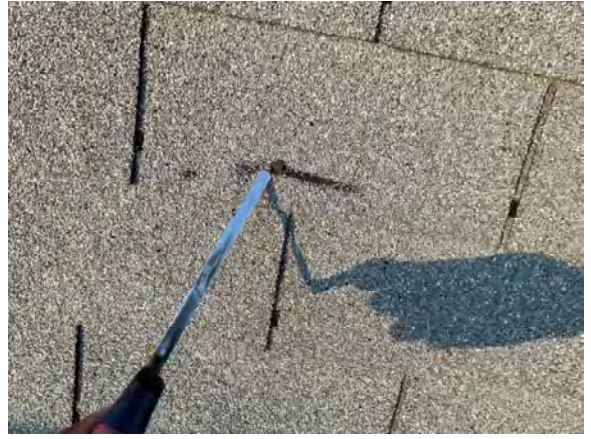
Photo #2: Fastener Backout

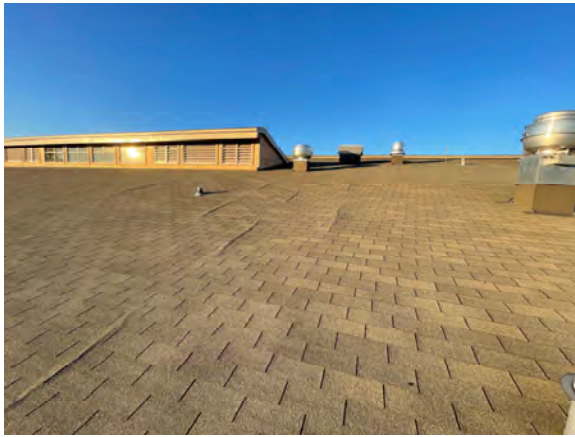
Photo #3: Shingle Ridging

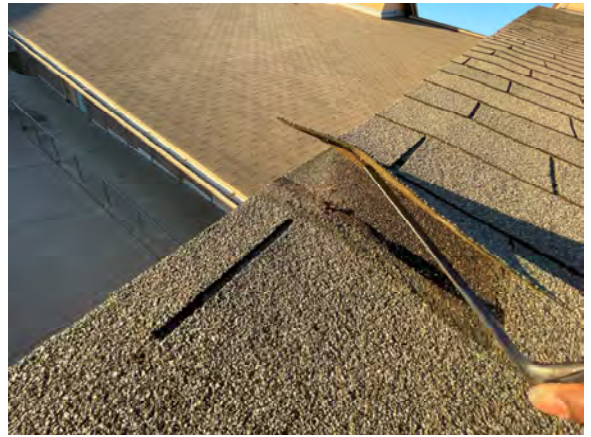
Photo #4: Fastener Backout

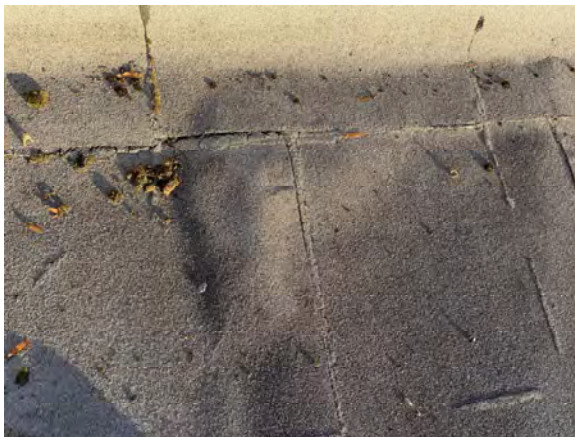
*Photo #11: Blister*

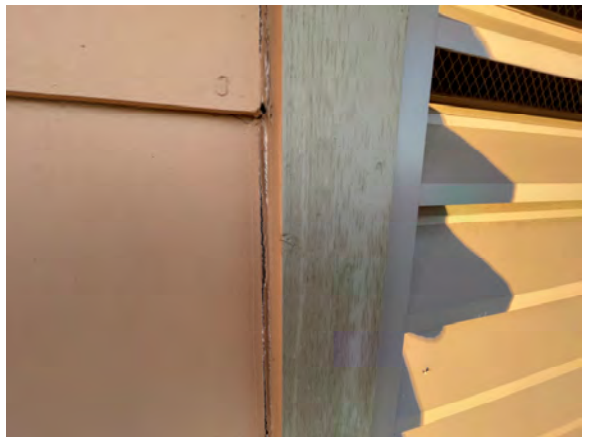
*Photo #12: Open Sealant Joint*

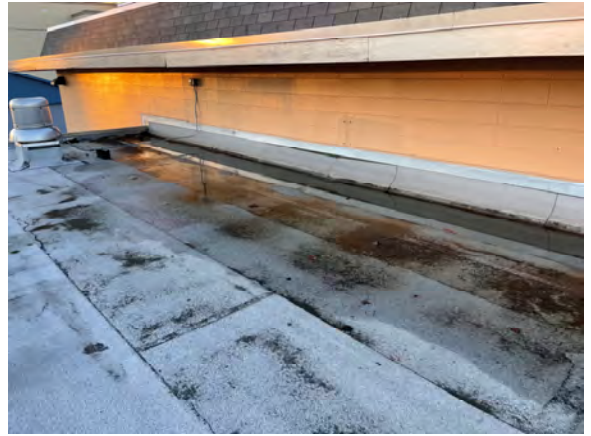
*Photo #14: Large Pond*

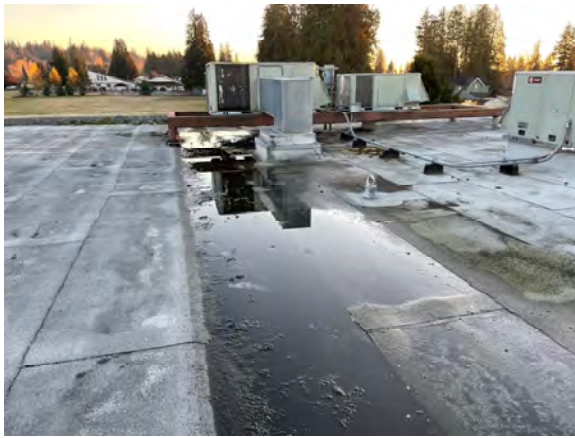
*Photo #15: Central Valley Pond*

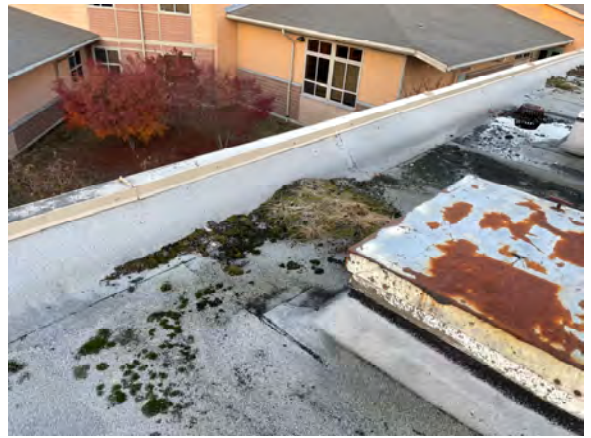
*Photo #16: Remnants of Bird Nest*

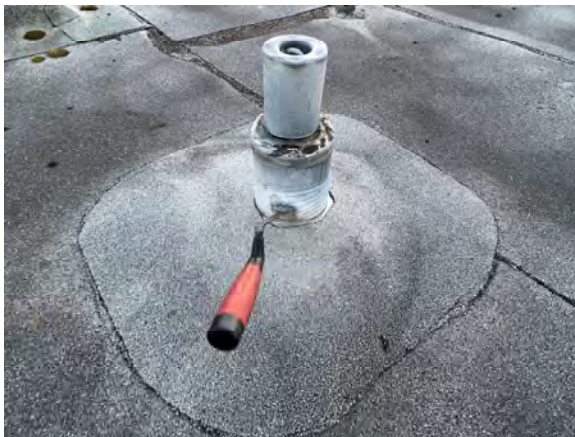
*Photo #17: Open Lead Flashing*

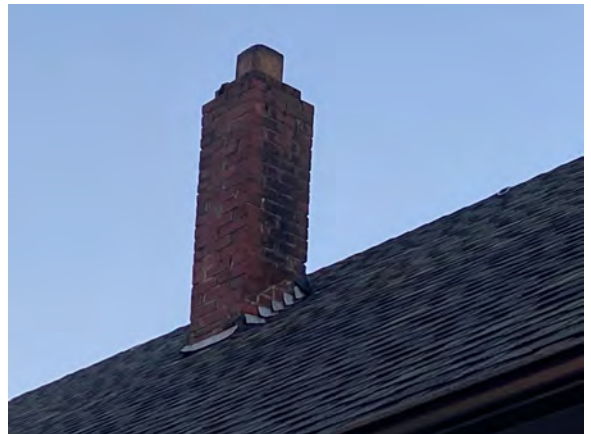
Photo #2: Chimney

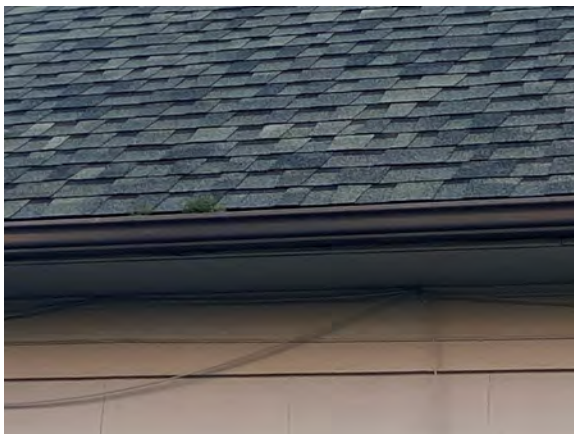
Photo #3: Debris in Gutter

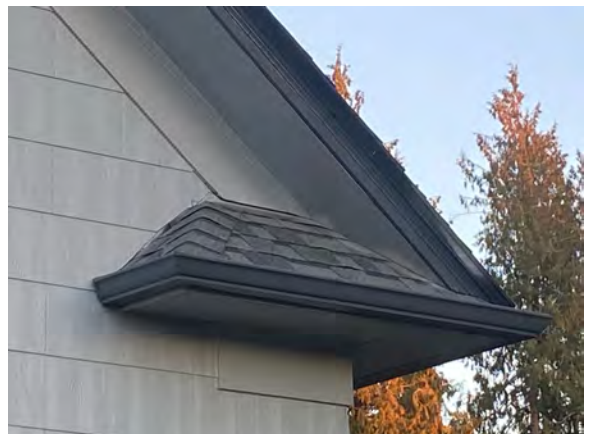
Photo #4: Siding & Gutter

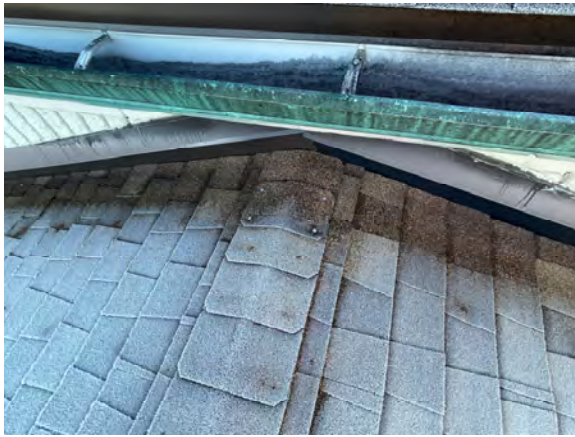
*Photo #4: Open & Failed Flashing*

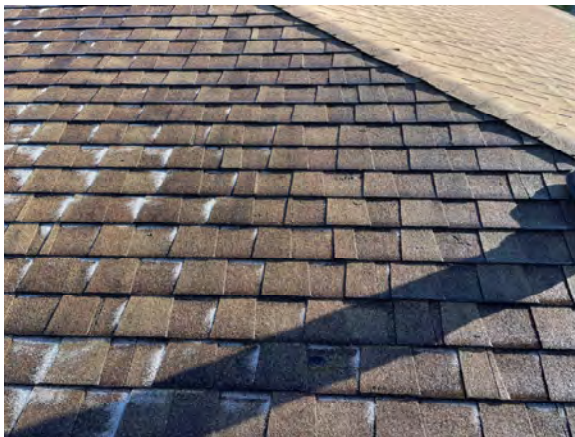
*Photo #12: Degraded Shingle*

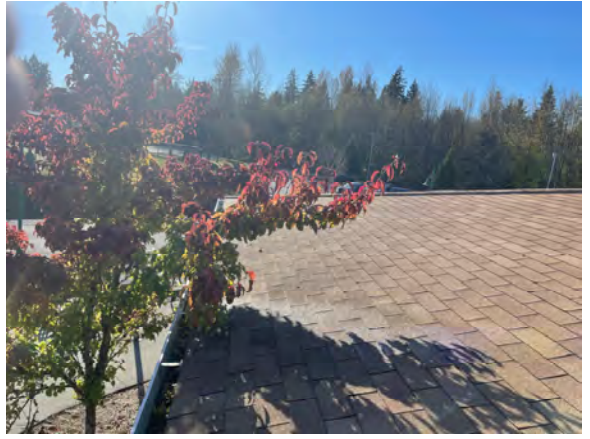
*Photo #3: Previous Shingle Repair & Missing Shingle*

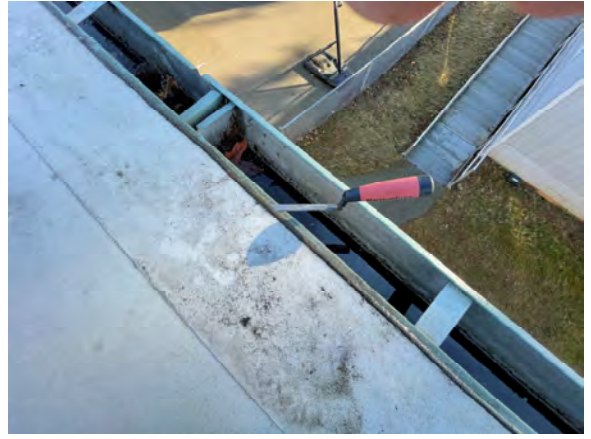
Photo #2: (MB) Open Gutter Edge Seam & Gutter Ponding

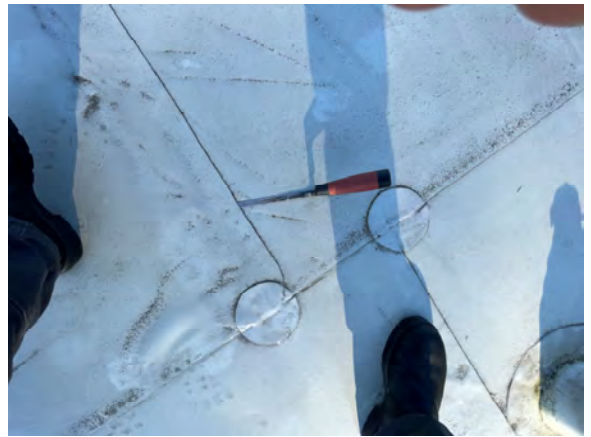
Photo #4: (MB) Open Seam

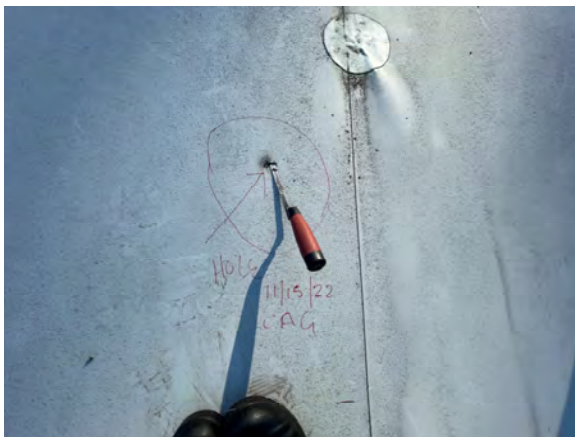
Photo #5: (MB) Hole

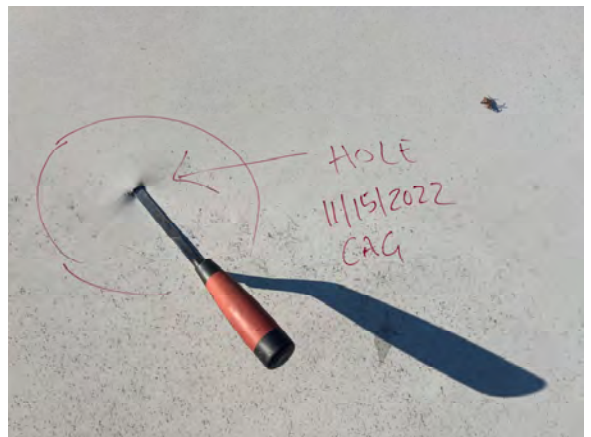
Photo #6: (MB) Hole

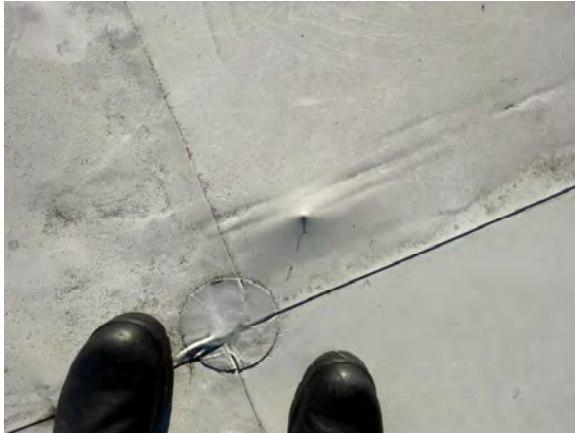
*Photo #7: (MB) Fastener Backout*

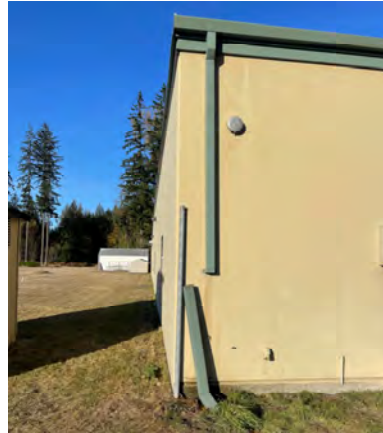
*Photo #8: (MB) Damaged Downspout*

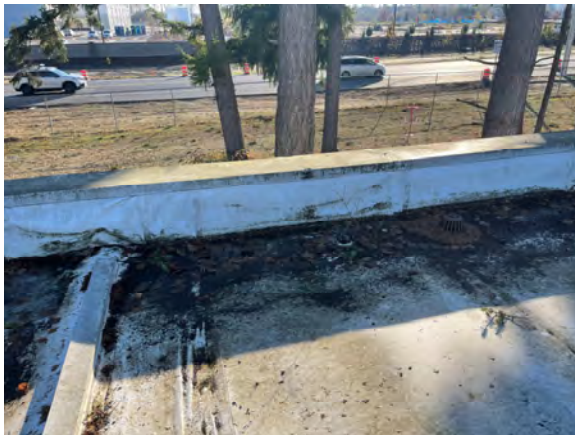
*Photo #9: (P1) Debris & Ponds*

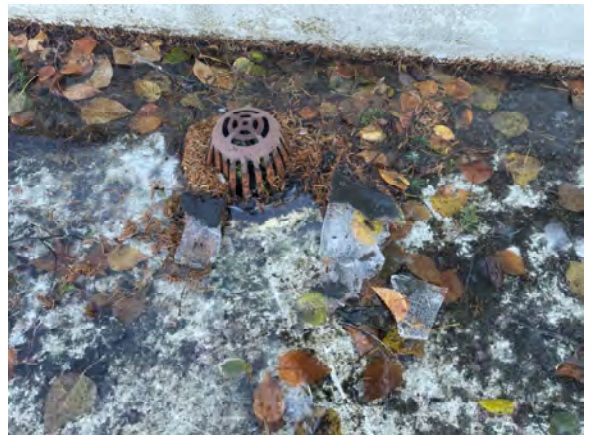
*Photo #10: (P1) Internal Drains with Ponds and Debris*

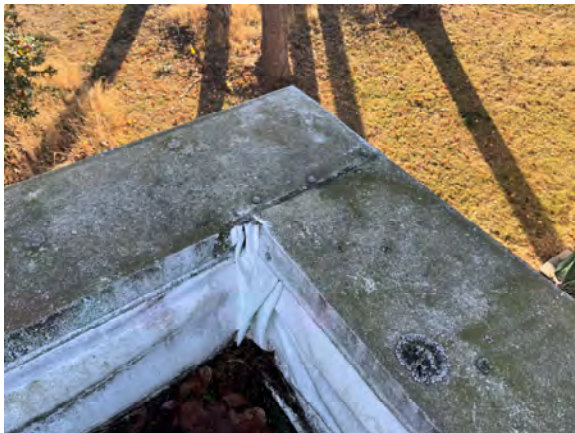
*Photo #11: (P1) Exposed Fastener*

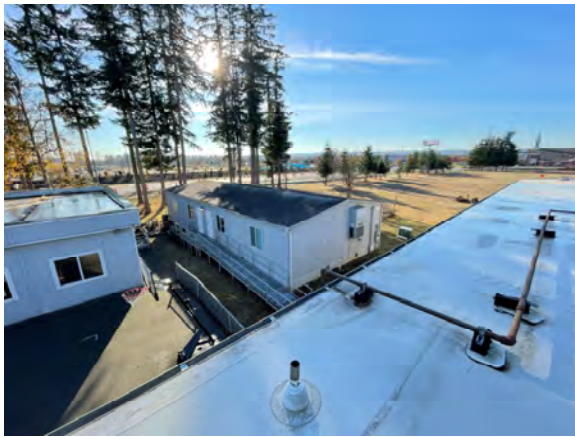
*Photo #12: (P1) Damaged Repair*

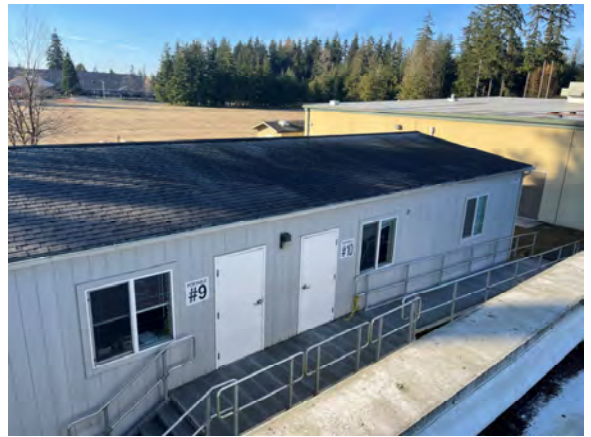
Photo #13: (P2) Overview of Roof

- (MB) Main Building Roof : Provide a repair and maintenance project
- (P1) Roof : Provide a repair and maintenance project
- (P2) Gable Portable : Replace shingle roof system
- (P3) Gable Portable : Provide a repair and maintenance project

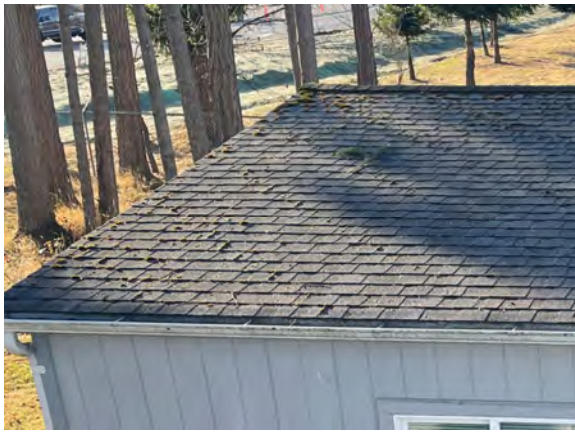
Photo #14: (P2) Eastern Roof Area

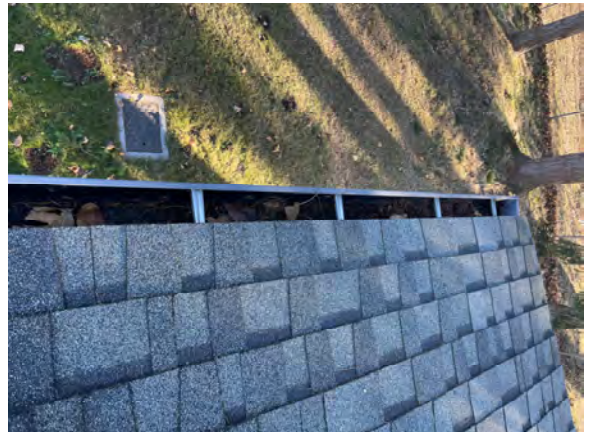
Photo #15: (P2) Algae Growth

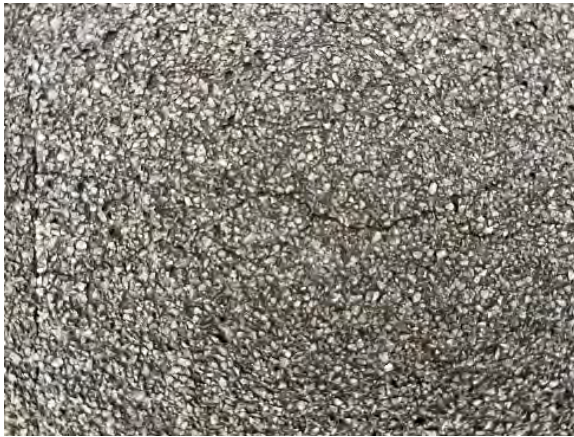
*Photo #1: Cracked Shingle*

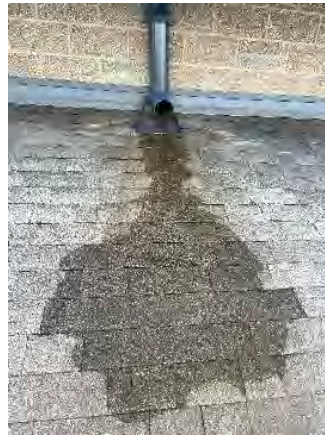
*Photo #2: Water Flow Over Roof Surface*

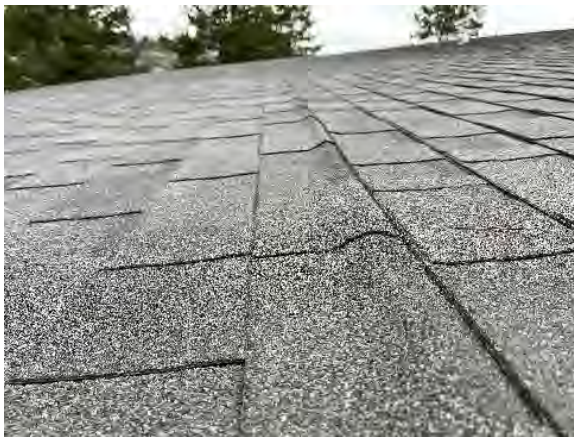
*Photo #3: Hump (Ridge) in Roof (Multiple Locations)*

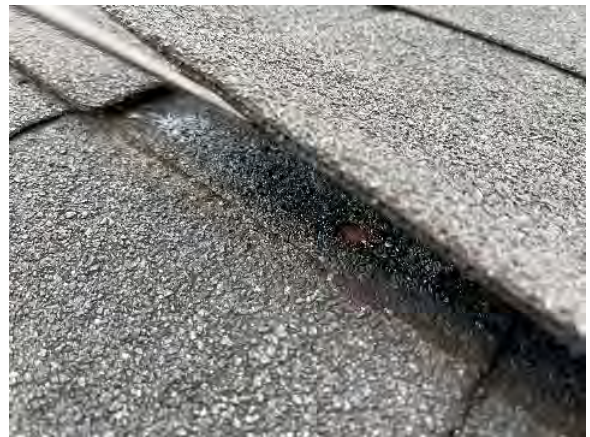
*Photo #4: Over-driven Nail*

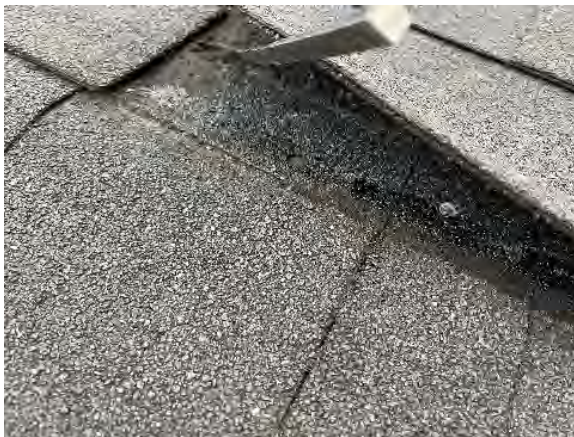
*Photo #5: Over-driven Nail at Back Slope*

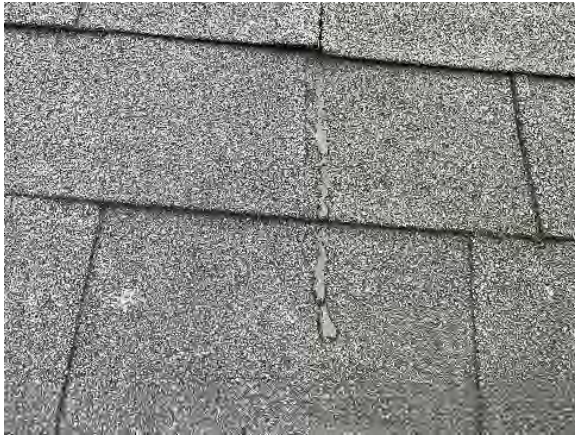
*Photo #7: Water Running Out on a Dry Day above Hump*

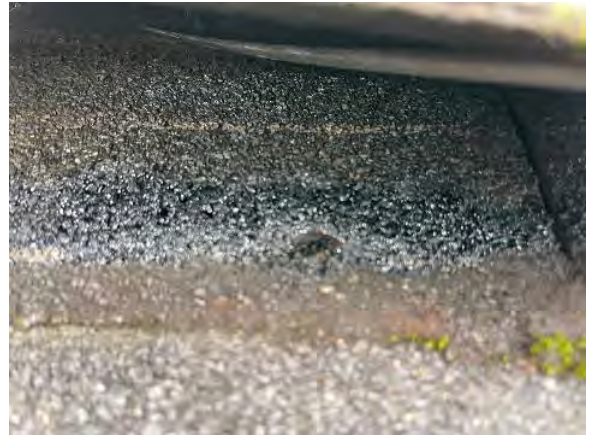
*Photo #8: Fastener Backout*

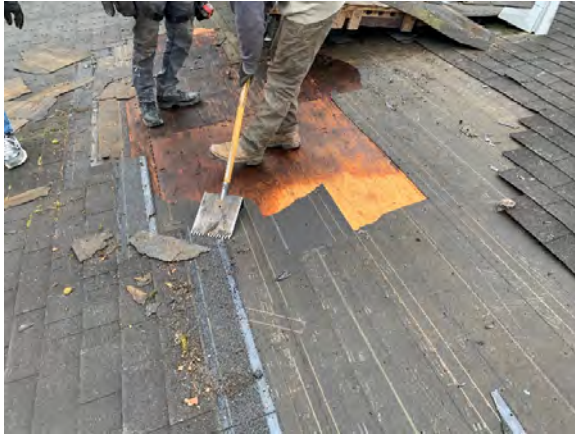
*Photo #9: Rotten Plywood Substrate*

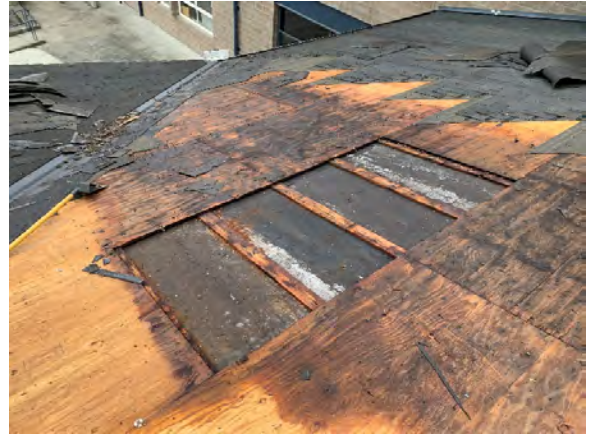
*Photo #10: Wet Furring and Insulation*

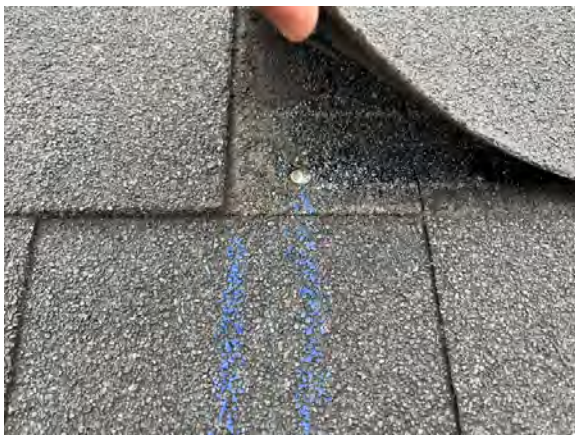
*Photo #11: Nail within Drainage Zone*

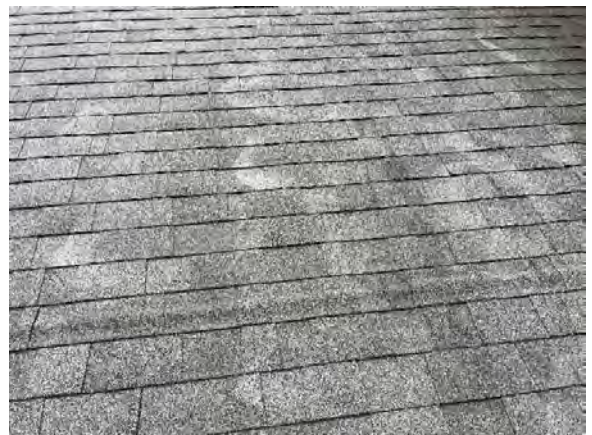
*Photo #12: Hump/Ridge Horizontal Across Roof*

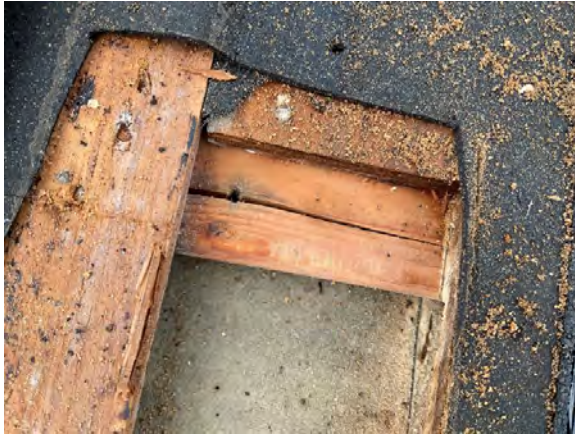
Photo #13: Damaged Furring Strip
